WITNESS EXPERT REPORT (VCAT)

1234 Main St. Melbourne VIC 3000

Buyer Name
16/10/2021 9:00AM

Inspector
Maison Azdari
Registered Building Practitioner & Pest Inspector
1300 471 805
booking@ownerinspections.com.au

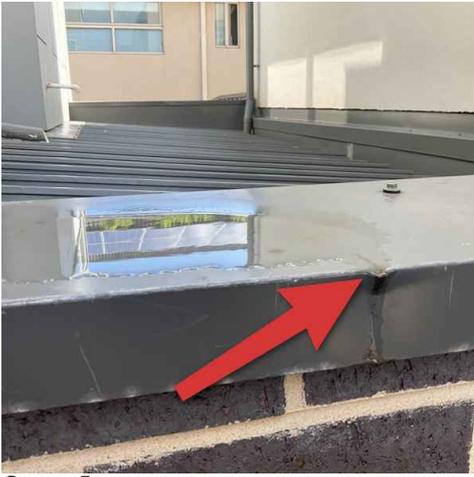
Garage Front

Metal roof/fascia/gutter has been damaged, scratched or dented in one or more areas.

The manufacturer clarified the brick wash must be done prior to the installation of the fascia to prevent any damage. Also, it states the painting touchup is NOT recommended, therefore, the damaged fascia/gutter/roof to be replaced.

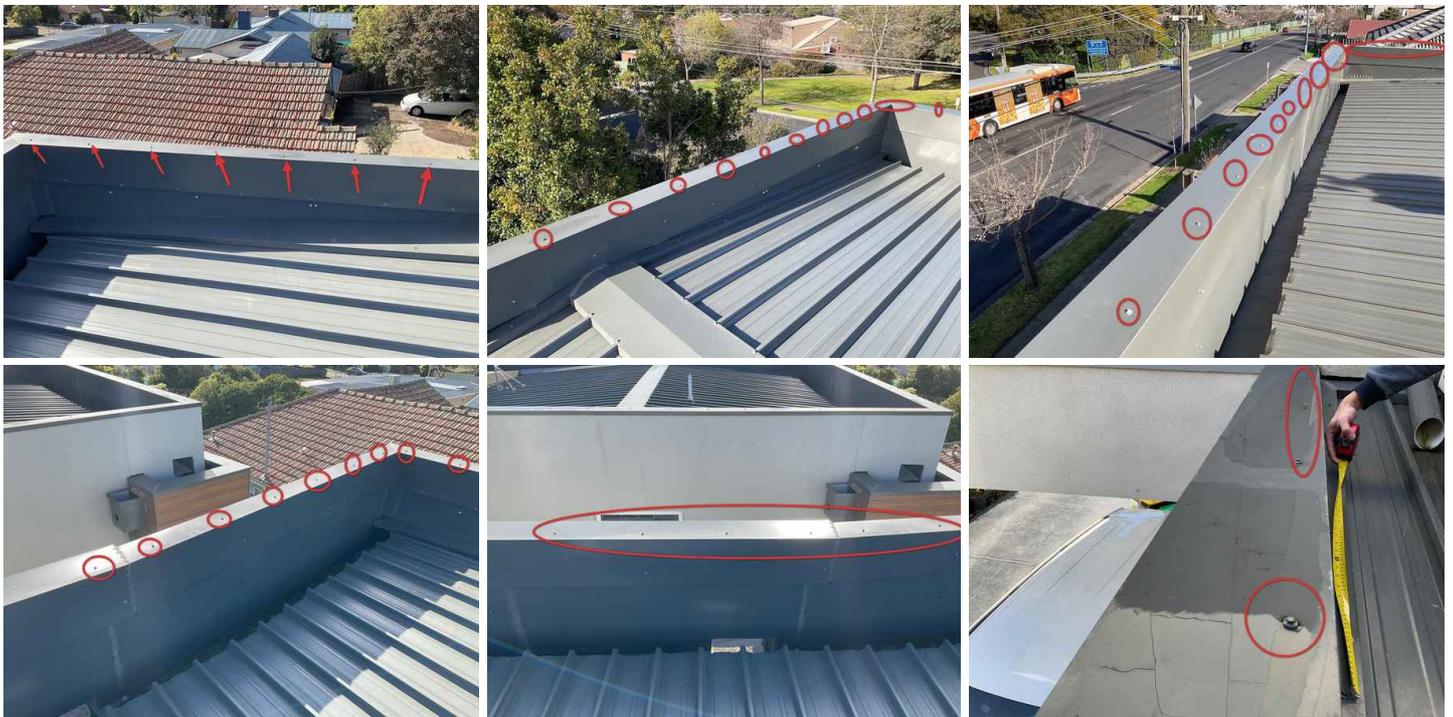
6.2.2 + Parapet Walls Capping

+ SIDE FIXING INTERVALS > 500MM

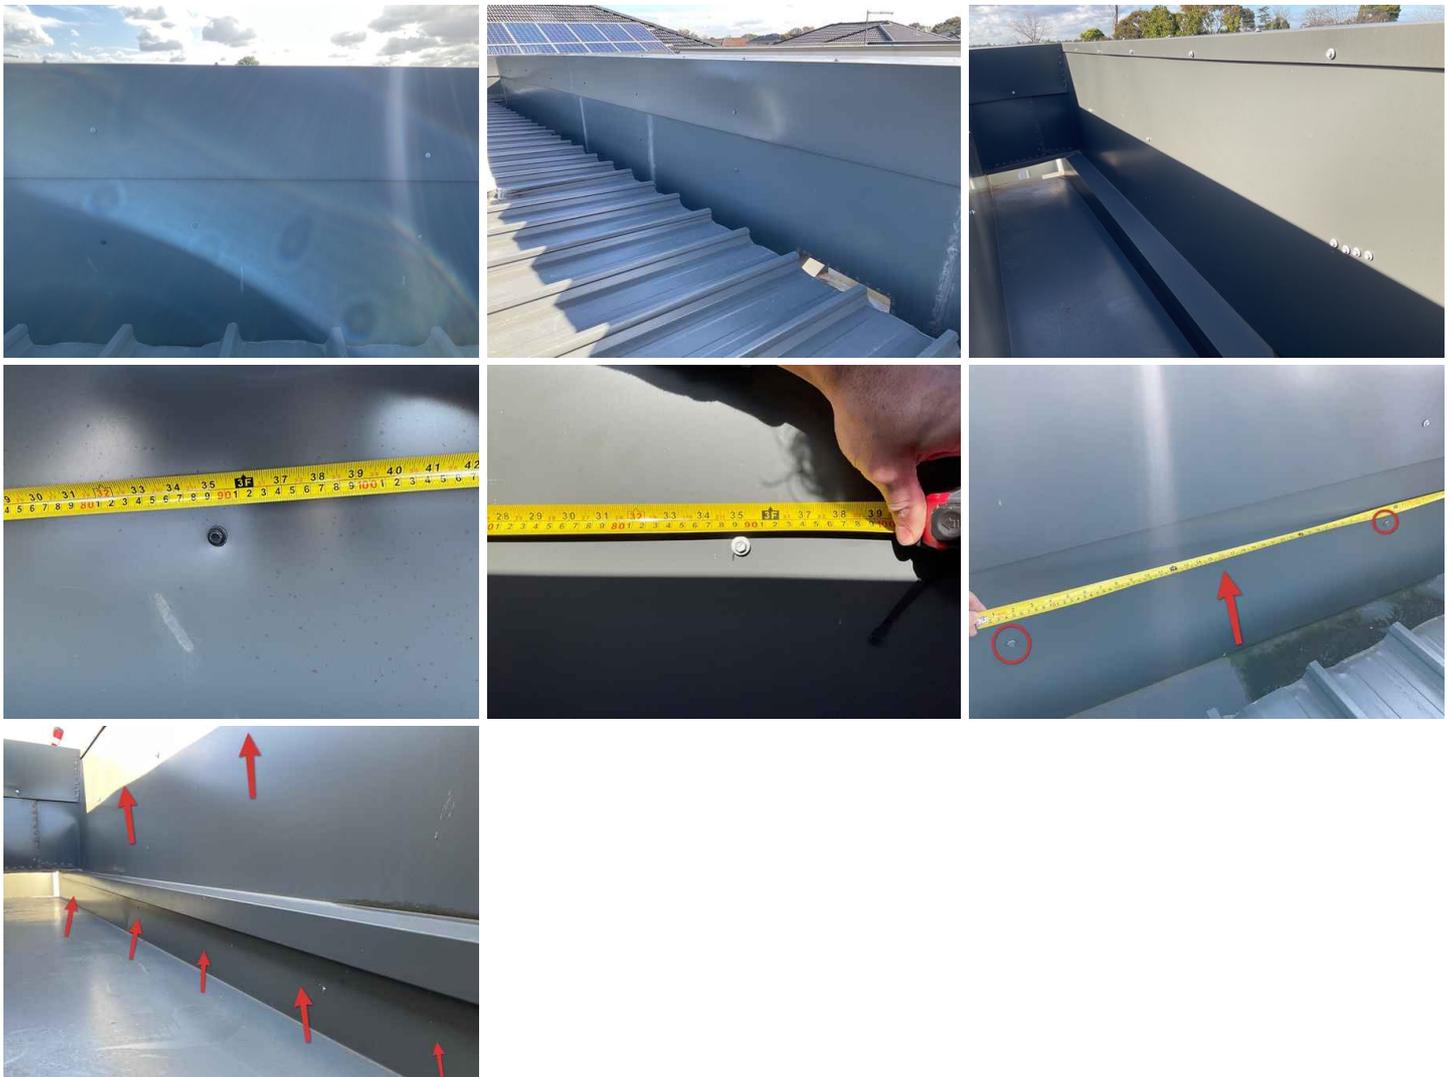
6.2.3 + Parapet Walls Capping

+ WATER PONDING NOTED

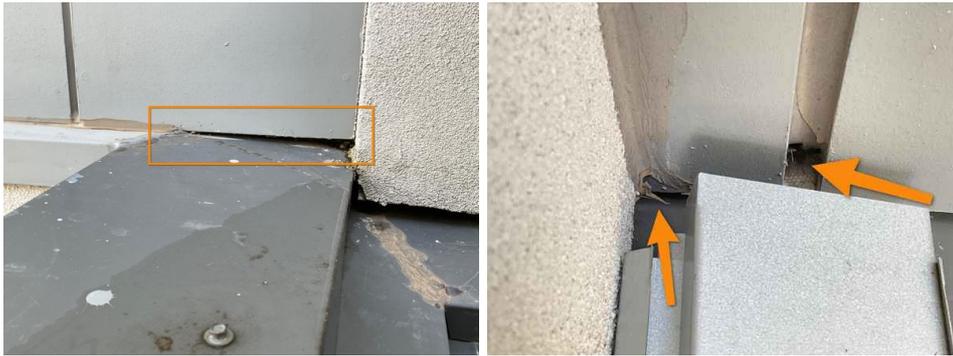
Flashing/sealing installed improperly and needs adjustment.

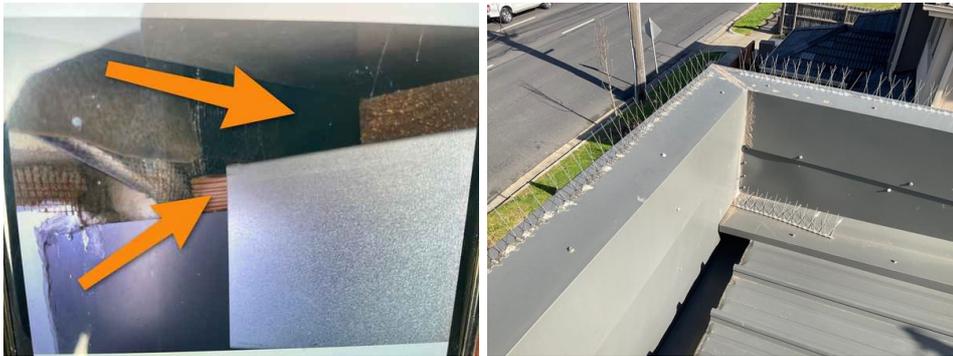
6.3.2 + Flashing and capping

EXCESSIVE GAP

The excessive gap is to be covered to prevent pests, birds and animals from entering the building and damaging walls and ceiling internal members.

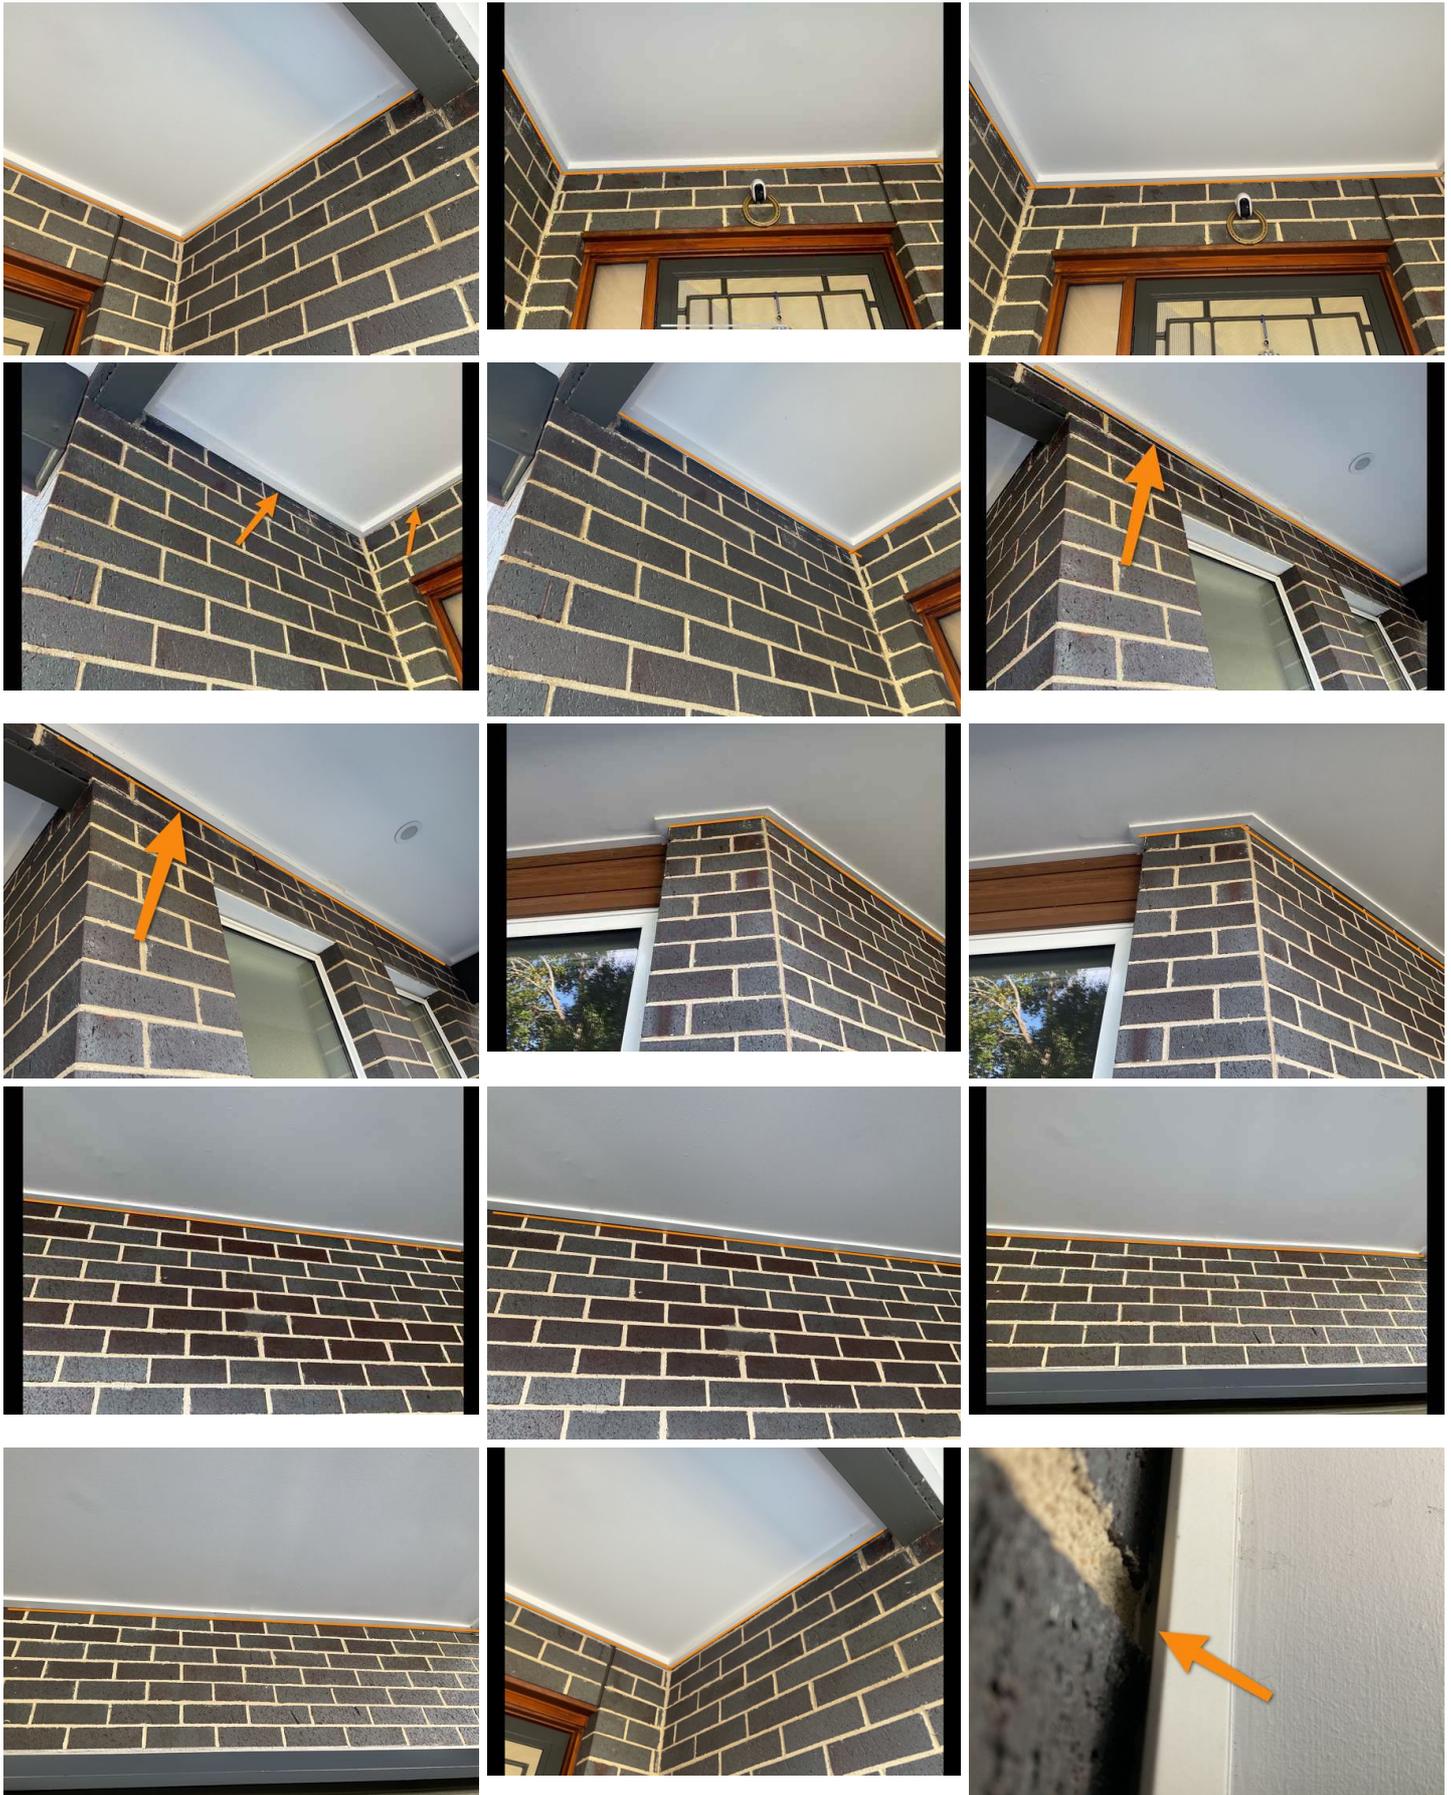
Garage

+ CAULKING/FILLING REQUIRED

One or more section(s) of eave require caulking or filling.

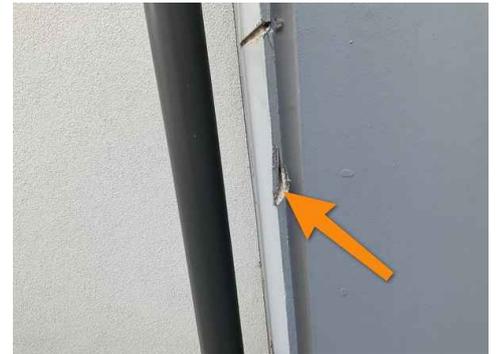
Over the Garage

The first-floor cement sheet cladding noted damage which can cause water to penetrate the cladding and degrading it over time.

The area is to be covered by a proper and durable glue/filler.

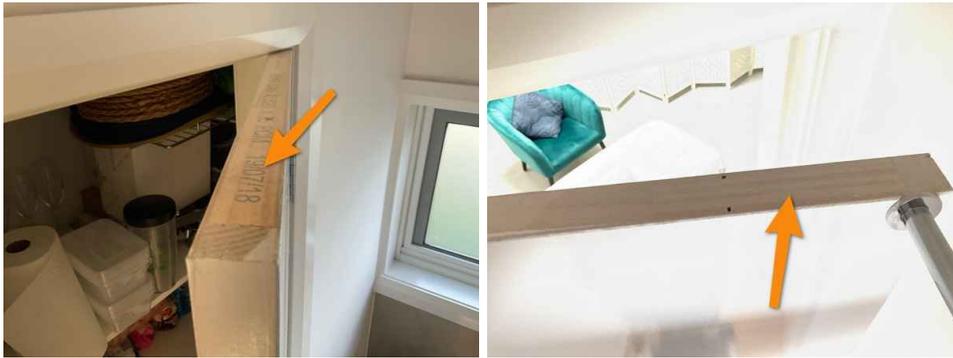
8.06 Sealing of door edges

Door leaves are defective if they do not have all sides, top and bottom edges sealed/painted in accordance with the manufacturer's specifications.

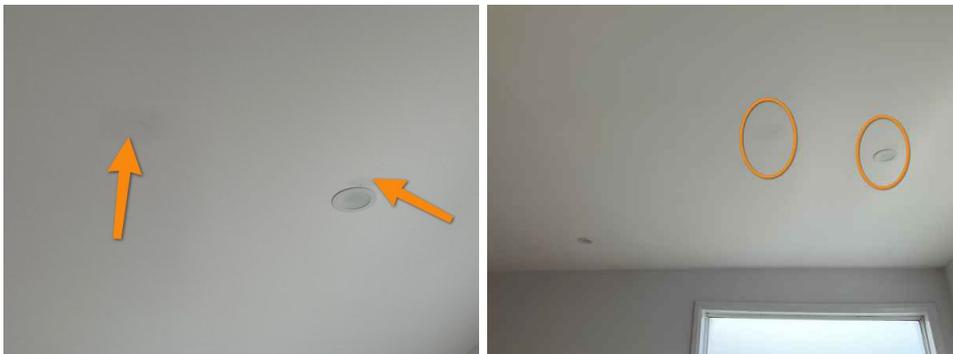
RETREAT AREAR CEILING PAINT DAMAGE

Damaged ceiling paint due to water leak to be repainted

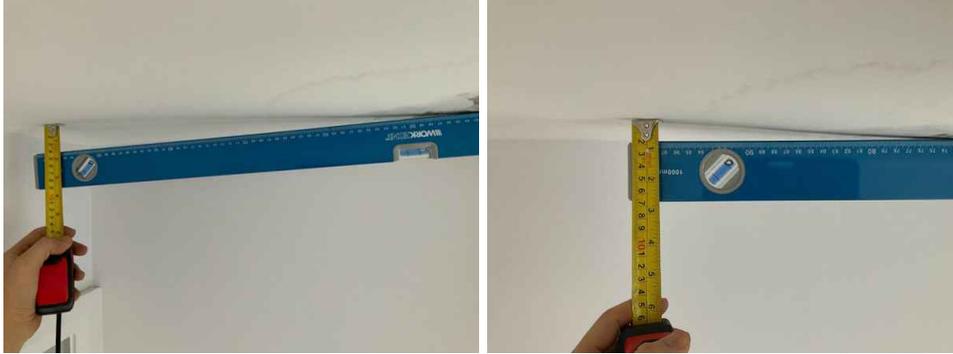
WATER DAMAGE, CEILING DROP AND MOULD IN BEDROOM 2

The water damage is being fixed by the builder, however, the dropped ceiling caused by the water damage is not fixed.

Also due to long term moisture existence, a big mould is growing in the ceiling which is dangerous for residents health and safety.

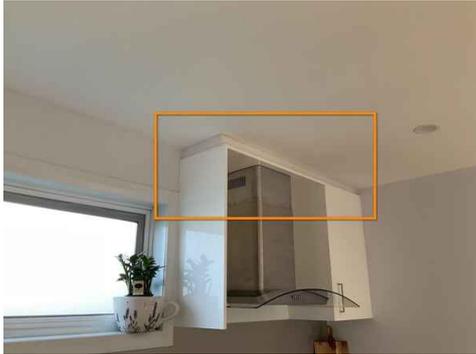
Kitchen

POOR PLASTERING

The quality of plaster over the kitchen overhead cabinet is poor. Replace the plaster and paint with the same colour as the dwelling walls.

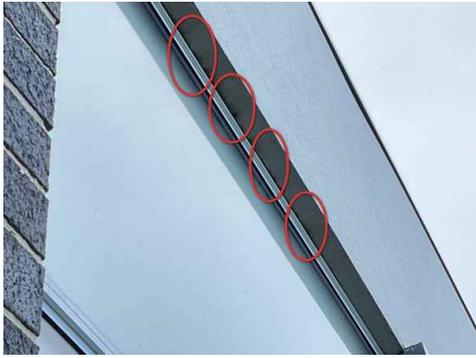
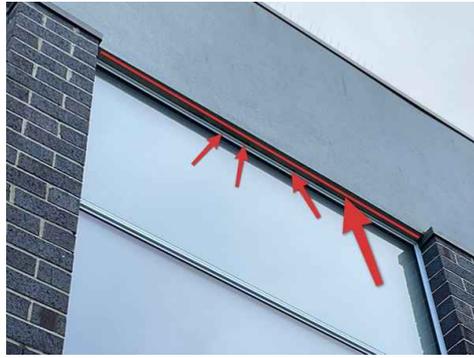
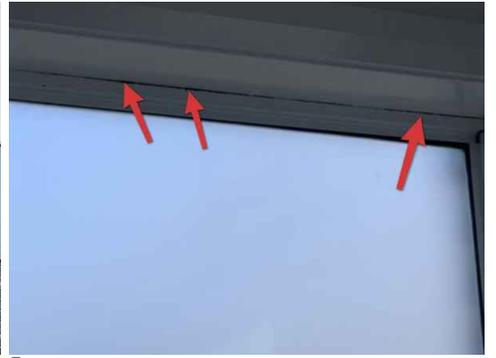
Front

Mould noted in on the windows surface of bedroom 1 and 2 due to lack of caulking between the windows external and cladding joints. The joints to be caulked properly and the moulds to be removed for the health and safety of the residents.

Moulds produce allergens (substances that can cause an allergic reaction), irritants and, sometimes, toxic substances. Inhaling or touching mould spores may cause an allergic reaction, such as sneezing, a runny nose, red eyes and skin rash. Moulds can also cause asthma attacks.

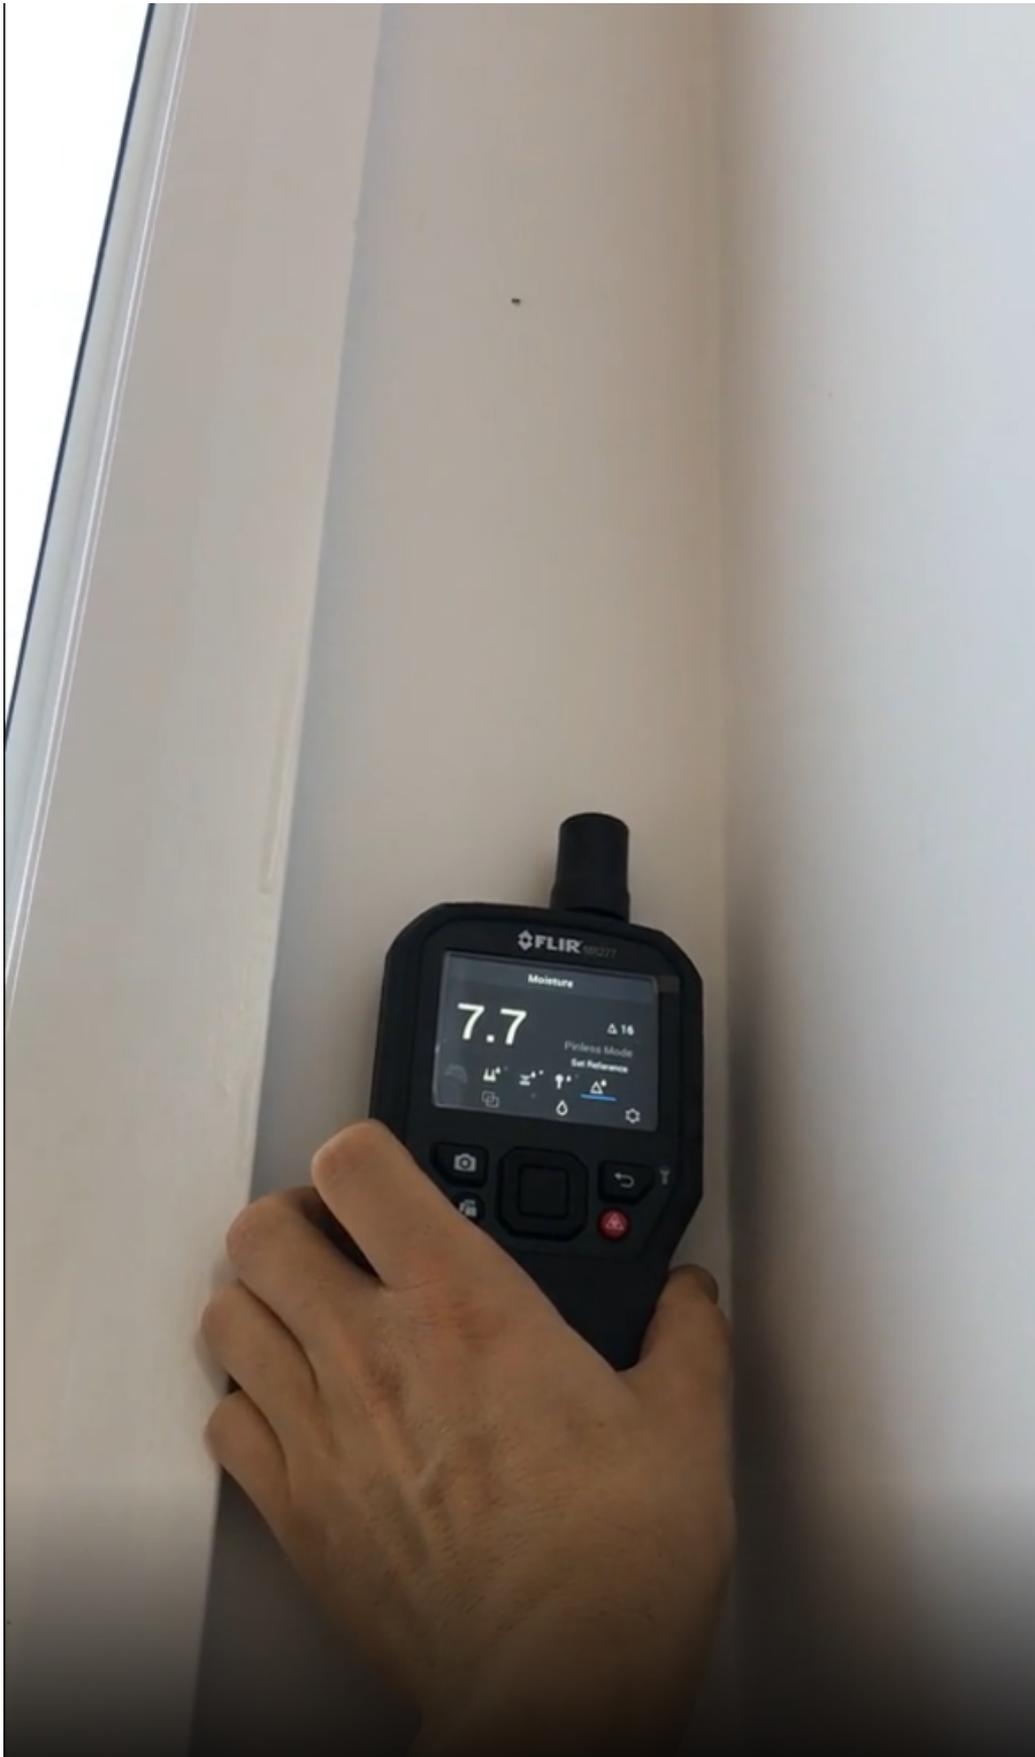
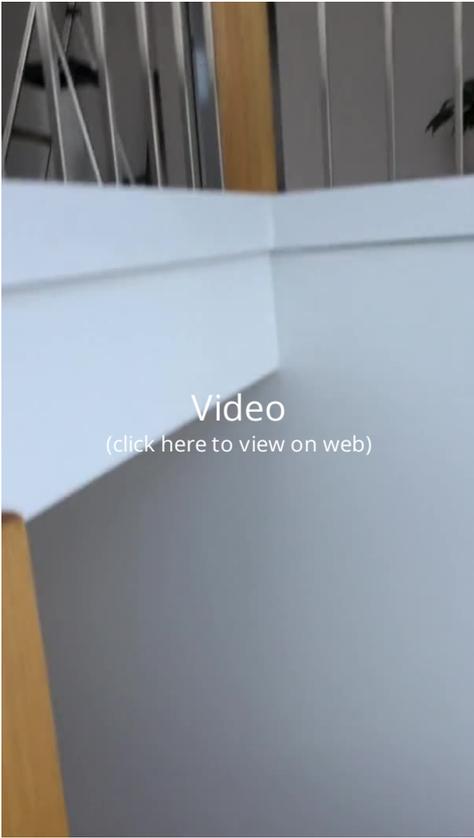
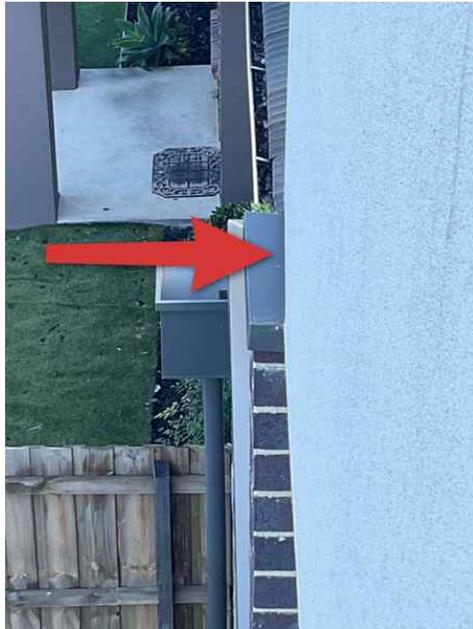
MOISTURE NOTED IN THE STAIRS AREA

Major Structural Defects/Safety Hazards

Moisture noted behind the plaster next to the windows in the staircase area. It seems to be due to negative grading of the flashing behind the wall outside.

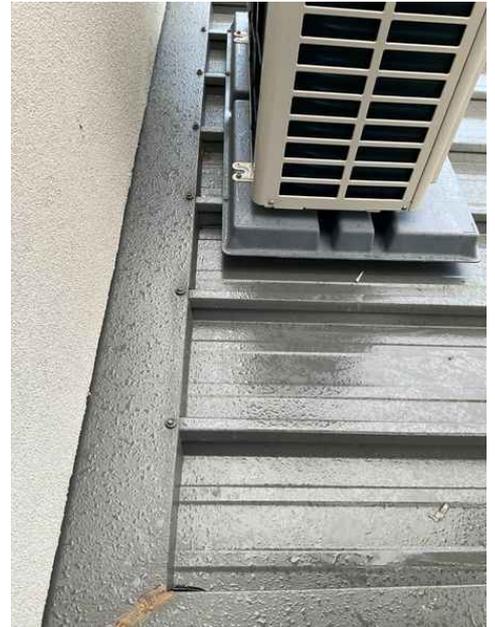
MOISTURE/LEAK NOTED IN THE DENNING ROOM CEILING

A very clear water stopping was noted on the dining room ceiling plaster which can cause water damage in the near future. This spot is located exactly 1.35m from the backyard sliding door which is the location of plaster joints. When water leaks to the ceiling area, it usually finds its way out from the plaster joints or downlight holes. This era is located under the air conditioner unit on the roof. The roof, fasteners and all joints are to be resealed and ceiling plaster to be replaced.
