# EXPERT WITNESS REPORT

I, Maison Azdari, have been engaged as an independent building expert witness in relation to water ingress and associated building defects affecting Sample Property, Suburb withheld NSW.

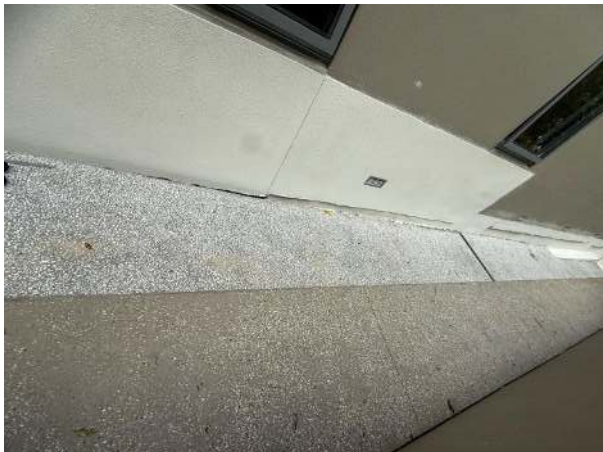
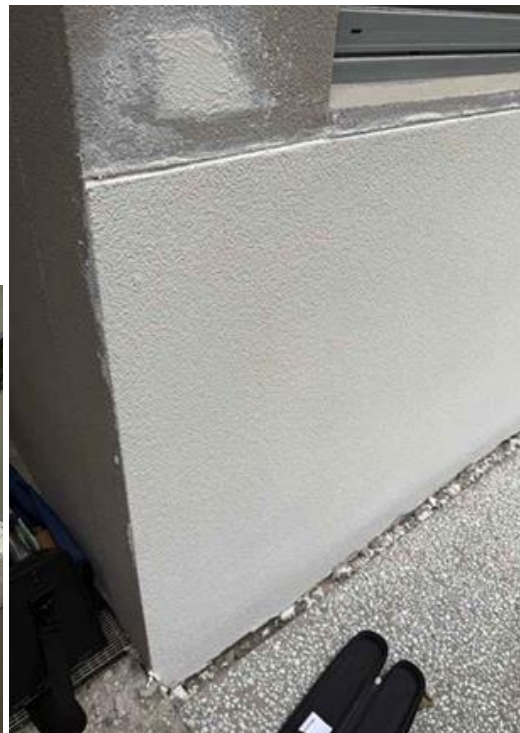
The damaged coatings and finishes to the Hebel wall have been removed and ground back to the windowsill level. However, I have not been provided with the Engineer's hold point inspection report, so I am unable to confirm whether the saw cuts and any repairs to overcuts comply with the regulated design.

Remove / grind off damaged coatings and finishes on the Hebel Panel wall up to the level of the windowsill. Provide straight orthogonal saw cuts along the extremities of the removed finishes for the full depth of the finish, as required. Do not overcut. Any accidental overcuts shall be inspected by the Engineer and then filled with non-shrink grout in accordance with the Engineer's instructions.

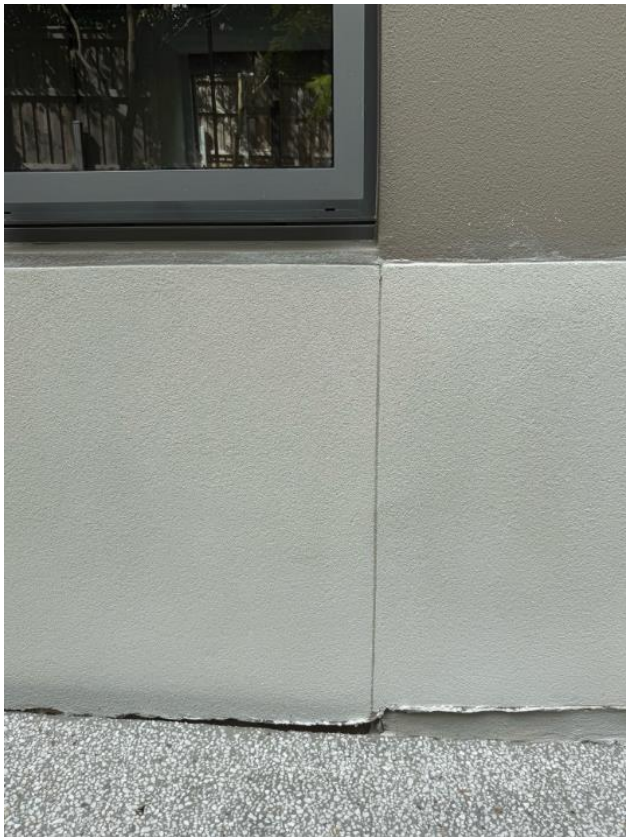
I have not been provided with the Engineer's inspection report for this hold point. As the joints are now concealed by finishes, I am unable to confirm whether the control joints were properly cleaned out, prepared and reinstated in accordance with the regulated design.

Clear out all existing control joints. Remove all existing sealants and backing rods, as required, and open up the joints. Ensure the open joints are clean from any impurities, straight and even width.

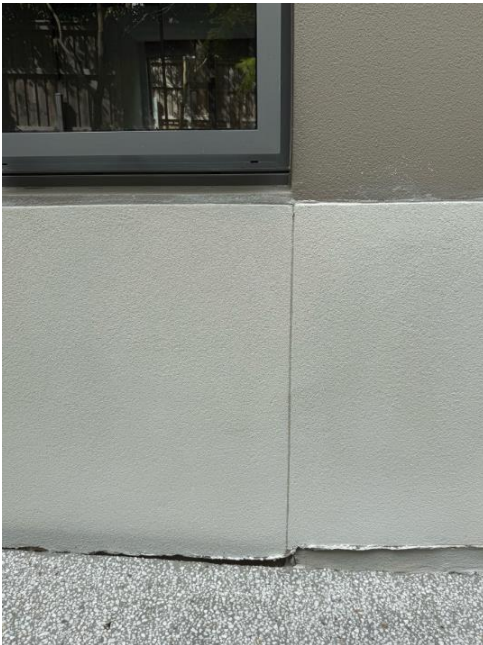
### **2.1 (3)**

This location has been covered at the time of my inspection. I have not been provided with any photographs or an Engineer's inspection report demonstrating how this joint was formed. I therefore cannot comment on whether the joint was created and cleaned in accordance with the regulated design.

Open up a joint between the bottom of the Hebel panel wall and the brick dwarf wall below. If there is no existing joint in this location, saw cut the mortar / grout between the Hebel panel and the brick dwarf wall for the full depth of the Hebel panel and minimum 10mm wide. Ensure, the cut is straight and even. Clean any remaining impurities and dust.

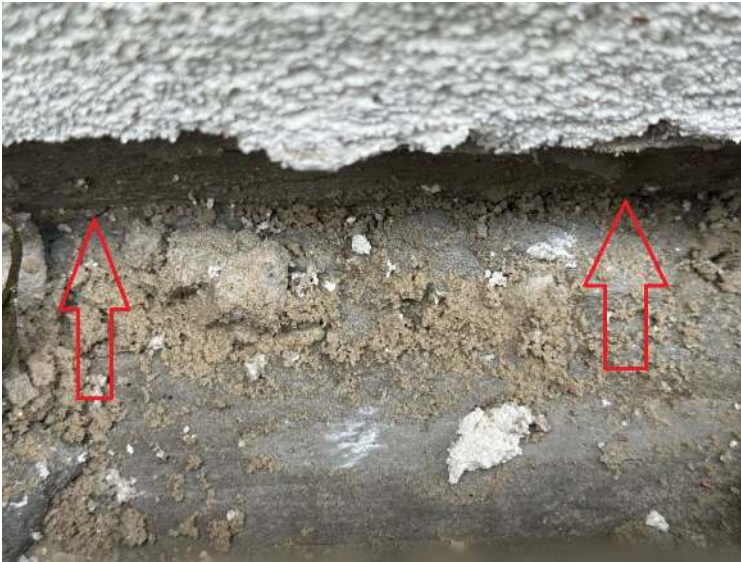
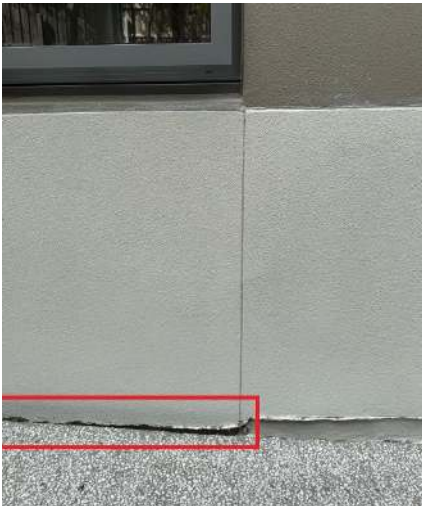
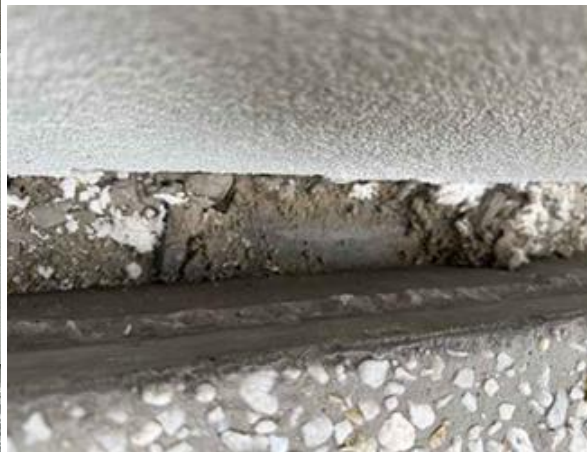
A flexible sealant fillet has not been installed at the junction between the slab and the brick dwarf wall. Also, there is a gap between the building slab and the pathway which is a water trap which can be source of future moisture issues. This gap is non-compliant with [company withheld] Regulated Design

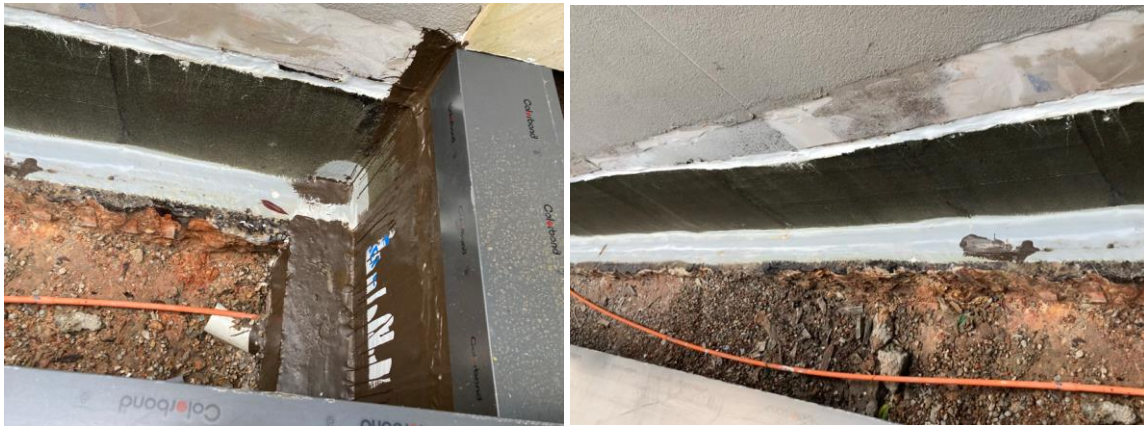
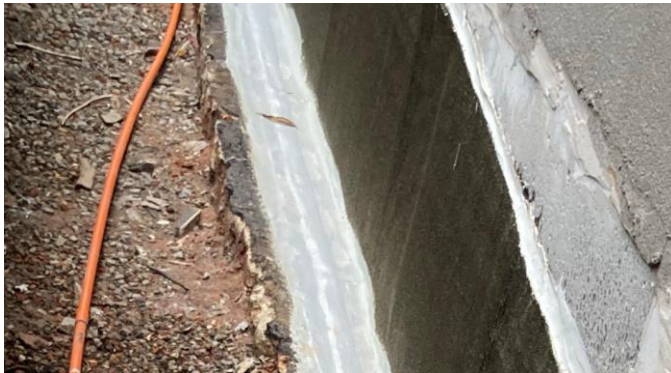
## 2.1 (6)

This element may now be concealed by subsequent concrete works and finishes. However, in the photographs provided to me, I cannot identify the specified saw cut located 300mm from the wall, nor any evidence of the membrane being turned into that saw cut and sealed as required by the regulated design. Also there are evidence of the damaged areas in the waterproofing. No Engineer's inspection report or construction photographs have been provided to demonstrate compliance.

Provide a 10mm wide x 20mm deep saw-cut in the concrete slab running parallel to, and at the distance of, 300mm away from the building wall.

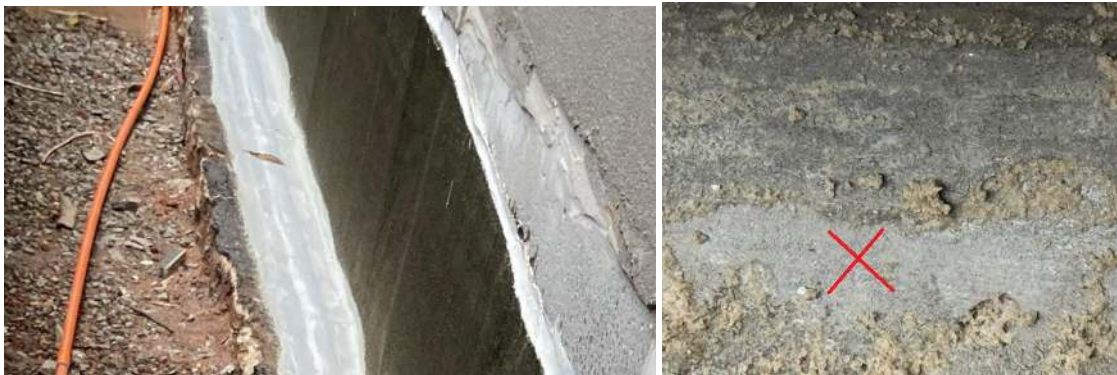
Photographs provided to me show that a waterproofing treatment has been applied in some parts of the concrete but still sections of the concrete are exposed without any visible membrane. For the applied waterproofing sections, however, based on its appearance, it does not resemble a PVC weldable sheet membrane and the available photographs do not show characteristics typical of a torch-on sheet membrane, for example lap seams and torch-applied detailing. The observed application appears more consistent with a liquid-applied and/or bituminous coating with a reinforcement or protection layer. On this basis, the works do not demonstrate compliance with the requirement for an approved fully bonded PVC weldable or torch-on sheet waterproofing membrane.

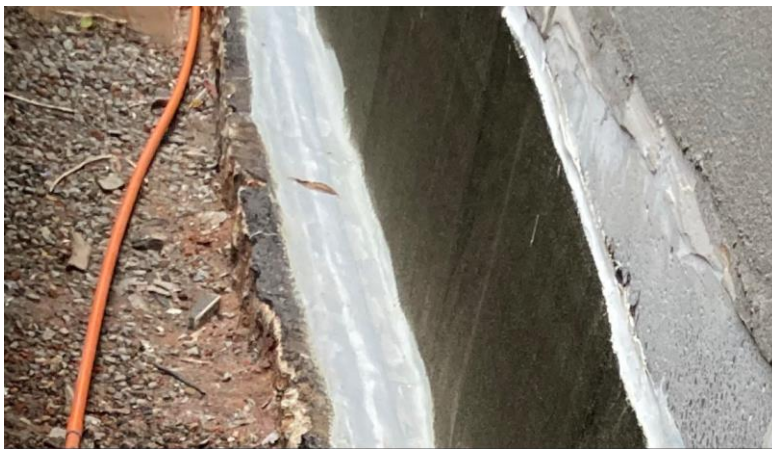
## 2.1 (9)

Even allowing that a waterproofing treatment has been applied, there is no evidence that the membrane has been folded into the required saw cut in the slab and sealed as specified. The available photographs do not show the membrane turned into a saw cut and the saw cut filled with an approved flexible sealant, and no Engineer's hold point inspection report has been provided to verify this termination detail.

For the termination point along the concrete slab, fold the membrane minimum 20mm into the saw cut in the slab and secure in place before filling the saw-cut with an approved flexible sealant.

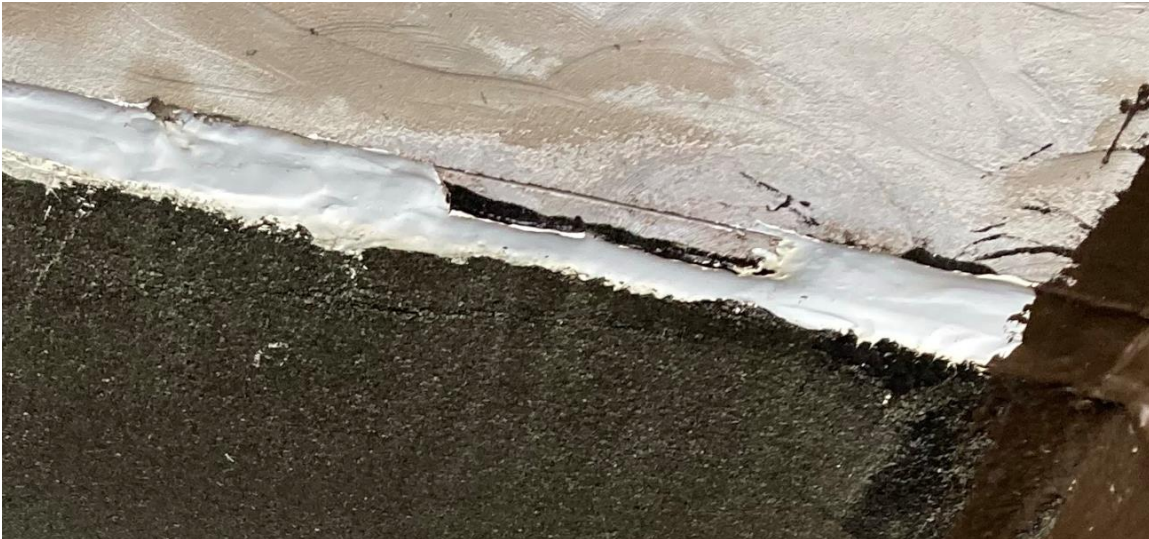
## **2.1 (10)**

Based on the photographs provided, the waterproofing treatment at the wall interface appears to be finished with surface sealant and/or render rather than a membrane folded minimum 30mm into the joint and mechanically and chemically secured as specified. No Engineer's hold point inspection report or photographs have been provided demonstrating the required termination into the joint between the brick dwarf wall and Hebel panels. Compliance cannot be demonstrated.

For the termination point in the wall, fold the waterproofing membrane minimum 30mm into the joint between the brick dwarf wall and the Hebel wall above, and secure mechanically and chemically to the bottom edge of the joint.

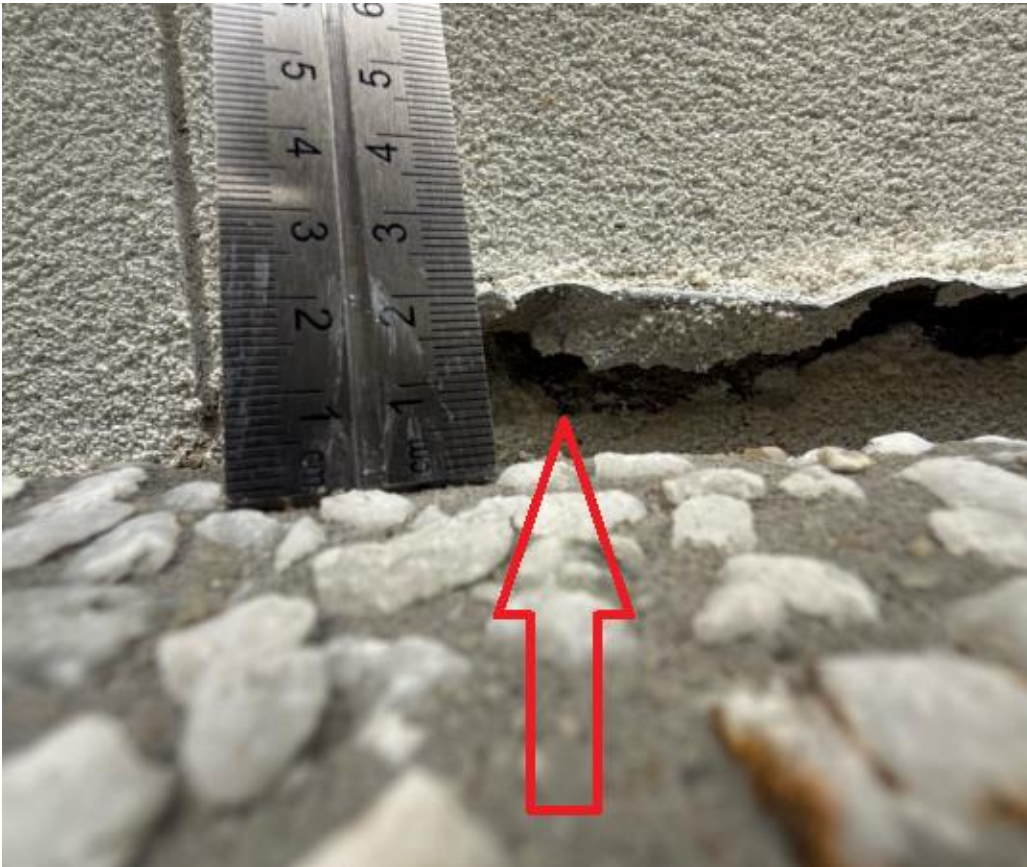
## 2.1 (11)

I could not see any aluminium or hot dip galvanized steel angle or over-flashing installed in the locations specified. There is no visible over-flashing element that would protect a membrane termination in the wall or slab, which indicates this requirement has likely not been met.

Install an aluminium or hd galv. steel angle / over-flashing in the saw cut for the termination point on the side of the capping beam as well as in the brick dwarf wall to cover the termination of the waterproofing membrane. For the termination point on the wall, the over-flashing is to comply with AS4654.2 requirements.

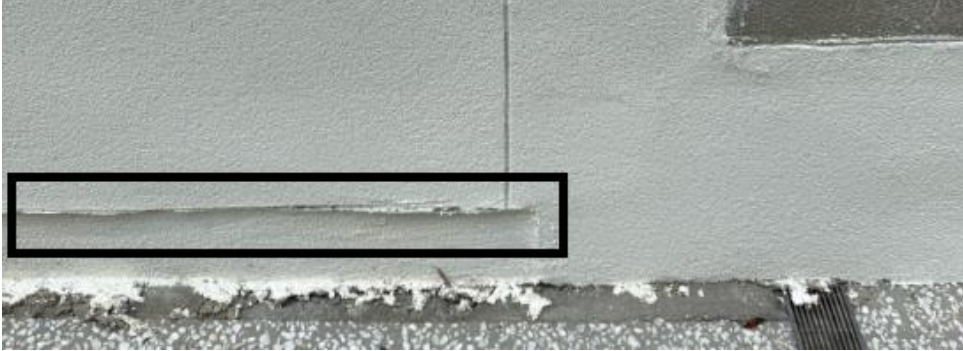
The joint between the brick dwarf wall and the Hebel wall has been filled and covered by rigid render rather than by an exposed flexible sealant joint. A flexible sealant system is required at this interface to accommodate movement. In my opinion, this requirement has not been met and the current render finish is inappropriate for this joint.

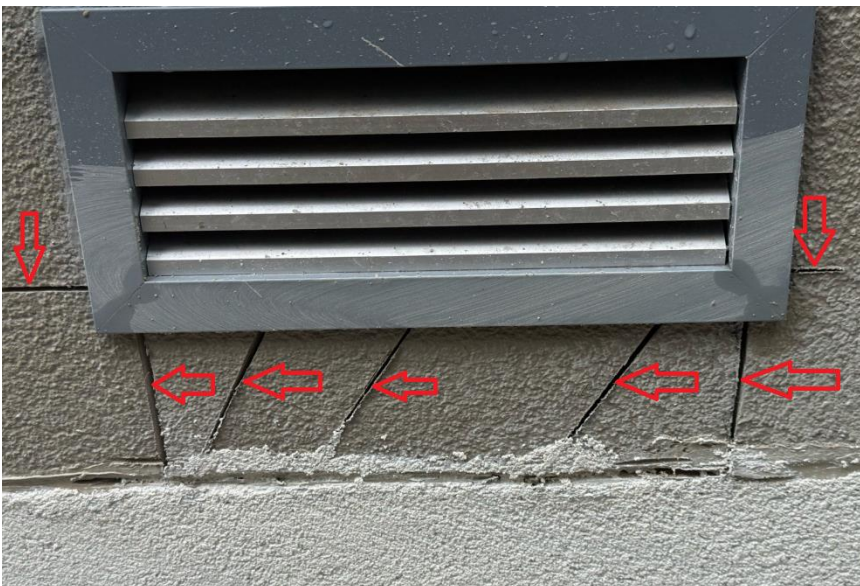
Installed, but the saw cuts are not covered. These cuts need to be filled by approved material (approved by Hebel) to protect the Hebel steels from corrosion.

**2.1 (15)** Install pressure equalisation slots at the bottom of Hebel panel wall in accordance with the Hebel panel supplier requirements and recommendations.

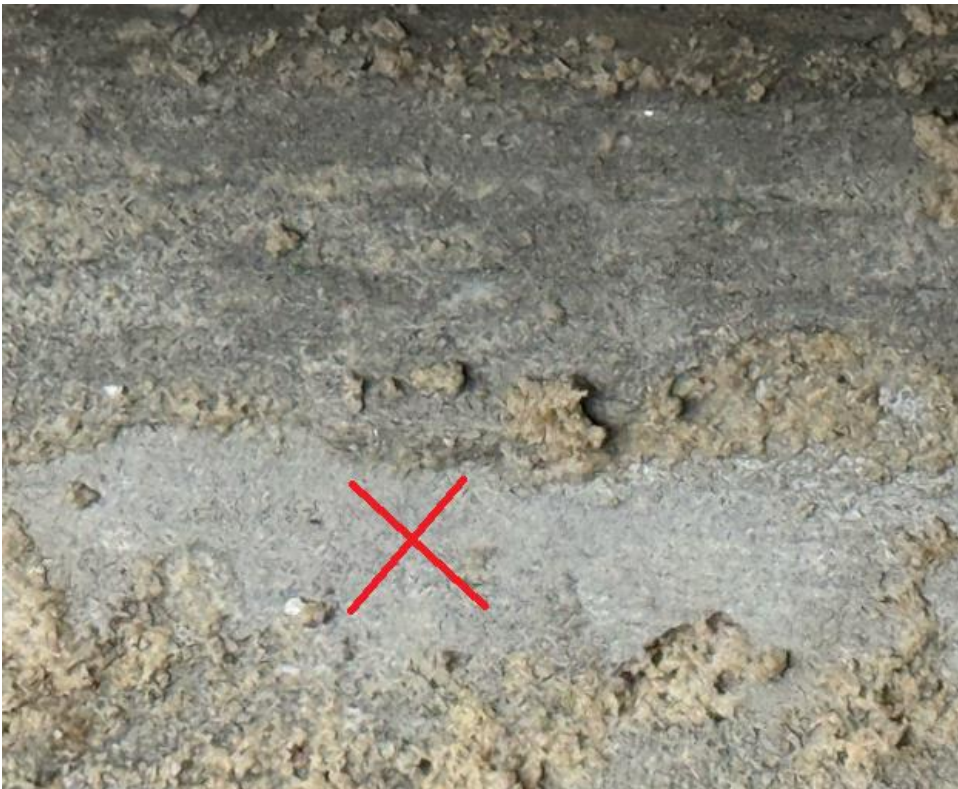
The top of the concrete is exposed without any cover. No photographic evidence or as-built confirmation has been supplied, so compliance cannot be verified.

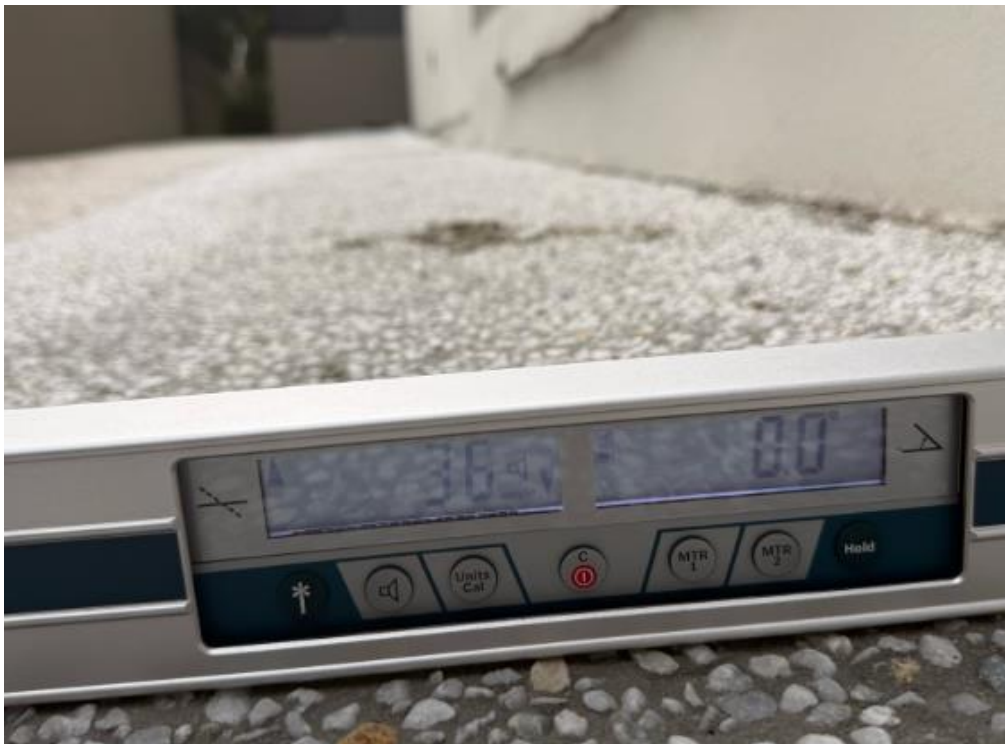
Surface falls towards the drainage points are visibly present and generally consistent with the specified minimum 1:100 fall. I am unable to confirm concrete compressive strength, slump or reinforcement cover, as no test results or compliance documentation have been provided.

**2.1 (19)** Pour minimum 130mm thick concrete wearing slab with SL82 reinforcing mesh (top). Provide minimum 1:100 falls in the top surface of the slab to the existing drainage points. Minimum concrete compressive strength at 28 days to be 32MPa. Slump to be 80mm. Minimum cover to reinforcement – 40mm. Provide broom finish for the slab surface.

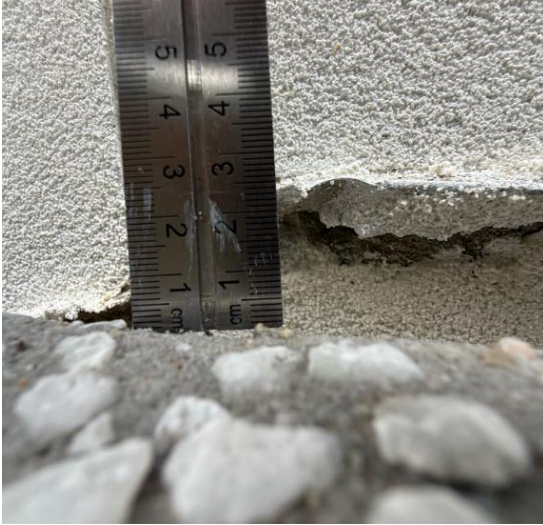
There are sections of the new slab where the finished surface is noticeably closer than 100mm to the proposed waterproofing termination level on the wall. This reduced clearance increases the risk of splash back and moisture ingress into the wall system. In my opinion these areas do not comply with the regulated design and require rectification.

**2.1 (20)** The top surface of the new slab along the external wall of the building is not to be higher than 100mm below the termination point for the waterproofing.

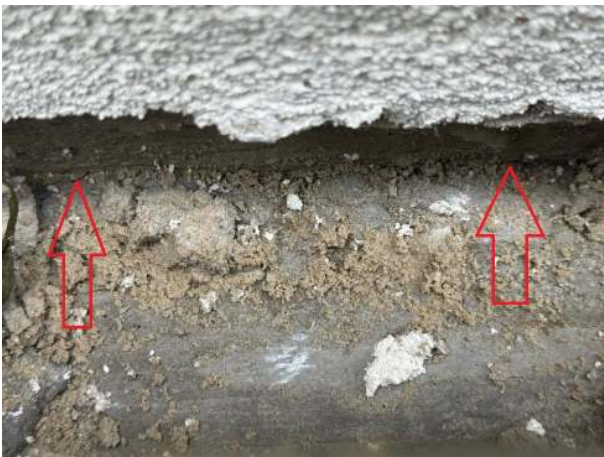
No visible expansion joint was observed at the interface between the new and existing slabs. There is no exposed compressible joint material evident at the slab junction. It appears that this expansion joint detail has not been formed in accordance with the regulated design.

**2.1 (21)** Provide expansion joint at junction between new and existing slab. Install 10mm thick compressible material in the joint to the level of 10mm below the top surface of the slab.

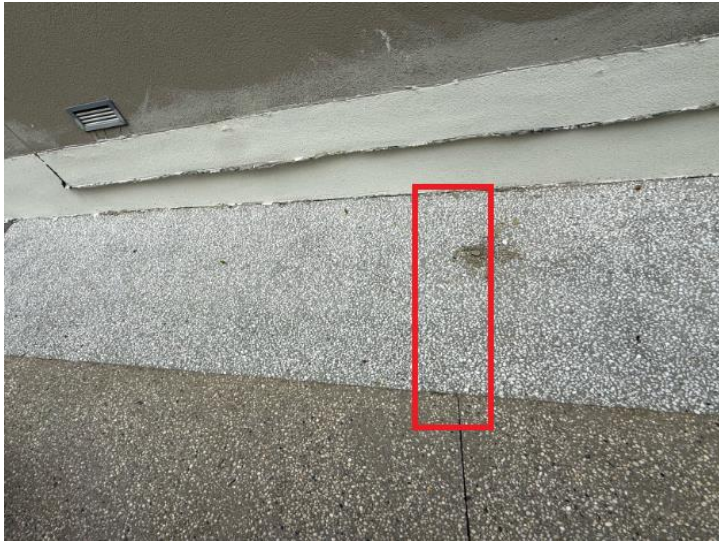
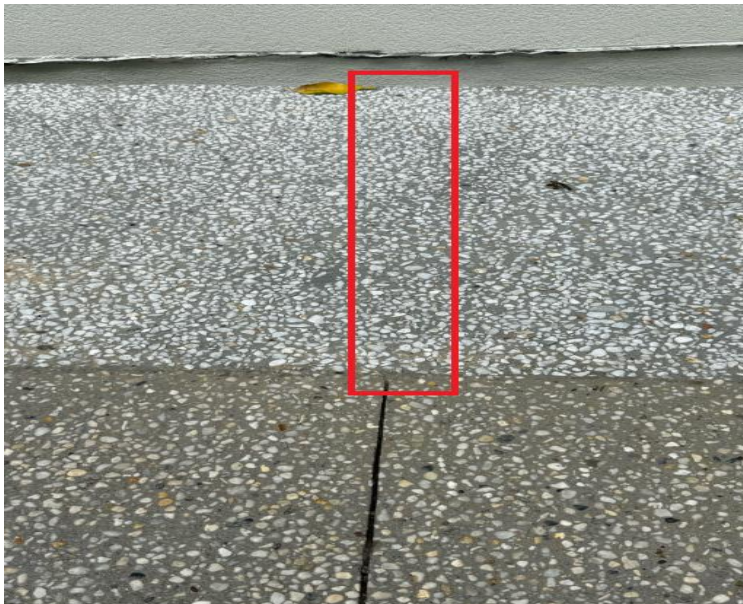
I did not observe any contraction joints or saw cuts within the new slab surface. There is no evidence of saw-cut joints filled with flexible sealant at the specified centres. I am therefore of the opinion that this structural and waterproofing control measure has not been implemented.

**2.1 (22)** Provide saw-cut joints within the new slab at 3 metres maximum. Saw cuts to be 5mm wide x 20mm deep and to extend for the full length / width of the slab. Terminate slab reinforcement on both sides of the saw cut. Fill the joints with an approved flexible sealant upon completion.

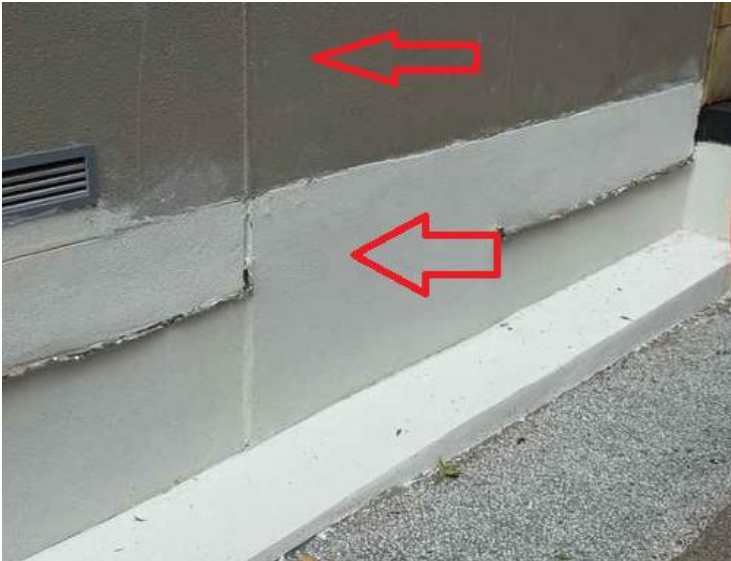
The Hebel wall has been re-rendered and repainted. The finish does NOT matches the surrounding façade in appearance/colour.

**2.1 (26)** Reinstate finishes / coatings on the Hebel wall in accordance with goods construction practice and Hebel panel supplier requirements and recommendations, and to match the existing.

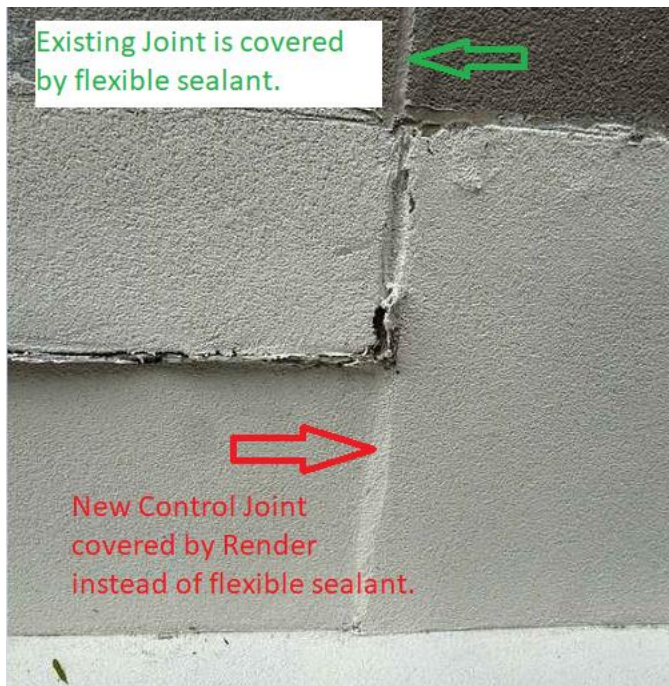
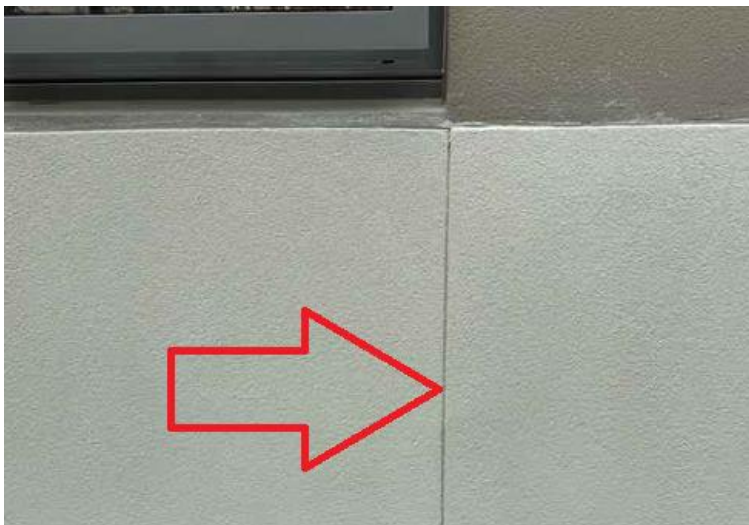
Control joints are bridged with rigid render and do not present as flexible sealed joints. I have not seen any evidence confirming that backing rods and flexible sealant have been installed consistently in accordance with the Hebel Panel Installation Guide. The absence of the Engineer's hold point inspection report further limits verification.

**2.1 (27)** Reinstate control joints with new backing rods and an approved flexible sealant in accordance with Hebel Panel Installation Guide. Provide a control joint between concrete or Dintel structures and Hebel Panel.

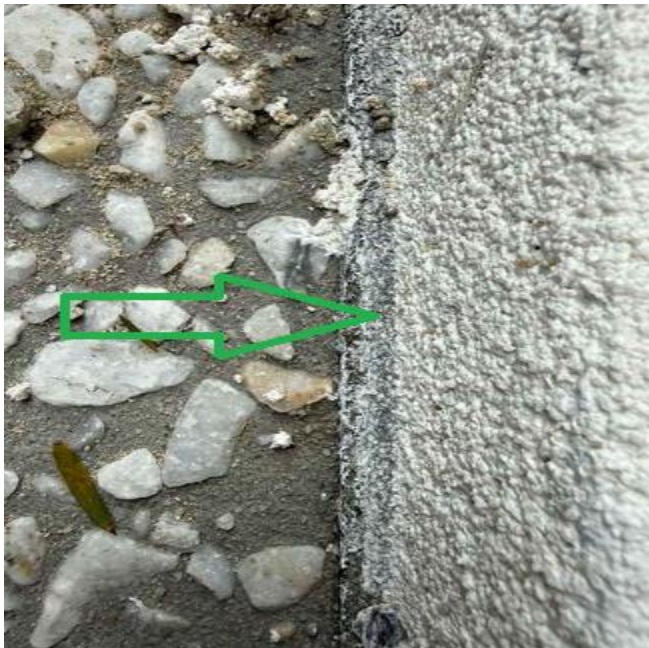
A flexible sealant fillet is present at the junction between the slab and brick dwarf wall in the eastern section. This appears consistent with the intent of the regulated design, subject to confirmation of product type.

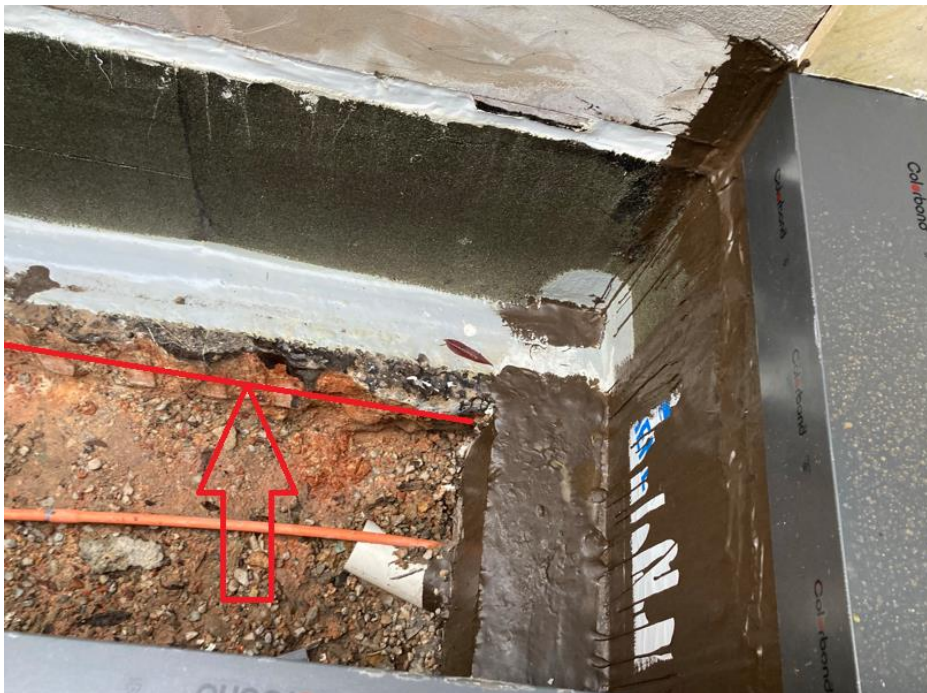
Because waterproofing details and rendering now conceal the side of the footing and/or capping beam, I could not confirm the presence of the specified saw cut. However, based on the construction photos provided to me by the home owner, it seems the saw cut at the side of the slab is not done.

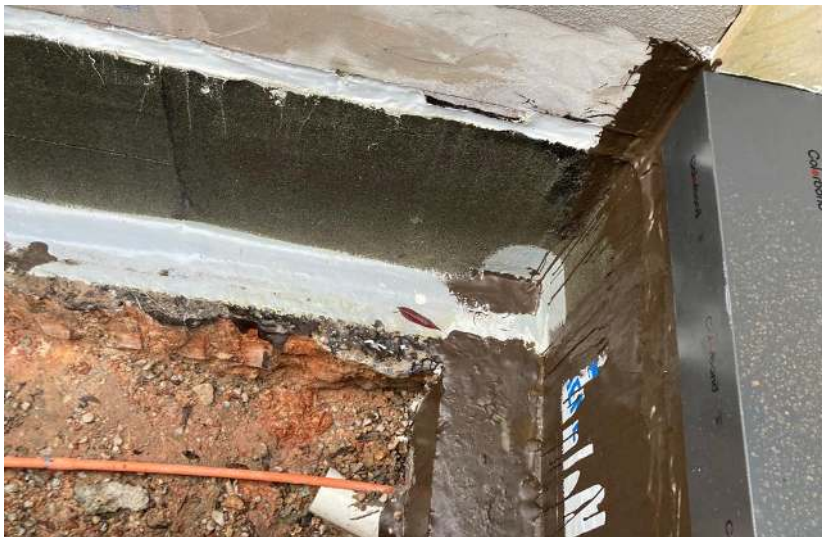
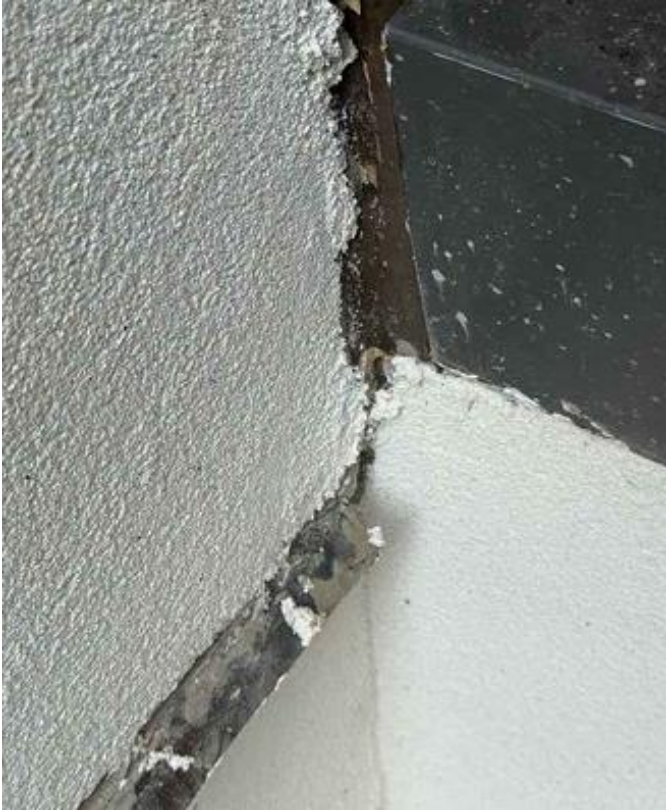
At the time of my inspection some of the waterproofing details were concealed by render and finishes. Photographs provided to me show that a waterproofing treatment has been applied at the wall and slab interface. However, based on its appearance, it does not resemble a PVC weldable sheet membrane and the available photographs do not show characteristics typical of a torch-on sheet membrane. In addition, there is no evidence that the membrane continues down the side of the footing and/or capping beam and terminates in the required saw cut. Further, the DPC at the brick dwarf wall to Hebel interface has not been folded over any demonstrated compliant sheet membrane, which is inconsistent with the design intent. On this basis, the works do not demonstrate compliance with the specified sheet waterproofing membrane requirement.

**2.2 (8)** Pressure water clean and prepare the concrete surface in accordance with the waterproofing manufacturer's instructions. Provide primers, as required.

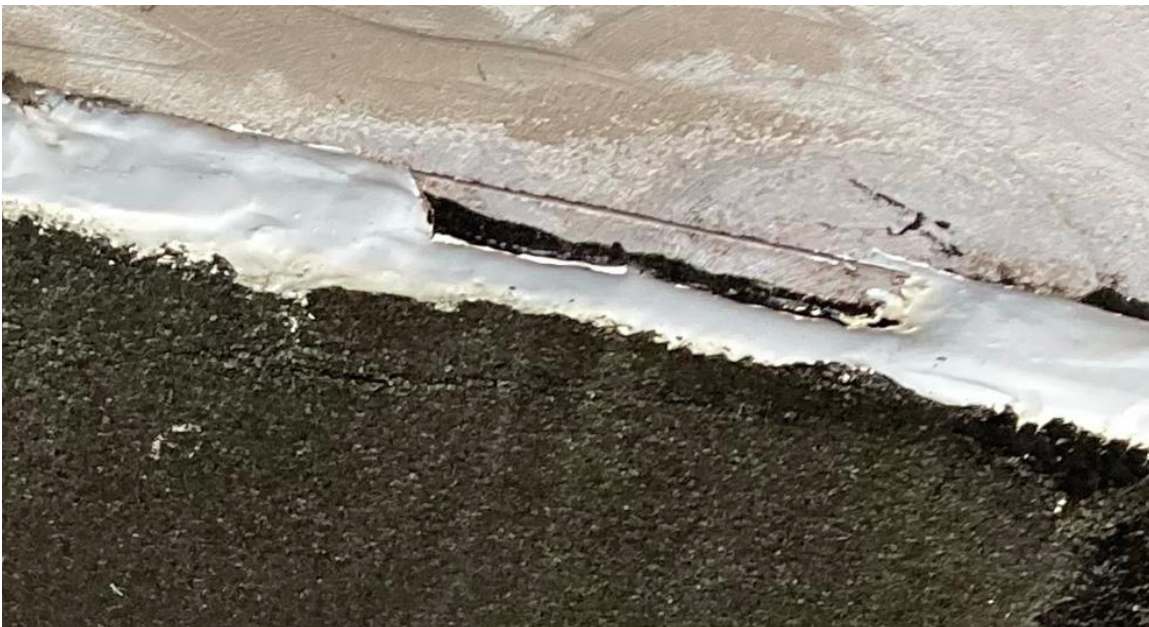
Based on the photographs provided, the waterproofing treatment at this wall interface does not demonstrate a sheet membrane folded into the joint and mechanically and chemically secured as required. Further, the DPC has not been folded over a demonstrated compliant sheet membrane at this joint. In the absence of the Engineer's hold point inspection report or clear construction photographs of this termination detail, compliance cannot be demonstrated. This is a critical omission from a waterproofing perspective.

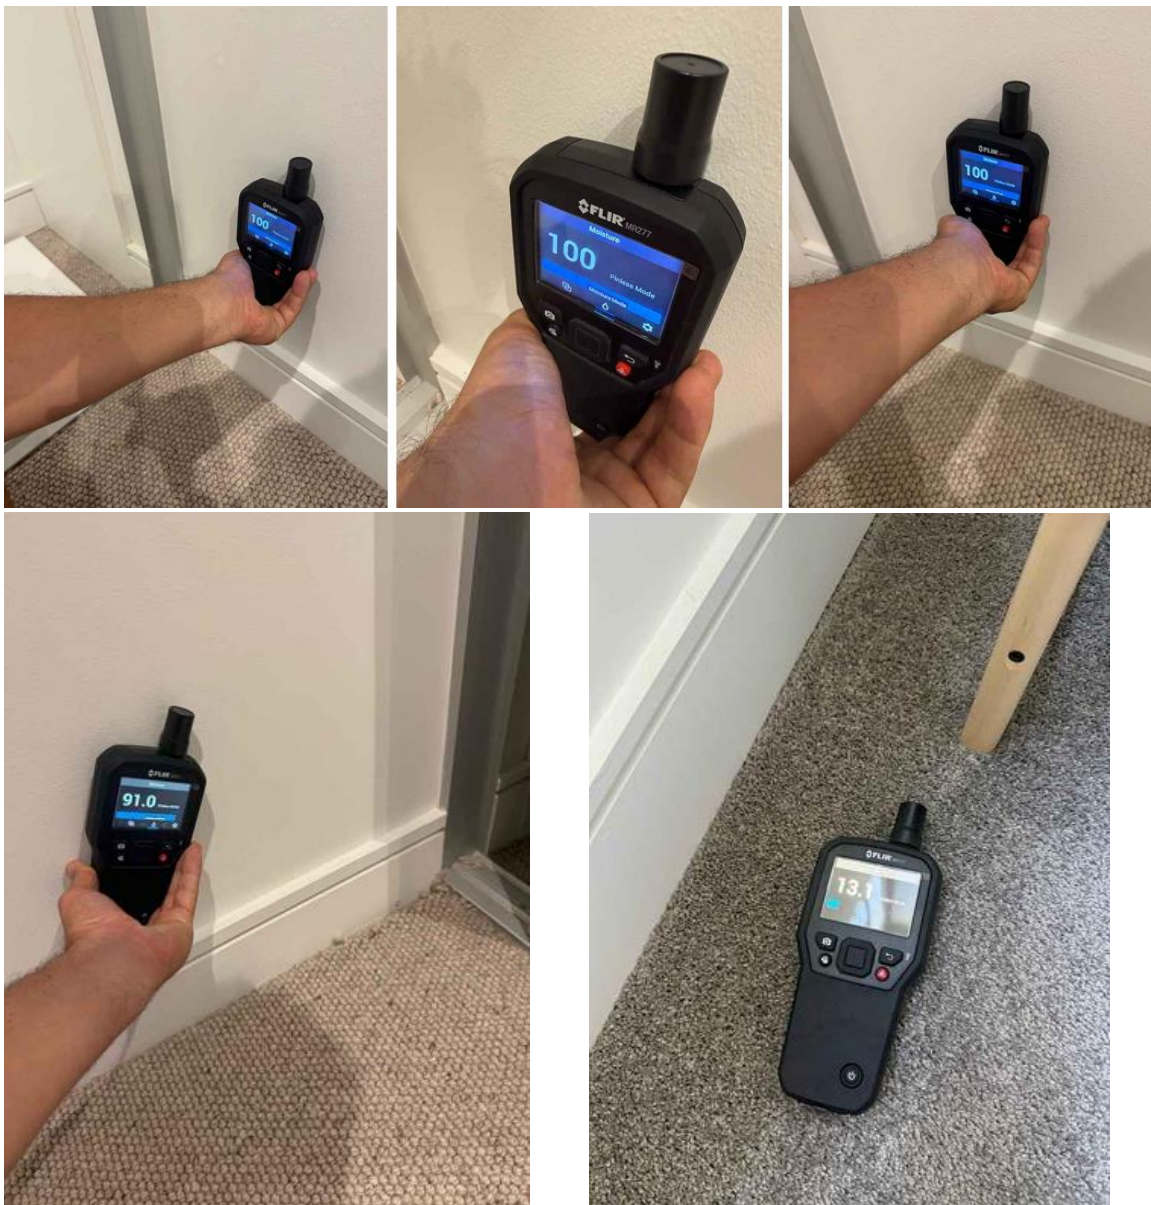
- Living room external wall adjoining former planter box: multiple readings at or near 100% at skirting level and up to approximately one metre above finished floor level.
- Bedroom external walls adjoining former planter box: multiple readings ranging from high to 100% at skirting level and within the lower wall zones.
- Built in robe to bedroom on southern elevation: moisture readings at or near 91-100% along the external wall line.
