## EXPERT BUILDING DEFECTS REPORT

| Site Address | Sample Property, Suburb withheld |
| Building Consultant | Philip Lowry |

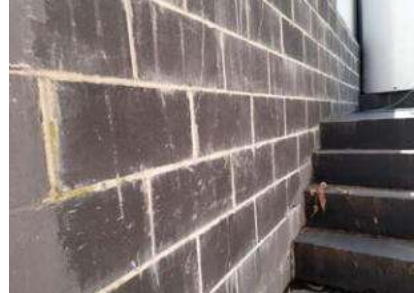
| ITEM # | SITE PHOTOS | SITE PHOTOS | SITE PHOTOS |
|---|---|---|---|
| 1. | <br>1. Marking/staining to eastern boundary retaining wall | <br>2. Marking/staining to eastern boundary retaining wall | <br>3. Marking/staining to northern boundary retaining wall |

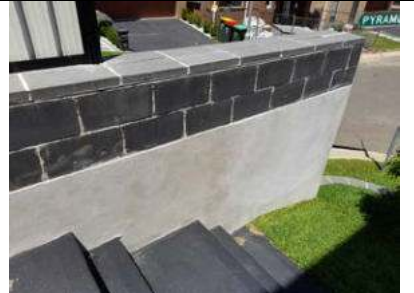
| ITEM # | SITE PHOTOS | SITE PHOTOS | SITE PHOTOS |
|---|---|---|---|
| | <br>4. Mortar missing from perp joint at masonry closer | <br>5. Damage to retaining wall units | <br>6. Marking/staining to southern boundary retaining wall |

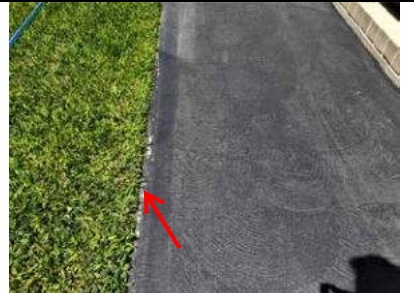
| ITEM # | SITE PHOTOS | SITE PHOTOS | SITE PHOTOS |
|---|---|---|---|
| | <br>7. Front driveway to dwelling | <br>8. Paint delamination to surface coating | <br>9. Paint delamination to surface coating |

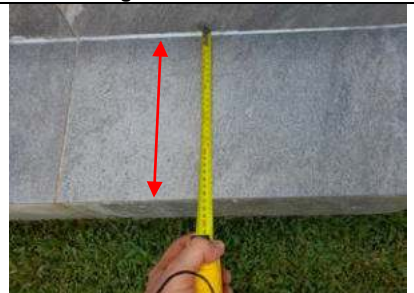
| ITEM # | SITE PHOTOS | SITE PHOTOS | SITE PHOTOS |
|---|---|---|---|
| | <br>10. Entry stair to property overhang the allotment boundary onto council nature strip | <br>11. Crack or gap at boundary point to tile joint in on entry stairs | <br>Entry stair tread 270mm width |

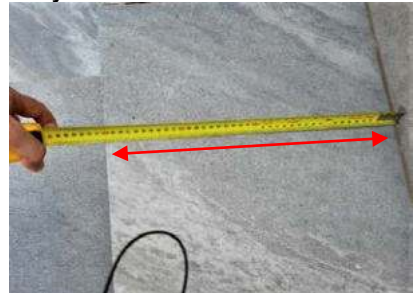
| ITEM # | SITE PHOTOS | SITE PHOTOS | SITE PHOTOS |
|---|---|---|---|
| | | | <br>Entry stair tread 400mm width |
| | | | 12. Entry stair treads vary from 270mm wide to 400mm in depth |

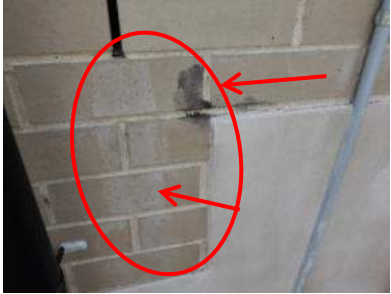
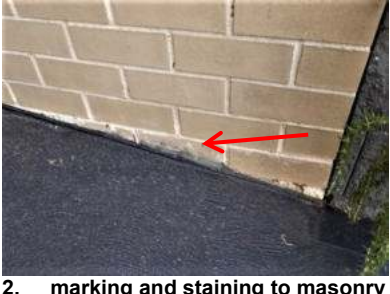
| ITEM # | BUILDING EXTERIOR PHOTOS | BUILDING EXTERIOR PHOTOS | BUILDING EXTERIOR PHOTOS |
|---|---|---|---|
| 2. | <br>1. marking and staining to masonry and at weep holes | <br>2. marking and staining to masonry wall | <br>3. marking and staining to masonry |

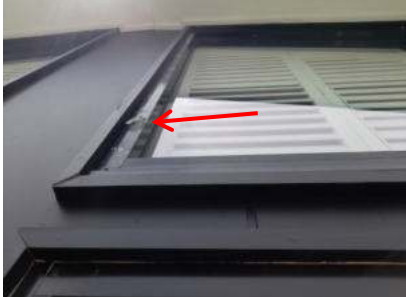
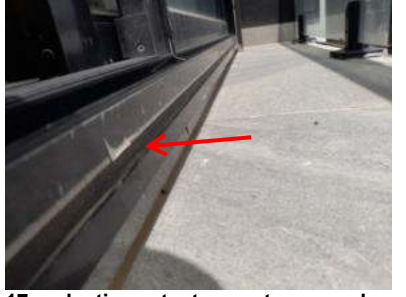
| ITEM # | BUILDING EXTERIOR PHOTOS | BUILDING EXTERIOR PHOTOS | BUILDING EXTERIOR PHOTOS |
|---|---|---|---|
| 2. | <p>15. plastic protectors not removed from aluminium windows bedroom 3</p> | <p>16. plastic protectors not removed from bedroom 3 aluminium windows</p> | <p>17. plastic protectors not removed from bedroom 3 aluminium doors</p> |

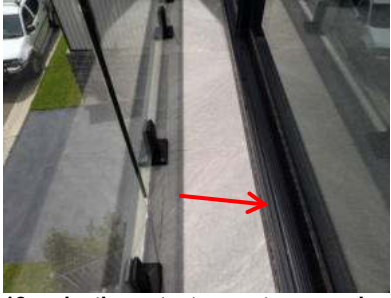
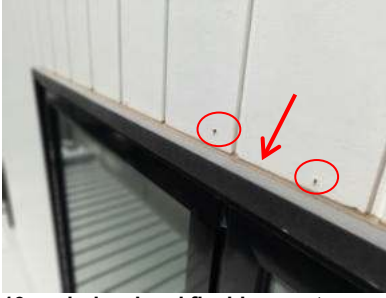
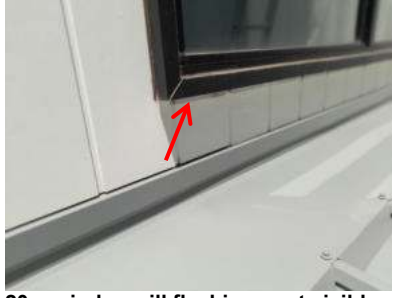
| ITEM # | BUILDING EXTERIOR PHOTOS | BUILDING EXTERIOR PHOTOS | BUILDING EXTERIOR PHOTOS |
|---|---|---|---|
| | <p>18. plastic protectors not removed from bedroom 2 aluminium doors</p> | <p>19. window head flashings not visible, silicone sealed around opening, 2 nail holes in cladding</p> | <p>20. window sill flashings not visible, silicone sealed around opening</p> |

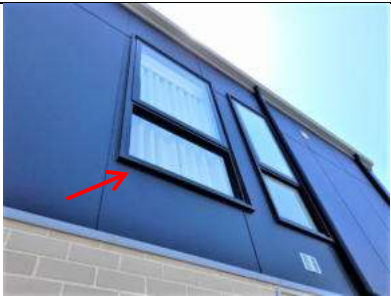
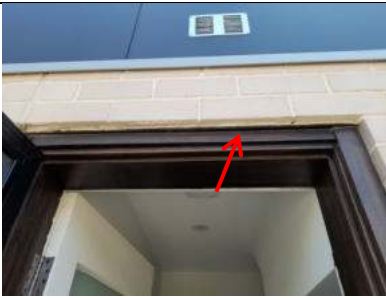
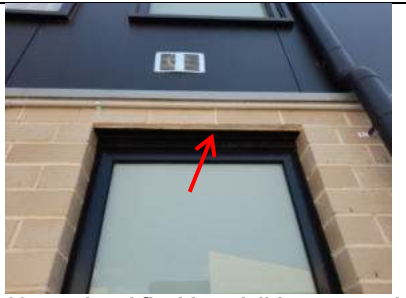
| ITEM # | BUILDING EXTERIOR PHOTOS | BUILDING EXTERIOR PHOTOS | BUILDING EXTERIOR PHOTOS |
|---|---|---|---|
| | <p>21. window sill flashings not visible, silicone sealed around openings</p> | <p>22. no head flashing visible to laundry door head and no weather protection of door opening</p> | <p>23. no head flashing visible to ground floor bathroom window</p> |

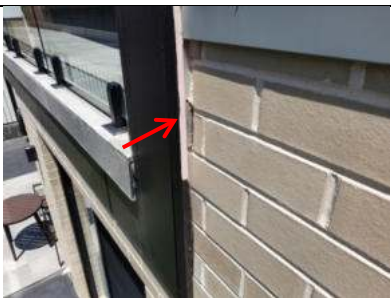
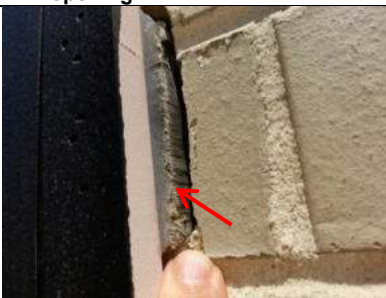
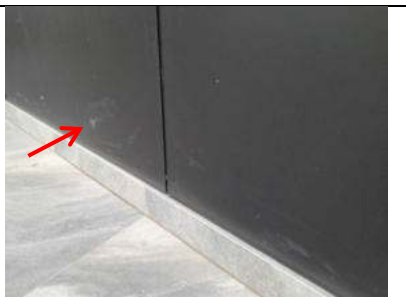
| ITEM # | BUILDING EXTERIOR PHOTOS | BUILDING EXTERIOR PHOTOS | BUILDING EXTERIOR PHOTOS |
|---|---|---|---|
| | <p>24. moulding unpainted adjacent main bedroom wall 2<sup>nd</sup> storey balcony</p> | <p>25. timber ceiling joist projecting adjacent main bedroom wall 2<sup>nd</sup> storey balcony</p> | <p>26. marking and staining visible to main bedroom wall 2<sup>nd</sup> storey balcony</p> |

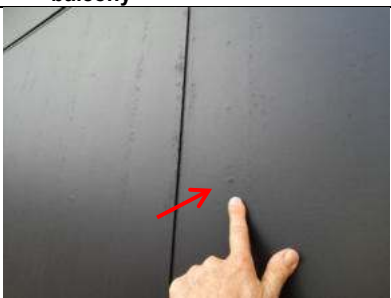
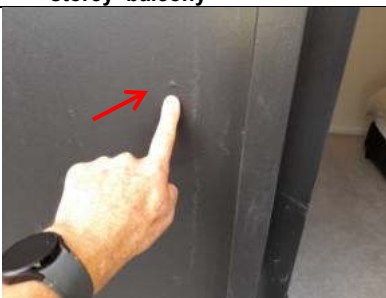
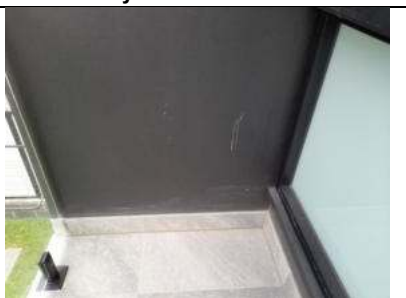
| ITEM # | BUILDING EXTERIOR PHOTOS | BUILDING EXTERIOR PHOTOS | BUILDING EXTERIOR PHOTOS |
|---|---|---|---|
| | <p>27. marking and fixing points visible to main bedroom wall on balcony</p> | <p>28. fixing points not flush &amp; visible to main bedroom wall on balcony</p> | <p>29. marking visible to main bedroom southern wall on balcony</p> |

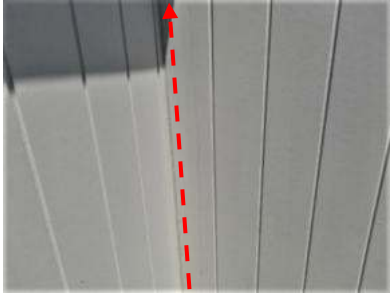
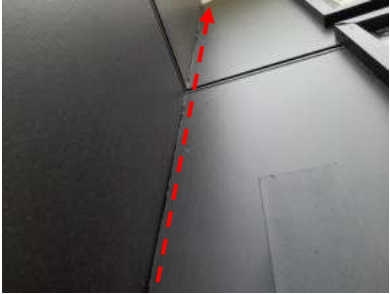
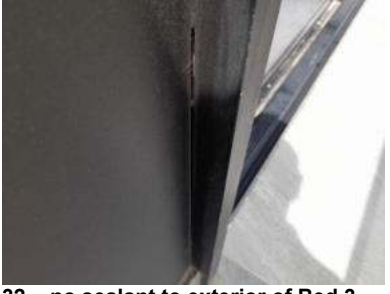
| ITEM # | BUILDING EXTERIOR PHOTOS | BUILDING EXTERIOR PHOTOS | BUILDING EXTERIOR PHOTOS |
|---|---|---|---|
| 2. | <p>30. no timber stop to wall panel internal corner to protect sealant from UV radiation breakdown</p> | <p>31. no timber stop and no sealant to internal corner of bed 3 balcony</p> | <p>32. no sealant to exterior of Bed 3 door frame</p> |

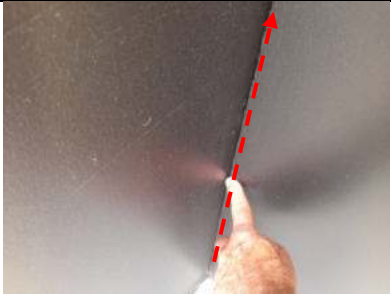
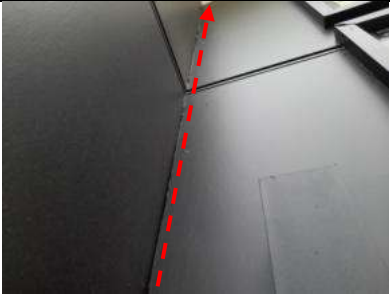
| ITEM # | BUILDING EXTERIOR PHOTOS | BUILDING EXTERIOR PHOTOS | BUILDING EXTERIOR PHOTOS |
|---|---|---|---|
| | <p>33. no timber stop and no sealant to wall panel internal corner of bed 2 balcony</p> | <p>34. no timber stop and no sealant to wall panel internal corner of bed 2 balcony</p> | <p>35. Damp proof course flashing (blue) not flush and projecting out from rear external wall of dwelling</p> |

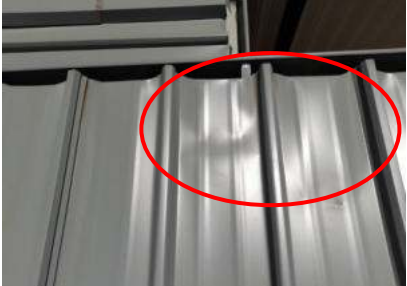
| ITEM # | ROOF EXTERIOR PHOTOS | ROOF EXTERIOR PHOTOS | ROOF EXTERIOR PHOTOS |
|---|---|---|---|
| 3. | <br>1. Cliplok sheeting on lower roof 0.8 degree fall below 1 degree minimum fall | <br>2. Cliplok sheeting on lower roof | <br>3. Damage/buckling to some roof sheets on lower roof above living room |

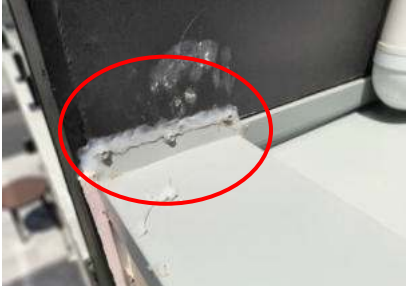
| ITEM # | ROOF EXTERIOR PHOTOS | ROOF EXTERIOR PHOTOS | ROOF EXTERIOR PHOTOS |
|---|---|---|---|
| | <br>4. No guttering to part of lower roof above living room | <br>5. Lower roof has no guttering to part of the roof and roof sheets draining on to roof flashings of lowest roof | <br>6. Lower roof - No over-flashing/ pressure flashing to capping upturn and silicone over-sealing exposed to UV radiation |

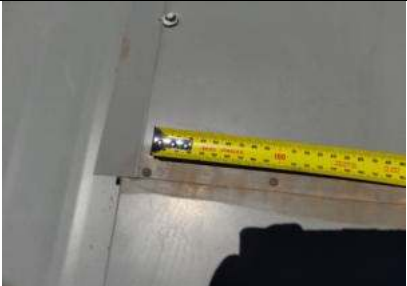
| ITEM # | ROOF EXTERIOR PHOTOS | ROOF EXTERIOR PHOTOS | ROOF EXTERIOR PHOTOS |
|---|---|---|---|
| | <br>10. Silicone exposed to UV radiation breakdown on upper roof | <br>11. Silicone exposed to UV radiation breakdown on upper roof | <br>12. Rivet spacing's not 40mm minimum spacing's on upper roof |

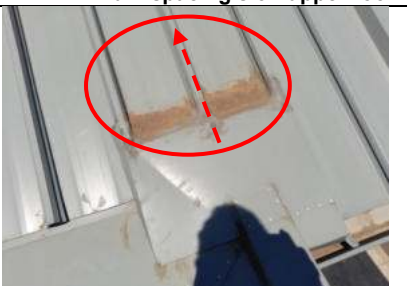
| ITEM # | ROOF EXTERIOR PHOTOS | ROOF EXTERIOR PHOTOS | ROOF EXTERIOR PHOTOS |
|---|---|---|---|
| | <br>13. Screw fixings to all longitudinal cappings on lower and upper roofs not maximum 500mm spacings | <br>14. Screw fixings to all longitudinal cappings on lower and upper roofs not maximum 500mm spacings | <br>15. No continuous back guttering/capping's up to apex of upper roof sheeting where roof changes length |

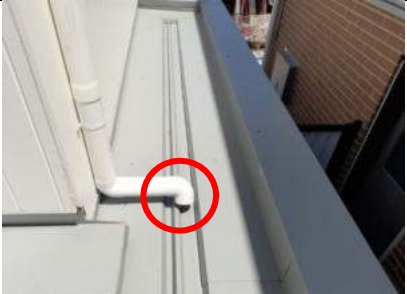
| ITEM # | ROOF EXTERIOR PHOTOS | ROOF EXTERIOR PHOTOS | ROOF EXTERIOR PHOTOS |
|---|---|---|---|
| | <p>19. 2<sup>nd</sup> storey Gutter above garage - outlet sealed with no downpipe connected on upper roof and will overflow/drain on wall claddings on front elevation over front of garage below</p> | <p>20. Down pipe spreader on lower roof draining on roof flashing</p> | <p>21. Downpipe draining upper roof to lowest roof has no spreader on lowest roof to suitably drain stormwater</p> |

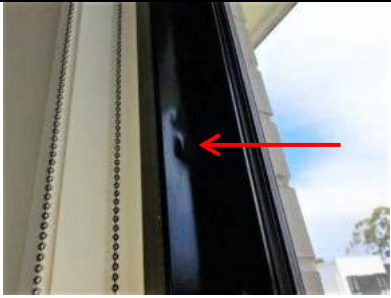
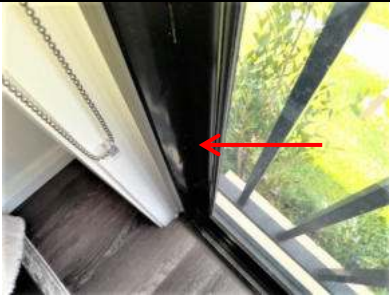
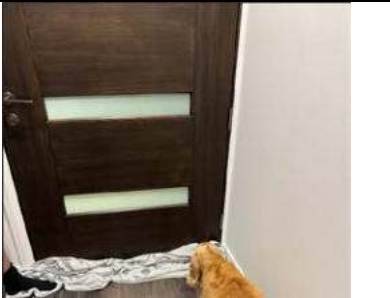
| ITEM # | BUILDING INTERIOR PHOTOS | BUILDING INTERIOR PHOTOS | BUILDING INTERIOR PHOTOS |
|---|---|---|---|
| 4. | <p>1. Foyer/front aluminium door frame buckling/impact damage</p> | <p>2. Foyer/front aluminium door frame buckling/impact damage</p> | <p>3. Front door leaking during weather event (owner image)</p> |

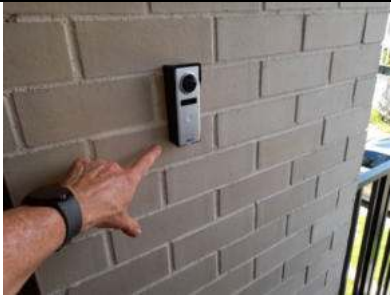
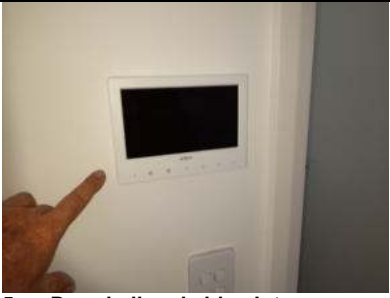
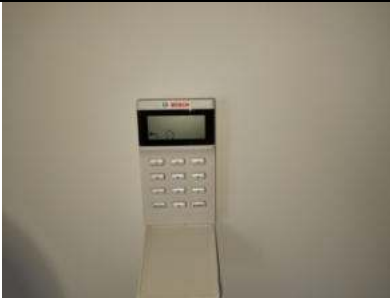
| ITEM # | BUILDING INTERIOR PHOTOS | BUILDING INTERIOR PHOTOS | BUILDING INTERIOR PHOTOS |
|---|---|---|---|
| | <p>4. Door bell and video to intercom not functioning</p> | <p>5. Door bell and video Intercom Control panel not functioning</p> | <p>6. Home alarm system not functioning</p> |

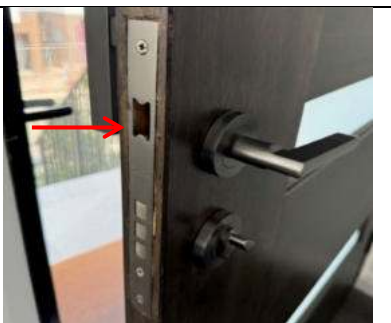
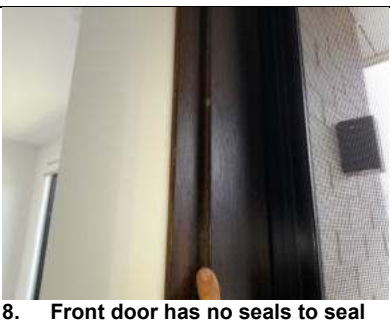
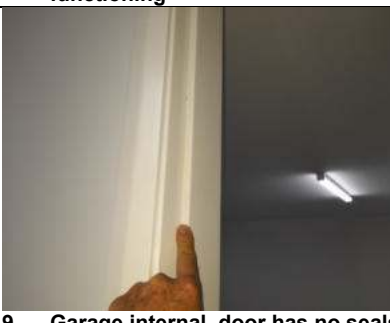
| ITEM # | BUILDING INTERIOR PHOTOS | BUILDING INTERIOR PHOTOS | BUILDING INTERIOR PHOTOS |
|---|---|---|---|
| | <p>7. Front door handle and tubular latch misaligned with faceplate, latch not projecting out of door</p> | <p>8. Front door has no seals to seal off conditioned space</p> | <p>9. Garage internal door has no seals to seal off conditioned space</p> |

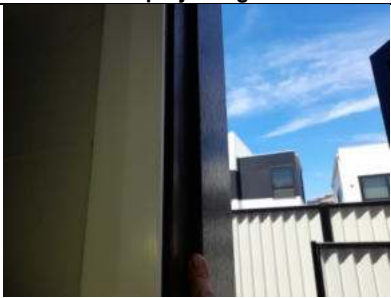
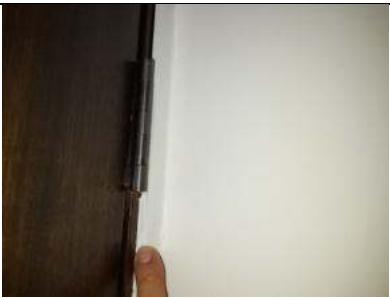
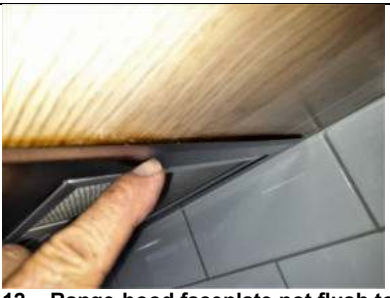
| ITEM # | BUILDING INTERIOR PHOTOS | BUILDING INTERIOR PHOTOS | BUILDING INTERIOR PHOTOS |
|---|---|---|---|
| | <p>10. Laundry door has no seals to seal off conditioned space</p> | <p>11. Bare or starved painted areas to front entry door frame architrave</p> | <p>12. Range-hood faceplate not flush to soffit face of cupboard</p> |

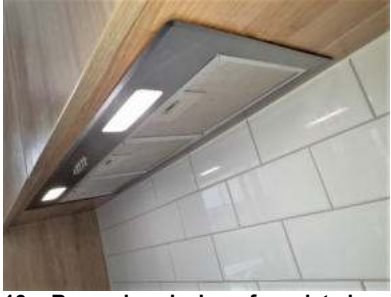
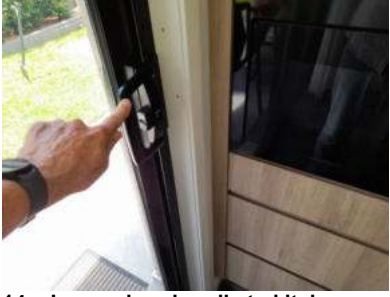
| ITEM # | BUILDING INTERIOR PHOTOS | BUILDING INTERIOR PHOTOS | BUILDING INTERIOR PHOTOS |
|---|---|---|---|
| | <p>13. Range-hood where faceplate is not flush to soffit face of cupboard</p> | <p>14. Loose door handle to kitchen balcony sliding door unit</p> | <p>This space deliberately blank</p> |

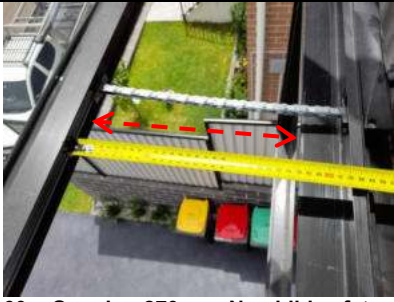
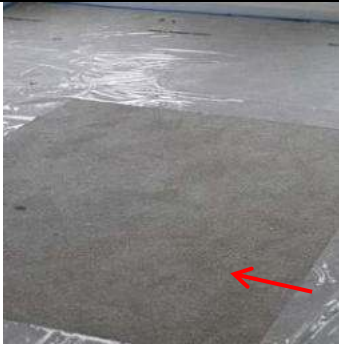
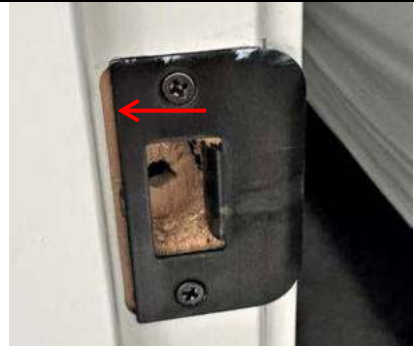
| ITEM # | BUILDING INTERIOR PHOTOS | BUILDING INTERIOR PHOTOS | BUILDING INTERIOR PHOTOS |
|---|---|---|---|
| 4. | <p>60. Opening 270mm, No child safety stop of 125mm max to awning bedroom 1 window above garage</p> | <p>61. Master bed room - Carpet unprotected, marked from builders trades (owner photo)</p> | <p>62. Master bedroom door keeper, damage around keeper</p> |

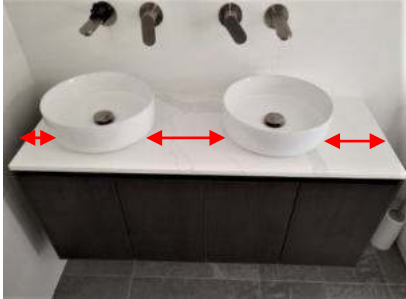
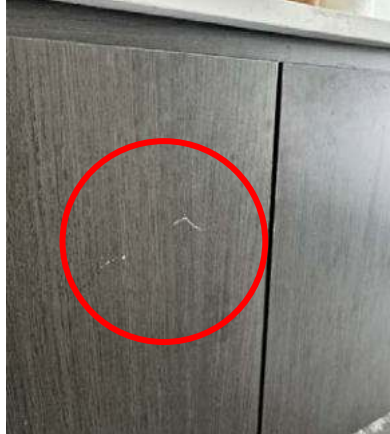
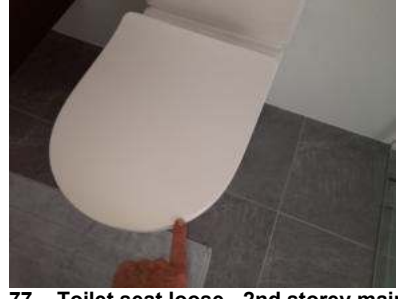
| ITEM # | BUILDING INTERIOR PHOTOS | BUILDING INTERIOR PHOTOS | BUILDING INTERIOR PHOTOS |
|---|---|---|---|
| 4. | <p>75. Vanity basins to 2nd storey main bathroom are misaligned, not centred with vanity unit below &amp; tap outlets misaligned with basins</p> | <p>76. Vanity unit joinery is damaged from scratching/marking</p> | <p>77. Toilet seat loose - 2nd storey main bathroom</p> |

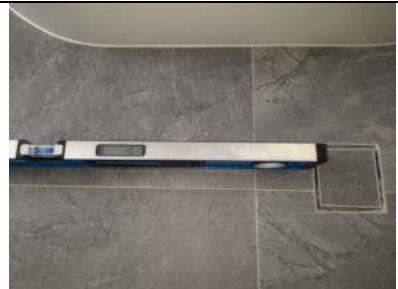
| ITEM # | BUILDING INTERIOR PHOTOS | BUILDING INTERIOR PHOTOS | BUILDING INTERIOR PHOTOS |
|---|---|---|---|
| | <p>78. No visible waterproofing upturn to water-stop at 2nd storey main bathroom door entry</p> | <p>79. Falls to floor waste main 2nd storey main bathroom 5 degrees and below 12.5 degrees minimum fall</p> | <p>80. Falls to floor waste main 2nd storey Bathroom 10 degrees, are below minimum 12.5 degrees</p> |

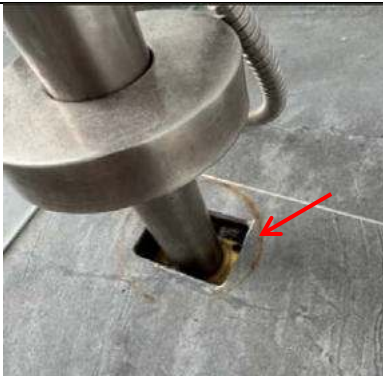
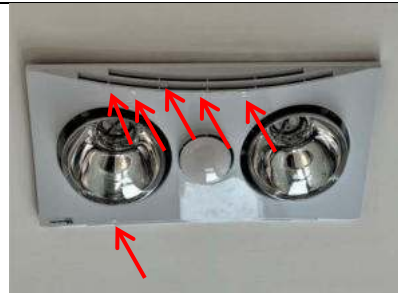
| ITEM # | BUILDING INTERIOR PHOTOS | BUILDING INTERIOR PHOTOS | BUILDING INTERIOR PHOTOS |
|---|---|---|---|
| | <p>81. Bath water inlet upstand has no waterproofing or upturn detail under floor cover plate (Owners photo)</p> | <p>82. No waterproofing upturn visible in 2nd storey Main bathroom shower recess</p> | <p>83. Bathroom IXL fan/light leaking water out of light cover, an electrical hazard</p> |

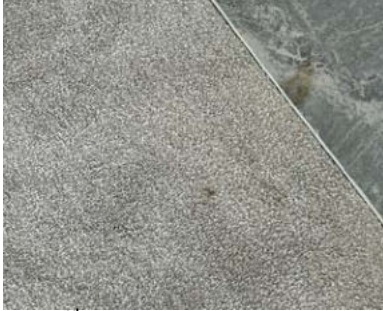
| ITEM # | BUILDING INTERIOR PHOTOS | BUILDING INTERIOR PHOTOS | BUILDING INTERIOR PHOTOS |
|---|---|---|---|
| | <p>84. 2<sup>nd</sup> storey living area carpet marked during building phase by trades (owner photo)</p> | THIS SPACE BLANK | THIS SPACE BLANK |
