OWNER INSPECTIONS

## EXPERT WITNESS REPORT

8 Example Street  
Googong, NSW 2620

Client Name  
JULY 19, 2024

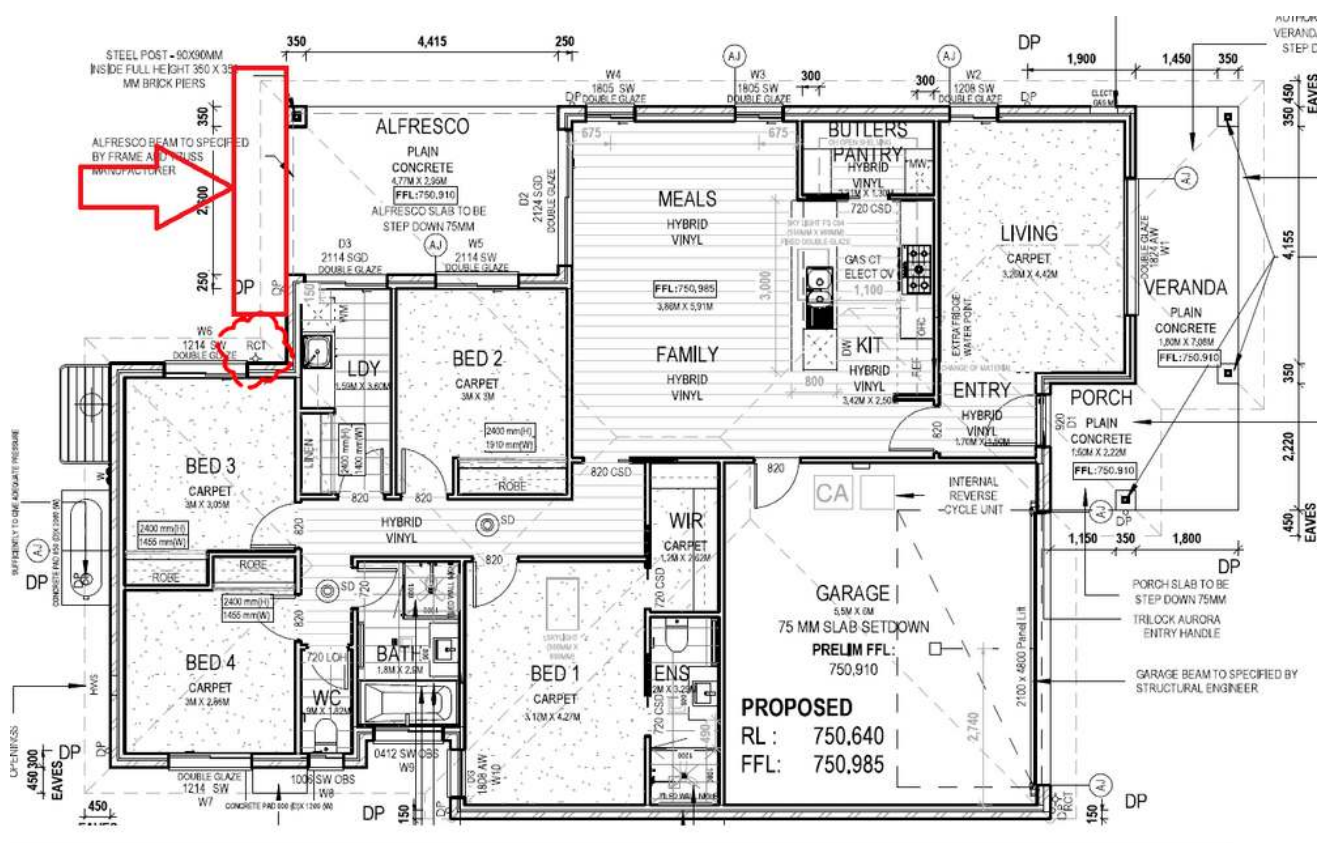
Alfresco

At the rear Alfresco, the slope of the gutter is negative, measuring 9mm/m away from the downpipe instead of the required minimum of 2mm/m towards the downpipe. This incorrect slope should be rectified to prevent potential defects such as water ponding in the gutter, which can lead to overflow during heavy rain, increased risk of water damage to the roof and surrounding structure, potential leakage into the dwelling, and accelerated deterioration of the gutter system due to stagnant water.

Gutters should be installed with the correct fall to avoid directing water away from downpipes or towards corners, which can lead to water damage and other associated issues. This ensures that water flows efficiently towards the downpipes without pooling in the gutters.

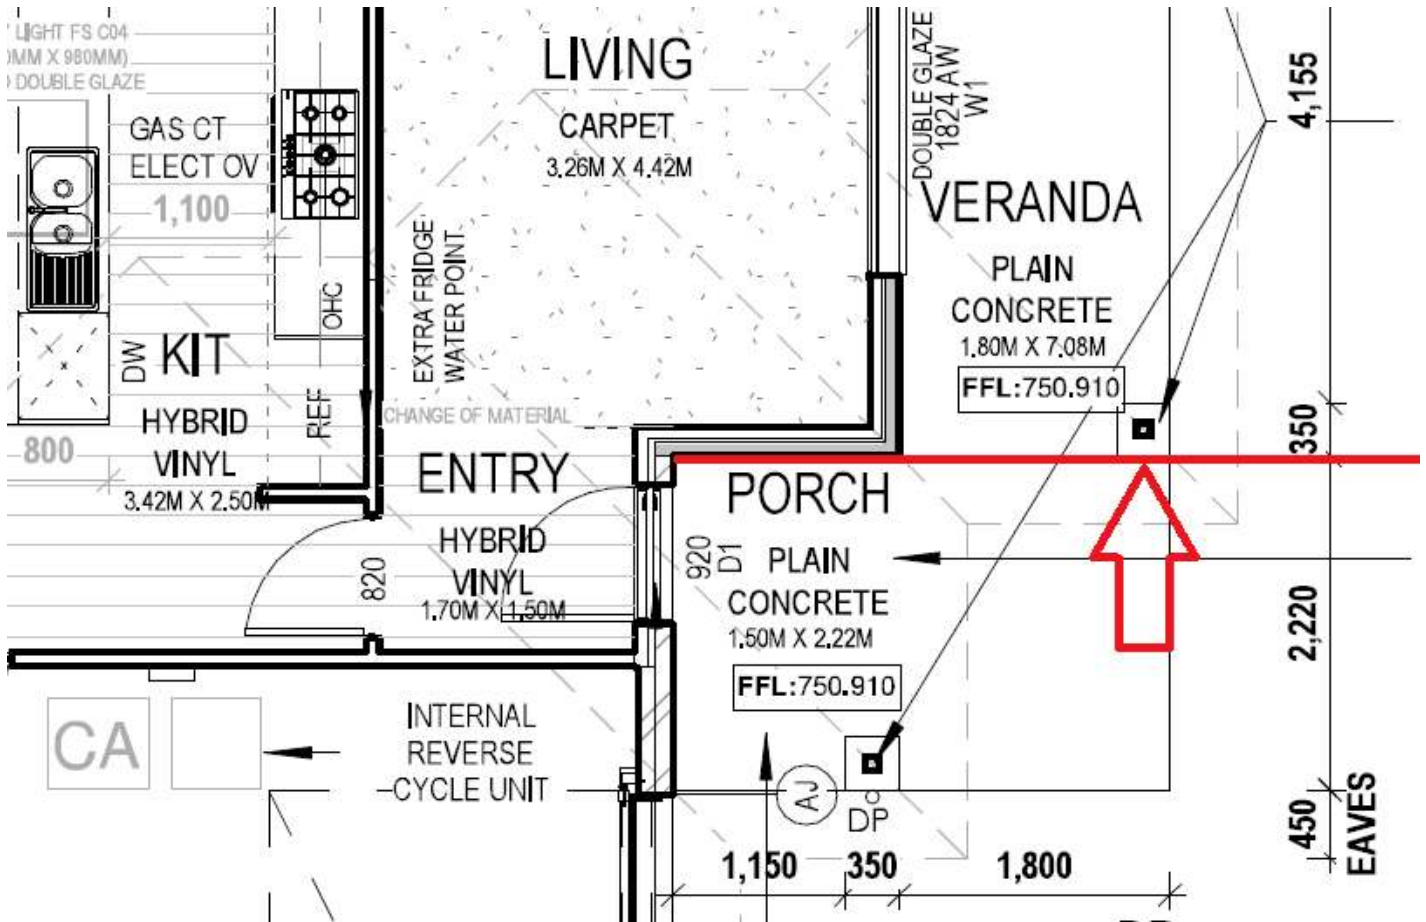
## 12.5.2 Concrete

**DEVIATION FROM THE PLANS: MIDDLE PILLAR MISALIGNMENT**

The working drawings specify that the middle pillar's southern face should be flush with the adjacent wall next to the entry door. However, the middle pillar has been constructed approximately 140mm north of the intended position.

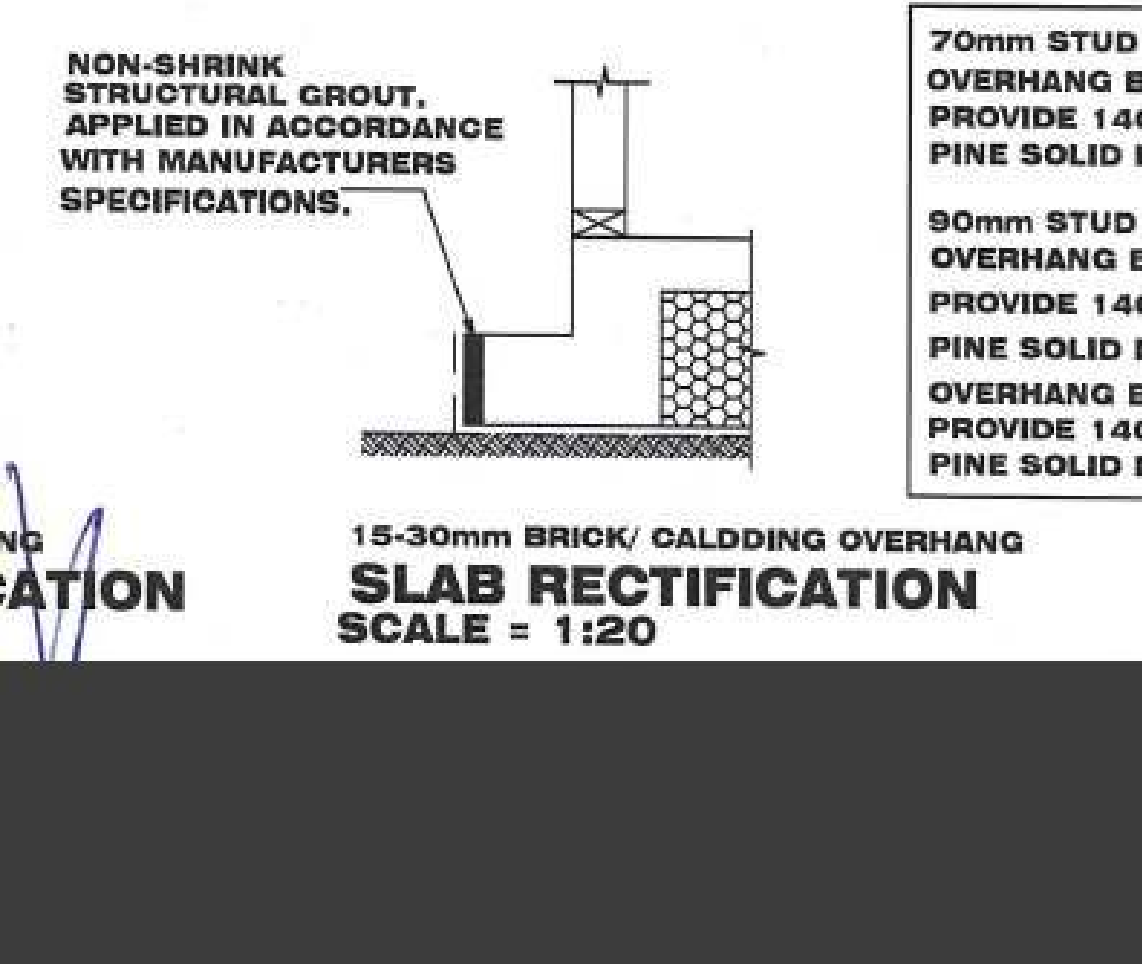
The brick wall at the front of the building **has a 50mm overhang**, exceeding the **maximum allowable 15mm** as per the National Construction Code (NCC). This excessive overhang compromises the structural integrity of the wall. In the short term, it may lead to instability and increased susceptibility to damage from external forces. Over time, the overhang can cause stress on the brickwork and mortar, potentially leading to cracks, water ingress, and deterioration of the wall's structural support.

The designer engineer provided the rectification method for up to 30mm overhang. A specific design for 50mm overhang by the engineer is to be provided.

To rectify this defect, the slab must be extended or additional concrete added to support the brick wall above. This can be achieved by attaching a properly reinforced concrete extension to the existing slab, ensuring it is securely bonded and integrated. An engineer to design the rectification details to ensure compliance with NCC standards and restore the structural integrity of the wall.

Note: The access to under the overhang brick is restricted by the Verandah Concrete. To rectify this issue, the verandah concrete to be removed and repoured after the rectification.

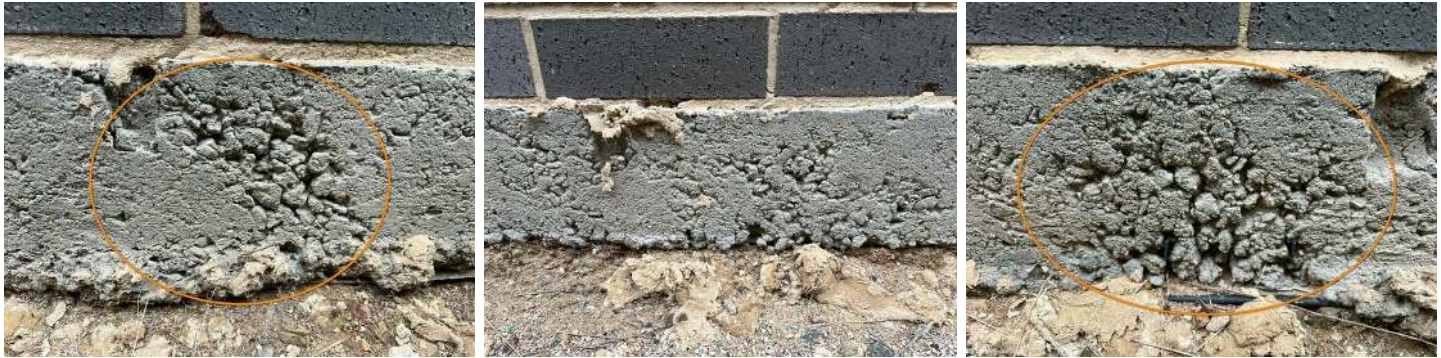
Honeycombing has been observed around the edges of the concrete slab. This defect indicates areas where the concrete has not fully consolidated, resulting in voids and exposed aggregate. Honeycombing can significantly affect the structural integrity of the concrete, leading to reduced strength, potential ingress of water, and corrosion of reinforcement over time.

A high-strength repair mortar should be used to fill the voids, ensuring it is properly compacted and bonded to the existing concrete. An engineer should evaluate the extent of the honeycombing and provide specific instructions for the repair to ensure the slab's structural performance is restored.

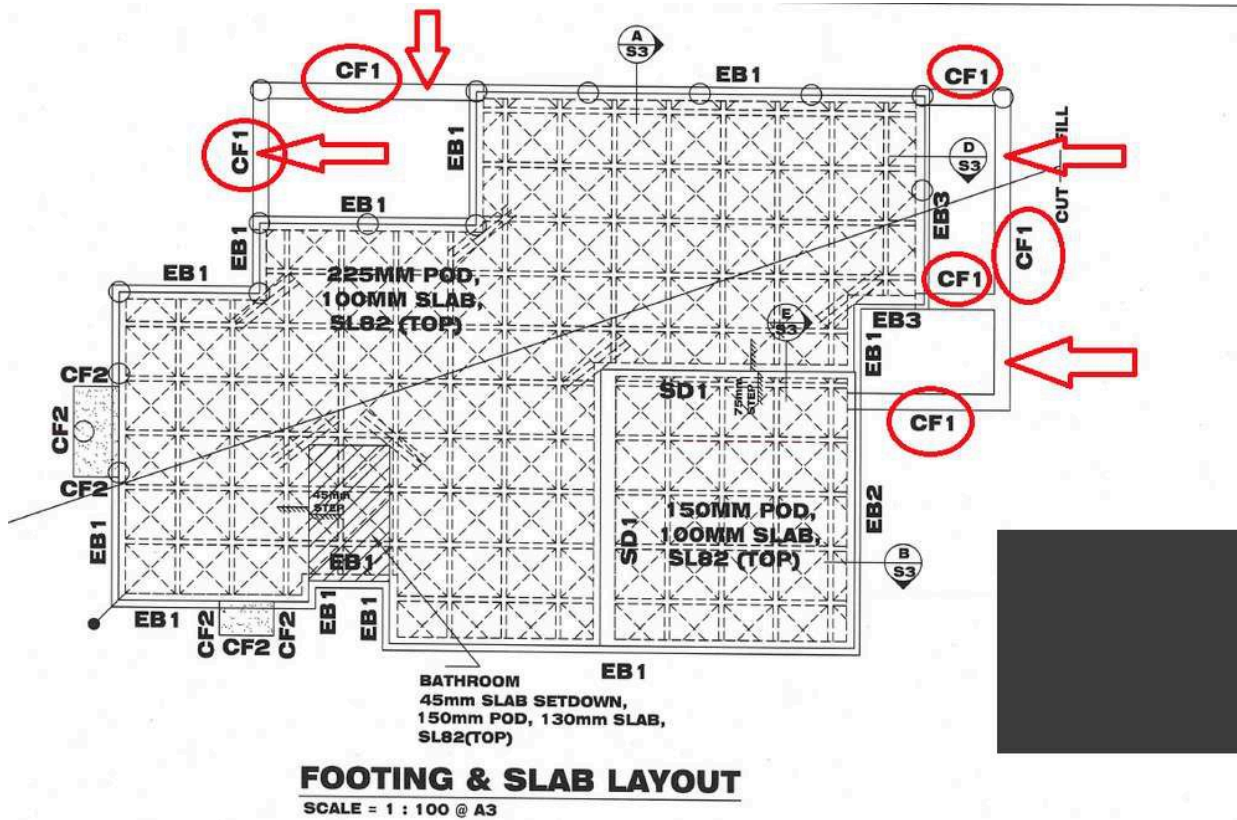
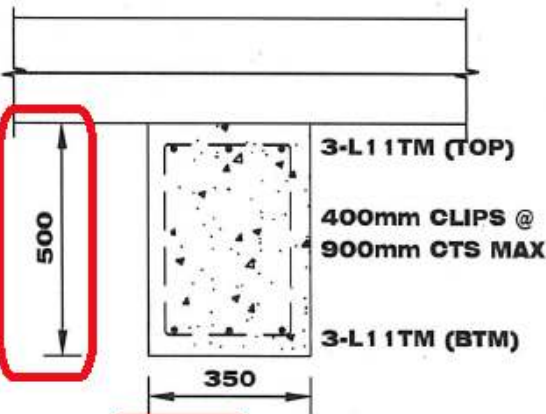
The construction deviates significantly from the approved engineering drawings, primarily due to the improper alignment and connection between the surface concrete and the CF1 edge beams. Without immediate remediation—such as underpinning or reconstructing the beams to extend properly beneath the slabs—the alfresco and verandah slabs are at risk of significant settlement, cracking, and long-term structural failure.

- A 300mm horizontal gap and 50mm vertical gap have been noted. Although smaller than other areas, this still presents a structural deficiency.

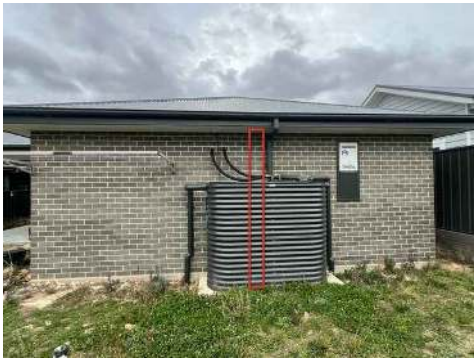
**Defect:** The articulation joint specified on the plans at the rear of the building (where the water tank is located) has not been constructed.

**Potential Future Issues:** The absence of the required articulation joint may result in uncontrolled cracking of the brickwork over time. This can compromise the structural integrity of the wall, lead to water ingress, reduce the overall durability of the building, and potentially result in expensive repairs or remedial work in the future.

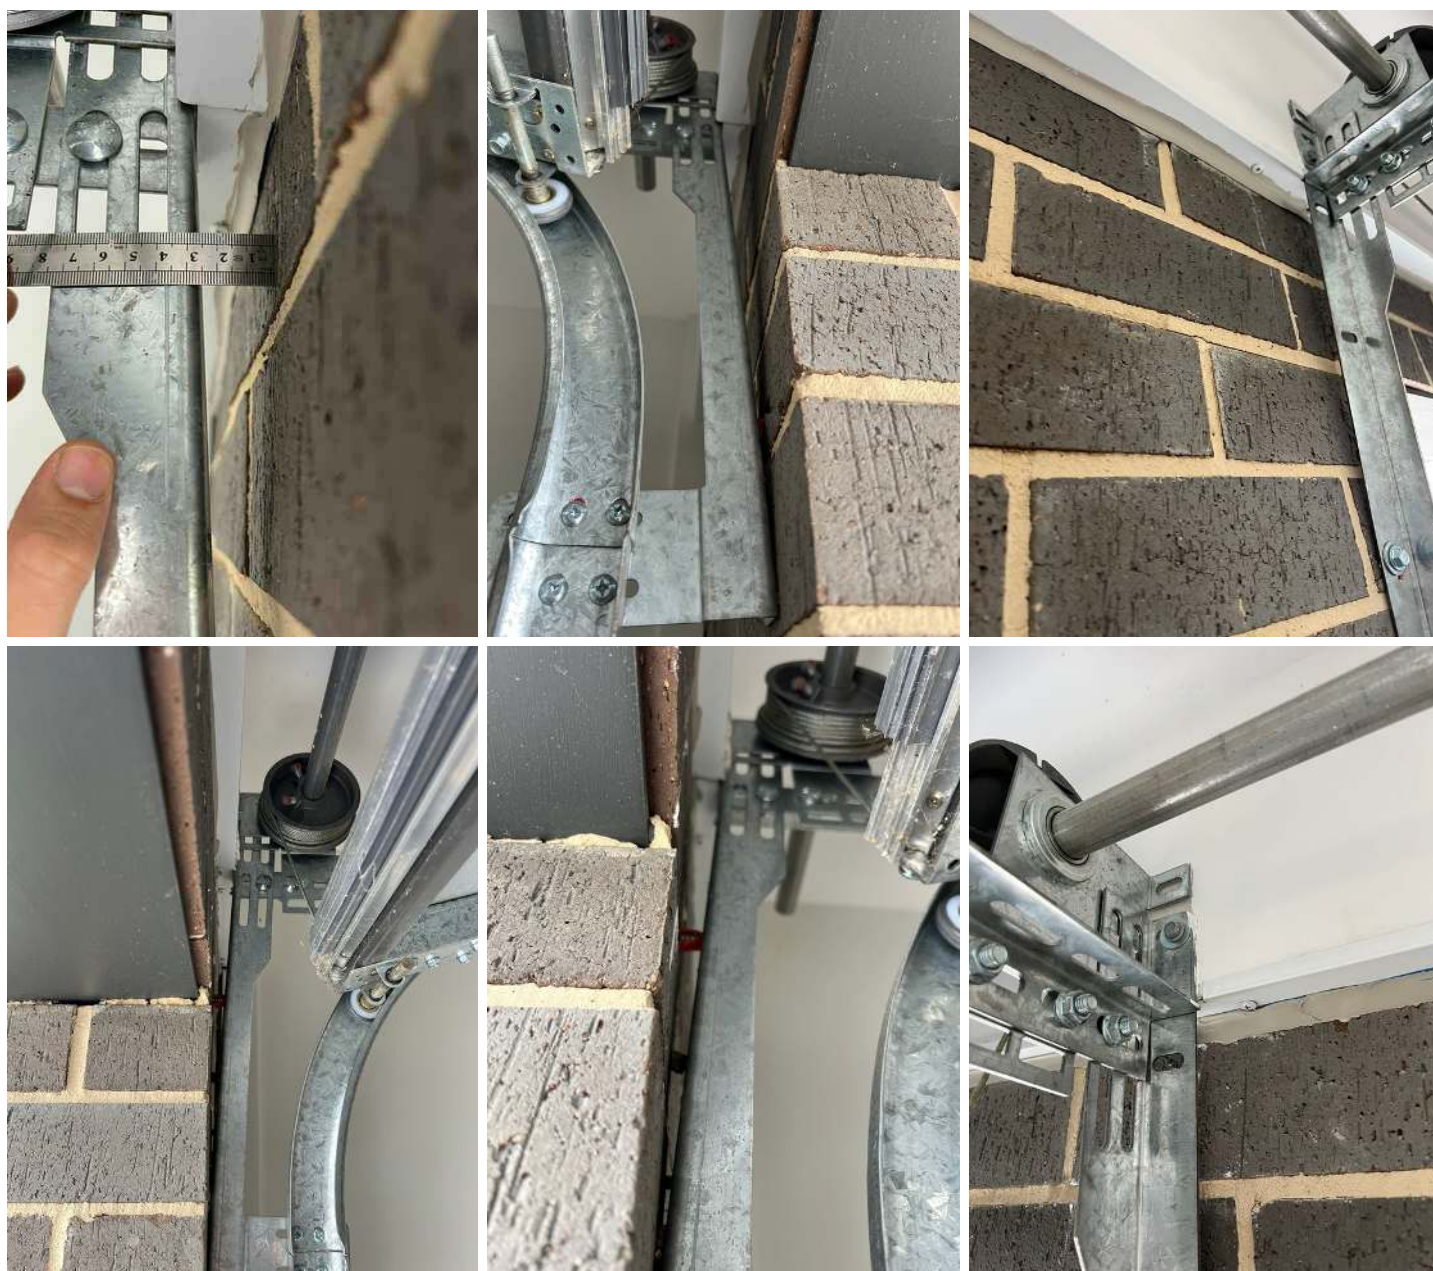
**IMPROPER INSTALLATION OF GARAGE DOOR BRACKET WITH UNEVEN GAPS**

**Defect:** The garage door bracket is not properly seated on the brickwork, leaving a gap of **20mm on the left side and 26mm on the right side** between the bracket and the wall. This indicates improper installation, as the top of the bracket is resting on plaster instead of securely on the brickwork. This issue likely arises due to the size of the beam extending outside the brickwork, which is not typical for similar types of buildings.

**Potential Future Issues:** The uneven gap and improper support can cause the bracket to loosen over time, especially due to the vibrations from the garage door's regular operation. This may lead to misalignment or malfunction of the garage door, and the bracket's inadequate support could cause damage to both the plaster and the door mechanism. Additionally, it increases the risk of structural failure, leading to costly repairs.

This installation does not follow good building practices and requires immediate rectification to ensure the stability and longevity of the garage door system.

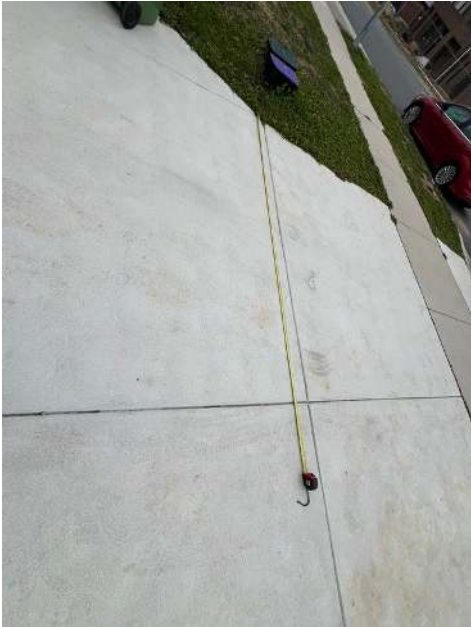
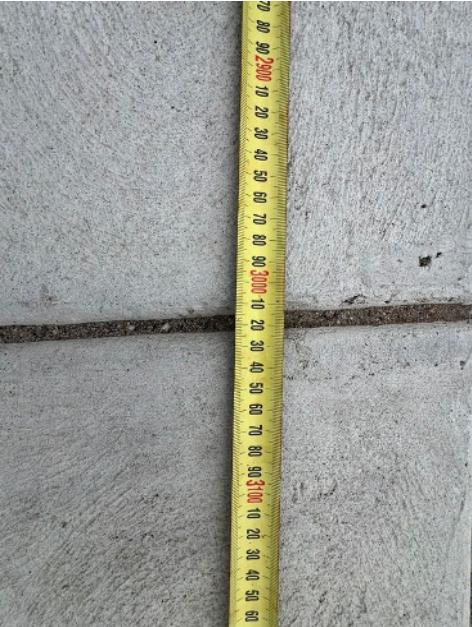
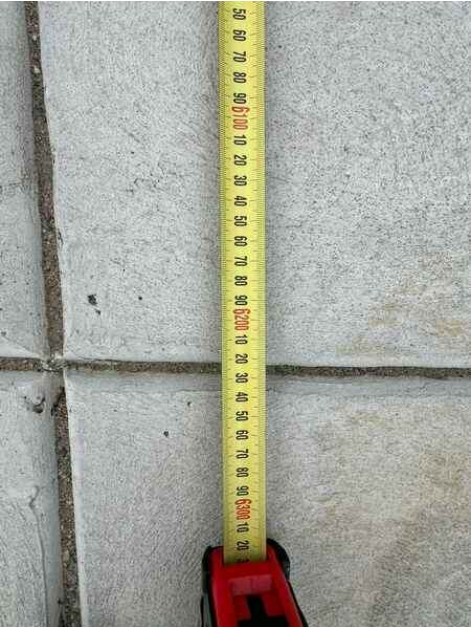
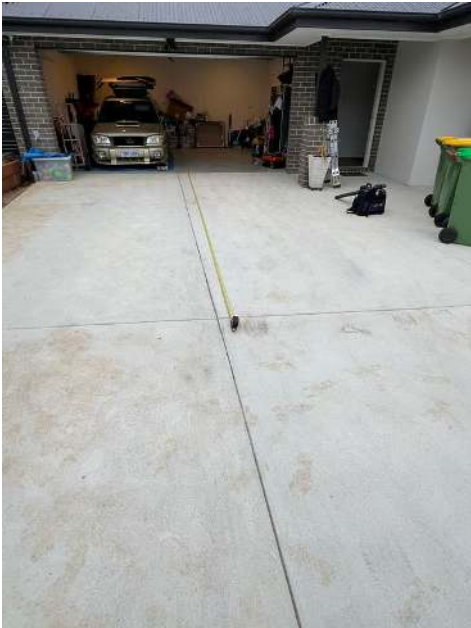
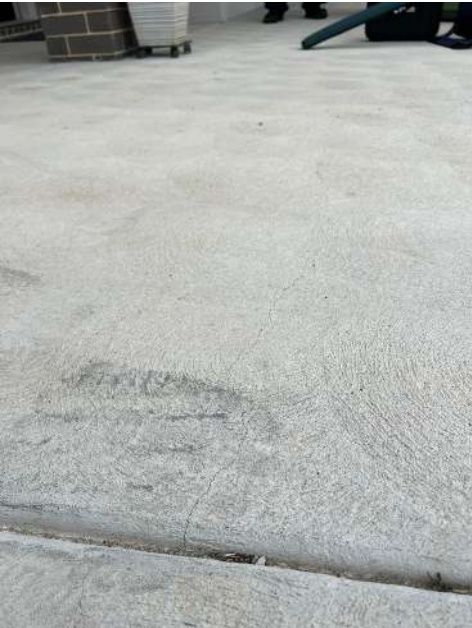
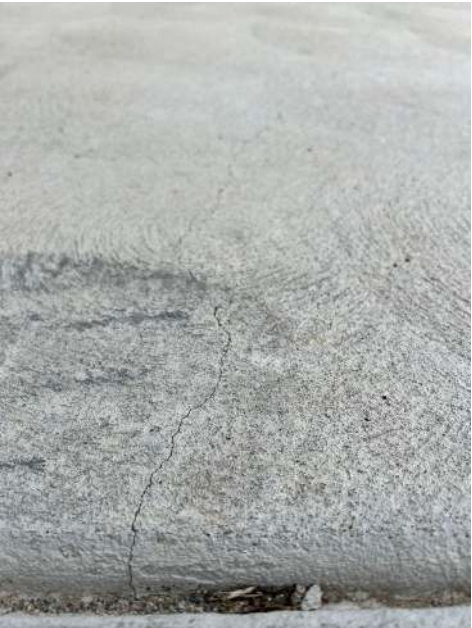
IMPROPER SPACING OF CONCRETE CONTROL JOINTS

**Defect:** The defect identified is that the distance between the concrete control joints has been noted up to 6 metres (6000 mm), while it should ideally be between 2400 mm and 3000 mm. Control joints are critical in concrete construction as they help manage and direct the natural cracking that occurs due to shrinkage, temperature changes, and other forces.

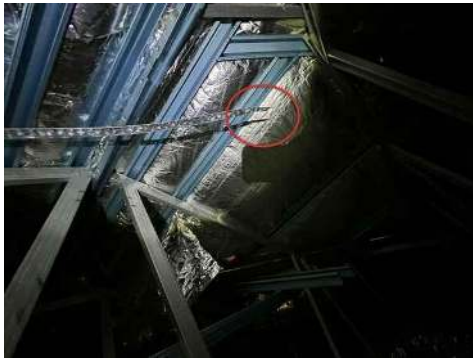
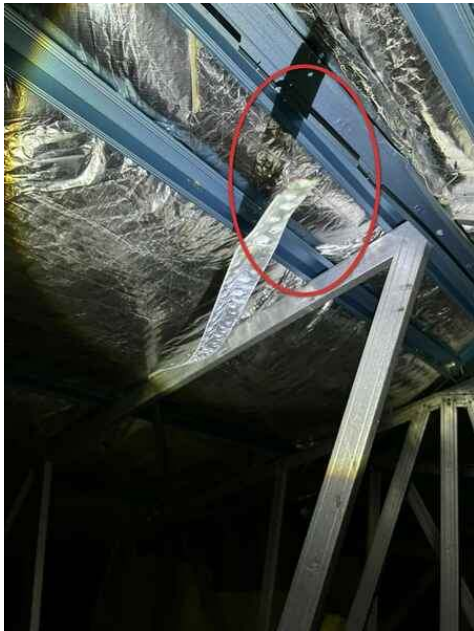
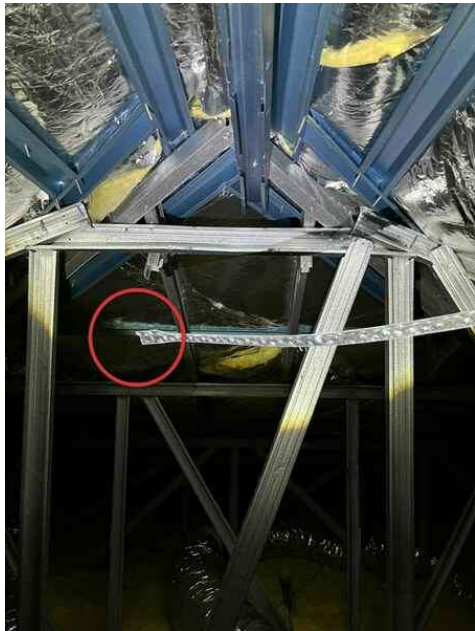
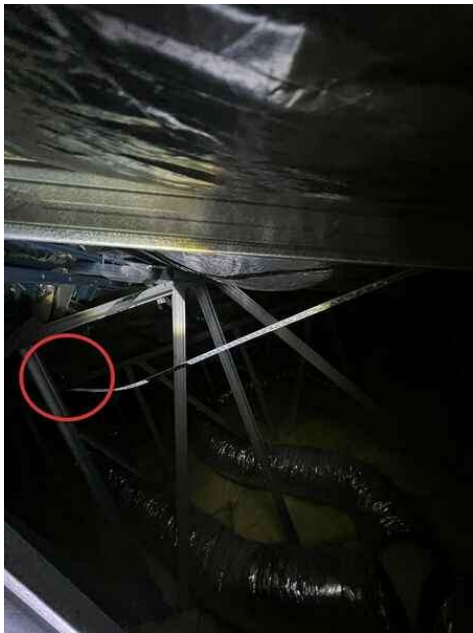
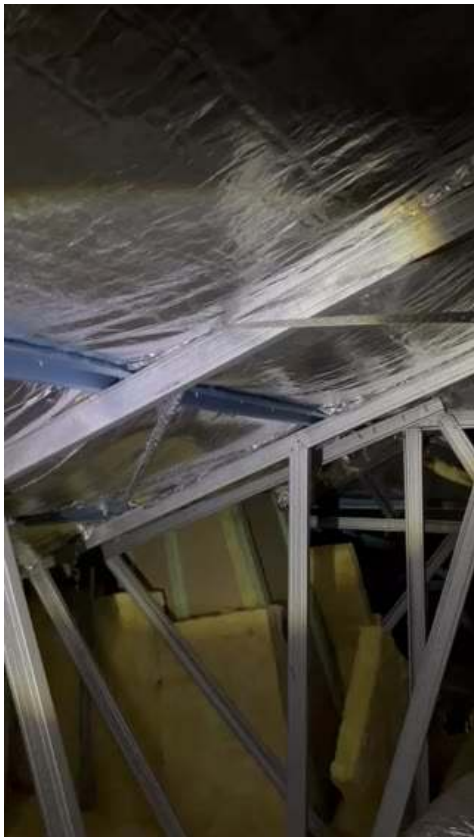
**Defect:** During the inspection, it was noted that multiple roof bracings had been cut. Roof bracings are critical structural components that help transfer loads from the roof to the supporting walls and ensure the overall stability of the roof structure.

Immediate repair or replacement of the cut roof bracings is necessary to restore the roof's structural integrity and ensure the safety and longevity of the building.

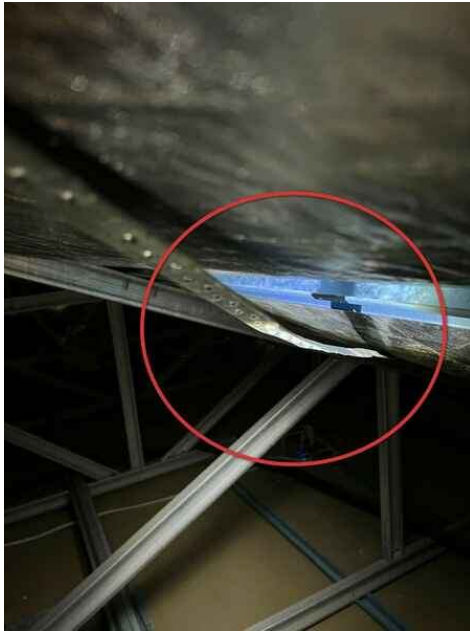
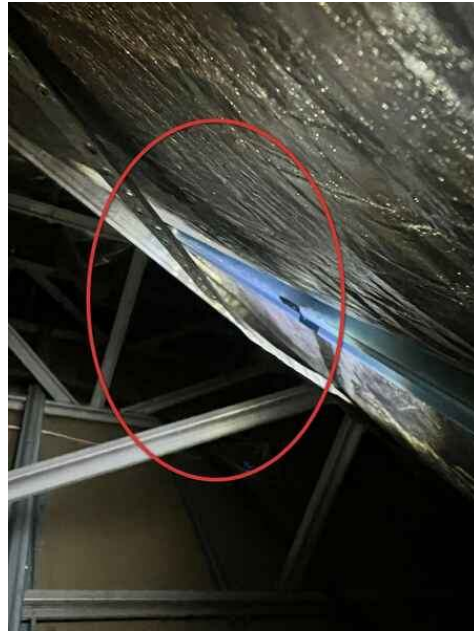
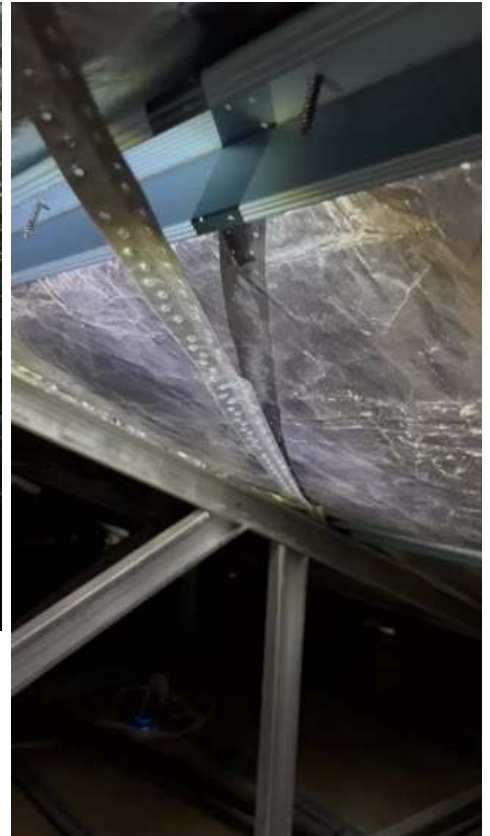
## 16.1.2 + Roof Structure

**UNTENSIONED ROOF METAL BRACINGS**

During the inspection, multiple roof metal bracings were found to be untensioned, compromising the roof's structural stability. Properly tensioned bracings are essential to resist lateral forces such as wind and prevent roof movement. Untensioned bracings may lead to roof sagging, water leaks, and potential safety risks. Immediate corrective action is required to tension the bracings according to structural specifications to maintain the building's integrity and safety.

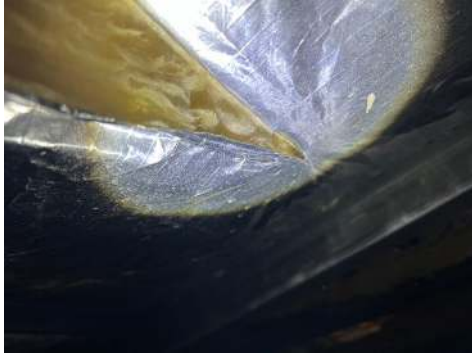
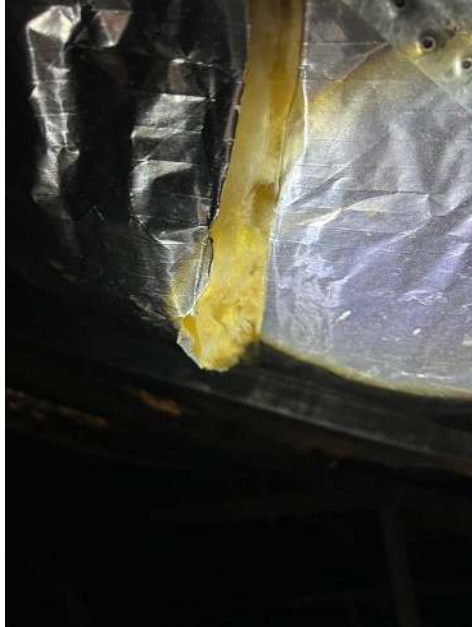
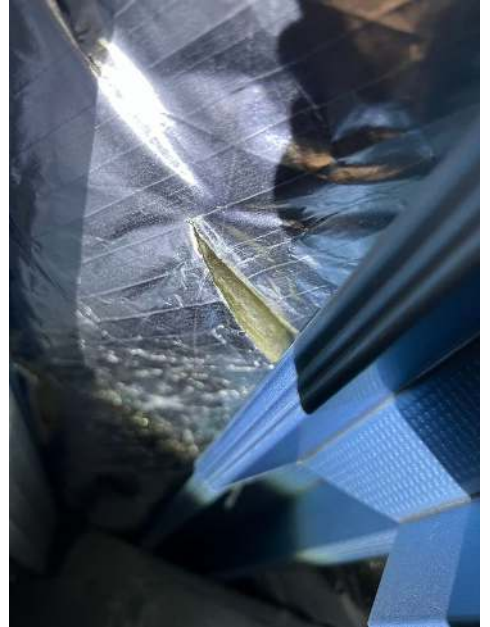
## 16.2.1 + Sarking/Sisolation

**DAMAGED OR CUT ROOF SARKING**

One or more sections of the roof sarking were noted to be damaged or cut.

Sarking, typically installed over roof trusses before the final roof covering, is essential in preventing condensation from forming on the underside of the roof and dripping onto the ceiling below. Without proper sarking, the risk of water leakage and moisture build-up increases, potentially leading to ceiling damage and structural issues.

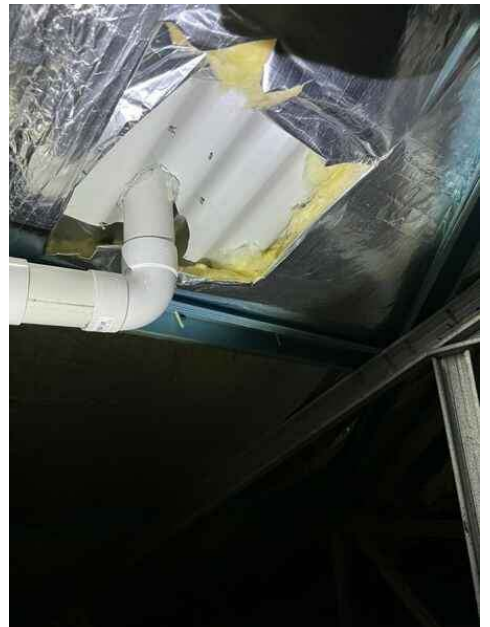
## 16.2.2 + Sarking/Sisolation

**UNSEALED SARKING AROUND ROOF VENT PENETRATION**

The sarking around the roof vent penetration is not sealed, leaving the area vulnerable to water ingress.

To ensure the roof remains water-tight and prevents moisture from entering, the sarking should be sealed properly using appropriate sealing tape. Failure to do so may lead to potential leaks and damage to the underlying structure.

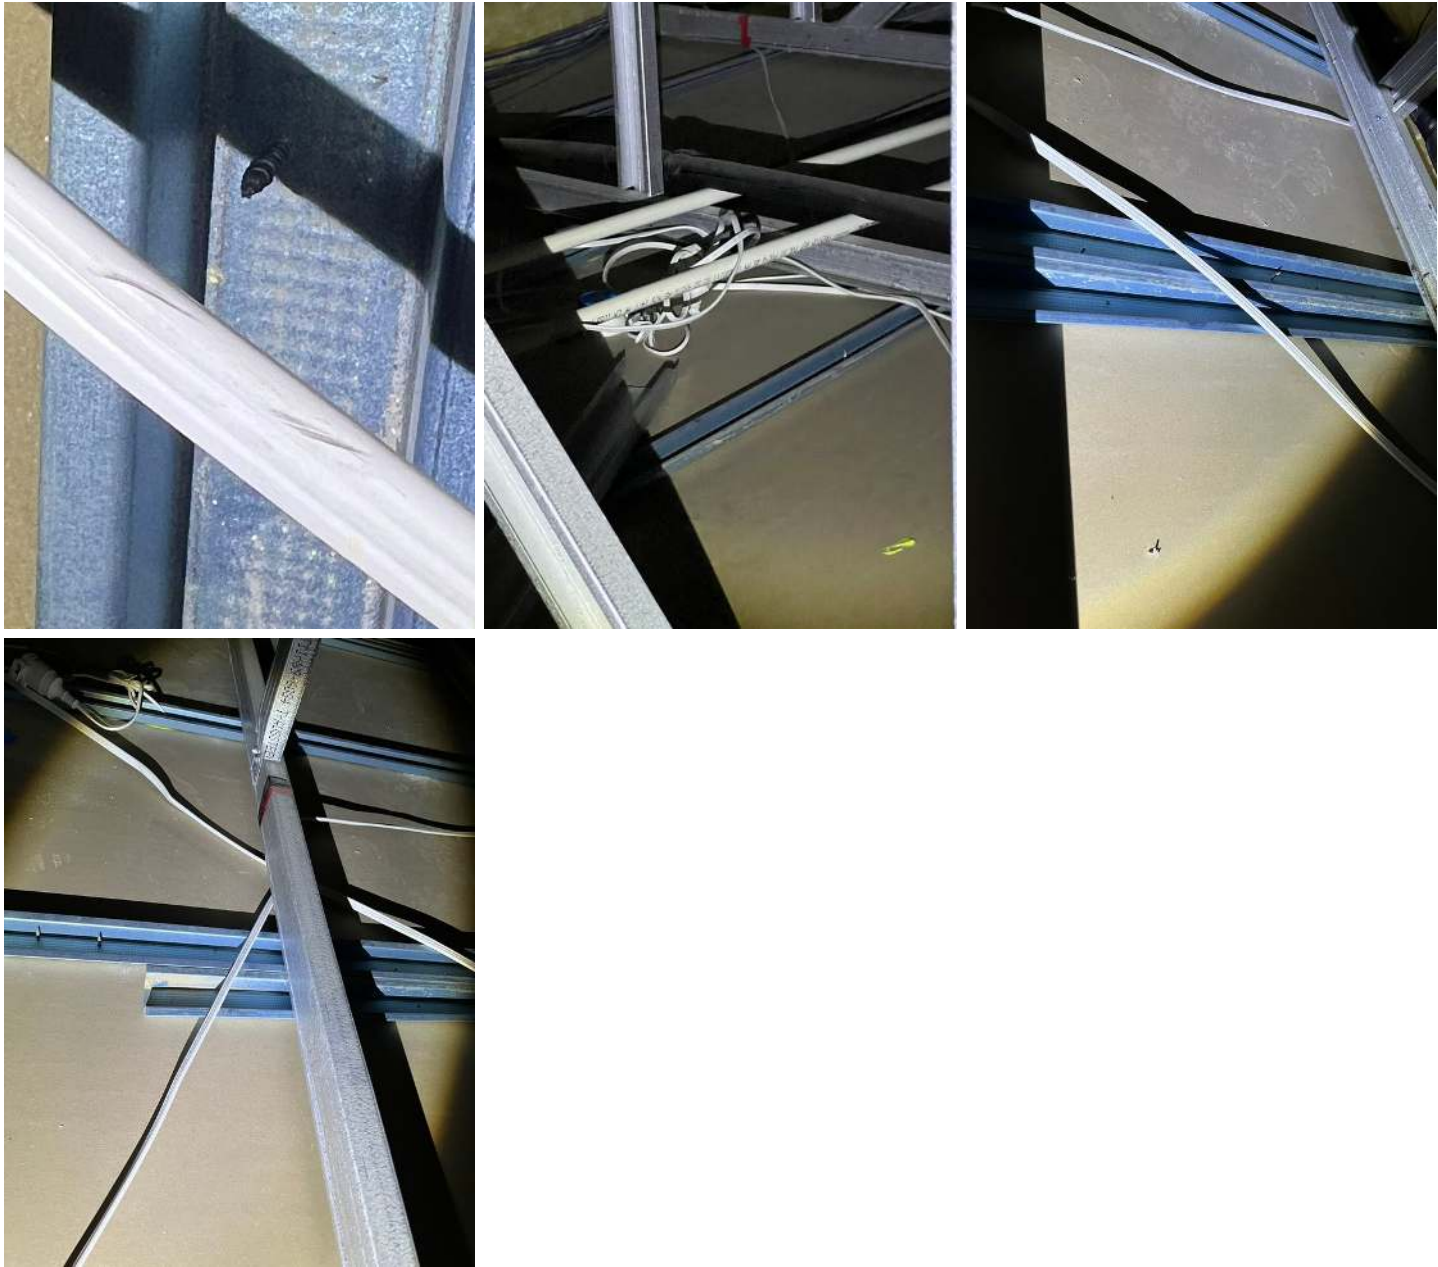
16.2.4 + Sarking/Sisolation

LOOSE AND UNSECURED ELECTRICAL CABLES IN ROOF SPACE

During the inspection, it was noted that the electrical cables in the roof space have been left loose and are either **not fixed** or **not fixed properly**. This presents a potential **safety hazard** as loose cables may be subject to damage, increasing the risk of electrical faults, short circuits, or even fire. Additionally, improper cable management can lead to interference with other systems or create obstructions during any future maintenance or repairs.

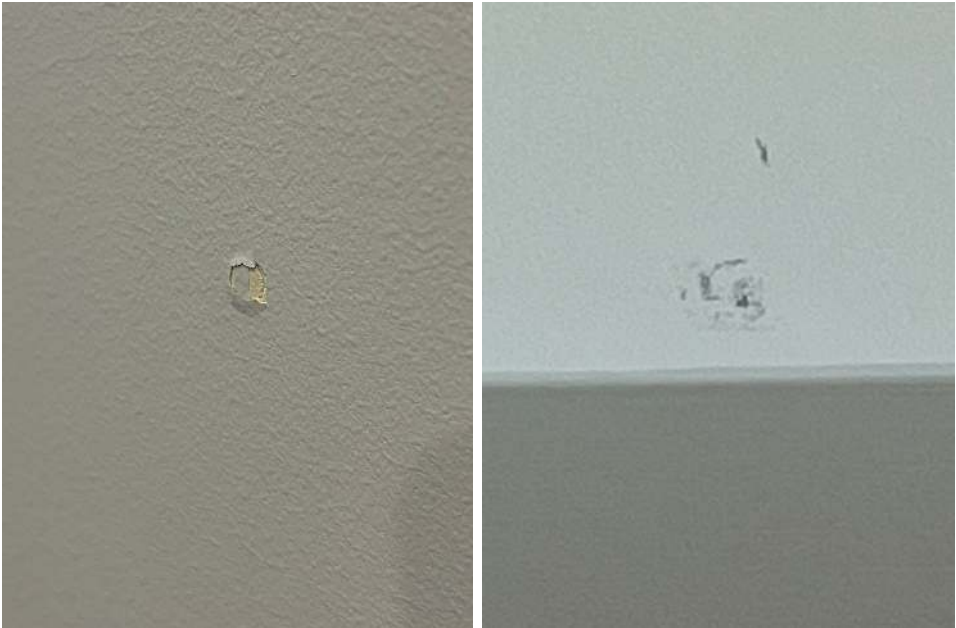
17.3.1 Plaster

WALL SURFACE DAMAGE

A noticeable chip or damage is observed on the wall surface, exposing the underlying material. This defect requires patching and repainting to restore the surface to its original condition and maintain aesthetic quality.

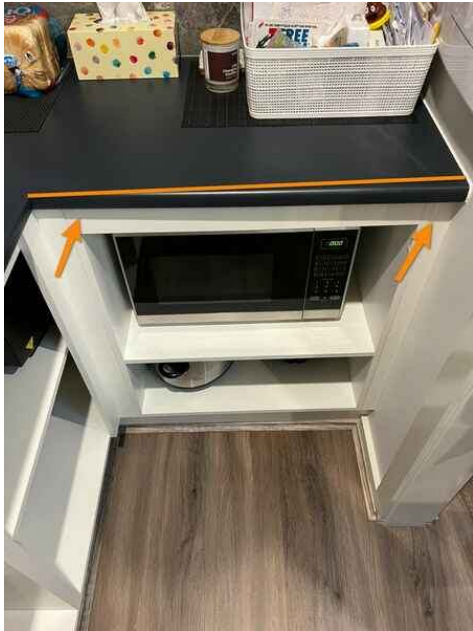
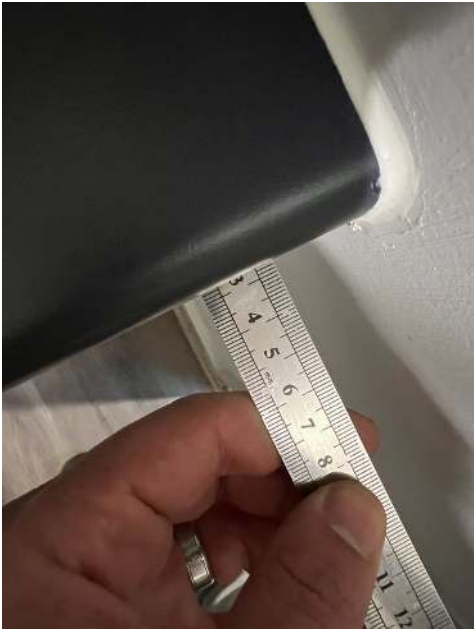
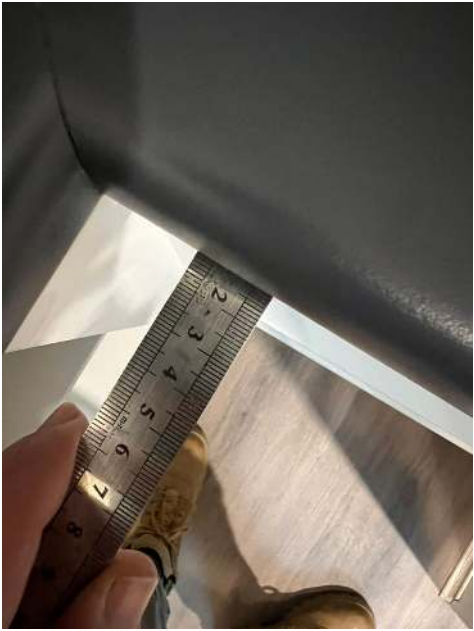
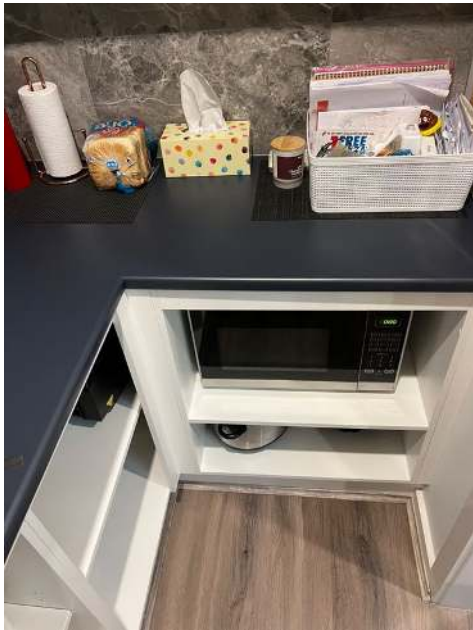
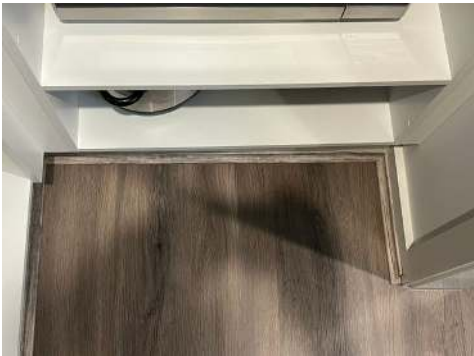
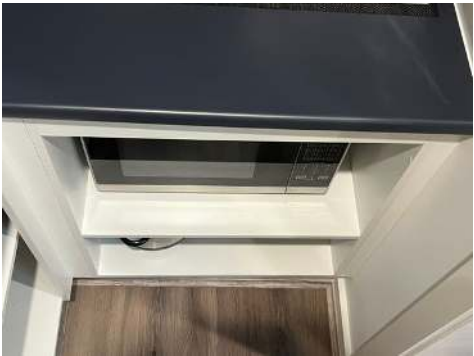
The benchtop in the pantry is not parallel to the surrounding cabinets, with a measured difference of **12mm on the left** side and **28mm on the right**, resulting in a **16mm discrepancy**. This misalignment is visually noticeable, particularly under the fixed light of the downlight, where the shadow accentuates the unevenness. Such a defect affects the overall finish and visual symmetry of the cabinetry, and rectification is required to realign the benchtop for a consistent appearance and proper installation.

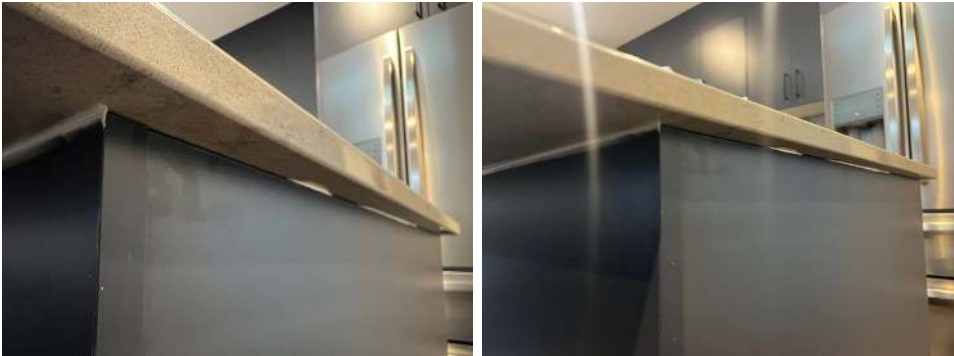
A section of the caulking under the cabinet island bench is incomplete. This can lead to gaps, which may allow moisture, dirt, or pests to accumulate, potentially causing damage to the structure and compromising the overall finish. Proper caulking should be applied to ensure a seamless and protected surface.
