## Building Damage Report

Sample Property , Suburb withheld , NSW

21/10/2024

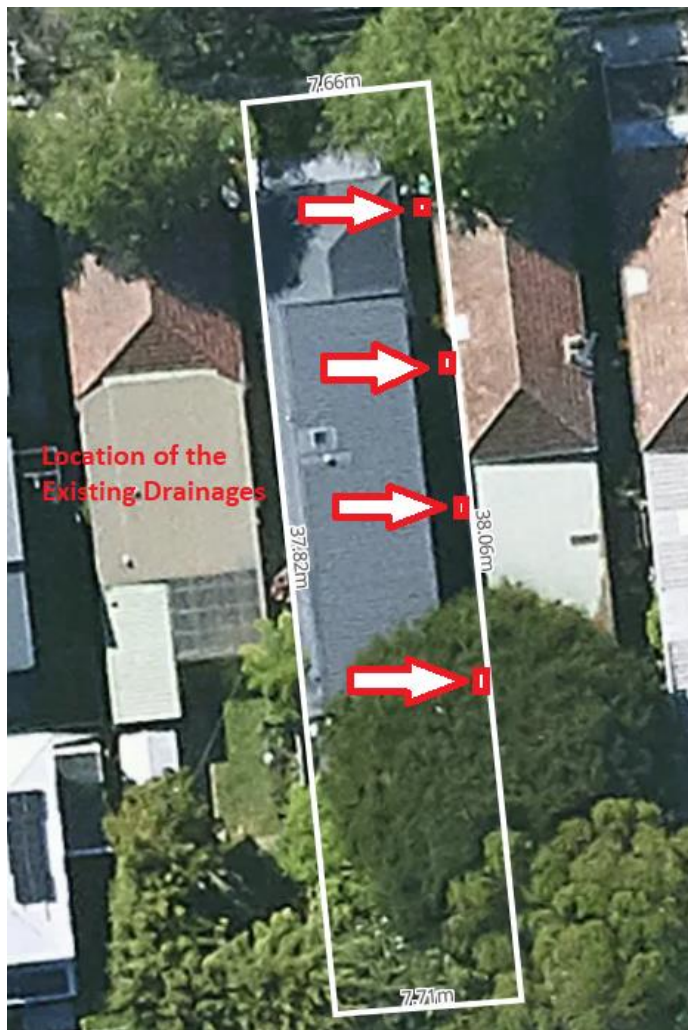
Not required. The existing drainage system is proper and operable. It was tested and effectively drains surface water to the stormwater system and away from the building.

During the inspection, four drains on the left side of the building were tested using an on-site hose. Over an hour-long test, all drains successfully drained water without any signs of blockage. Measurements confirmed that the site grading directs water away from the building, with gradients varying between 8mm/m and 25mm/m, complying with AS 3500.3-2018 (Plumbing and Drainage—Stormwater Drainage). The water test demonstrated that water runs away from the building and towards the drains, with no signs of ingress into the subfloor.

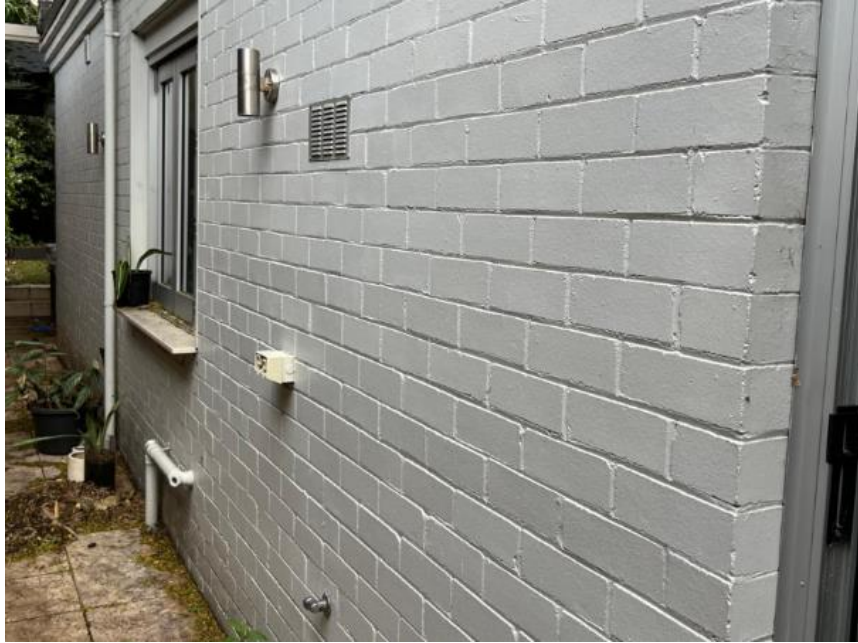
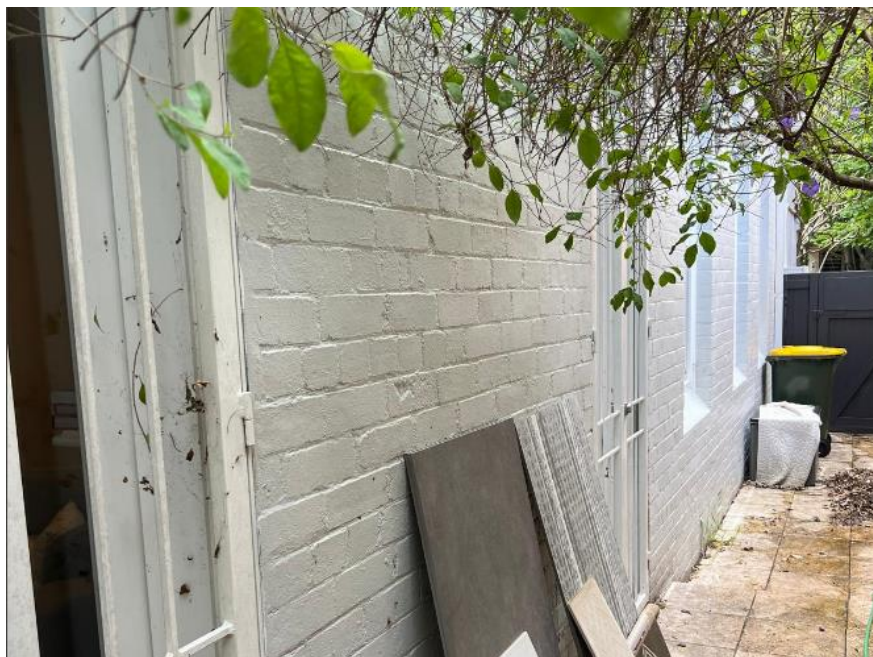
Disagree. The tuckpointing and mortar are in good condition, and replacement is not required. The engineer's report does not specify any defects in this area.

*Justification:* Tuckpointing is necessary when mortar joints are deteriorated, which can compromise structural integrity or allow moisture ingress (as per AS 3700-2018, Masonry Structures). Since the mortar joints are in good condition, this work is unnecessary.
