## EXPERT WITNESS INSPECTION

Sample Property ,  
Suburb withheld, **Queensland**  
Name withheld  
[company withheld]

## Preliminary investigation report: Building Defects

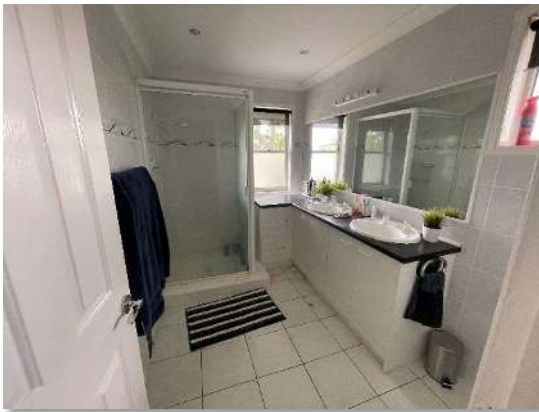
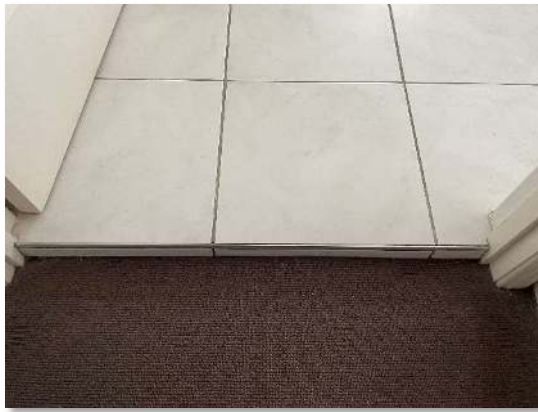
Photograph 1

The bathrooms at some stage appear to have been retiled. This is supported by the large step into the wet areas. We note there is NO water stop of the door entries. This leads us to believe the waterproofing is non-conforming.

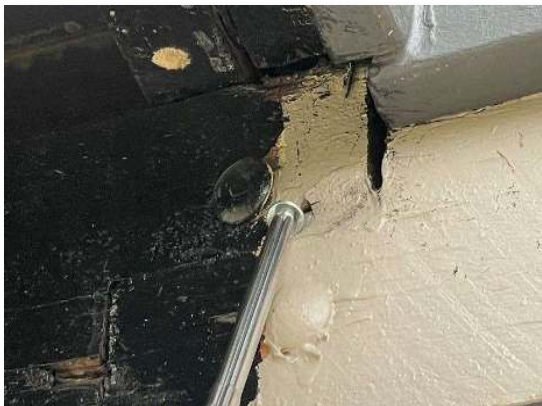
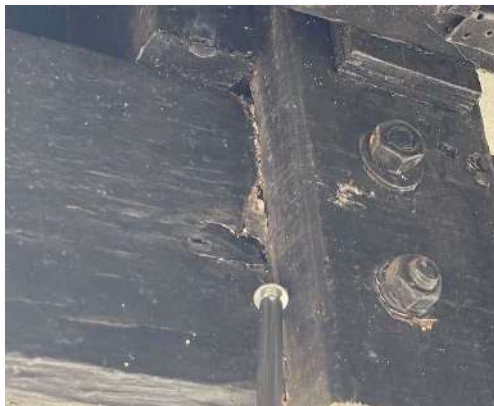
The timber first level verandah has significant wet rot to the bearers. This decay significantly reduces the structural performance of the verandah. Cut ends of timber shall be painted to prevent decay.

**Safety Note.** This verandah should be isolated and not be used until member replacement has occurred.

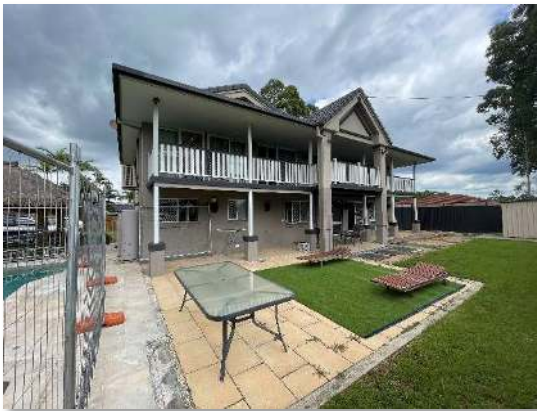
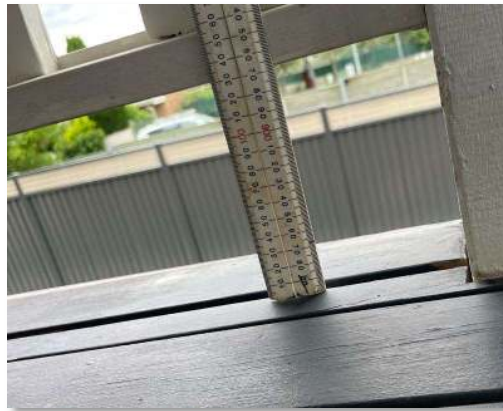
The first level timber verandah is protected by a timber handrail. The maximum allowable openings is 125mm. Our inspection confirms in some locations spacing are as big as 130mm. This spacing increase is most likely caused by the seasoning of the large load bearing timber bearers. As they season, they shrink toward the centre of the timber section. It is not uncommon to see 20mm shrinkage in a 200mm member.

**Safety Note.** This verandah should be isolated and not be used until a rectification has occurred.

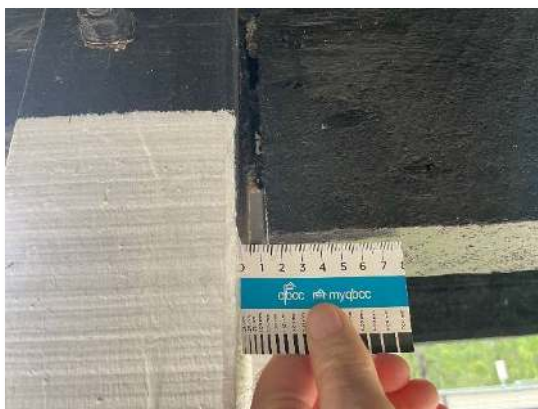
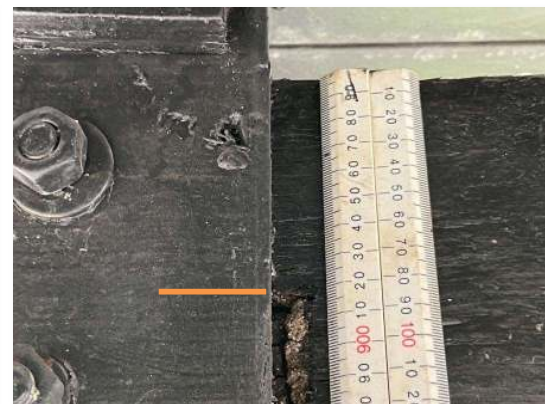
The first level rear timber verandah has been installed using large timber bearers which span from timber post to post. The central timber bearer has not been installed in a tradesman like manner. Adequate bearing has not been achieved in this installation. Current installation only has an 80mm scarf of the 240mm beam that is supported by the post.

**Safety Note.** This verandah should be isolated and not be used until member replacement has occurred.

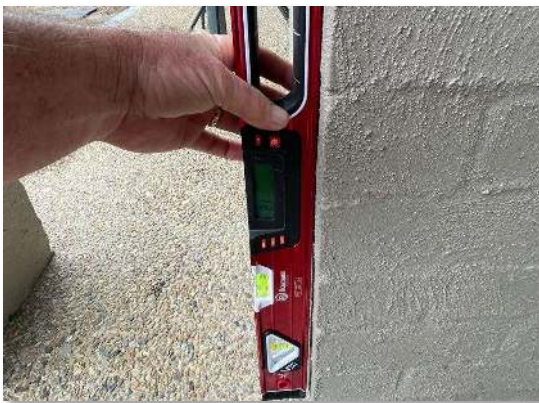
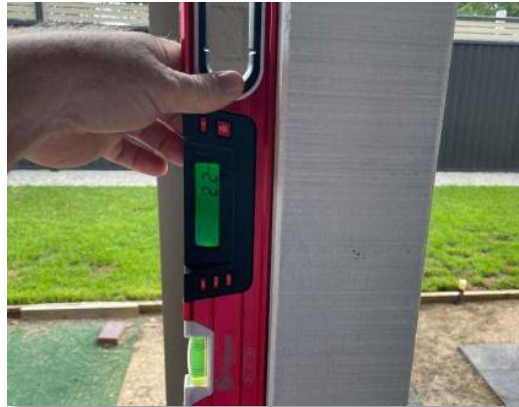
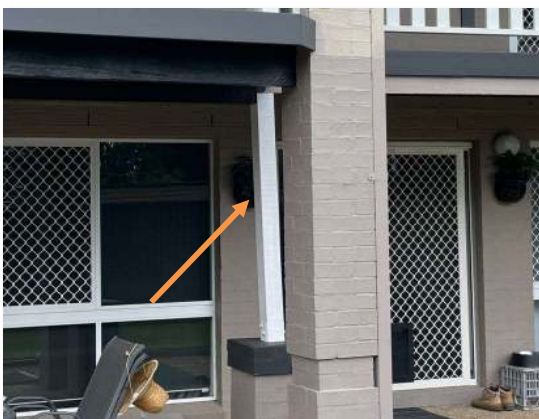
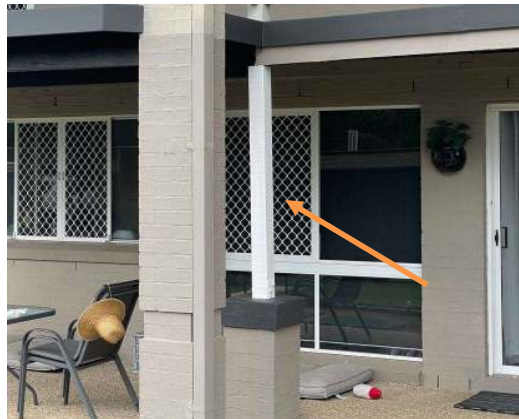
The timber rear verandah is supported on timber posts that are in turn supported by dwarf feature brick piers. Several of the piers have rotated up to 22mm/mtr, due to subsidence of the foundation under the outer edge of the footing.

**Safety Note.** This verandah should be isolated and not be used until further assessment is completed by a structural engineer.

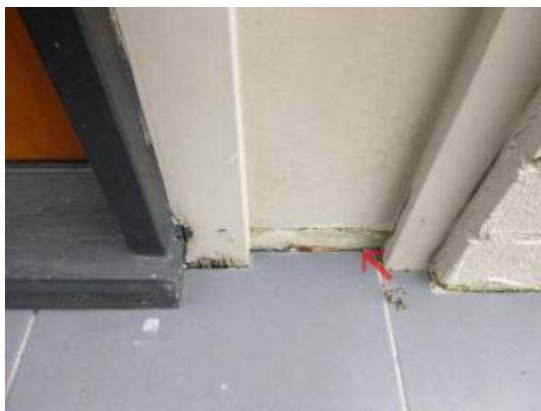
Photograph 10

Ground clearance of building cladding and timber trims is important, a minimum standard is in place to allow a visual inspection for termite infestation. In this case timber is in direct contact with no visual barrier. Early identification can save extensive damage.

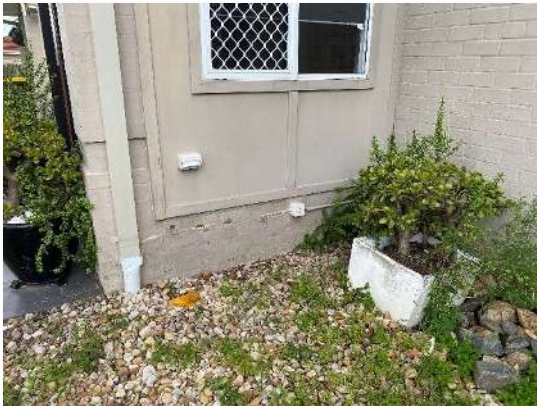
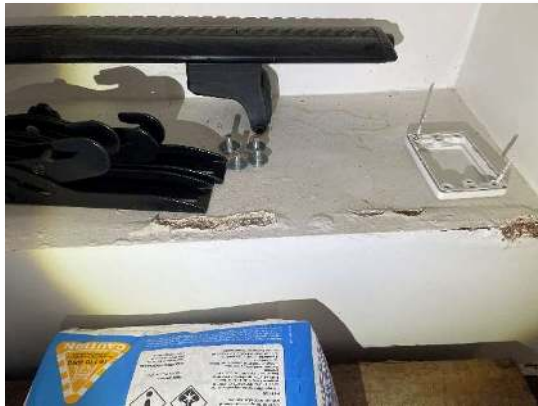
The entry to this building has been changed over the years. The feature open entrance has been closed in. This entry was never designed with the appropriate damp courses to prevent rising damp. As such we currently have rising damp affecting internal elements of the building. This damp can cause mould which is a health issue.

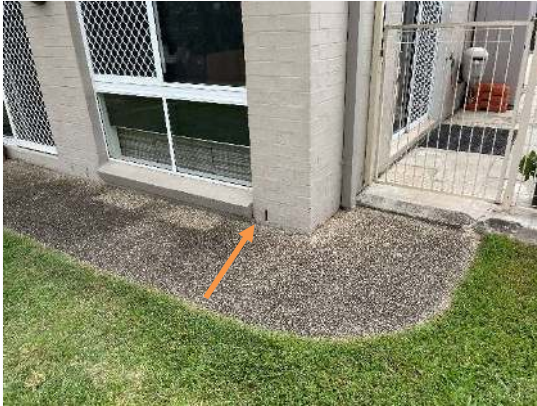
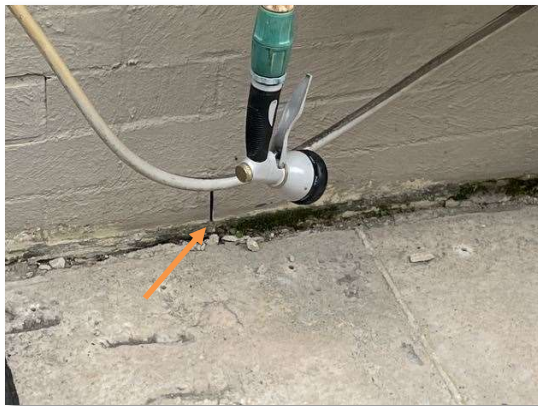
Photograph 8 and Photograph 9

The minimum clearance off a paved concourse can be reduced in some instances to a minimum of 50mm. In many locations on this building this threshold has been breached with less than minimum clearance. In periods of extreme rainfall, water may back flow into the house through the weep holes.

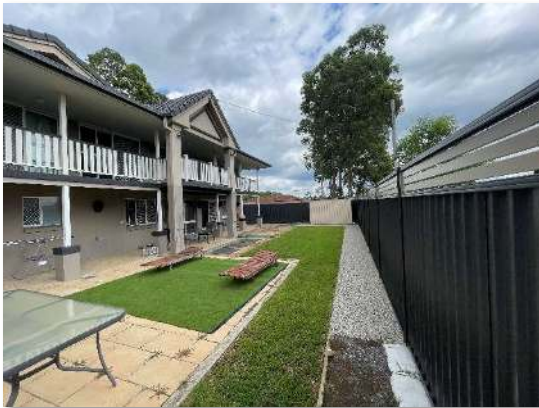
In order to maintain stable foundations for the building, all surface water shall be drained away from the building. Graded soils shall fall a minimum of 50mm over the first 1metre away from the house.

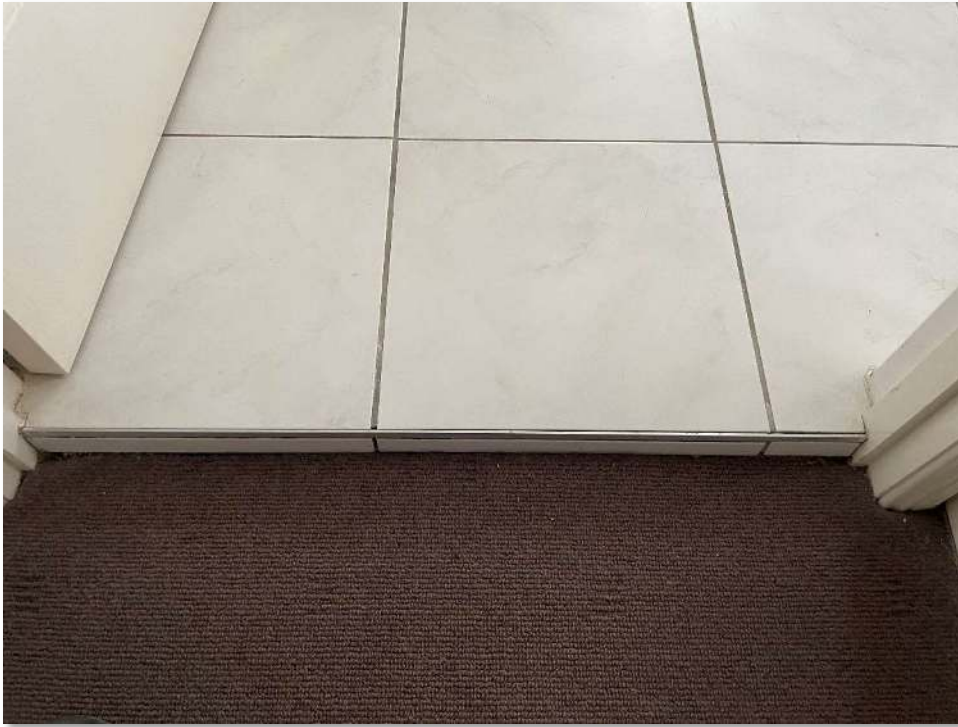
PHOTOGRAPH 1. NO WATER STOP TO BATHROOM ENTRY

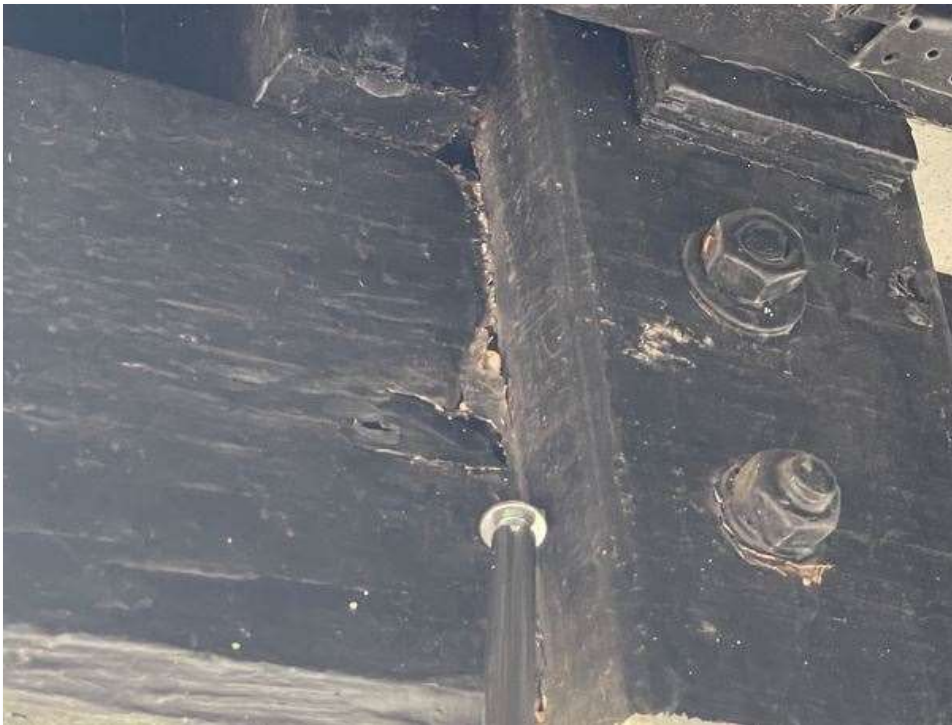
PHOTOGRAPH 2. BEARER DECAY

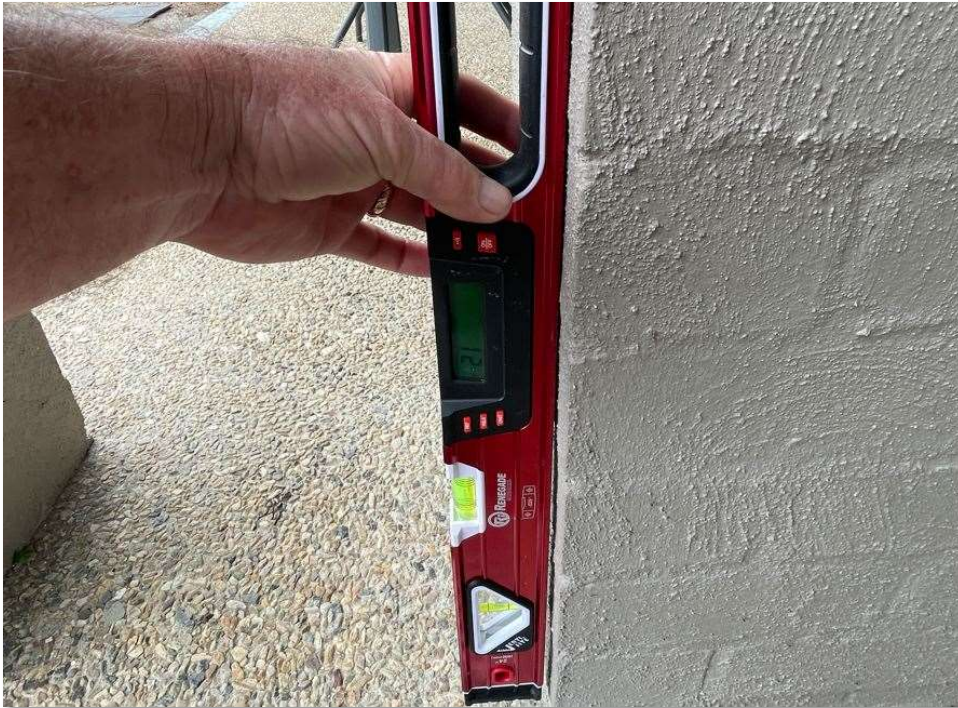
PHOTOGRAPH 3. BRICK PIER 21MM/MTR OUT OF PLUMB

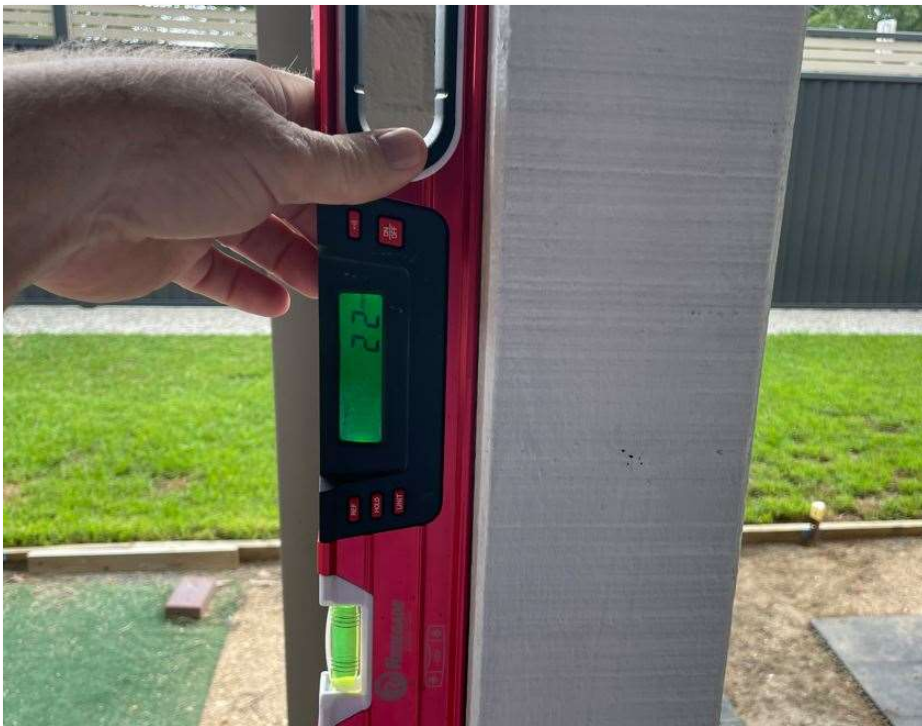
PHOTOGRAPH 4. TIMBER POST 22MM/MTR OUT OF PLUMB

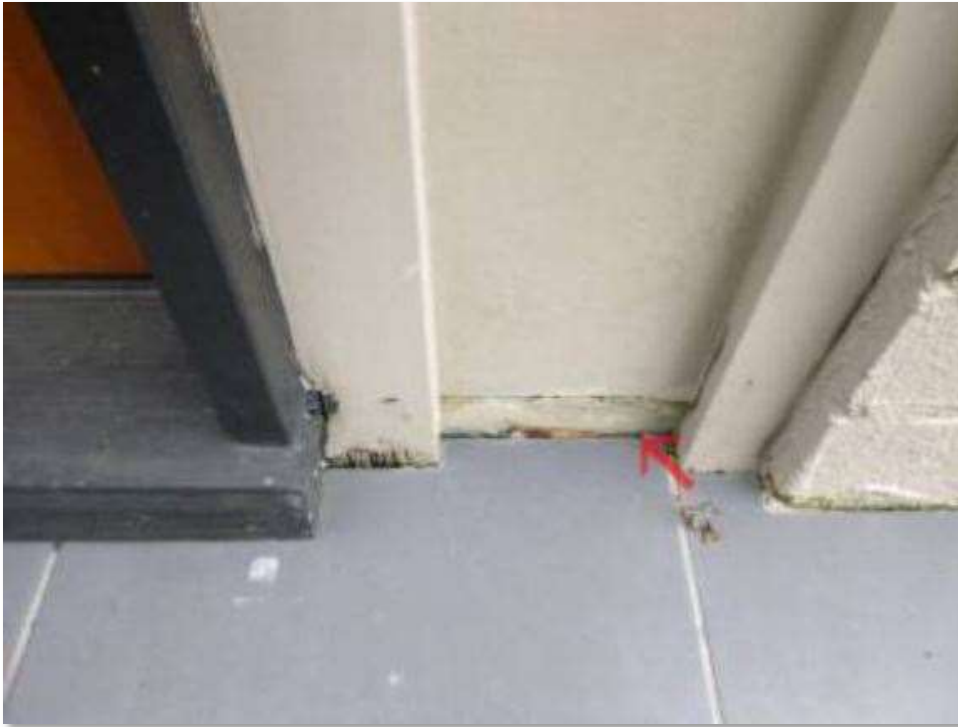
PHOTOGRAPH 5. CLADDING AND TIMBER BRIDGING TERMITE BARRIER

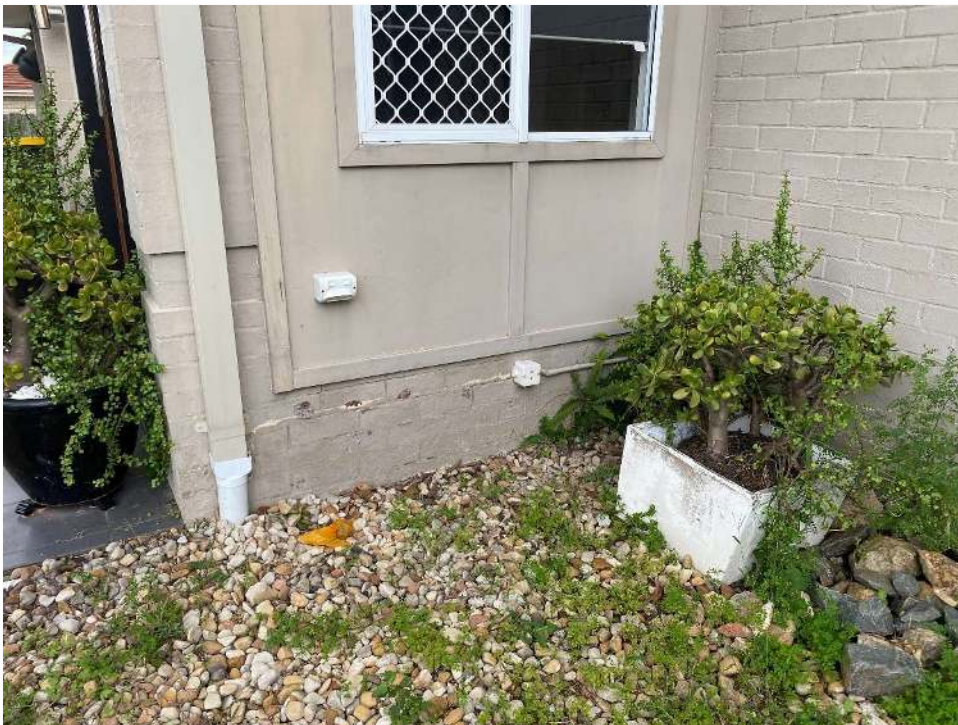
PHOTOGRAPH 6. NO DAMP COURSE

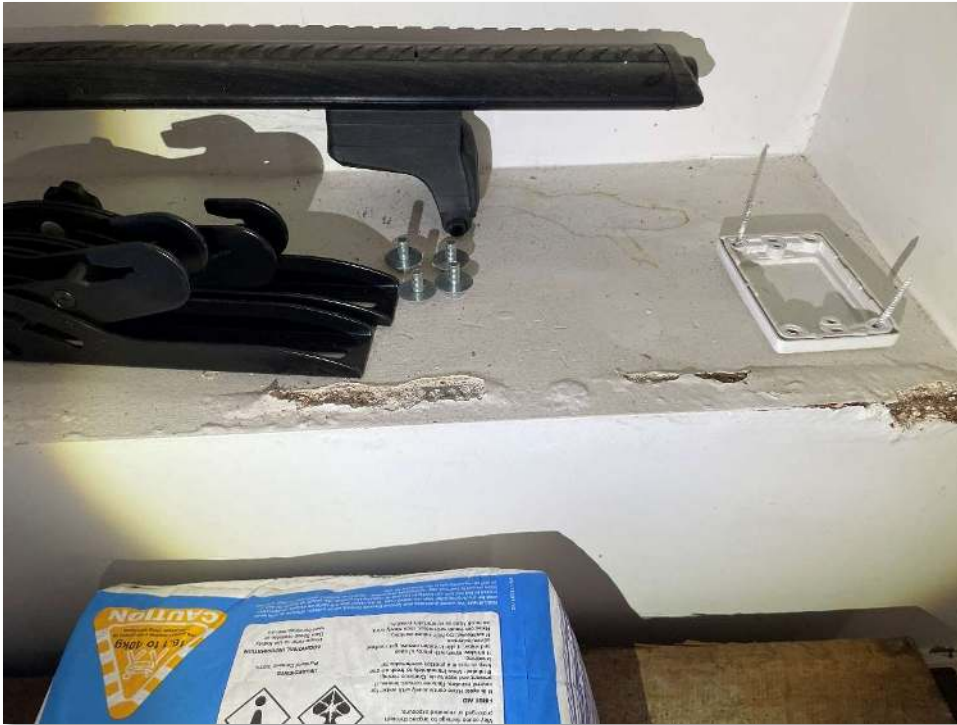
PHOTOGRAPH 7. RISING DAMP

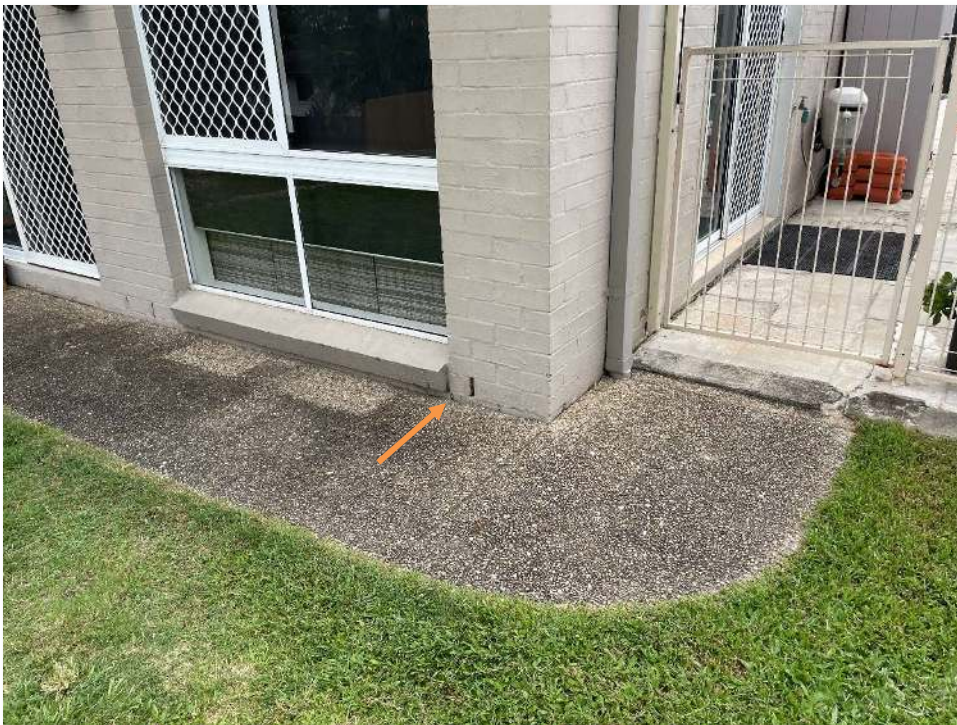
PHOTOGRAPH 8. LOW CLEARANCE ON WEEP HOLES

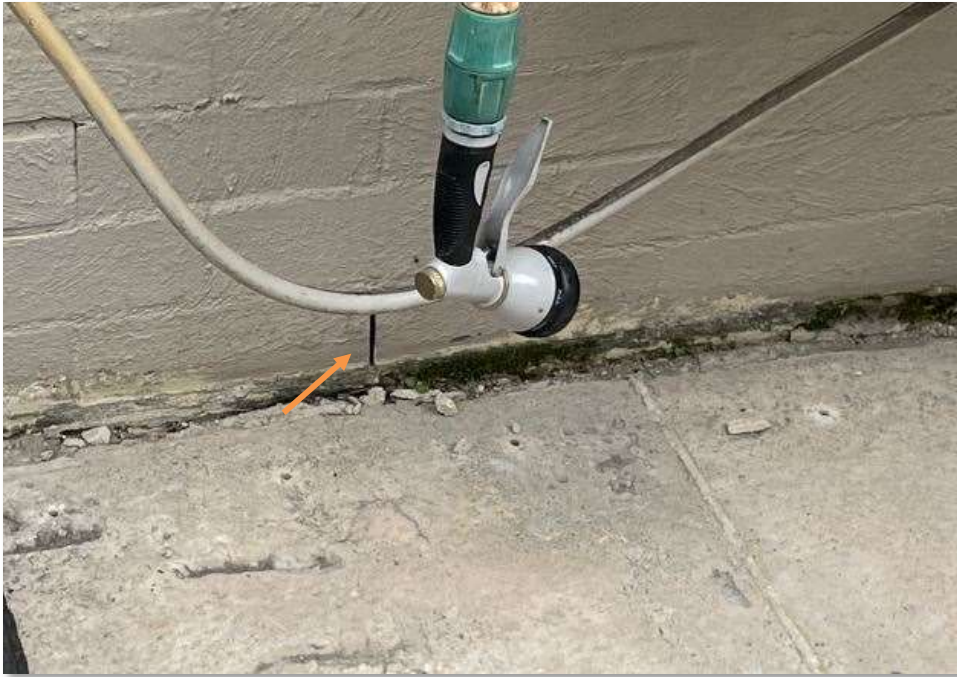
PHOTOGRAPH 9. LOW CLEARANCE ON WEEP HOLES

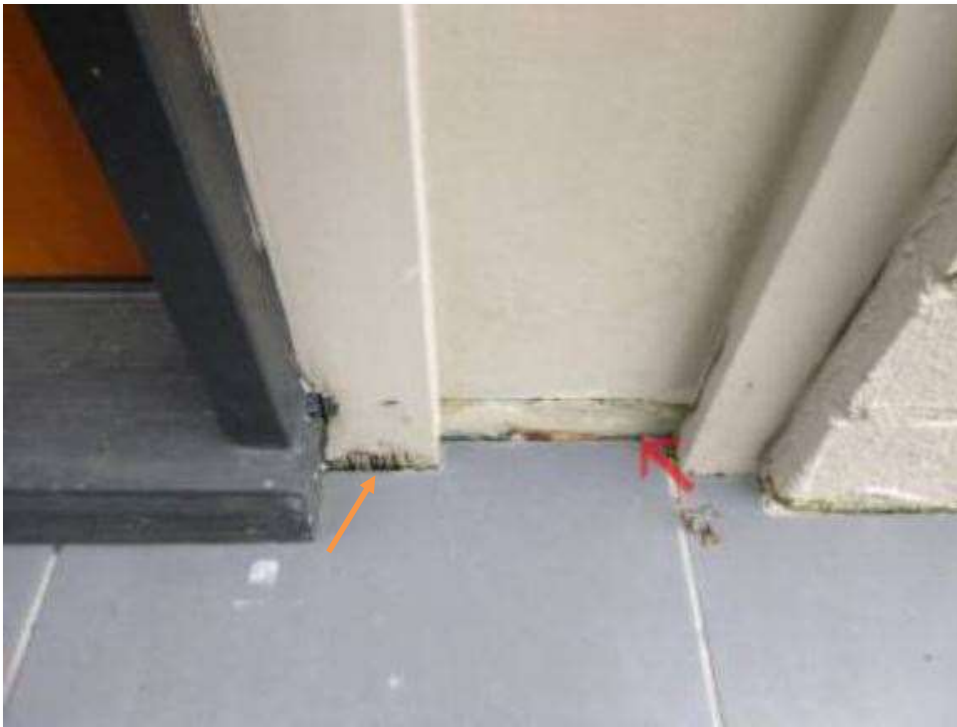
PHOTOGRAPH 10. NO GROUND CLEARANCE FOR TERMITE INSPECTION
