# Expert Witness Building Report

**Property Address:** Sample Property, Suburb withheld, QLD

Prepared for: QCAT Proceedings – Reference Number: [case number withheld]

Prepared by: Maison Azdari, Owner Inspections

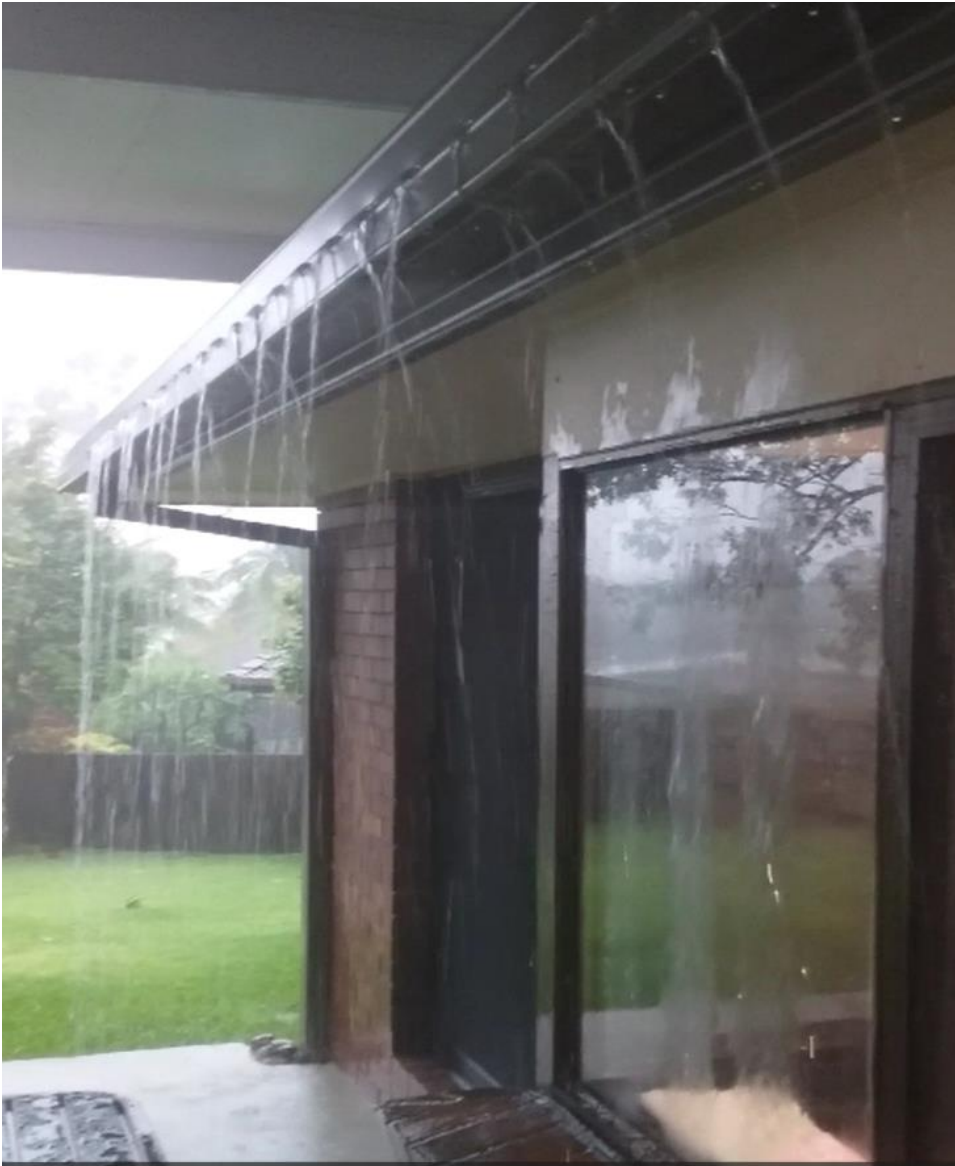
This significant additional flow was never contemplated in the original house roof design, which was engineered solely for its own catchment. Consequently, the house gutters were forced to carry volumes well beyond their hydraulic capacity, inevitably leading to overtopping during rainfall events. Once gutters overflow, water readily tracks over fascia boards, behind flashings, and through even minor defects in roof underlays.

*Screenshot of Video supplied by homeowner, showing the house gutters were forced to carry volumes well beyond their hydraulic capacity, inevitably leading to overtopping during rainfall events:*

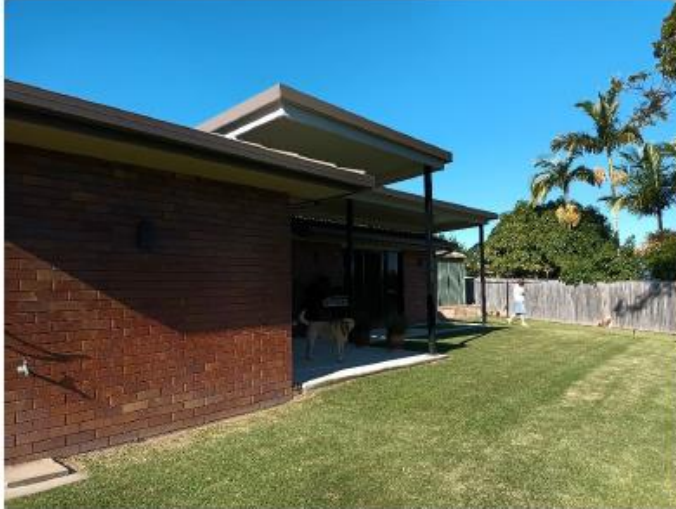
Photo No-5: Photo showing a general view of the pergola.

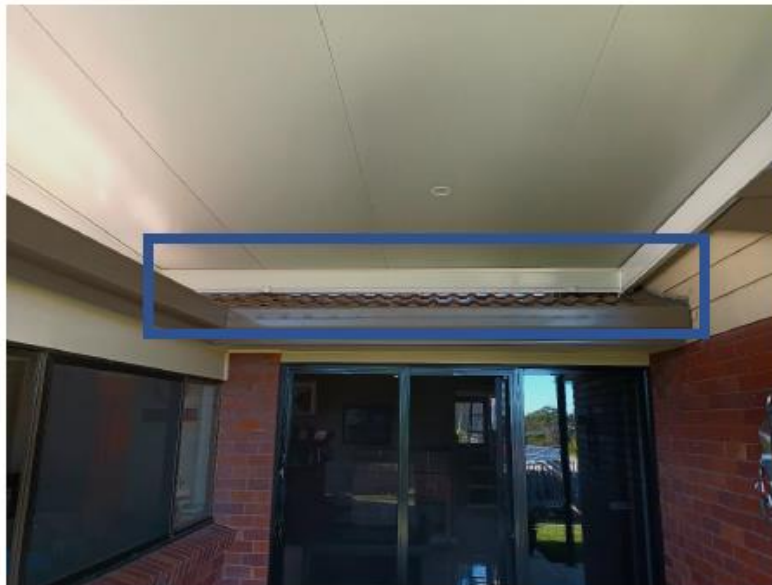
This situation was further exacerbated by the documented insufficient clearance between the patio roof and the house tiles (in some areas **less than 70mm**). This inadequate separation obstructed the normal shedding of water down the roof plane, promoting ponding and capillary backflow beneath the tiles.

Photo No-6: Photo showing a lack of separation or clearance between the pergola and the house's roof.

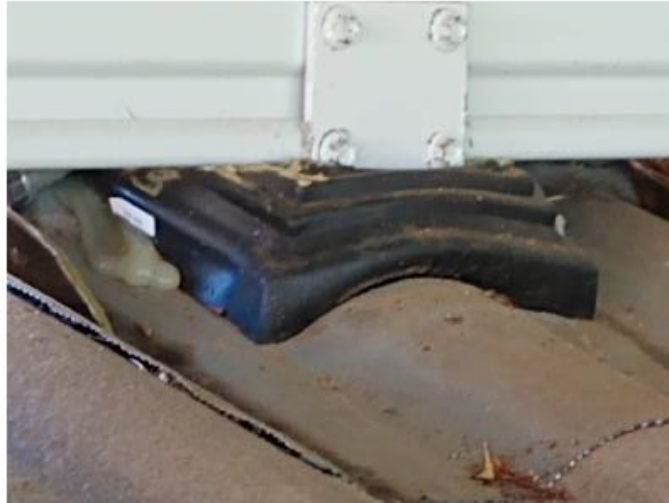
Photo No-7: Photo showing Dektite roof flashing

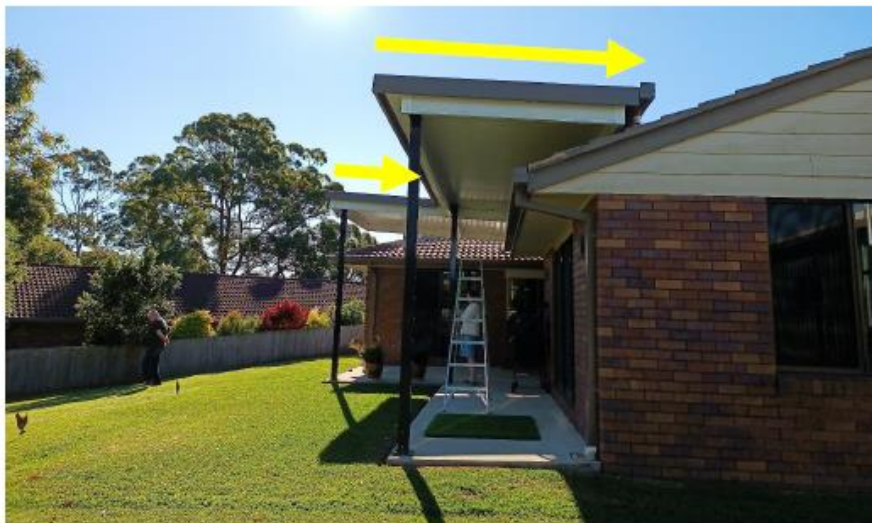
However, by reversing this slope, the builder fundamentally altered the intended drainage regime. As a result, approximately **25 m<sup>2</sup>** of additional roof catchment area now discharged directly onto the existing tiled roof of the dwelling. This non-compliance can be quantified through standard flow calculations. Under a moderate design rainfall intensity for the Redlands region of **236 mm/hr**, the runoff from this added area equates to:

Photo No-8: Photo showing the pergola's improper roof pitch and how it directs water towards the house

- Complete demolition and reconstruction of the patio structure in strict accordance with the approved engineering drawings NM085 and NM086. This must include establishing the correct roof fall, along with proper installation of gutters and downpipes to manage stormwater effectively.

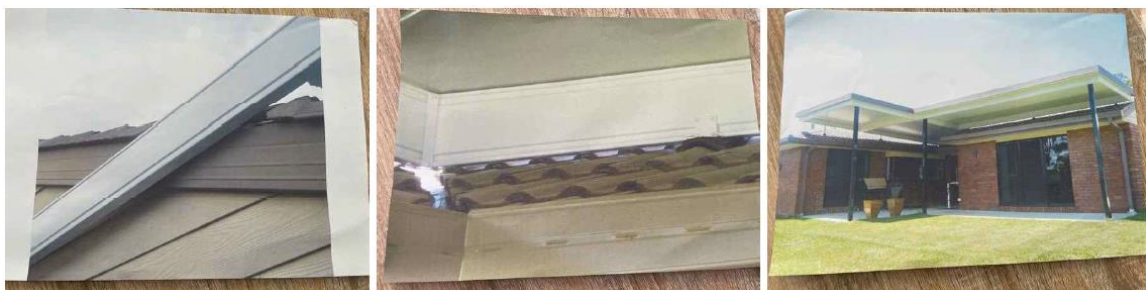
The existing house tiled roof and flashings have been left in a compromised condition following the removal of the defective patio structure, which had been constructed too close to the original roof line and improperly cut into the gable. There are clearly visible issues including damaged tiles, temporary coverings using tarpaulins and unsecured flashings, and areas where inadequate patching attempts have left gaps and exposed sections. This creates an immediate risk of water penetration into the roof cavity.

Photographs provided by the homeowner show the condition of this section prior to demolition:

The damaged sections should be fully restored, including replacing broken tiles, reinstating proper flashings, repointing ridges, cladding, and ensuring the roof is watertight in accordance with relevant Australian Standards and good building practice. This aligns with the independent site-specific inspection by my colleague Dan Winton supporting these findings.

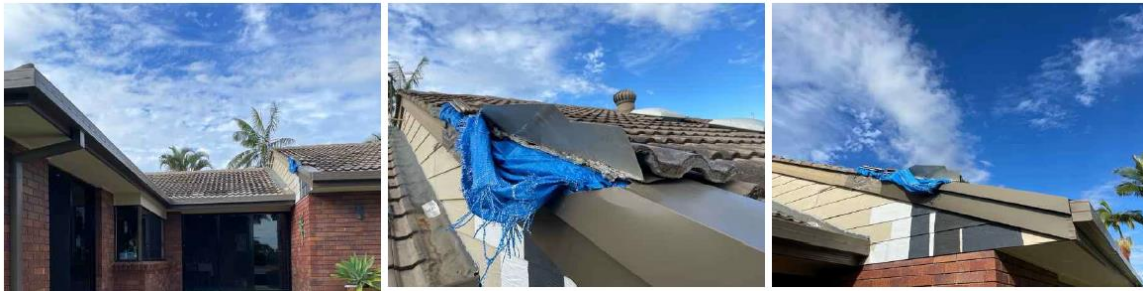
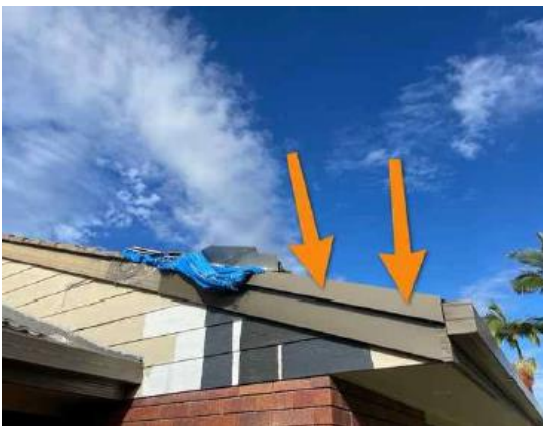
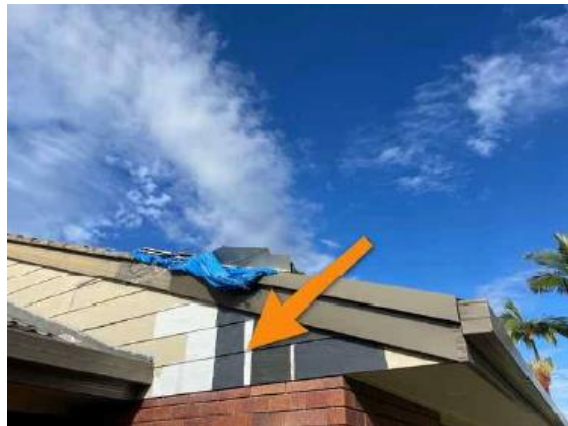
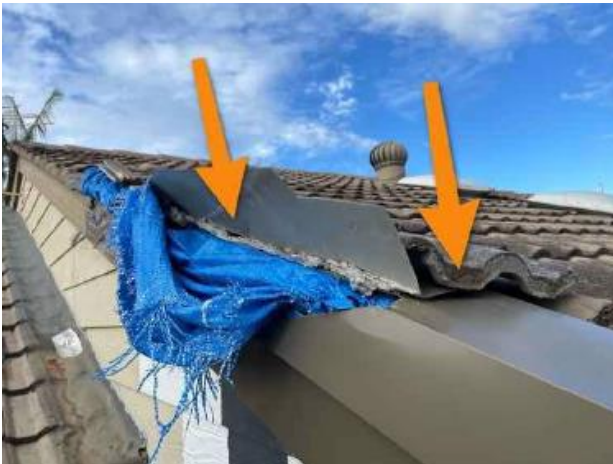
Photographs taken by my colleague show the condition of the area following demolition of the patio:

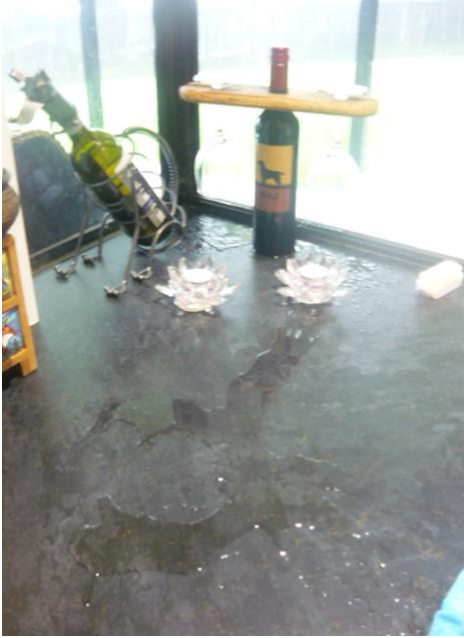
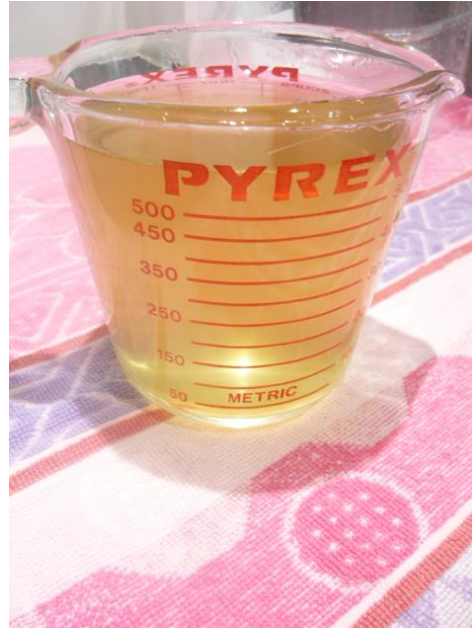
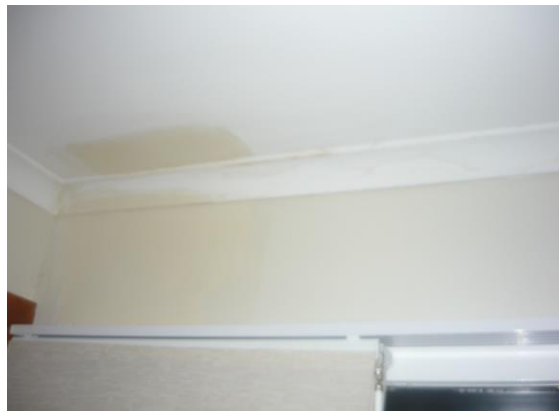
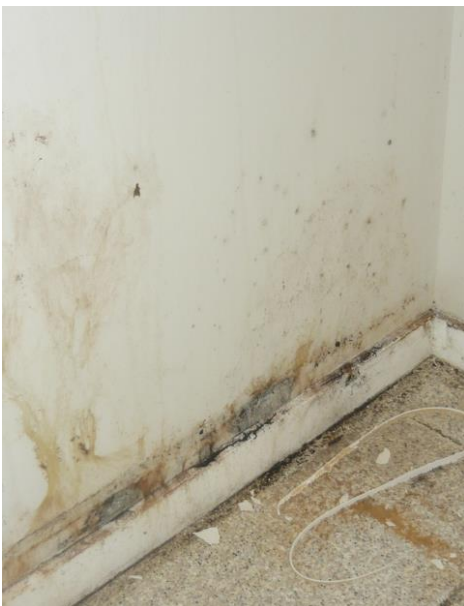
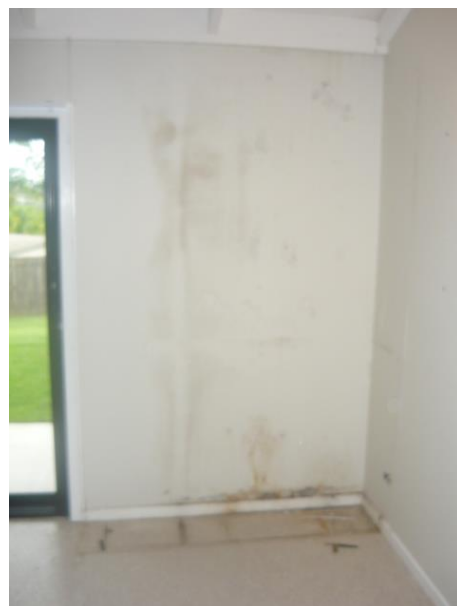
*Water Ingress photos supplied by homeowner:*

Inspections by [company withheld] revealed **active leaks in both the family and rumpus rooms**, along with visibly damp plasterboard. Prolonged exposure to moisture promotes **fungal growth and compromises the structural performance of plasterboard**, which may necessitate complete replacement. Further, once ceiling insulation becomes saturated, it loses its thermal properties and creates a concealed environment favourable to mould growth. Electrical systems running through these cavities are also exposed to an increased risk of **short circuit or fire**.

- Repair of the existing roof tiles, battens, sarking and internal plasterboard, accompanied by certified mould remediation to restore structural and health standards within the dwelling.

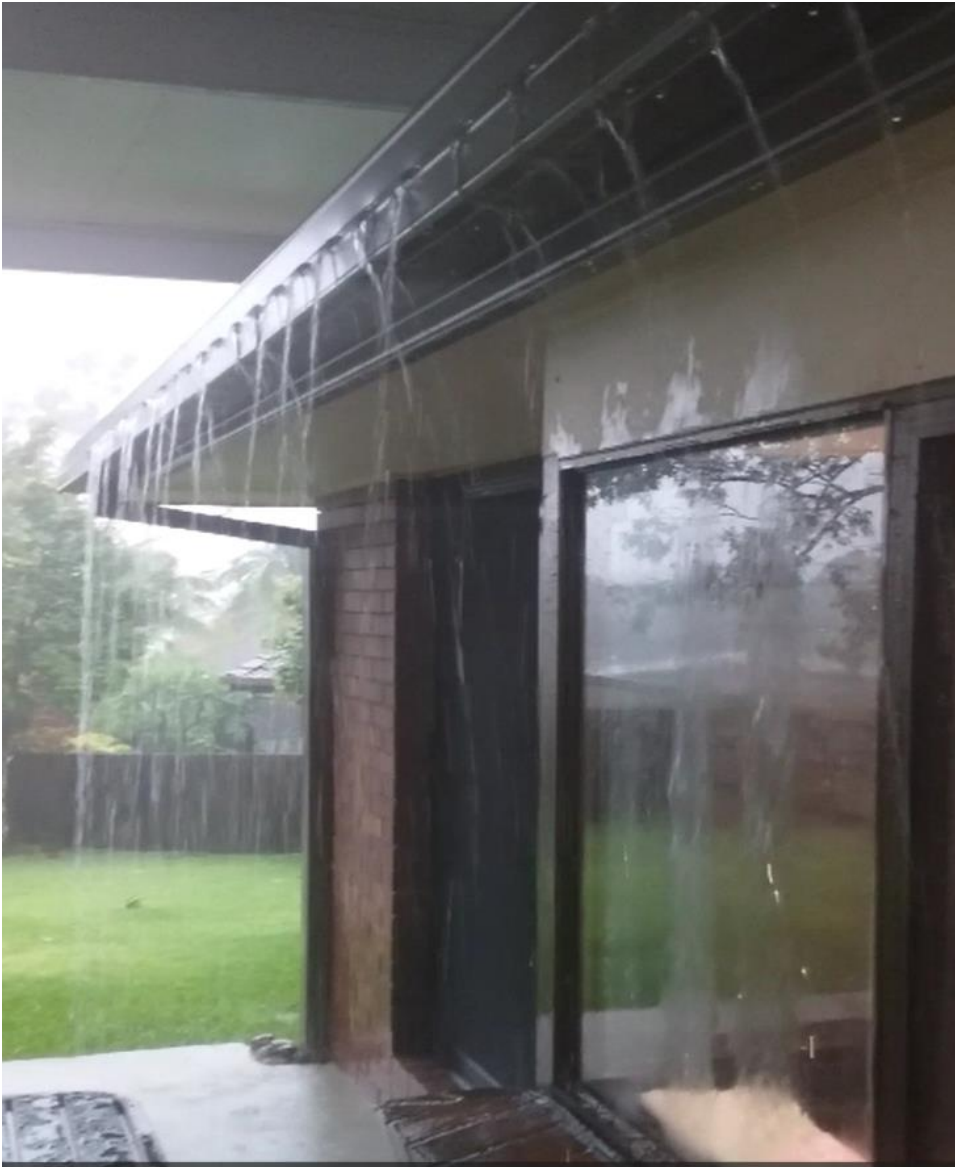
*Video Screenshot:*

Video footage provided by the homeowner showed **substantial stormwater overflow onto the existing roof**, clearly overwhelming the existing stormwater management system and corroborating the findings of improper slope and drainage.
