## EXPERT WITNESS REPORT

Sample Property

09/06/2026

**Craig Palmer**

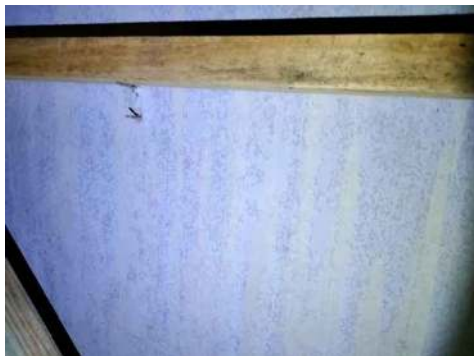
Roof-space view of the external wall build-up behind the cladding — timber framing, sarking and services visible; Fixings missing supporting battens.

- Provide an as-built batten survey; achieve 600 mm maximum centres (450 mm at corners) or a specific certified alternative design.
- Obtain written James Hardie or RPEQ acceptance of the custom cavity-batten system for N3 structural and weatherproofing performance.
- Open up to confirm a continuous water-control membrane with documented laps, penetrations and terminations; install or repair where missing.

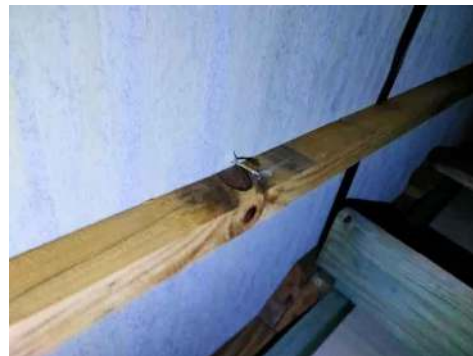
Roof-space view of a steel/timber member with rust-coloured staining against the sarking behind the cladding — early-corrosion indicator relevant to the durability assessment.

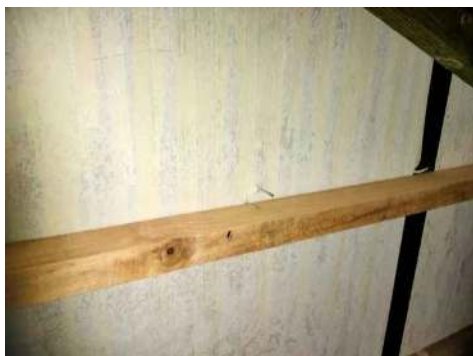
Roof-space view of a timber member with a metal bracket / bolt fixing against the membrane — fixing penetrations have missed battens.

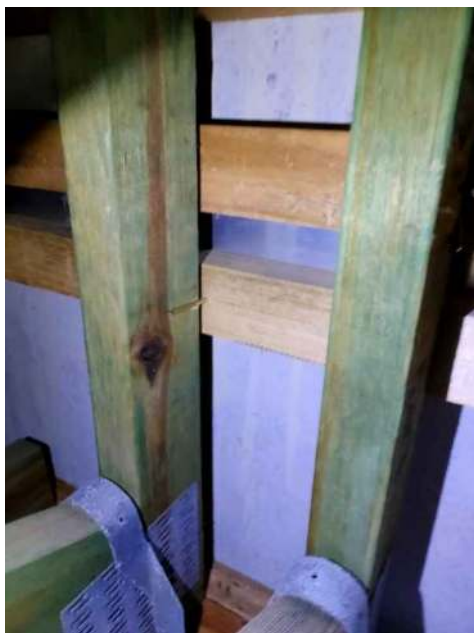
Roof-space view of timber framing against the wall lining fixings missing battens

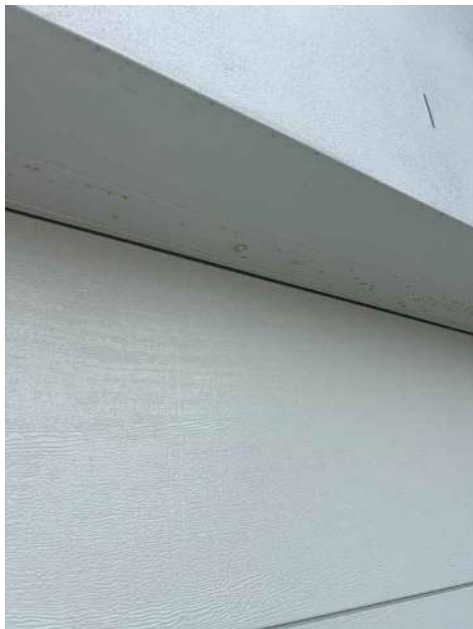
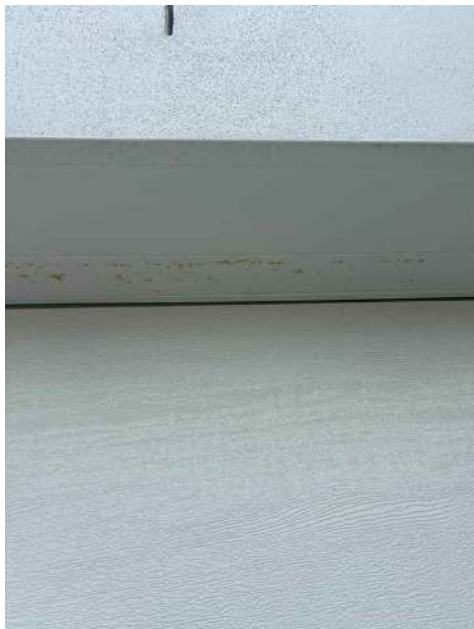
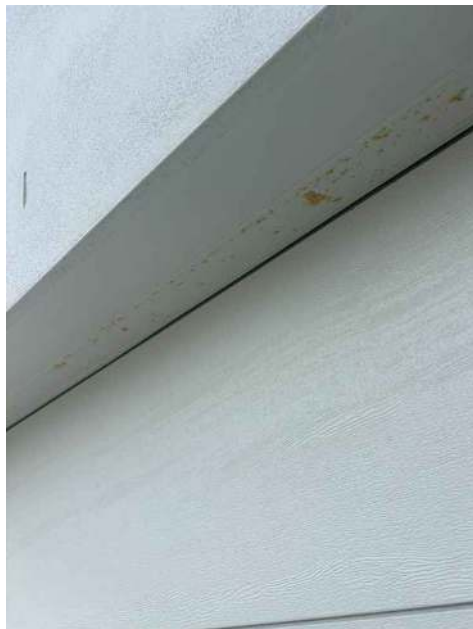
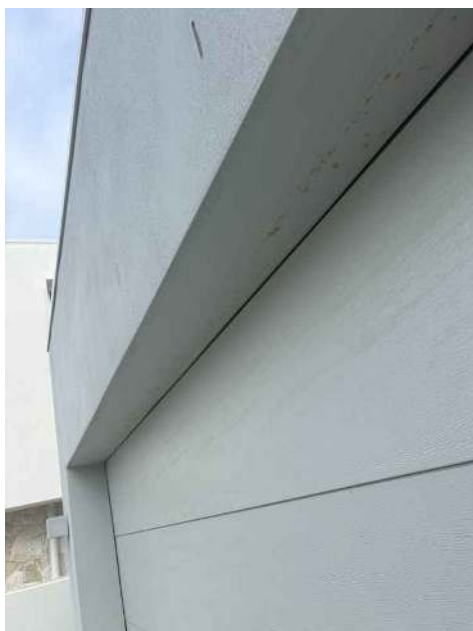
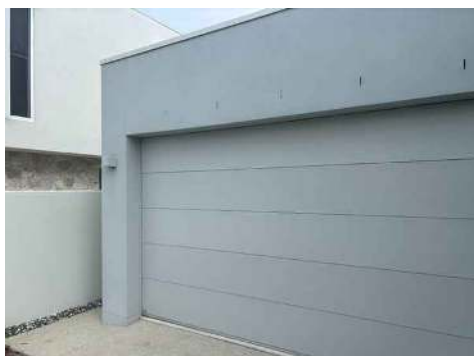
**Site observations.** Lintels at several external openings were observed to carry an R3 marking — a lower durability classification than the contracted R4. The garage lintel was unmarked and exhibited visible corrosion. Exposed structural steel members inspected at the gable, balcony and garage zones showed inconsistent coatings, with surface roughness, coating thinning and rust-coloured staining bleeding through the paint film at fixings and junctions. These conditions are consistent with the corrosion and durability concerns raised and are inconsistent with the specified R4 requirement for this exposure.

Rust spots forming on the lintel above the garage. - this side faces away from the saltwater canal.

- For R3-marked lintels and the unmarked, corroded garage lintel, replace or remediate under a written engineer/manufacturer-approved specification demonstrating how the completed system achieves R4 durability and the required service life.

- Provide an RPEQ or manufacturer completion statement and an explicit warranty for the repaired system.

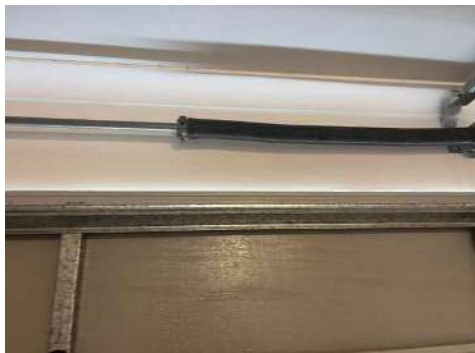
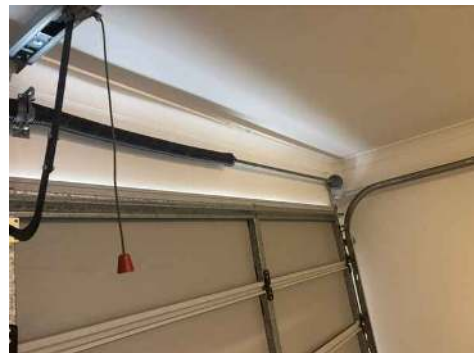
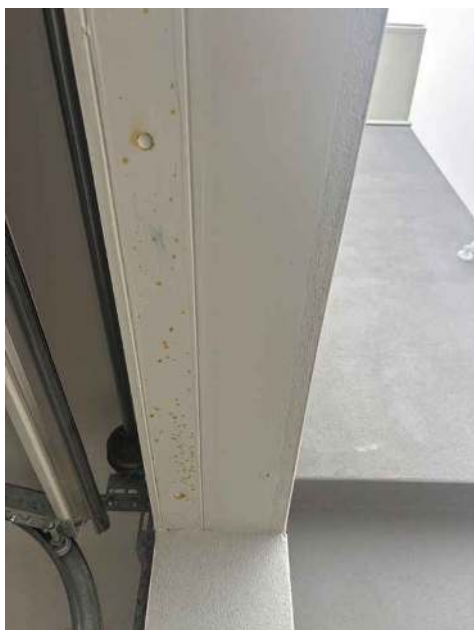
Garage opening head / lintel zone viewed from within the garage (sectional door and head) — corresponding to the garage lintel reported as unmarked and significantly corroded (Item 3).

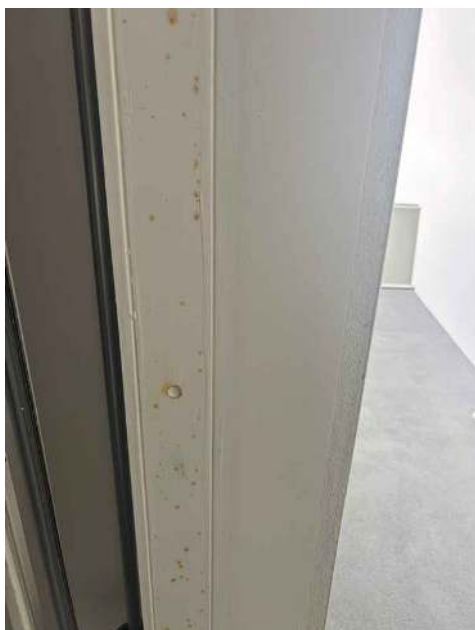
Interior structural post / column with bolt fixings and rust-coloured spotting — exposed steel showing early-corrosion indicators (Items 1–7).

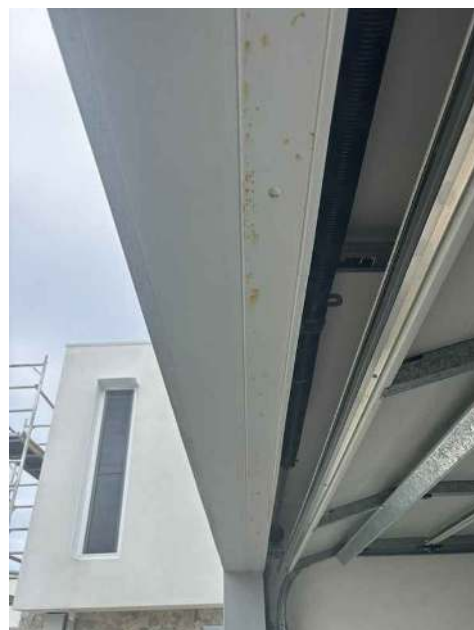
Interior wall / column junction with rust-coloured staining and spotting — coating breakdown / early corrosion at a structural interface (Items 1–7).

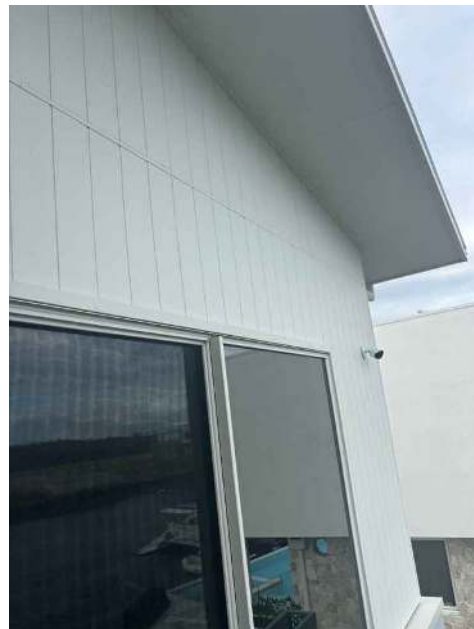
Upper-level gable window with insect screen in raking Axon cladding — head meets the raking cladding with no eave above the opening (Items 13–18).

**Site observations.** The upper-level windows identified are set into raking gable cladding. On inspection these heads are finished with a slim head trim and sealant, with no visible projecting head flashing and no eave or soffit above them to protect the opening. This is consistent with the complaint and is precisely the condition the NCC clause and the Axon guide are directed at preventing.

**Eave exception.** The NCC permits omission of the head flashing only where the opening is adequately protected by an eave wider than three times the height of cladding above the opening. The observed openings are in raking gable walls with no eave above them, so the exception cannot be assumed to apply. It must be calculated for each individual opening and should not be applied across all upper-level windows.

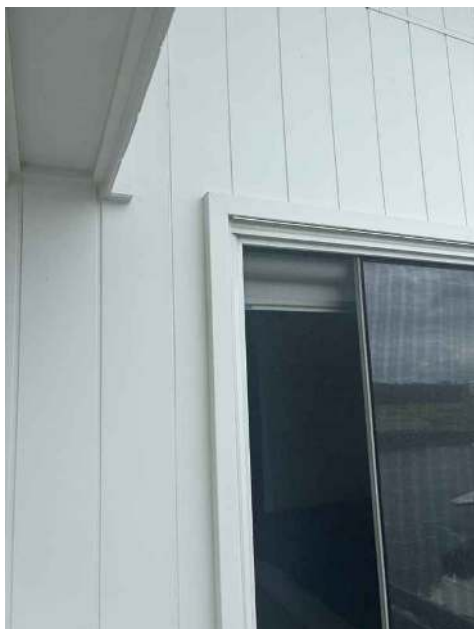
Upper-level gable windows in raking Axon cladding with the eave at the apex and canal beyond — head-flashing condition in dispute (Items 13–18).

The upper-level gable windows were observed to be weatherproofed with sealant only. No head flashing was installed over these window openings, and there is no eave above the gable windows to provide protection. Reliance on sealant alone is not an acceptable substitute for a head flashing, because sealant has a limited service life and is not a durable, primary means of preventing water entry above an opening.

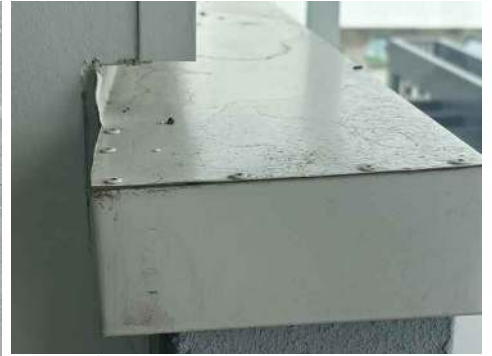
Upper flashing between 1st and ground floors - has been laid with a fall INTO the property.
