## INVESTIGATION REPORT

# BUILDING DEFECT, WATER INGRESS AND MOULD ASSESSMENT REPORT

**\*\*Report purpose:\*\*** Assessment of reported roof water ingress, consequential internal damage, elevated moisture and mould contamination, together with a recommended rectification scope of works.

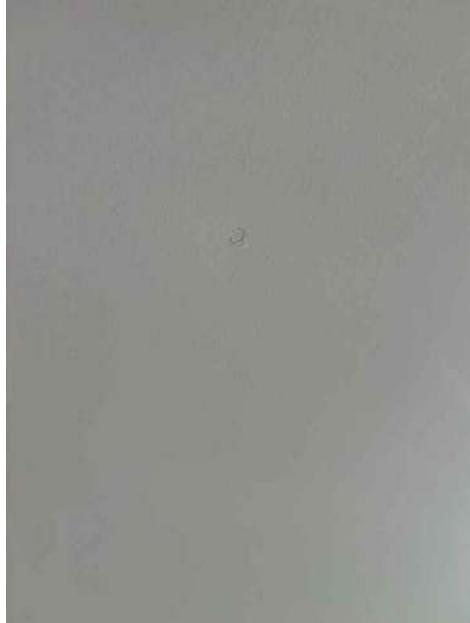
minor water staining and small mould marks to the children's playroom / bedroom at the front of the house

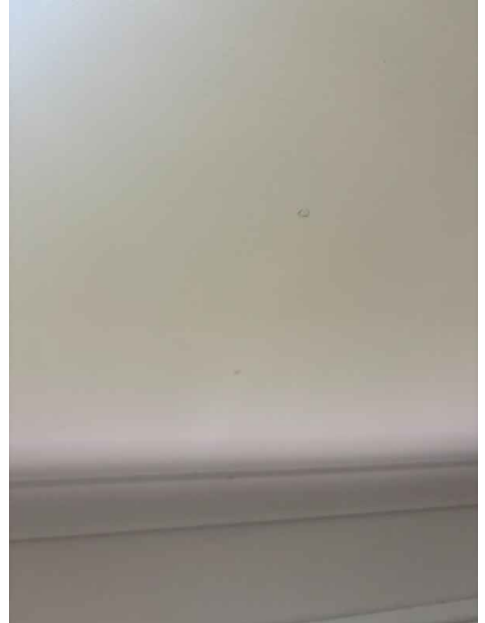
ceilings in the children's play bedroom appear to be letting go at the fixings this is consistent with water ingress from the roof space

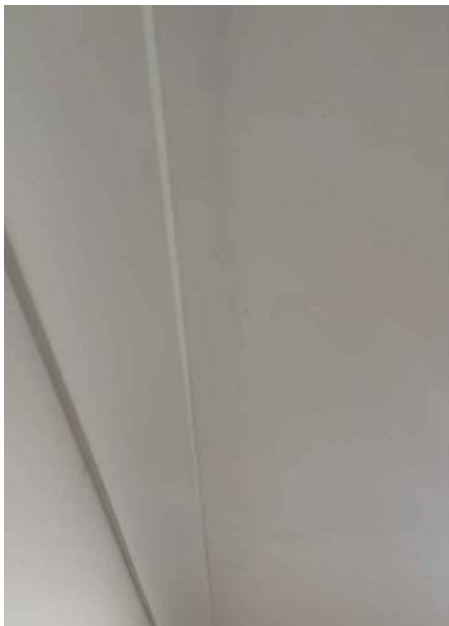
evidence of staining into the Cornice ceiling junction

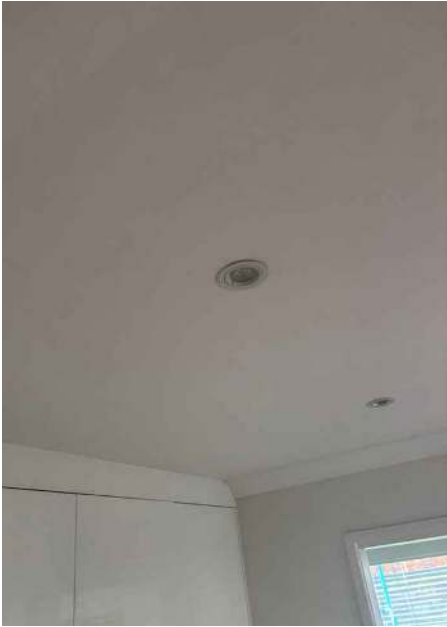
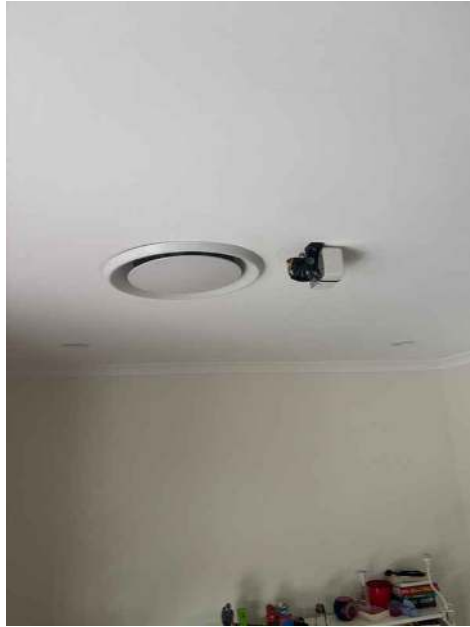
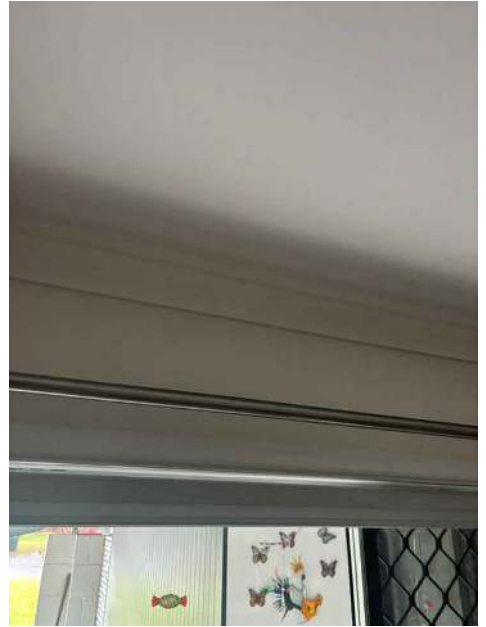
partial electrical fit off has been completed in the children's bedroom number two however this all requires a second inspection and test due to water ingress and removal and reinstatement to facilitate ceiling replacement

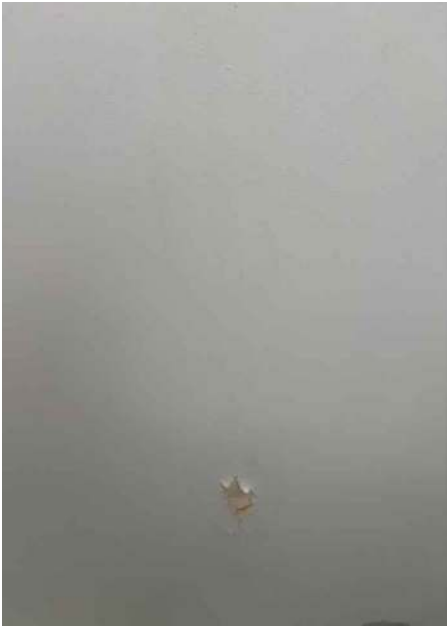
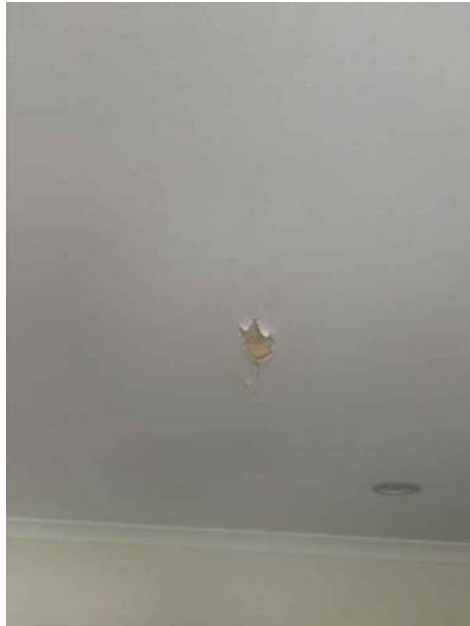
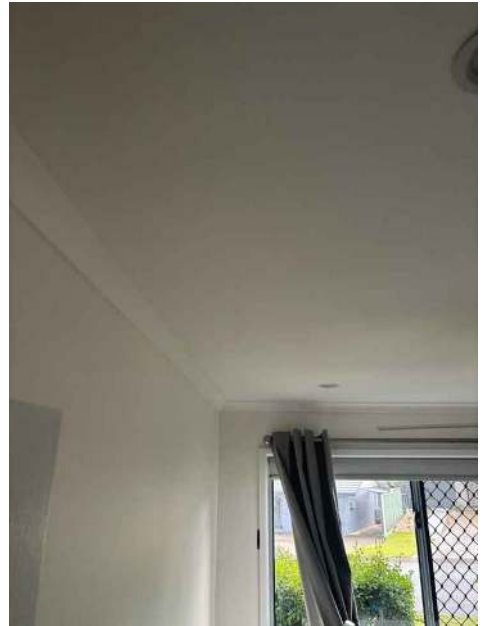
this image is in the second children's bedroom back from the front of the property these ceilings have just been replaced under an insurance claim however the roof has continued to leak whilst the insureds are out of the property causing these ceilings to fail the ceilings now require complete replacement again there are elevated moisture readings across the ceiling space

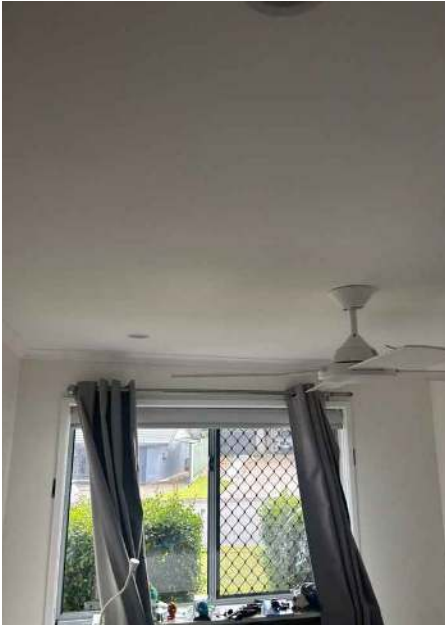
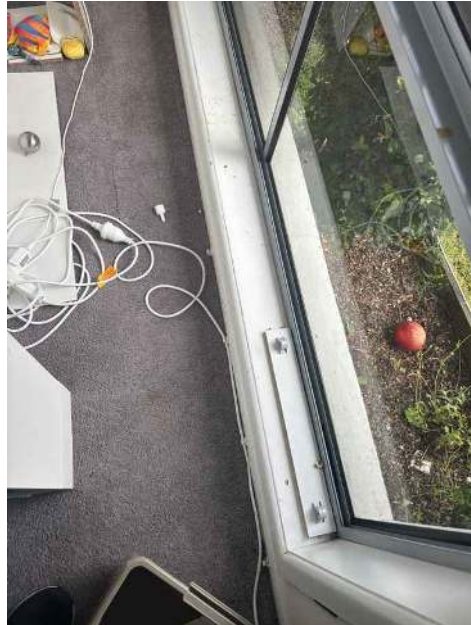
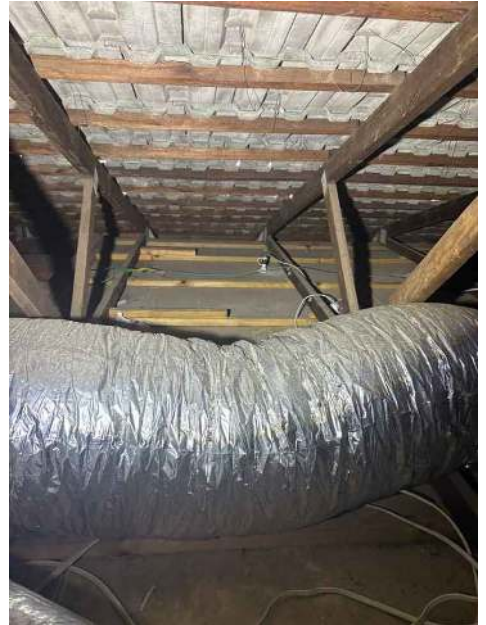
this window is at the front of the property in the children's bedroom. The window exhibits high moisture levels towards the centre and around the frames. This is likely to be a combination of ingress from the roofline and ingress forced by vegetation growing so close to the window and the front facade of the building. The window is examined externally and found to be lacking silicone sealant around its perimeter. The windows have recently been replaced, however finishing works including silicone have not been completed.

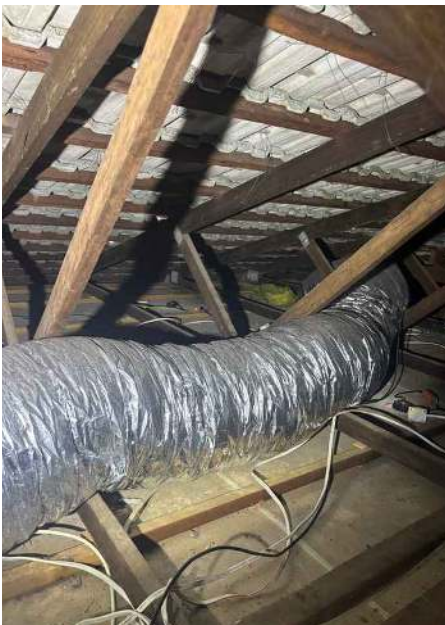
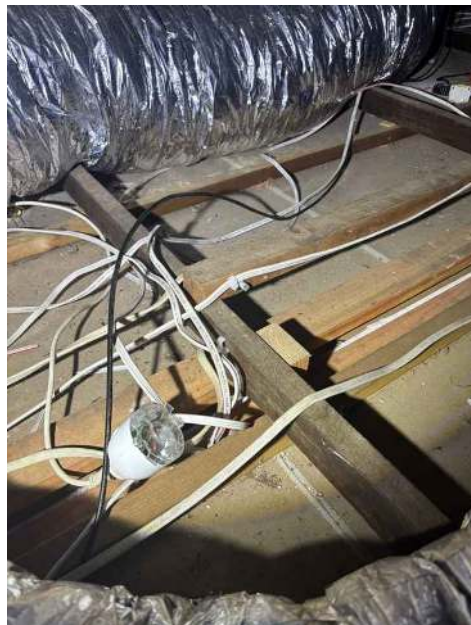
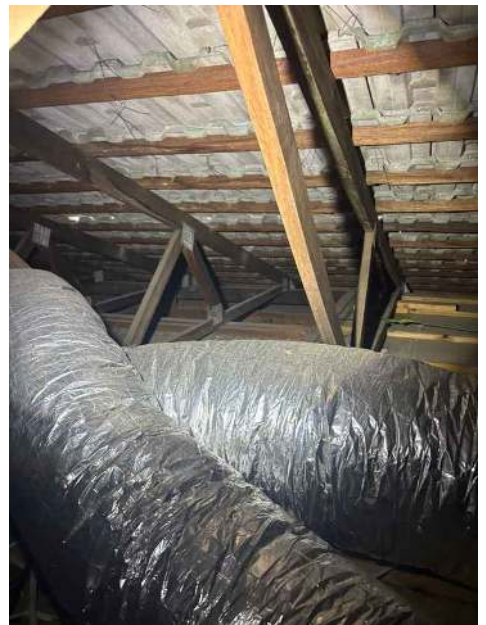
various locations within the roof cavity show water staining and mould build up to the backs of the gyproc seats on the ceiling. This includes the ceilings that have been recently replaced, indicating that a leak was still occurring after they were conducted.

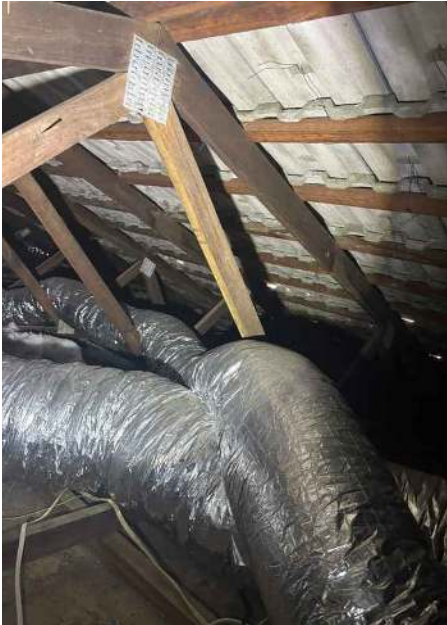
there is no sacking or anticon insulation within the roof cavity So the roof is solely reliant on the tiles to shed water during rain events Obstructions in the drainage tiles combined with the solar brackets being silicone into place has led to additional ingress

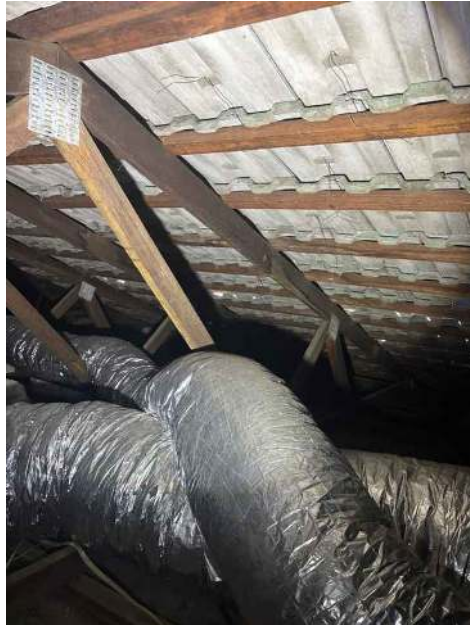
the main roof trusses have water stain marks in various locations across the front elevation of the property The locations of all these marks coincide with the locations of the solar brackets that were affixed to the roof but have now been removed

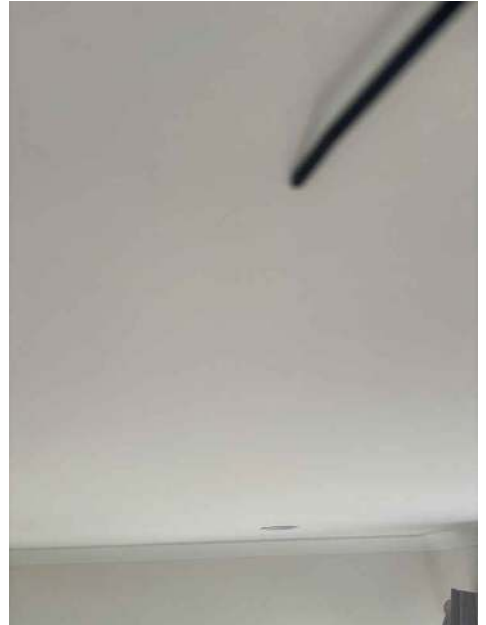
this is the front bedroom the children's room at the front of the house This has recently been replastered and painted as part of the insurance works and now the ceiling has wet and shows signs of moisture ingress again

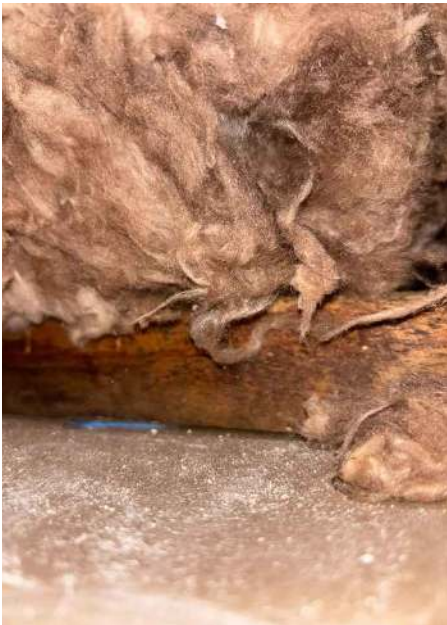
photograph was taken in the ceiling cavity of the front children's bedroom there is evidence of mould and water staining to the timber trusses that support the main roof structure this is consistent with water ingress that has been left the
