## DILAPIDATION REPORT

Sample Property

**Kosie (Kosmas) Touretsoglou**

Registered Building Practitioner & Pest Inspector

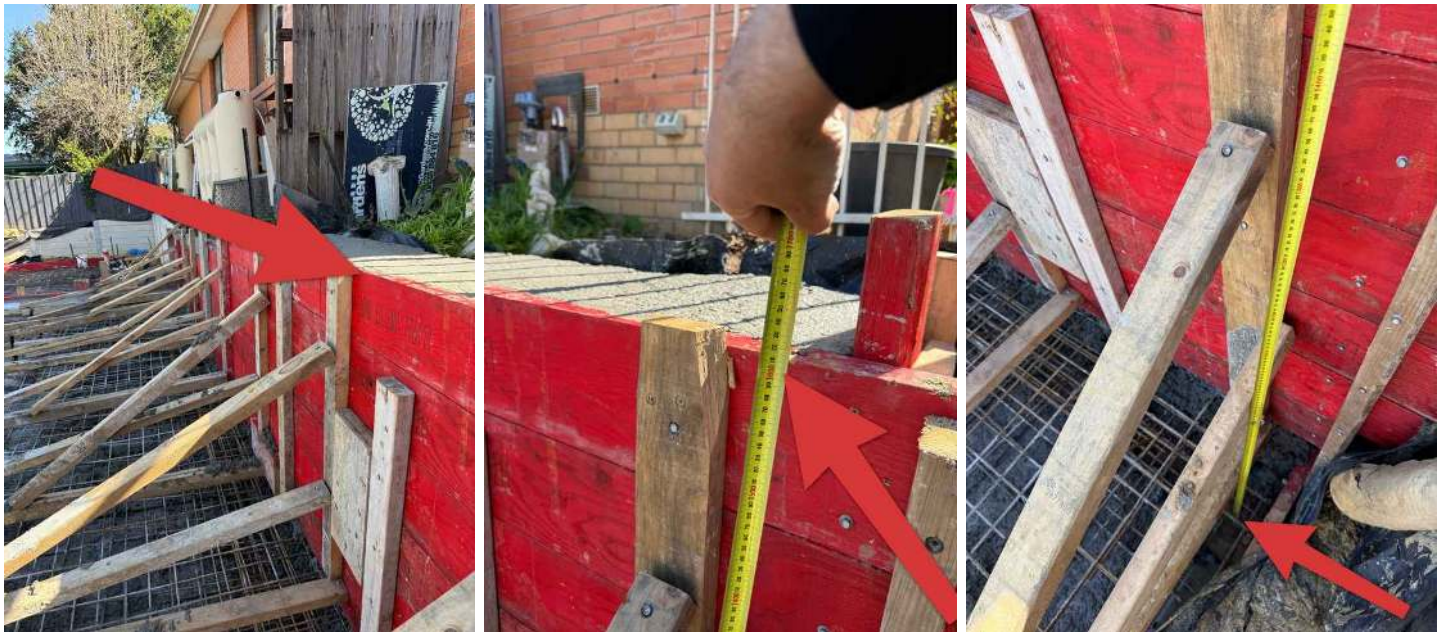
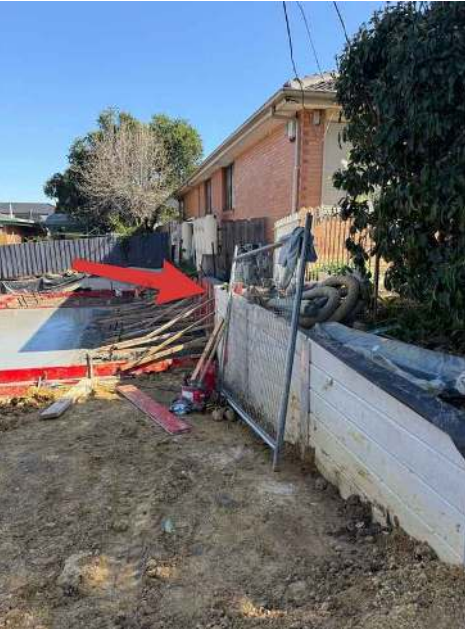
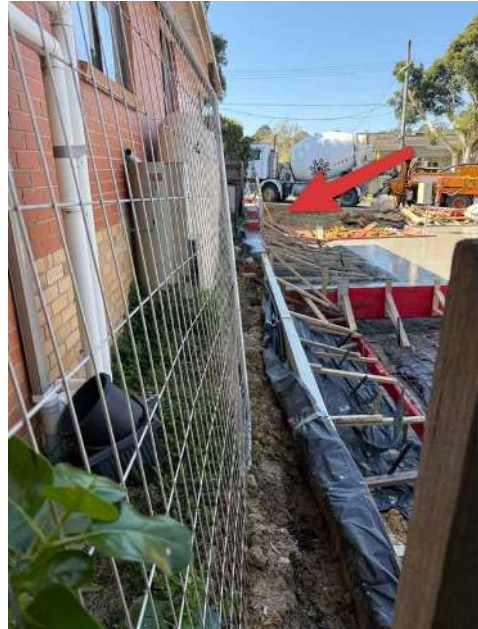
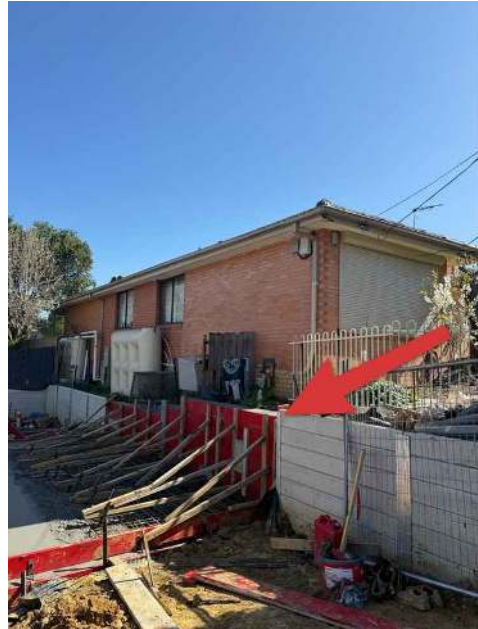
### 3.1.1 Excavation

## EXCAVATION DEPTH – DISCREPANCY WITH ENGINEERING ASSESSMENT

The engineering report provided for the adjoining works describes the excavation adjacent to the subject property as being approximately 1.0 m deep relative to the adjoining existing ground level. This dimension forms a significant basis of the engineer's subsequent 45-degree assessment and conclusion regarding the potential zone of influence.

During this inspection, the vertical distance from the adjoining existing ground level to the base of the excavation was physically measured at the depicted location at approximately 1,600 mm. This measurement has been photographically documented within this report.

This represents a material difference of approximately 600 mm from the excavation depth relied upon within the engineering assessment. While the engineering report photographically documents the horizontal separation between the excavation and adjoining dwelling, no corresponding measurement photograph demonstrating the stated approximately 1.0 m excavation depth was identified within the report reviewed.

Using the same simplified 45-degree methodology adopted within the engineering report, an excavation depth of approximately 1,600 mm would result in materially different projected geometry from that assessed using a depth of approximately 1,000 mm.

No conclusion is made within this inspection as to whether the excavation has undermined or adversely affected the structural support of the adjoining dwelling. It is recommended that the actual excavation depth and site geometry documented within this report be referred back to the project structural engineer for further assessment and confirmation that the conclusions contained within the previous engineering report remain applicable.

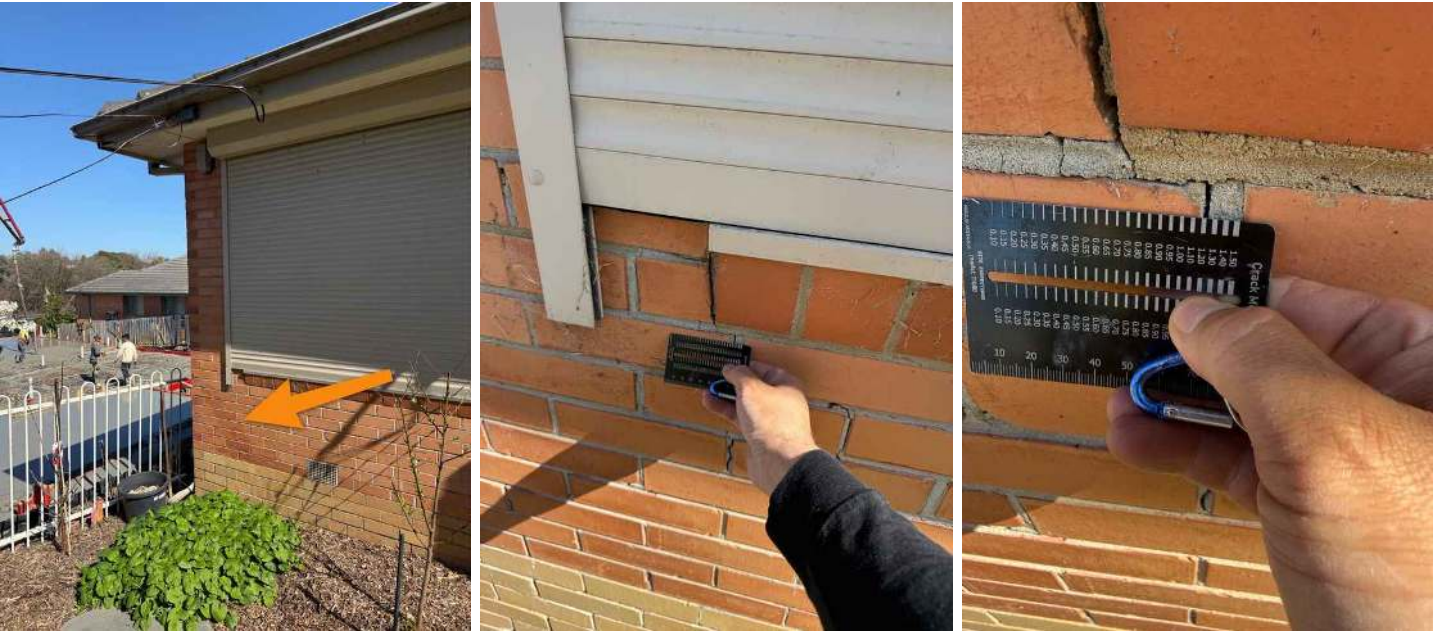
MINOR BRICKWORK CRACKING – 1.2 MM

Minor cracking was noted to the brickwork at the front left corner of the dwelling. At its widest observed point, the crack was measured at approximately 1.2 mm.

In isolation, the cracking does not appear to represent a structural concern at the time of inspection. The location, extent and measured crack width have been documented to provide a reference of the condition observed prior to the progression of the adjoining construction works.

Cracking identified and measured during this inspection has been photographically documented to provide a record of its condition at the time of assessment.

Given the adjoining excavation and construction works, it is recommended that the identified cracking be periodically monitored and remeasured during and following the works. Any measurable increase in crack width, development of new cracking or other evidence of movement should be referred to a suitably qualified structural engineer for further assessment.

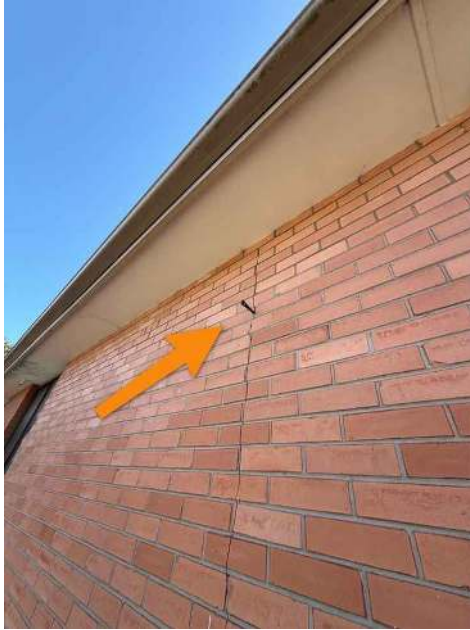
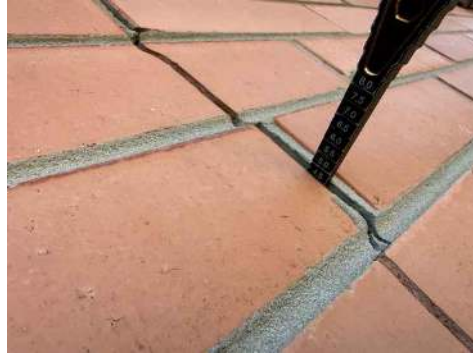
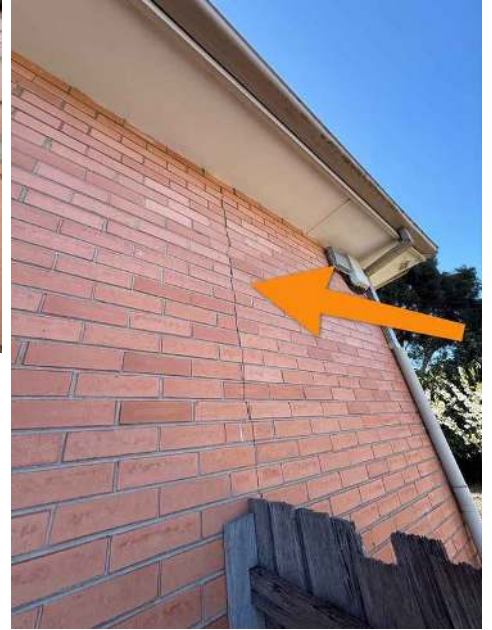
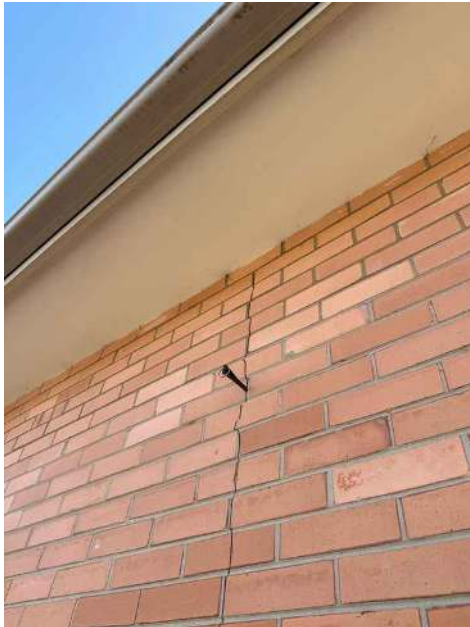
## 4.1.2 Brickwork

**BRICKWORK CRACKING – GREATER THAN 4.5 MM**

Cracking was noted to the depicted brickwork, measuring greater than 4.5 mm at the highest safely accessible measurement point. The cracking appears to widen further along the higher brick courses. Refer to the accompanying photograph identifying the location at which the measurement was taken.

It could not be established during this inspection whether the cracking was present prior to the commencement of the adjoining excavation works. Based on the visible cracking pattern and direction, there is no clear indication that it is directly associated with the adjoining excavation; however, causation cannot be determined from visual inspection alone.

Given the extent of the cracking and the nearby excavation works, assessment by a suitably qualified structural engineer is recommended to determine its significance, likely cause and whether further investigation, monitoring or rectification is required.
