## EXPERT WITNESS REPORT

Unit 5 / 21 Sample Street  
Dandenong, VIC 3175

Client Name  
DECEMBER 1, 2023

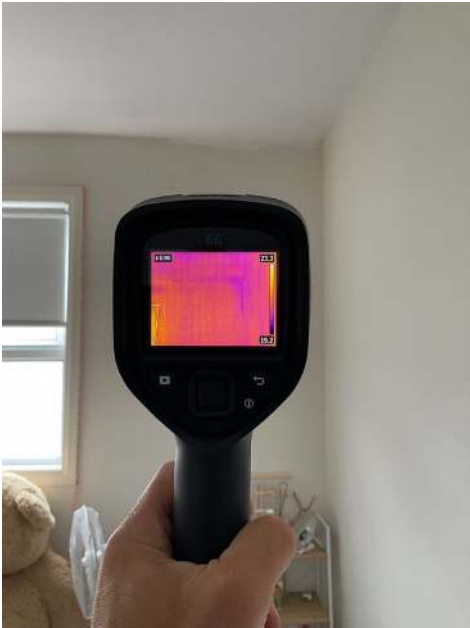
1st Floor bedroom

The first floor bedroom ceiling had previously been repaired by the owner due to a roof leak to the first floor roof. This is noted and checked for general information only. There was no moisture detected to this area.

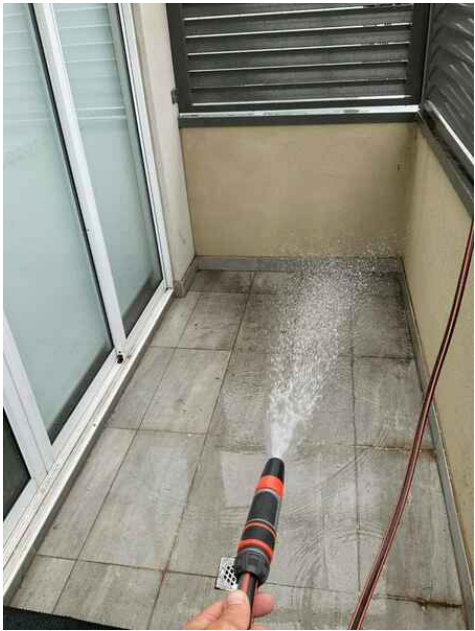
Roof over balcony.

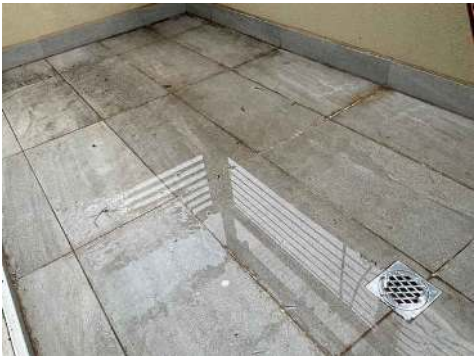
Hose test carried out to check ponding water and leak to garage ceiling

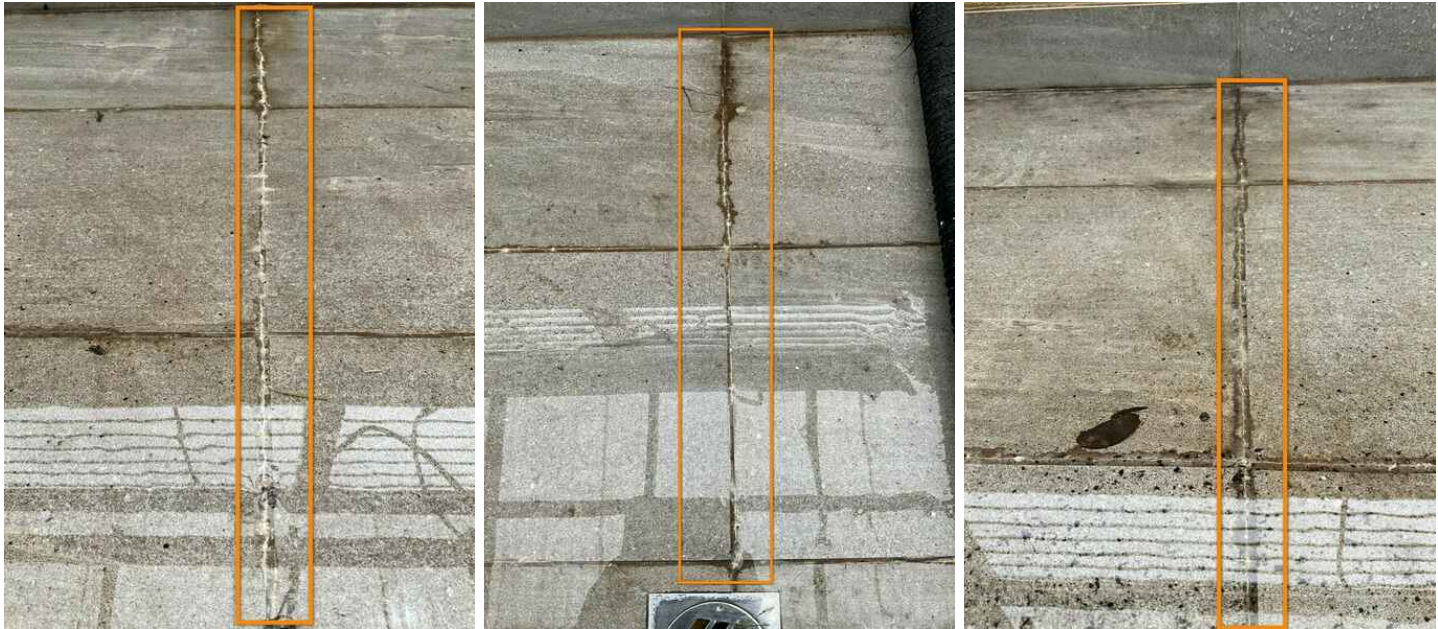
A minimal fall of 5mm occurs in the first 200mm section at the end of the balcony, then flattens out to the drain. This has caused ponding water, efflorescence and trapped water in the balcony substrate.

Using a 1200mm level, shows no fall at the drain

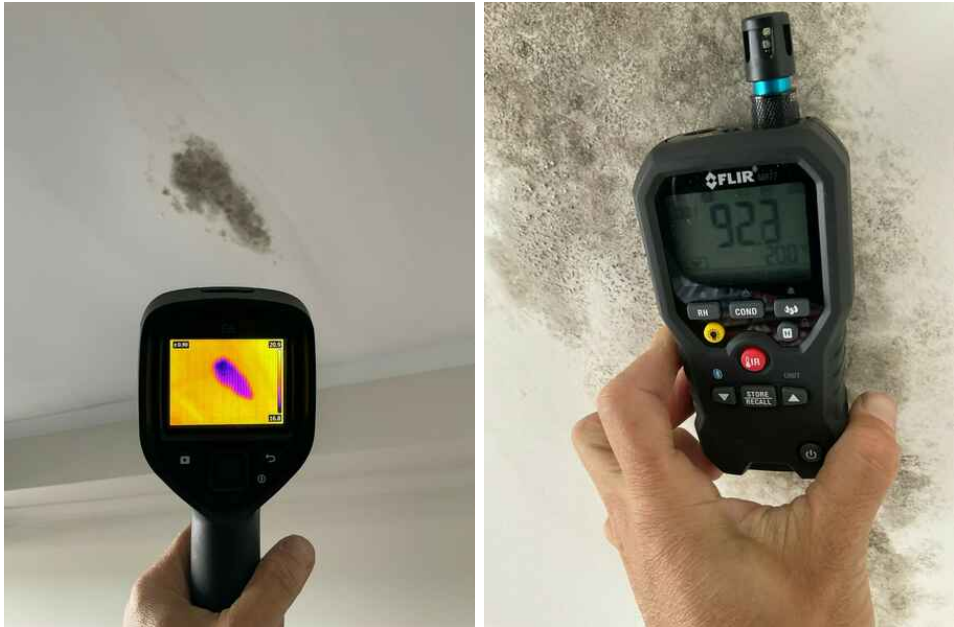
Moisture increase with time, as water ponds to the balcony.

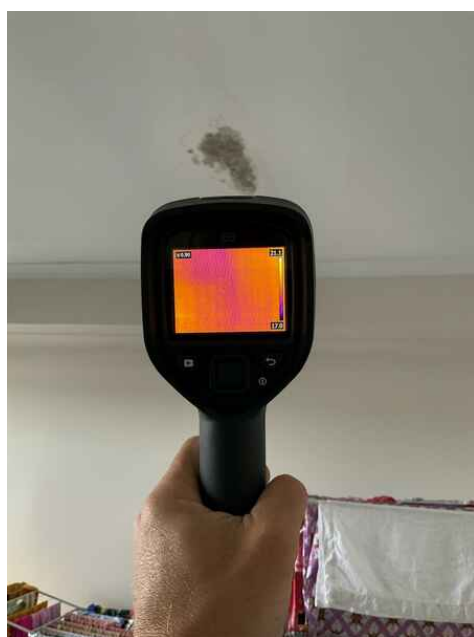
Garage Ceiling Prior to Hose Test Carried Out

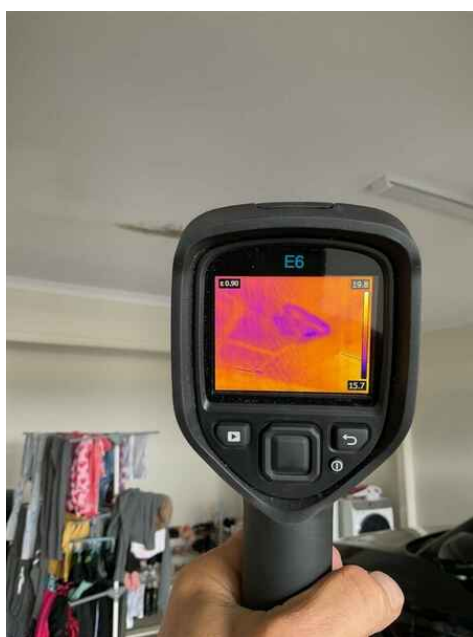
Additional leak towards the front of the garage.

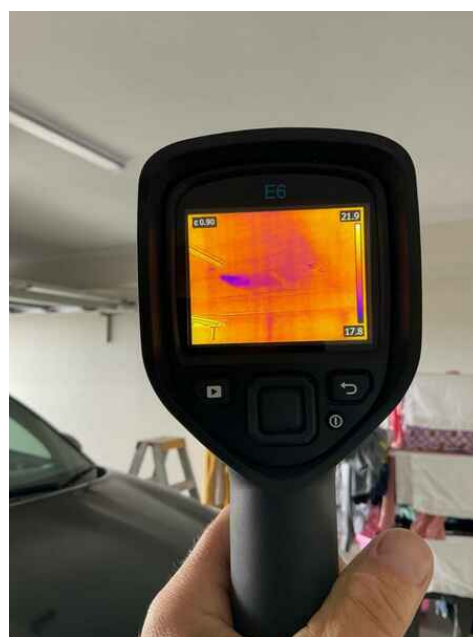
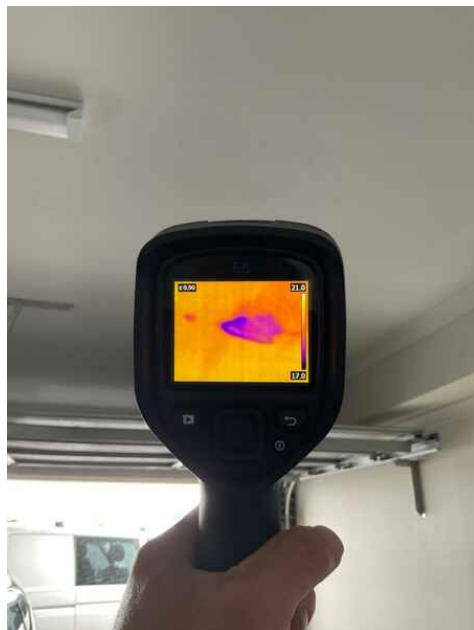
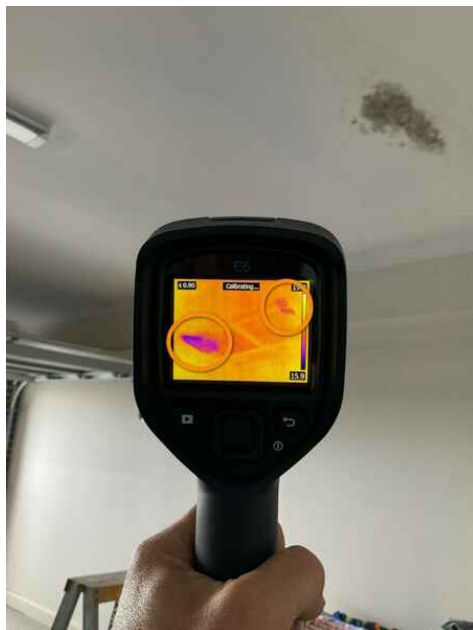
2 x locations to garage showing water ingress

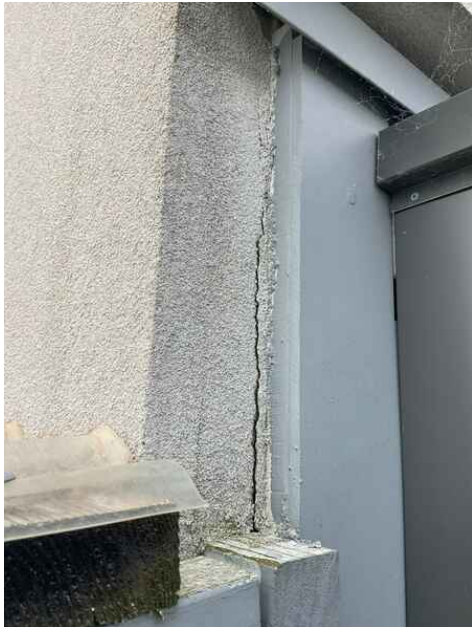
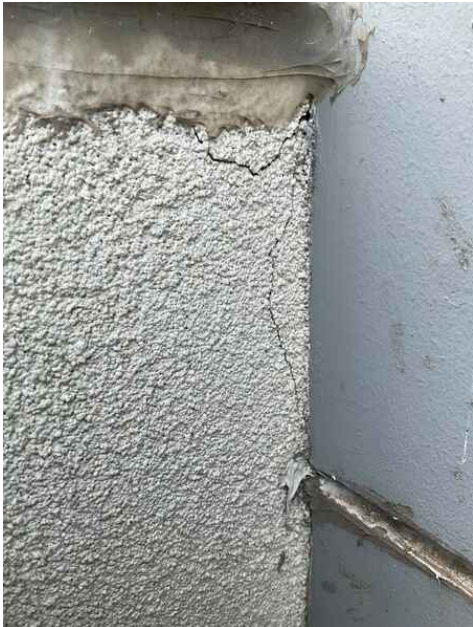
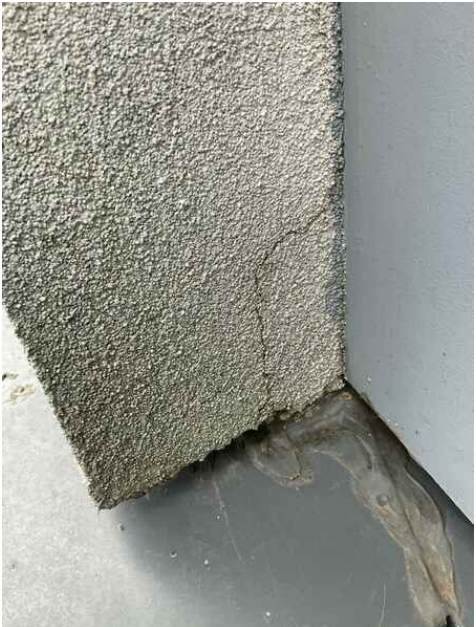
- a) 3 render cracks to the first floor wall cladding above this area. Render cladding is defective if it allows the ingress of water. These cracks are to be repaired and sealed watertight. At external corners, render is likely to crack if the panel joint has not been done correctly. During repairs to these external corners, it is necessary to ensure the panels have adequate adhesive between the panels to prevent cracking. It is likely the installation manual was not followed, and the reason for the large corner crack.

Render crack over garage - No.1

Render crack over garage - No.2

Render crack over garage - No.3

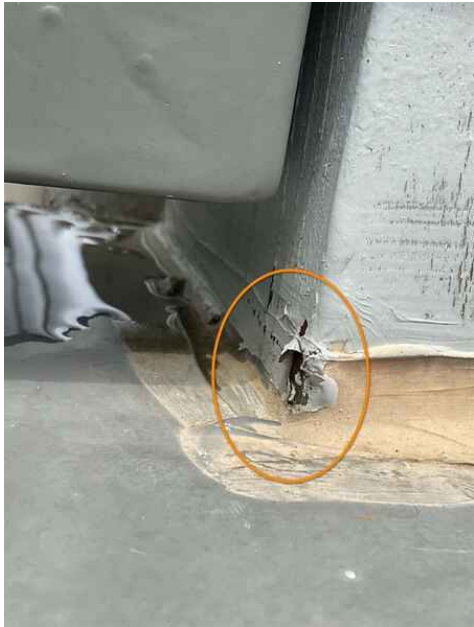
- b) The sealant around the timber post has visible holes that are allowing water ingress. The metal flashing around the post is loose and is falling towards the timber post. Additionally, the metal capping as a whole is ponding water and does not have the required 3 degrees of fall to prevent corrosion to the metal surface. The manufacturer of the metal flashing '**Lysaught**', states in their installation manual that ponding of water should be prevented. **AS1562.1 - Sheet Roof and Wall Cladding Design** also states 'ponding of rainwater can accelerate corrosion. The metal capping should be removed and reinstalled with the required fall, and sealed appropriately around the timber post junction. An upstand to the flashing should be implemented around the timber post to ensure water drain properly away from the timber post.

Sealant degraded to Timber post to metal capping connection.

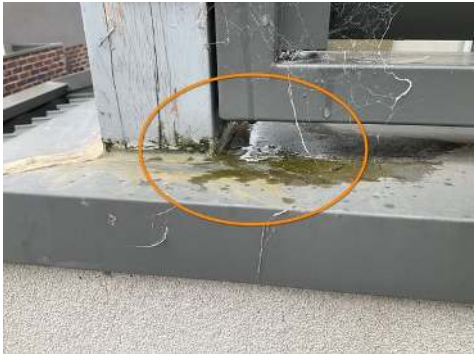
Water ponding adjacent to post connection

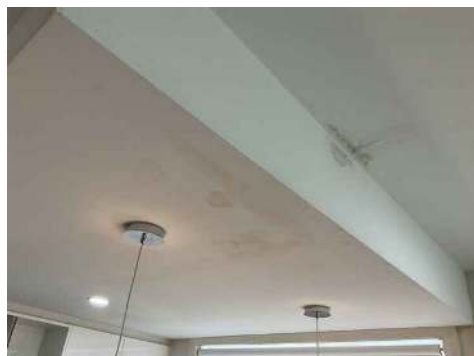
Water Stain and Mould to Kitchen Area

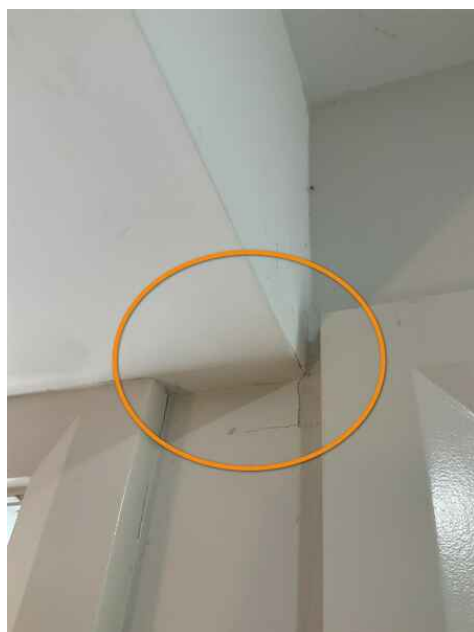
Plaster cracking due to water ingress

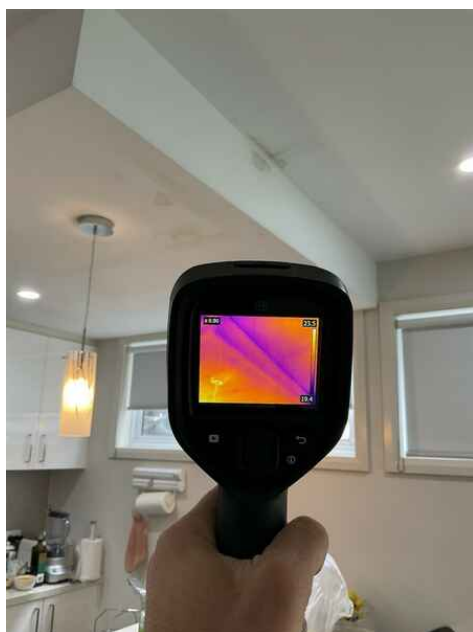
No moisture prior to hose test

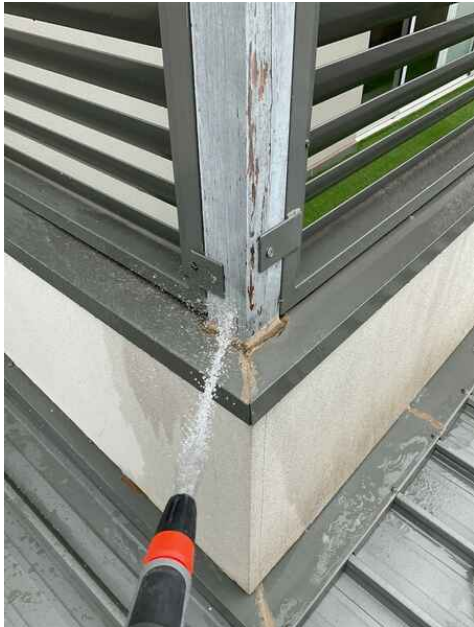
Hose test conducted to timber post above water stain in kitchen

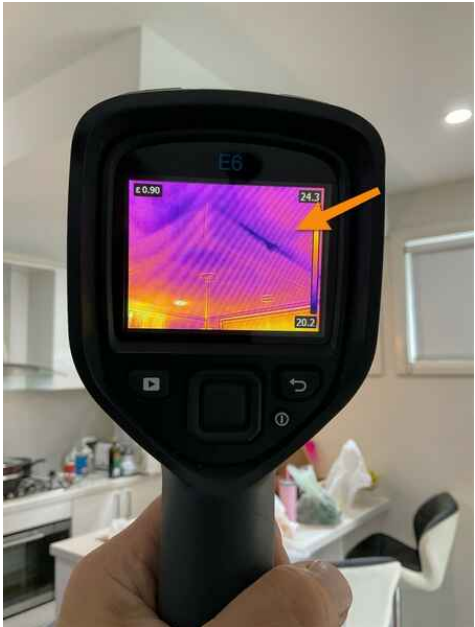
Moisture evidence after hose test to timber post

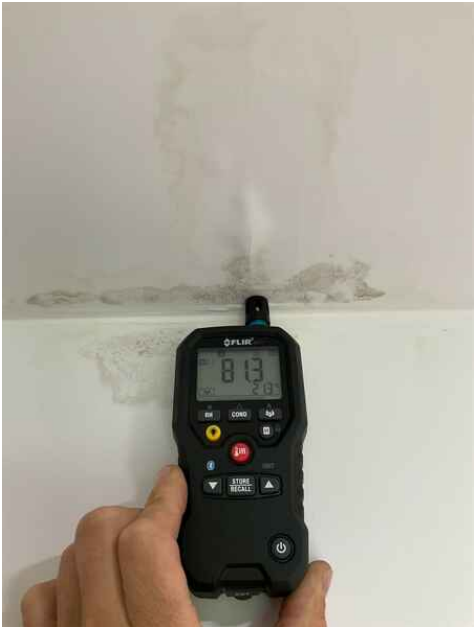
High Moisture reading after hose test

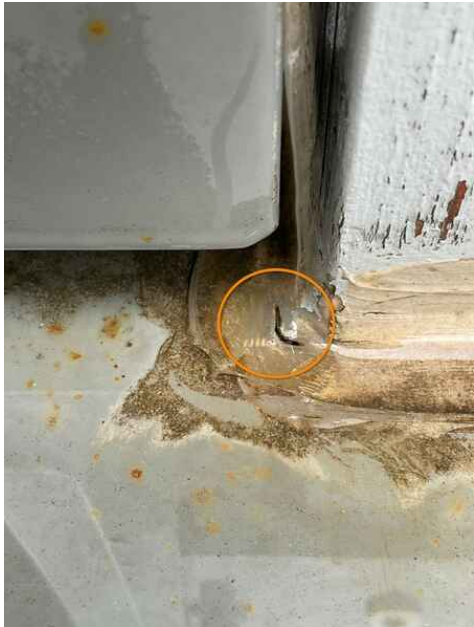
- a) There are visible holes to the timber post to metal flashing junction, which are to be sealed water tight.
- b) The render has a crack that is allowing water ingress and is to be rectified to ensure it is water tight. Render cracks that allow water ingress are considered defects. This is another external corner that was likely not constructed as per installation manual.

Hole to silicone at timber post to metal flashing connection

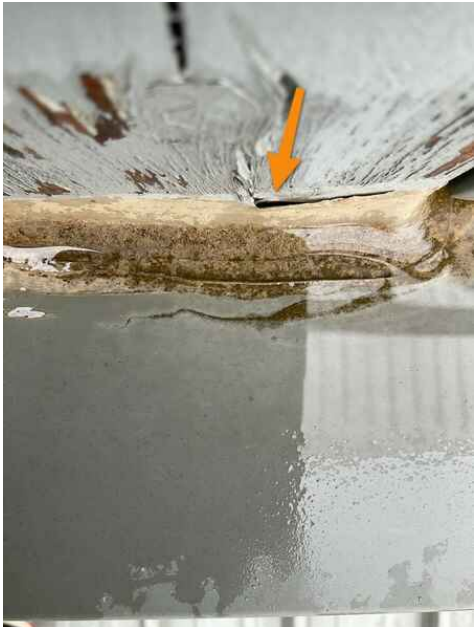
Silicone has degraded and a hole is present

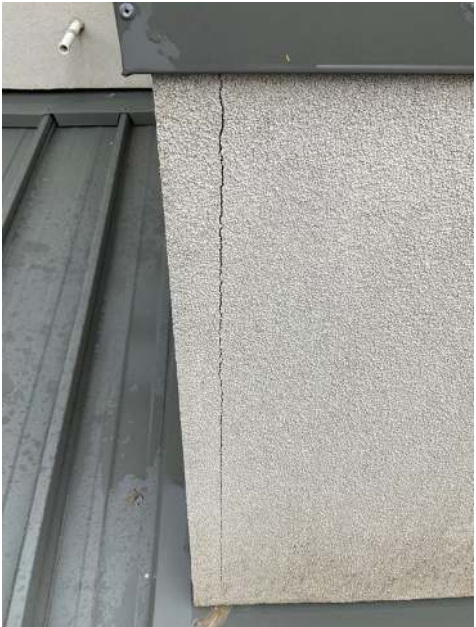
Render crack in this area above water stain

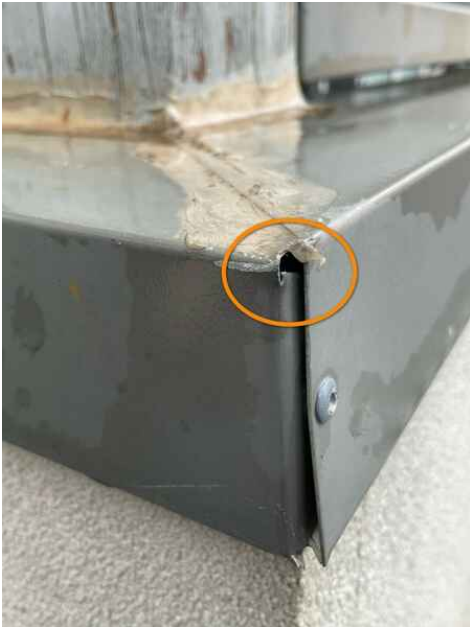
End of flashing is not sealed.

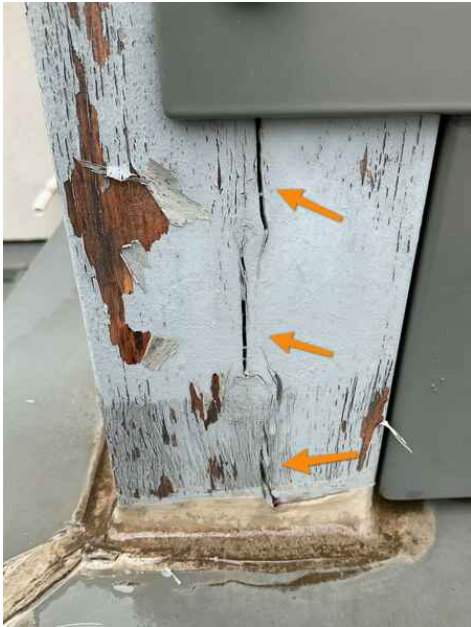
Cracks in timber post which can allow water ingress to travel past the timber post to metal flashing connection

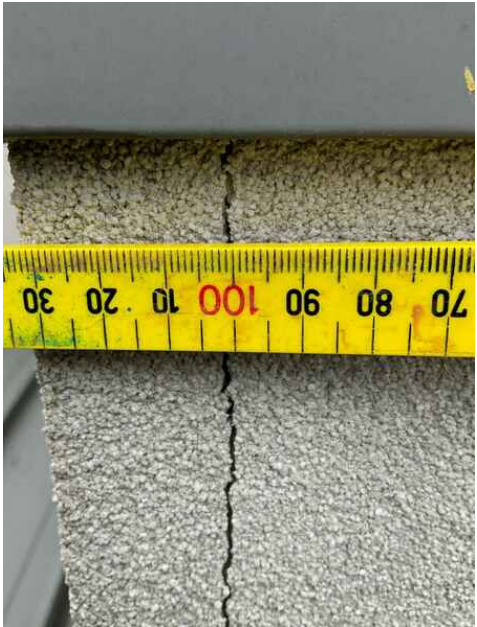
0.7mm render crack in this area above

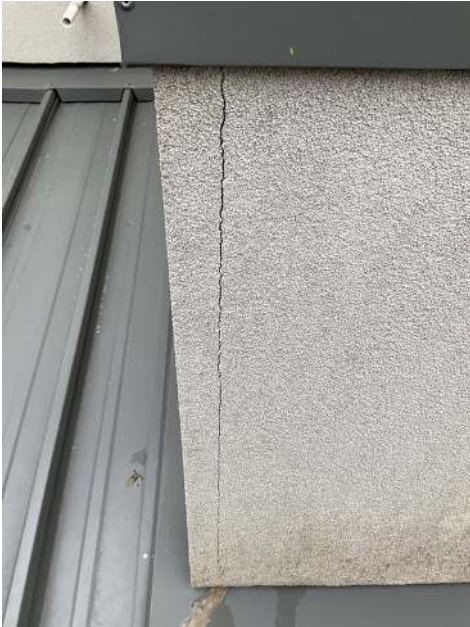
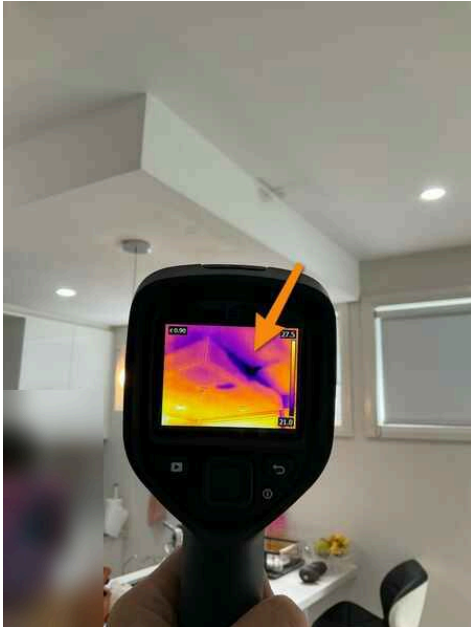
Moisture increased substantially with time after hose test

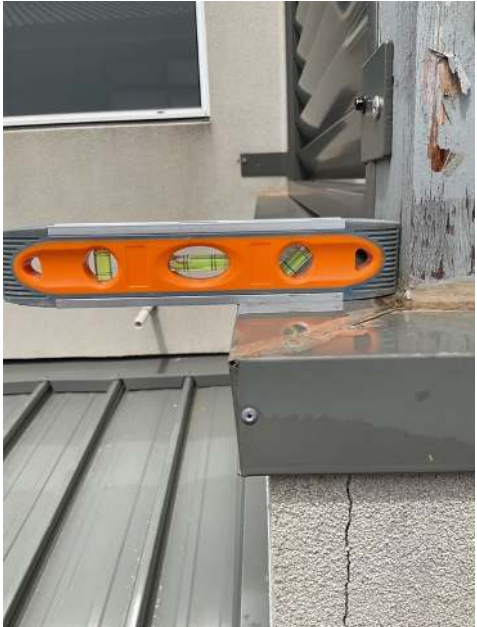
- d) The metal capping is falling towards the timber post, which is the same as the opposite side of the balcony. This is required to be replaced and done correctly.

Negative fall towards post to flashing connection

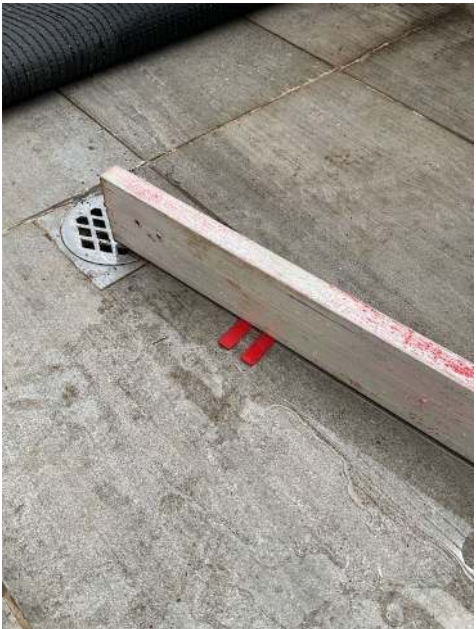
Water ponding to balcony above the water stain area

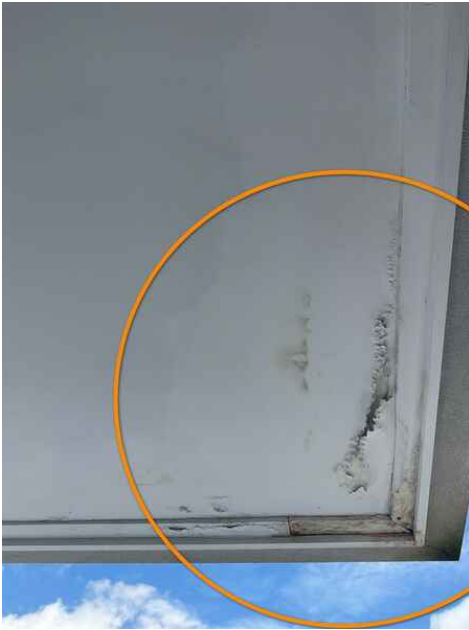
Visible water damage

The sill flashing needs to be rectified to ensure adequate fall is achieved, the matrix cladding is to have the required 6mm gap installed between the bottom of the cladding and the sill flashing, and the existing sealant is to be removed. These building defects must be repaired to ensure no future water ingress occurs to this area.

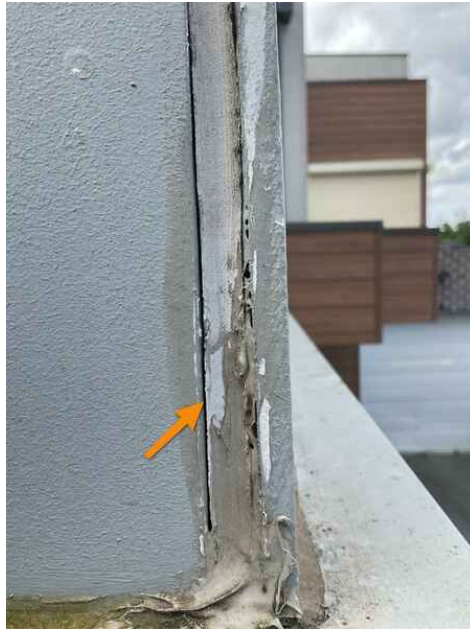
Matrix cladding joints require re sealing. - Homeowners Maintenance

As per normal homeowners maintenance, all gaps that eventuate from normal footing and building movement should be sealed approximately every 5 years. Sealant products (in particular that are open to UV radiation), will only last approximately 5 years. It is the homeowners responsibility to ensure the cladding is maintained as per the installation manual and the VBA guide to Standards and Tolerances - 2015. I recommend the entire facade matrix cladding to be resealed by a professional caulking sealant contractor.

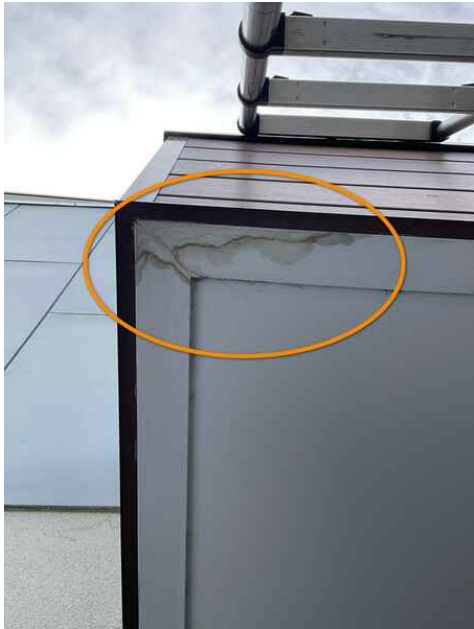
The Euroclad vertical starter profile does not have the required fall to drain water away from the cladding and adjacent eaves lining. There is no gap to the bottom of the cladding that is also required to drain water away from the cladding. The vertical starter profile is to be adjusted with the required fall and gap to prevent water ingress/damage.

Visible water damage

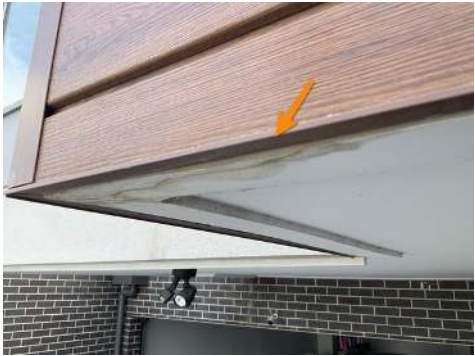
MDF used for external trim, is swollen due to moisture and needs replacing.

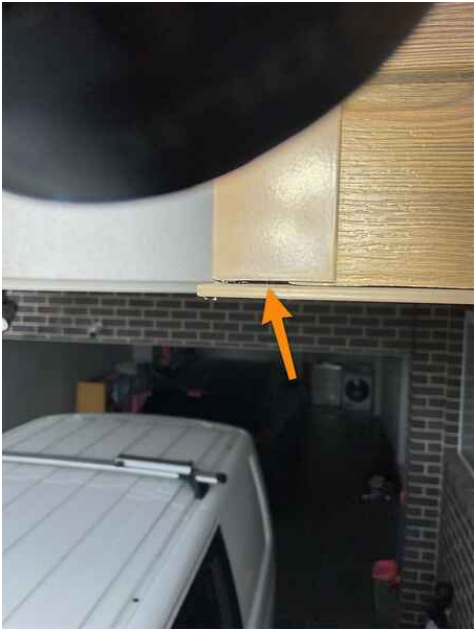
Euroclad Vertical Started Profile is not falling away from the ceiling. It is falling towards the ceiling

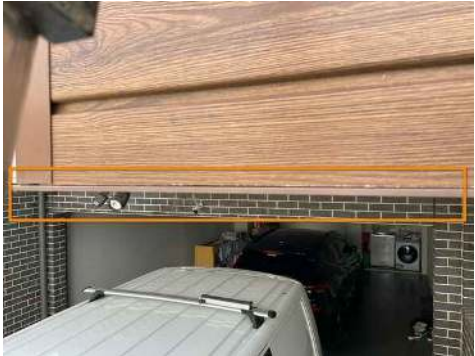
No gap left to bottom to drain water away.

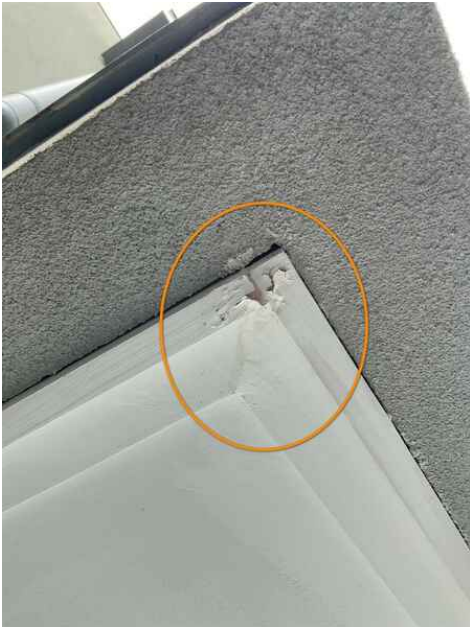
Leak No.1

There are 3 leaks above the garage panel lift door section. The defects associated with these leaks are:

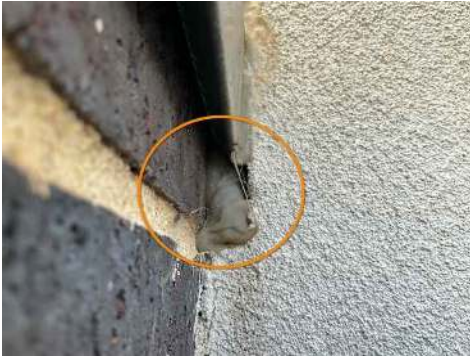
- a) Numerous holes to cladding which were not sealed properly at the construction stage.
- b) Render crack to the internal corner junction which is allowing water ingress.
- c) There is a horizontal surface on top of the EPS Cladding which is ponding water and allowing water ingress. A metal capping should have been installed at the construction stage to prevent water ingress to this area.
- d) Numerous gaps and holes to the matrix cladding. As stated previously, this is part of normal Homeowners Maintenance.
- e) The bottom edge of the matrix cladding has been fully sealed, which is not as per the installation instructions. This needs to be removed to prevent water ingress.

Holes not selaed

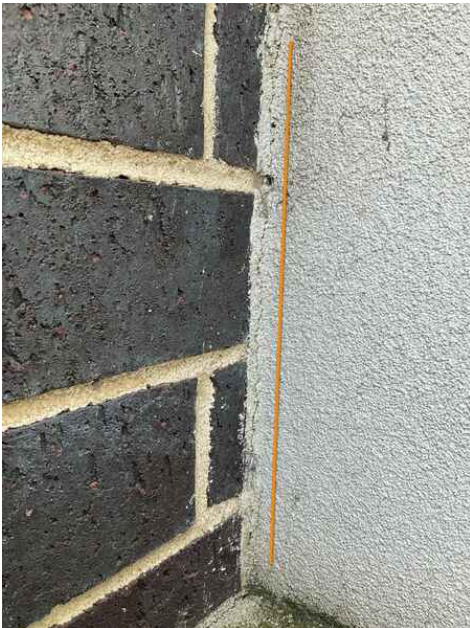
Render crack to be repaired watertight

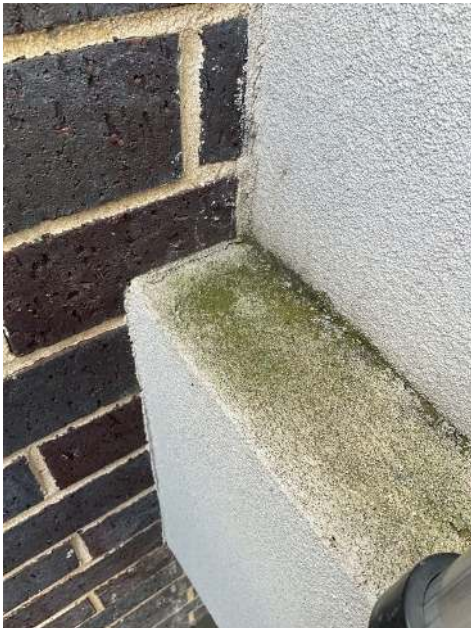
Ponding water. No flashing installed
