## Preliminary Expert Witness Report

| Address: | Sample Property Suburb withheld Victoria |
| Site Inspection Details: | 26 <sup>th</sup> November 2024 – 2:06PM |

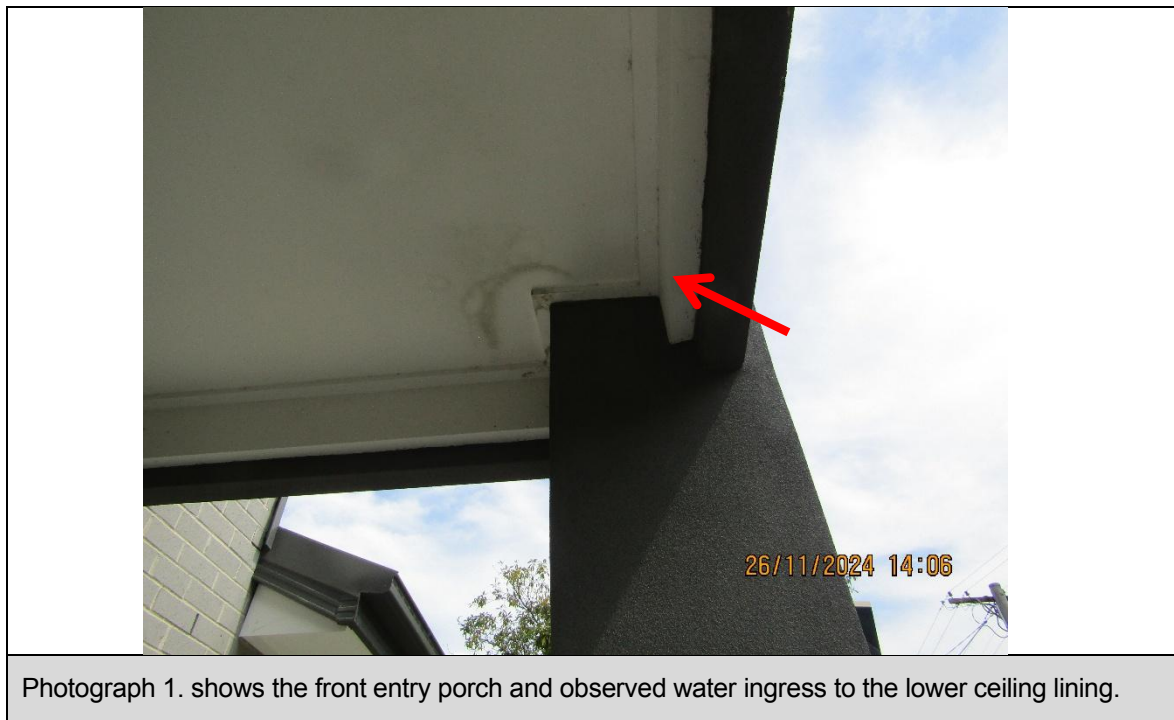
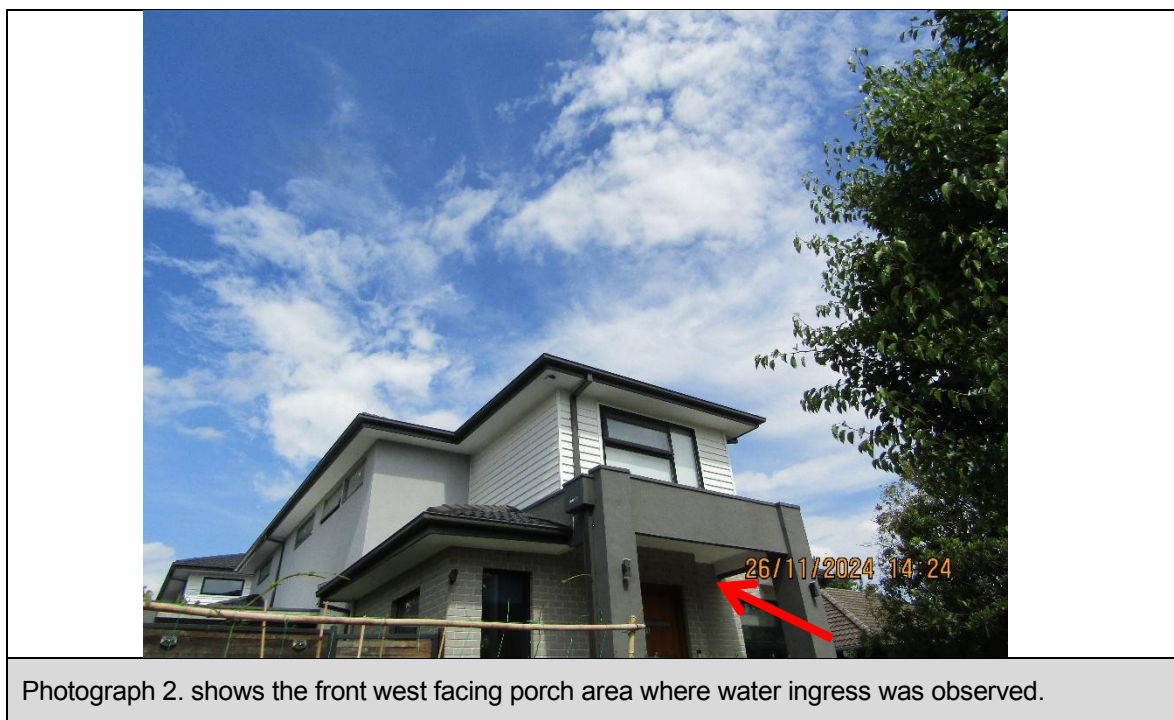
- 5.4 The building contractor was not present at the time of my inspection.
- 5.5 On entering the property, the applicant stated that approximately, four months ago during a heavy storm rain event water ingress had occurred. Large amounts of rain water entered the front porch roof cavity. The painted cement based ceiling lining was water stain as observed at the time of my inspection.(See photo nos. 1 and 2 - Appendix A of this report)

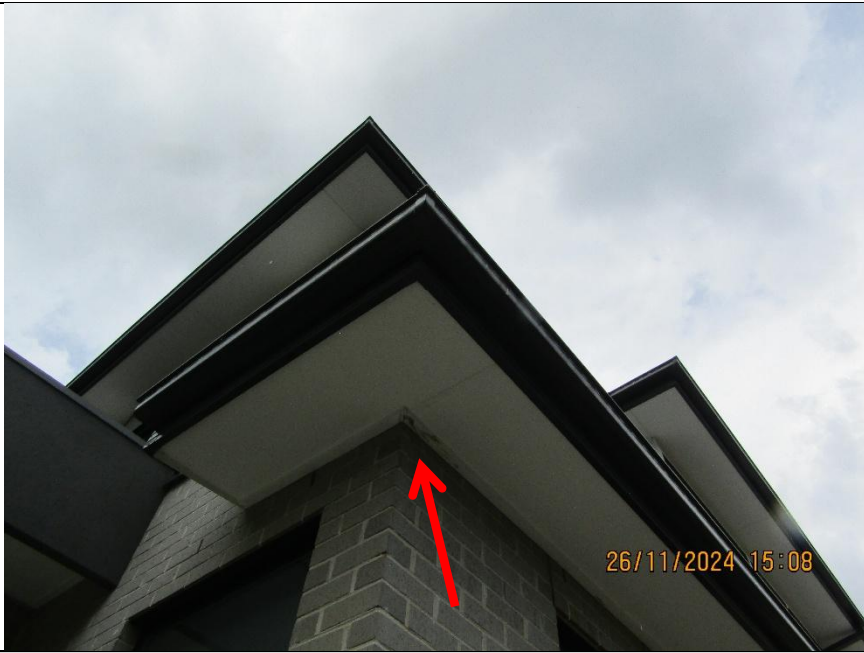
- 5.6 I was then taken around the external perimeter of the residential unit 1 and shown further water ingress. Damage to the soffit eave lining on the southern elevation was observed. Water staining was observed to the painted cement based sheeting from water ingress.(See photo nos. 3 - Appendix A of this report)

Photograph 3. shows the side south elevation and damaged eave lining from water ingress from overflowing gutters. This is due to blockage and restriction of the storm water system.

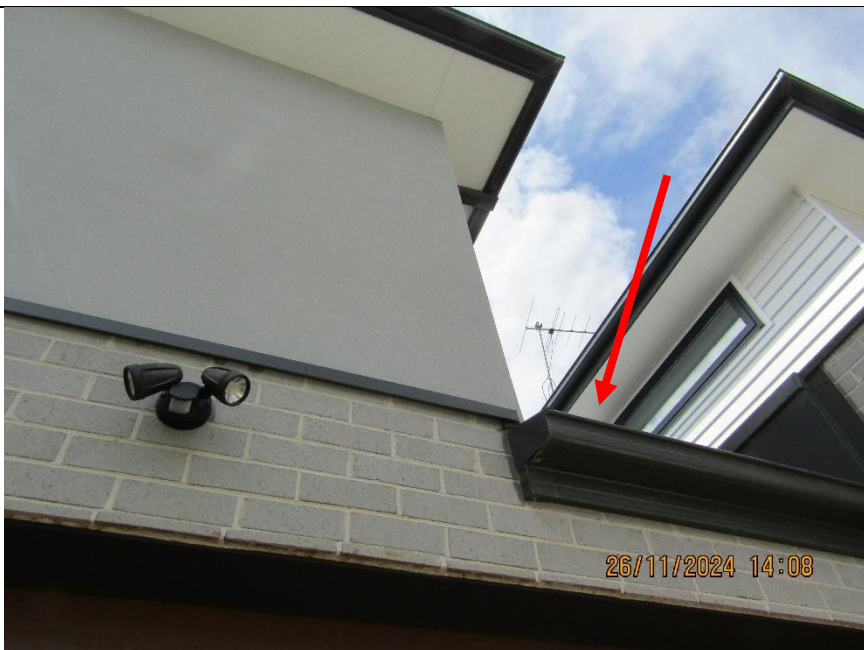
- 5.7 The applicant then directed my attention to the external garage where I was shown roof drainage guttering which had over flowed. The applicant informed me the entire gutter fills and a sheath of water overflows from the gutter during heavy storm events. I observed water marks along the guttering and downpipe which would indicate overflowing of storm water and down pipe blockage.(See photo nos. 4 and 6 - Appendix A of this report)

Photograph 4. shows the garage overflowing gutter during heavy rain events. No water ingress damage was observed to the garage. Water overflowing to the gutter and down pipe was evident.

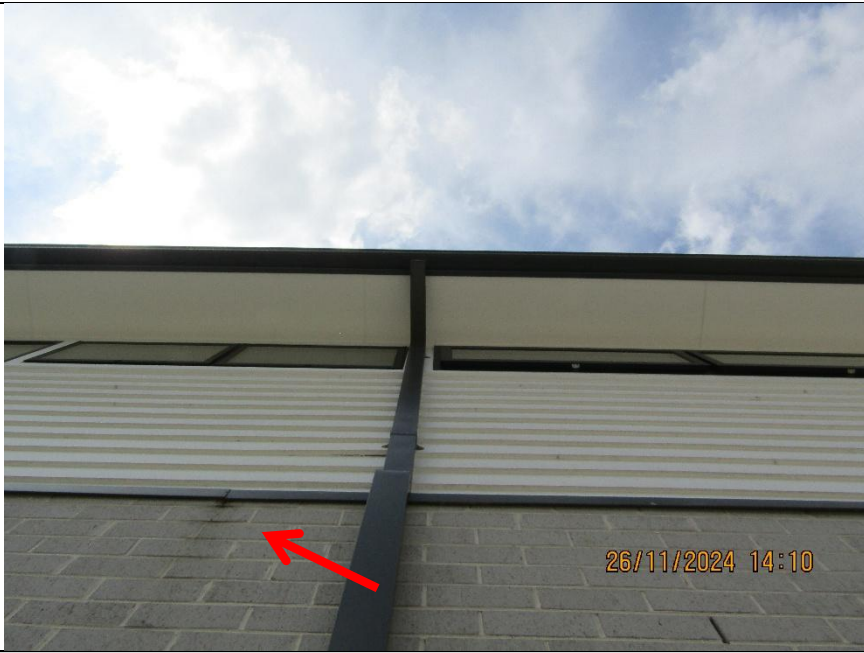
- 5.8 During my inspection I further observed minor damage to the external wall transfer flashing. This was positioned on the southern wall elevation. Water at the flashing joint showed signs of a poorly sealed lap joint. Discolouring down the brick wall below indicating a build-up of algae to the top of the Z flashing due to pooling of water to the flat section within the flashing. Due primarily from negative grading of the flashing during installation. Indicative of pooling due to poor installation. There appears no water ingress within the wall cavity.(See photo nos. 5 - Appendix A of this report)

Photograph 5. shows the external southern elevation and water staining from a wall flashing. The wall flashing has not been correctly installed.

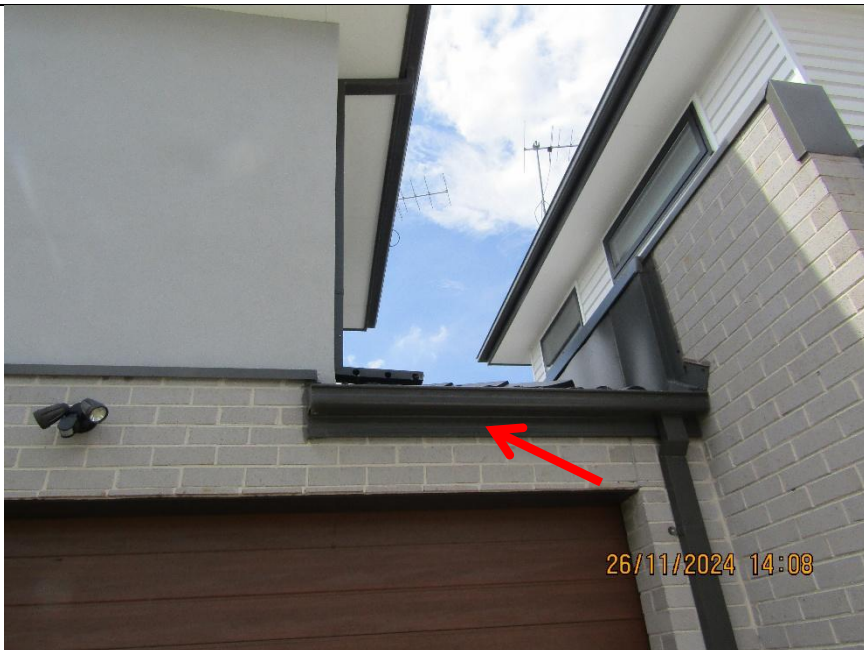
Photograph 6. shows the side garage section where water ingress has been alleged to have occurred. No visible water ingress damage was observed. Evidence of water marks does indicate a blocked or non-functioning roof drainage gutter and down pipe.

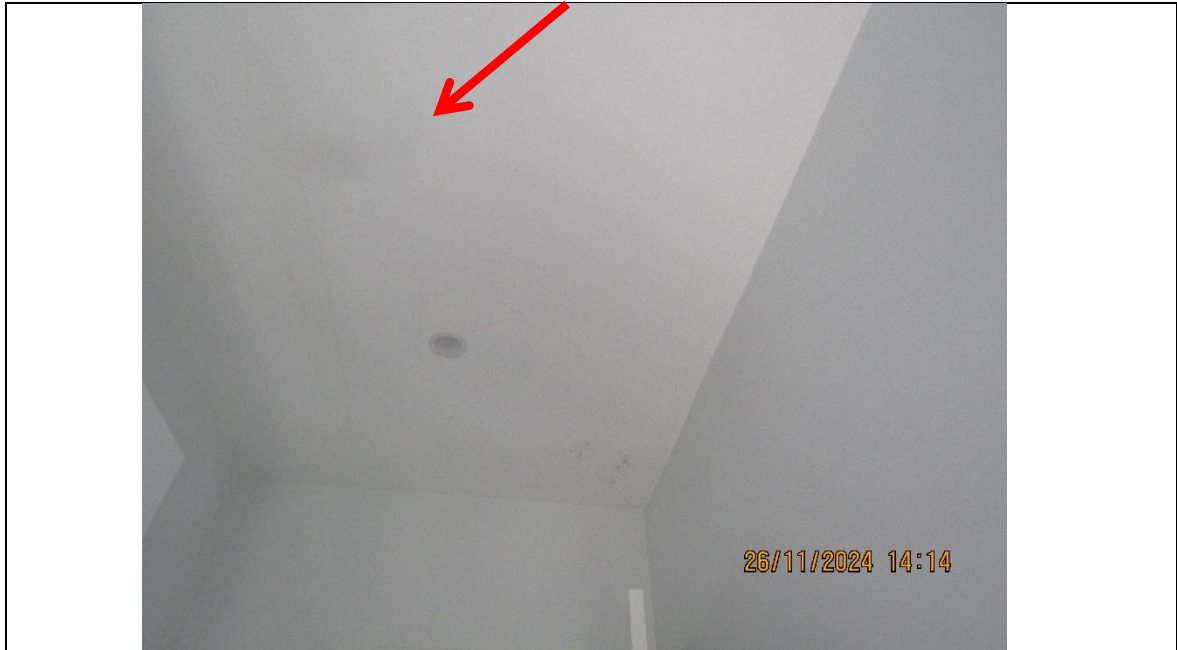
- 5.9 The applicant was more concerned about internal water ingress which had occurred to the laundry. The painted plasterboard ceiling within the laundry had experienced water ingress. During heavy rain events it is alleged water drains into the roof cavity and through the ceiling down lights. I observed a blackened painted plasterboard ceiling which indicated long term water ingress and mould appearing to the surface of the plasterboard.(See photo nos. 7 - Appendix A of this report)

Photograph 7. shows the internal laundry painted plasterboard ceiling with water stains and mould due to long term water ingress from a failed roof drainage system.

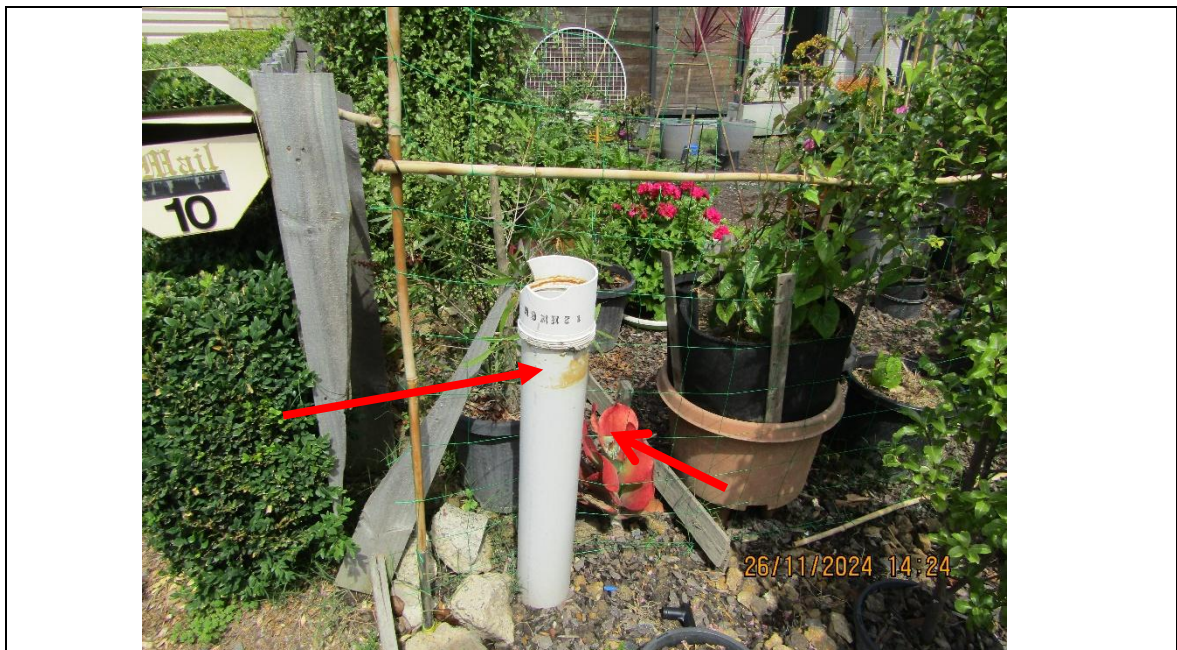
Photograph 8. shows the front section of the residence and the storm water point which required a storm water pit 4 not installed. This is considered in-complete building works by the building contractor.

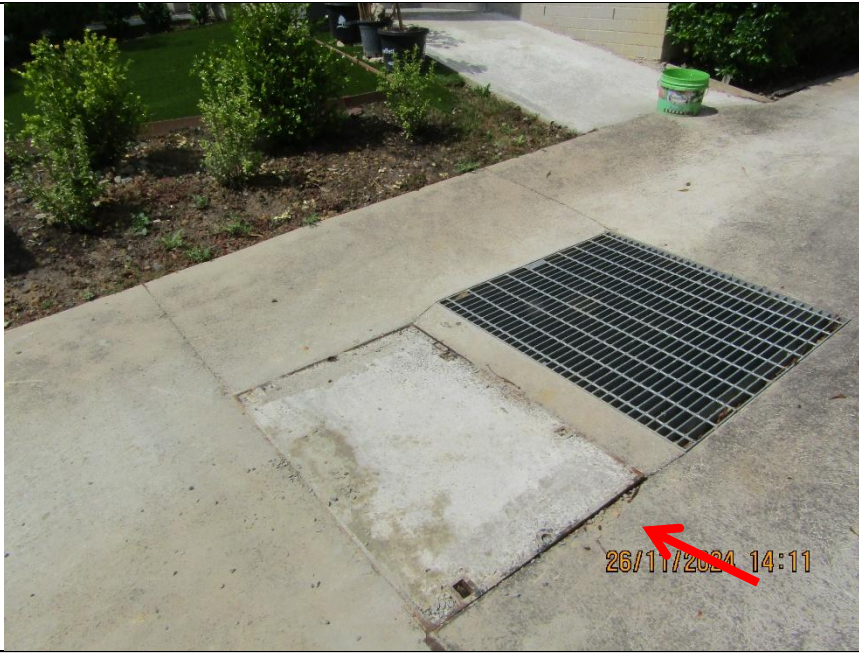
- 5.12 The construction of the larger Pit (5) was also observed to be non-compliant. The concrete lid was not level and could not be positioned correctly. The drainage pipe within was crushed and water flow partially restricted.(See photo nos. 9 and 10 - Appendix A of this report)

Photograph 9. shows the front civil storm water drainage system and Pit 5 which has not be certified by the local council Civil Engineer.

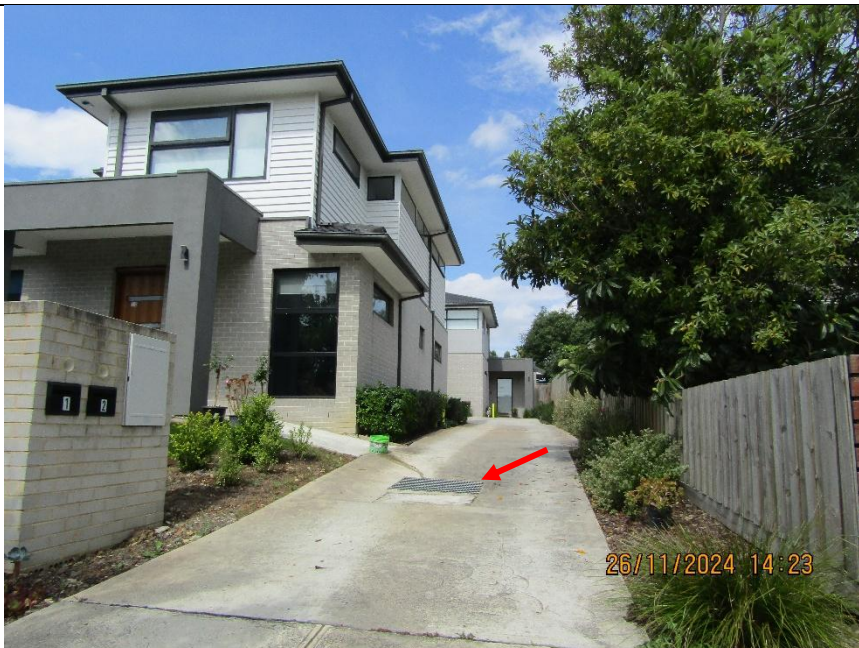
Photograph 10. shows the front drive way and civil pit 5 as being observed as non-compliant and not approved as civil drainage design by the local council Civil Division.

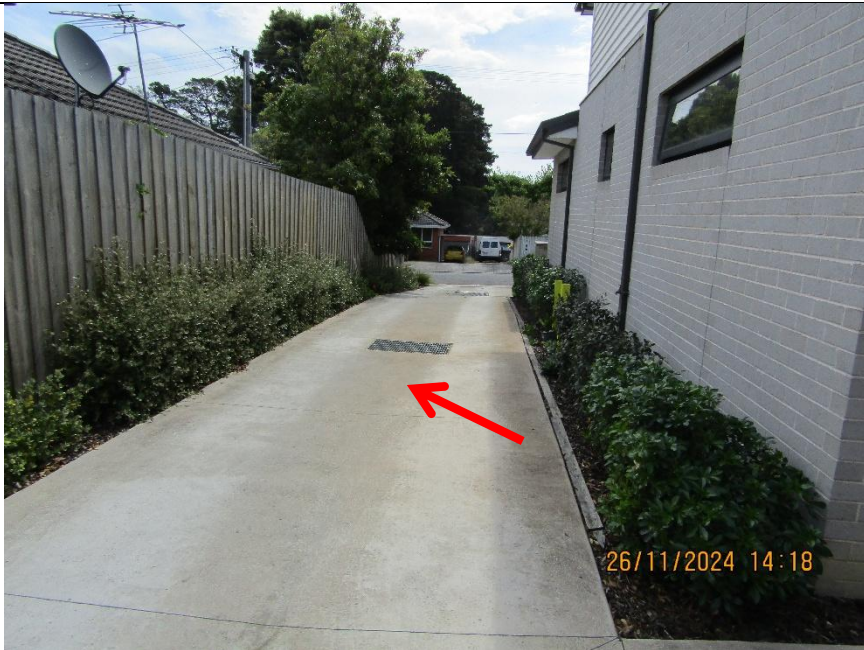
- 5.13 The applicant alleged that Pit (3) further up the sloping concrete drive way overflowed during heavy rain events. This would indicate a blocked and restricted storm water drainage system. Sediment and water stains around the grate indicating an overflowed pit. This is also evidence why the roof drainage down pipes and gutters appeared to have blockage and over flow during heavy rain events.(See photo nos. 11,12,13 and 14 - Appendix A of this report)

Photograph 11. shows the civil storm water drainage system and pit 4 which overflows during heavy rain events.

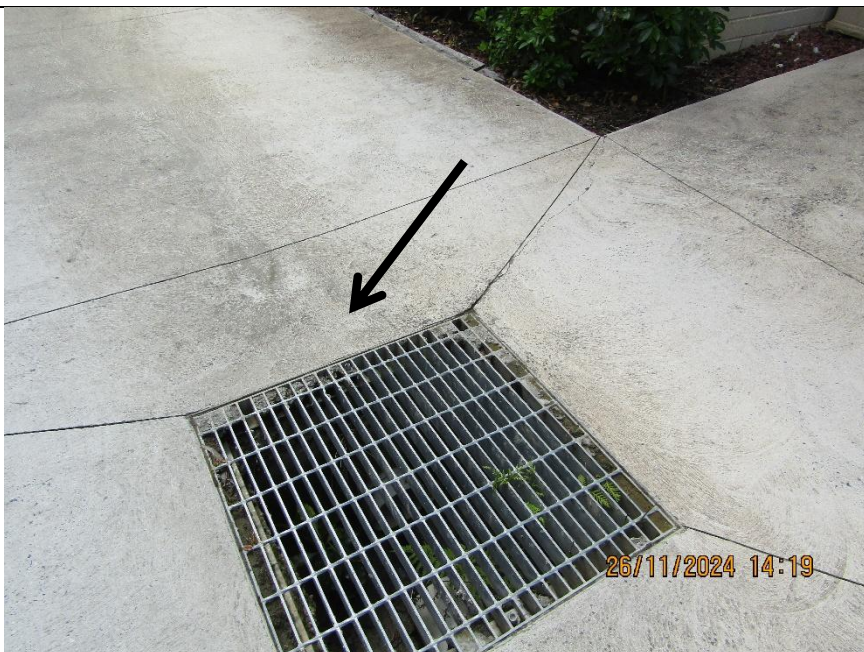
Photograph 12. shows the civil drainage storm water system and a compliant pit 4 with a 150mm drainage sub-surface pipe. This pit and staining debris around the pit indicate overflowing during heavy rain events.

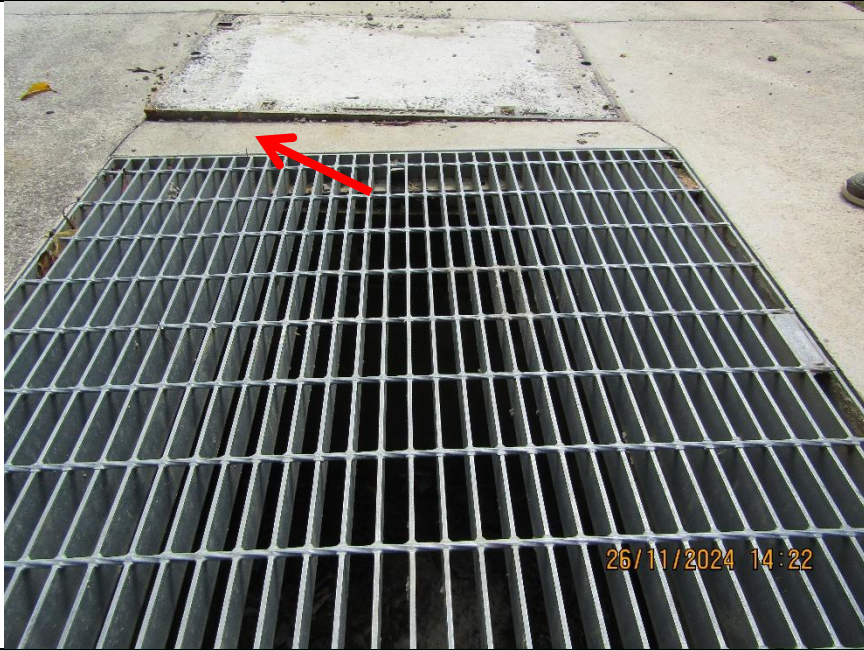
Photograph 13. shows the civil storm water drainage and secondary baffle pit which is non-compliant. The concrete lid does not sit flush. This is considered non-compliant building work by the building contractor.

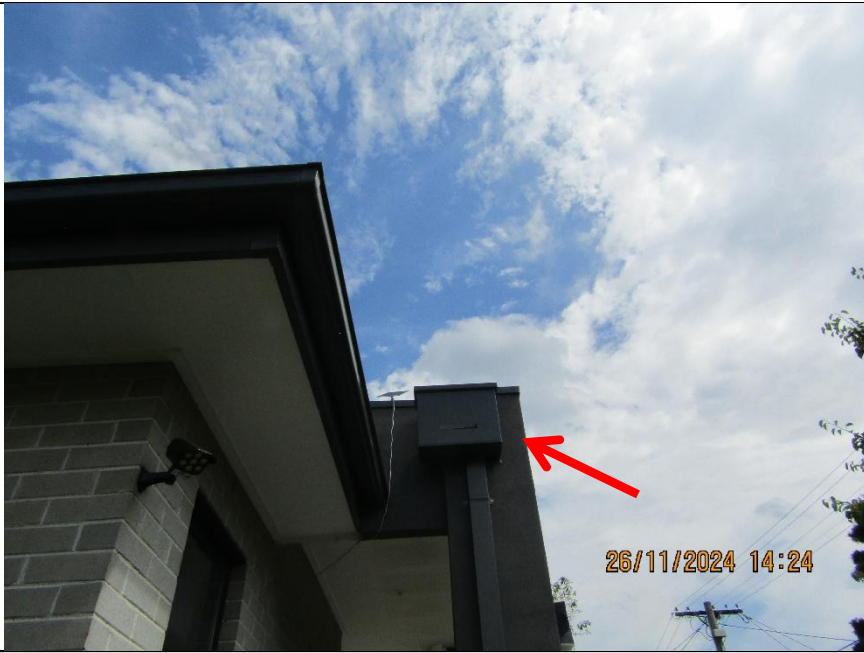
- 5.14 I then concentrated my inspection to the front porch roof cover, box-gutter and rain head drainage system. I observed that the overflow provision of the box-gutter and rain head down pipe were under sized. This would indicate the box gutter would fill up with water during heavy rain events and over flow at the small outlet low end of the box-gutter. The rain head did not have a compliant overflow out let that would disperse storm water to the atmosphere if the down pipe was blocked. The size of this horizontal slot in the rain head is too small. Subsequently restricting storm water exiting from the box-gutter, resulting in overflow into the porch roof cavity. .(See photo nos. 15,16 and 17- Appendix A of this report)

**6.4 The rain head design undertaken to the front porch and the box gutter fail to drain water during heavy rain events. This is due to the design and insufficient size of the overflow requirements under Australian Standard (AS) 3500.**

Photograph 15. shows the front porch and rain-head including overflow slot which is not compliant. The rain-head is not dispersing rain water to the atmosphere during a heavy rain event adequately due to poor installation.

- 6.23 Water is not draining away from the residence. This is considered defective building work for which the building contractor is responsible for.
- 6.24 My recommendation that the box gutter to be altered to conform to AS3500.3 & HB39 Installation Code for Metal roof and Wall Cladding, Section 5.3.2 Gutter Installation, (I) requirements for: i) Direction of discharge; ii) Straight guttering; iii) Sizing of Rain Head opening is to match the width of the box gutter.

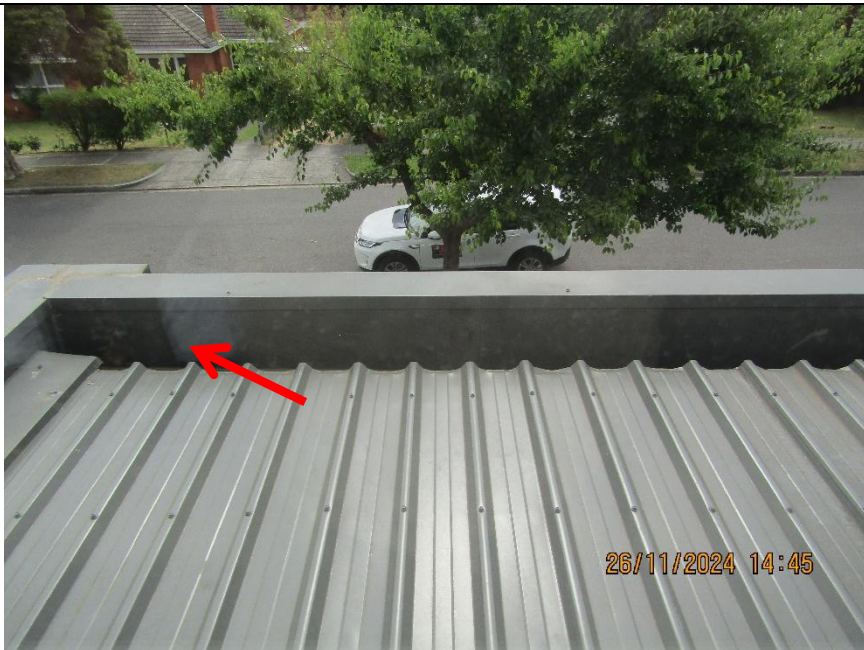
Water ingress to the internal residence has been observed due to a failed roof drainage system. The box gutter to the front porch roof cover has failed during heavy rain periods and subsequently overflowed in the applicant's porch roof cavity. This is primarily due to a constructed box gutter and rain head roof drainage which has been inadequate to cope during rain events.

Photograph 16. shows the box gutter which is filling and overflowing into the porch roof cavity during heavy rain events.

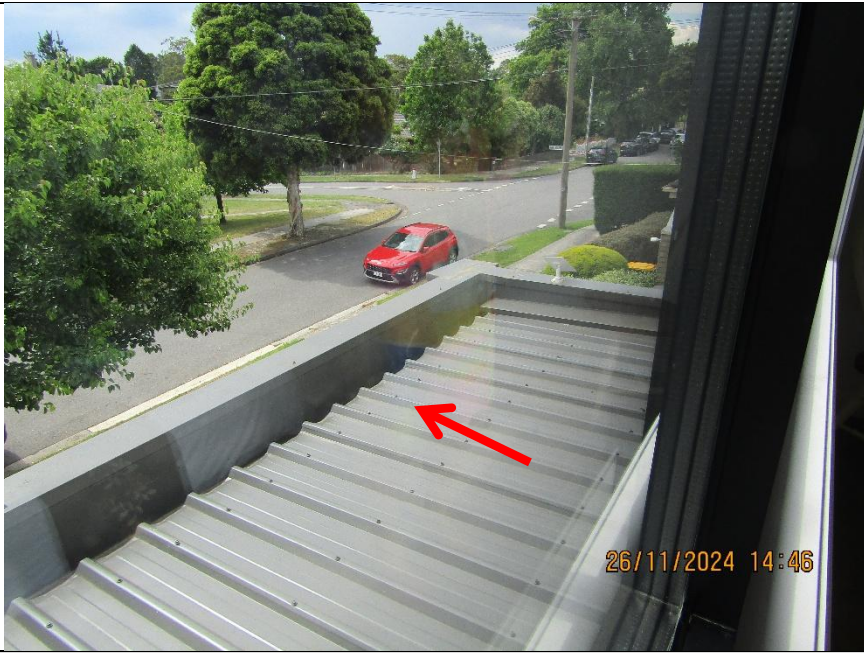
Photograph 17. shows the front porch and roof cover which is designed only to accommodate for a small roof surface area of storm water drainage.

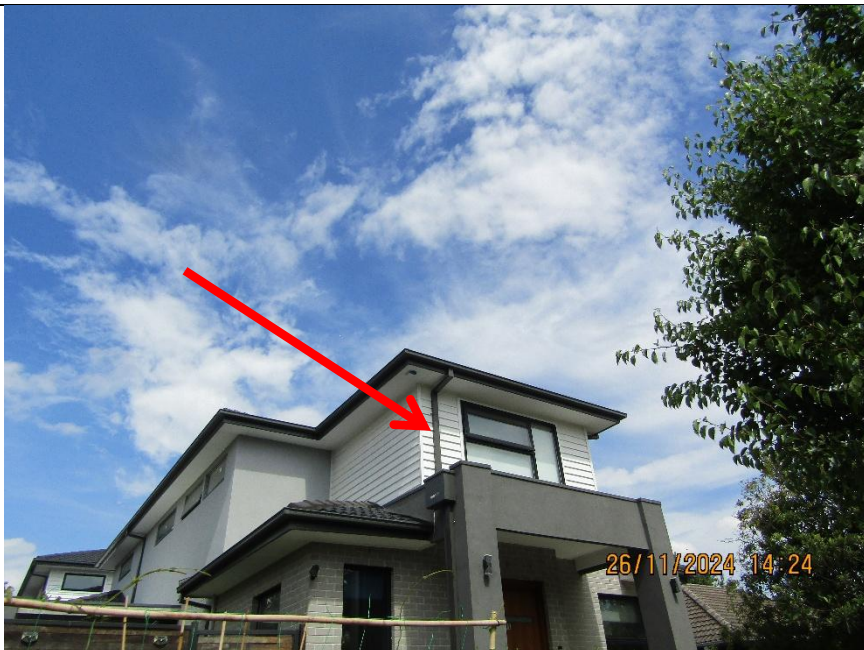
- 5.16 I observed that the building contractor has contravened the designed architectural plans [company withheld] dated 25<sup>th</sup> October 2018 with down pipe placement. The building contractor has placed a first floor down pipe which drains onto the lower front porch roof cover. This contravenes the design requirements of the architectural hydraulic design and further contributes to large amounts of water into the box-gutter. This is considered a building defect by the building contractor.(See photo nos. 18 - Appendix A of this report)

Photograph 18. shows the upper roof and roof drainage down pipe dispersing additional storm water onto the porch roof cover. This is non-compliant building work as the porch was not designed to take the rain water from the upper roof. This also contravenes the hydraulic design of the roof.

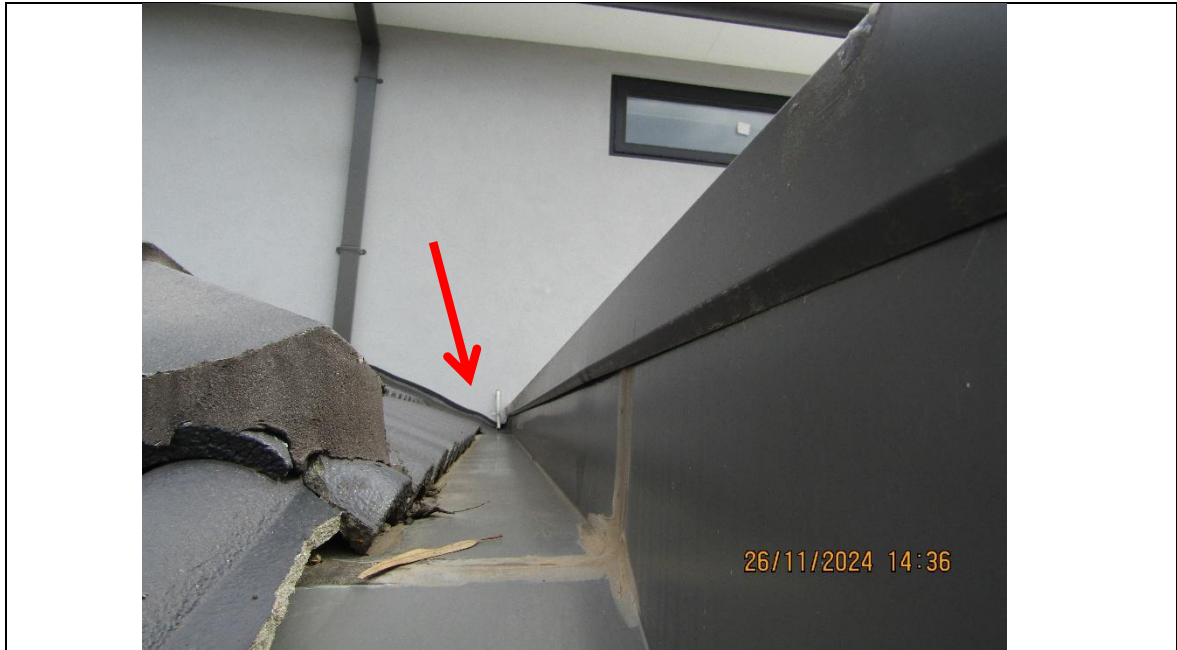
contractor has contravened the designed architectural plans [company withheld] Pty Ltd dated 25<sup>th</sup> October 2018 with not installing a box-gutter. This is considered a building defect by the building contractor. (See photo nos. 19,20,21 and 22 - Appendix A of this report)

**6.6 Furthermore, the building contractor has failed to install a box gutter to the side northern roof drainage system The box gutter was not installed however in lieu a valley gutter. The non-compliant valley gutter is not a viable alternative to a conventional box gutter. The gutter water direction must flow directly into the rain head and not at opposing directions of water flow. The valley gutter changes should have been undertaken in accordance with the designed and approved AS 3500 and approved by relevant acting building certifier. This is considered a building defect by the building contractor.**

Photograph 19. shows the valley gutter over the laundry. The design requires a box-gutter not a valley gutter. This is considered defective building work.

- 6.10 I recommend the box gutter gutters and valley gutters within Unit 1 to be fully replaced and achieve all compliance aspects for fall and support. Box gutter to have sumps installed. Rain heads to be fully sealed and have overflow discharge equivalent to box gutter capacity and in the same direction of water flow. Box Gutters to have overflows installed, discharging to the atmosphere; Flashings to be fully secured. Have suitable pressure flashings with robust fixing to comply with VBA requirements. Spreaders and down pipes to be increased in size. Roof sheets to be fully replaced and not patched in areas which is considered non-compliant workmanship.

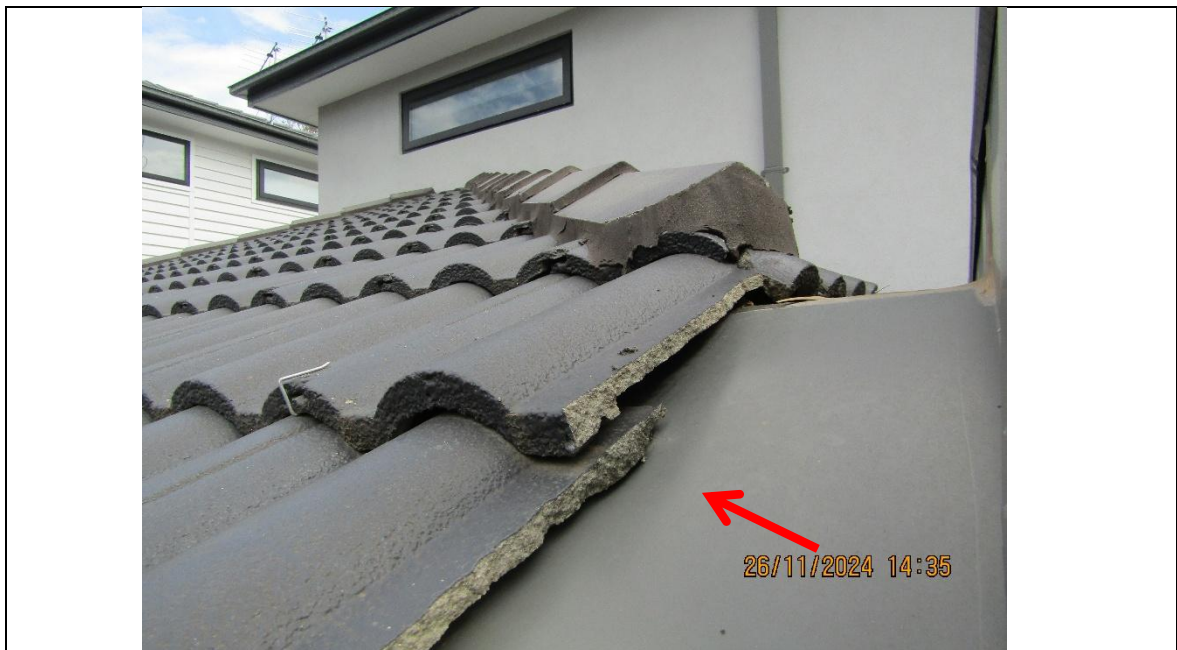
Photograph 20. shows the non-compliant valley gutter in lieu of a required box gutter. This valley gutter cannot cope with heavy rain event allowing water ingress within the roof cavity.

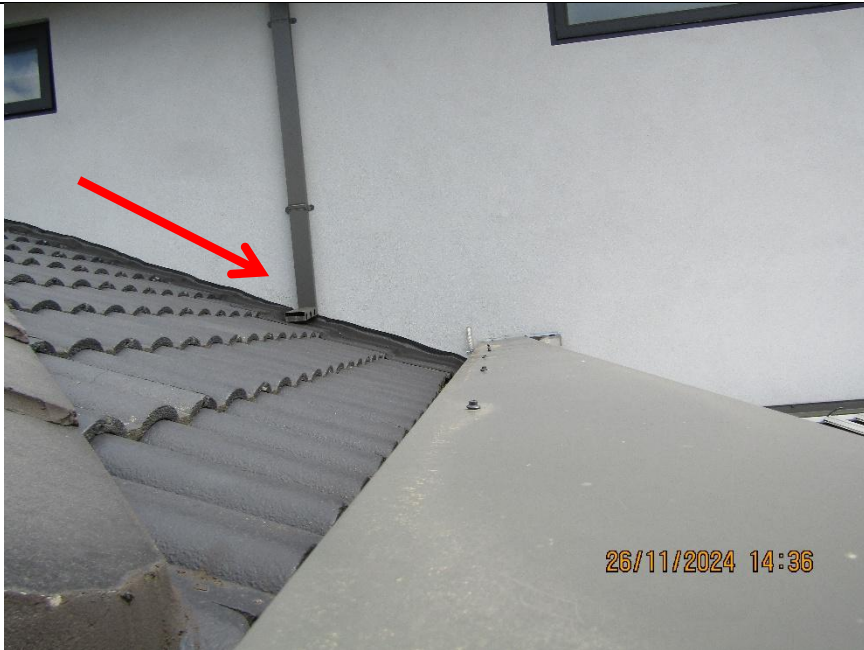
Photograph 21. shows the spreader downpipe dispensing large amounts of water into the valley gutter. The valley gutter cannot cope with heavy rain events and subsequently water is entering the roof cavity over the laundry.

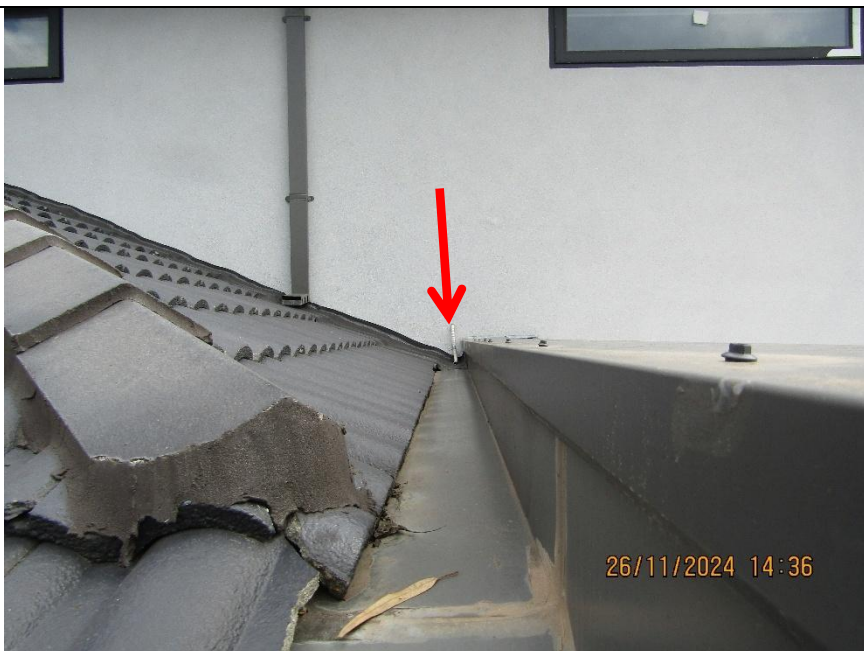
Photograph 22. shows the area where water ingress has occurred into the roof cavity, over the laundry. Note the 100mm depth required for a box-gutter at the end and wall junction has not been achieved. The building contractor has put lead flashing at the wall and valley gutter junction only.
