## INVESTIGATION REPORT

Sample Property

21/08/2026

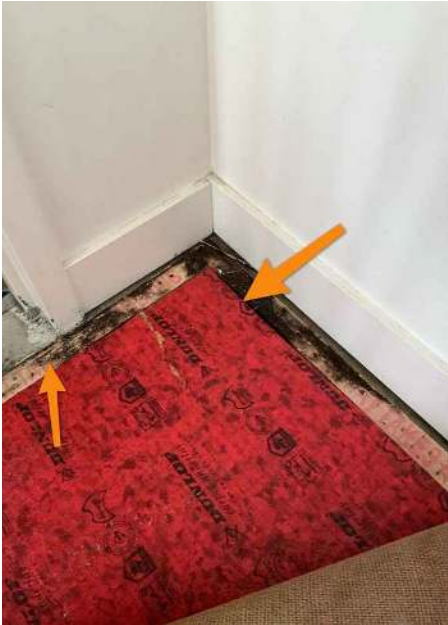
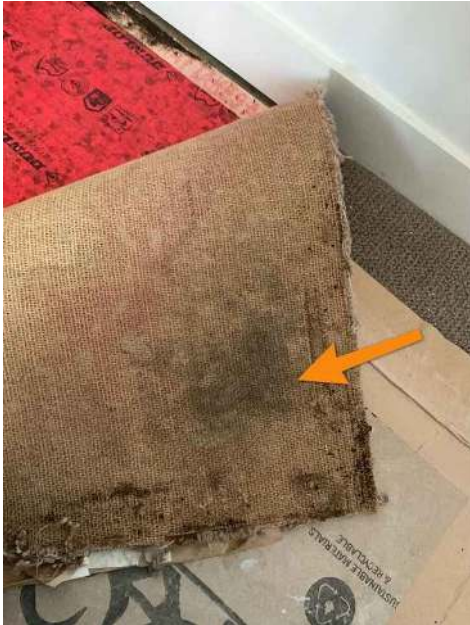
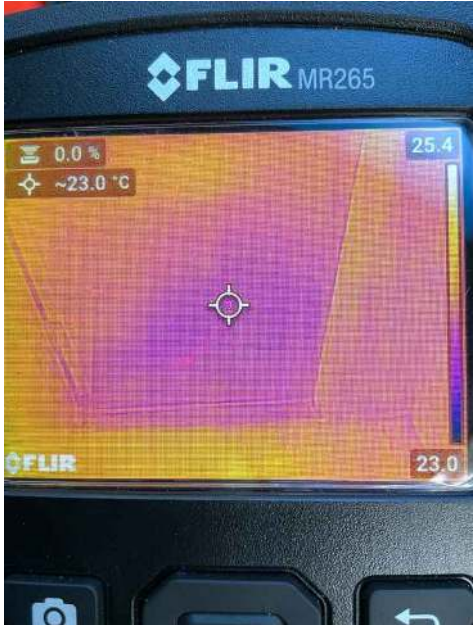
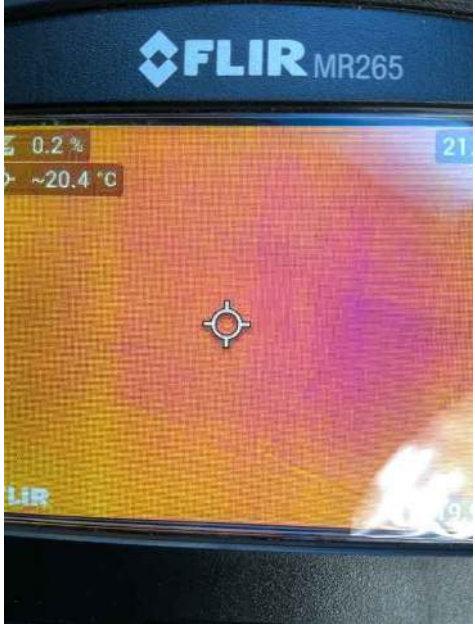
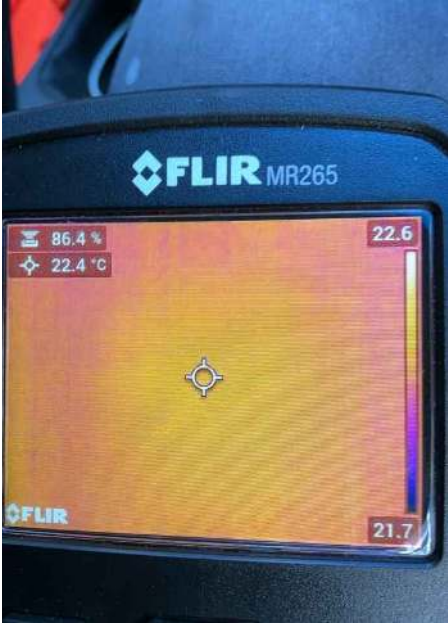
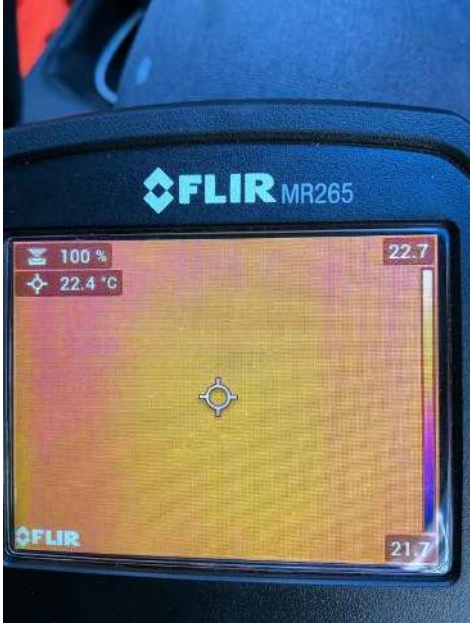
#### Ensuite water leak: Water leak

On inspection. It was found that initial the tenant had noticed a water leak to ensuite.

On a closer look there was mould found under carpet at the doorway to the ensuite. At a closer look area was dry yet mouldy. Possibly created by original water leak.

There was no other signs of water leaks at this point.

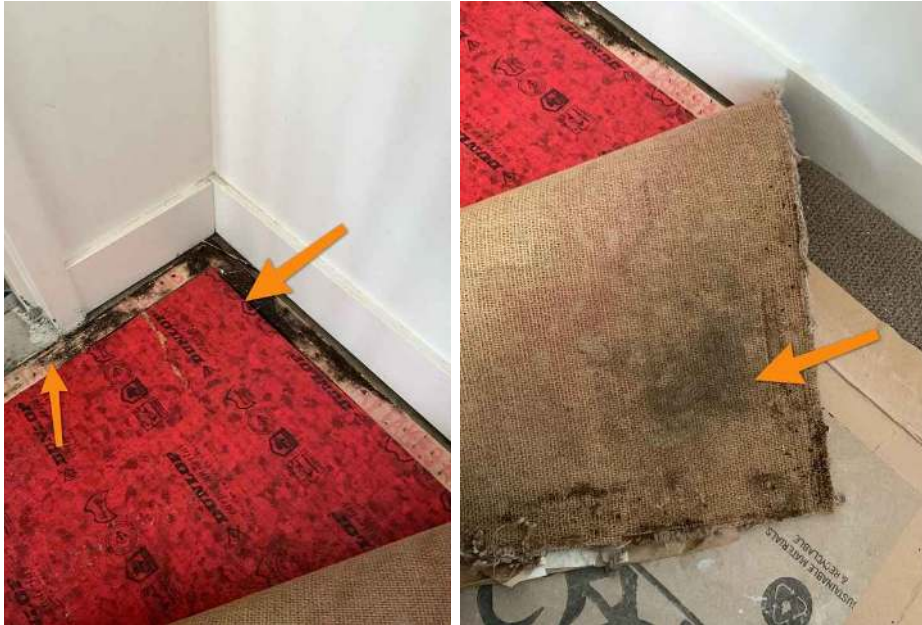
Carpet

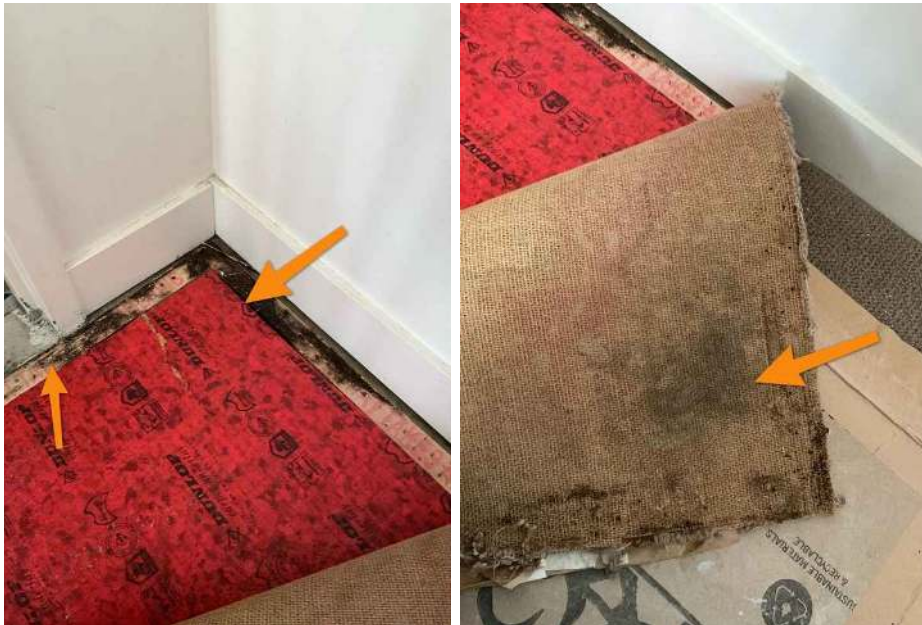
Entrance to ensuite

Water damage to carpet and mould.

General views of Bed 1 is acceptable. With water damage to carpet in front of ensuite door only.

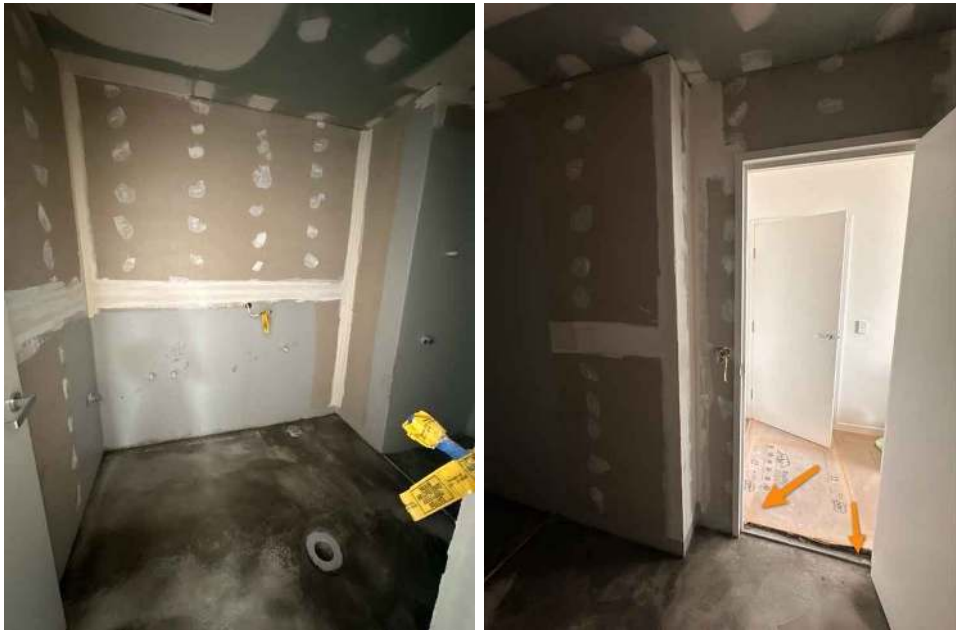
ENSUITE

Ensuite is under remedial work due to water leak to flooring in ensuite.
