## PRACTICAL COMPLETION INSPECTION (PCI)

Sample Property

15/09/2026

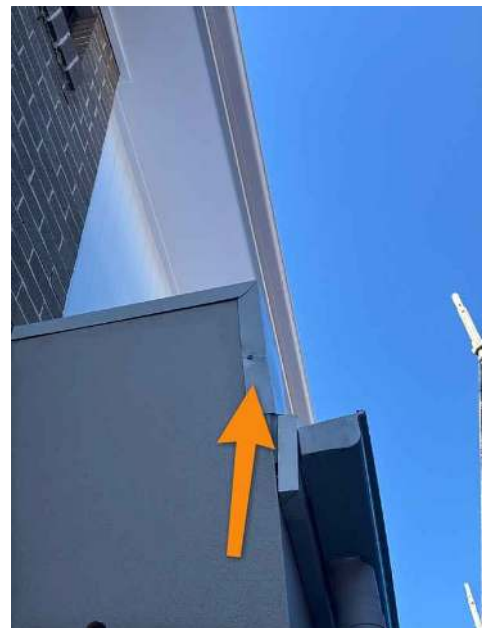
### 4.3.3 + Parapet Walls Capping

#### UPTURN FLASHING

No upturn or pressure flashing has been installed to the parapet.

Recommendation: Recommend a licensed roof plumber install a compliant upturn and pressure flashing, in accordance with AS/NZS 2904 (Damp-Proof Courses and Flashings) and the NCC (ASCB Housing Provisions Part 7.2/7.3 – Roof Cladding), to ensure the junction is adequately secured and weathertight.

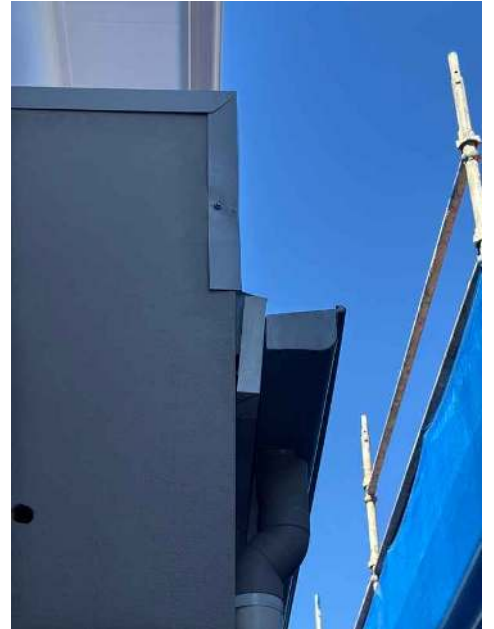
## 5.1.2 + Gutter and Fascia

**POOR WORKMANSHIP**

The fascia is not flush with the wall.

Recommendation: Recommend a licensed contractor adjust the fascia to sit flush against the wall.

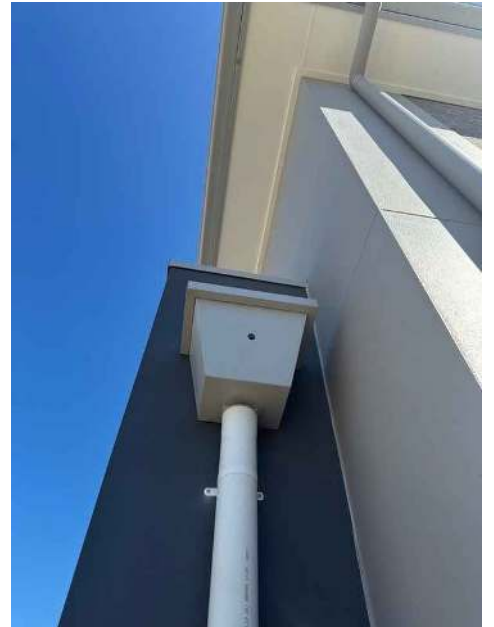
## 5.2.1 + Rainheads

**NON COMPLIANT**

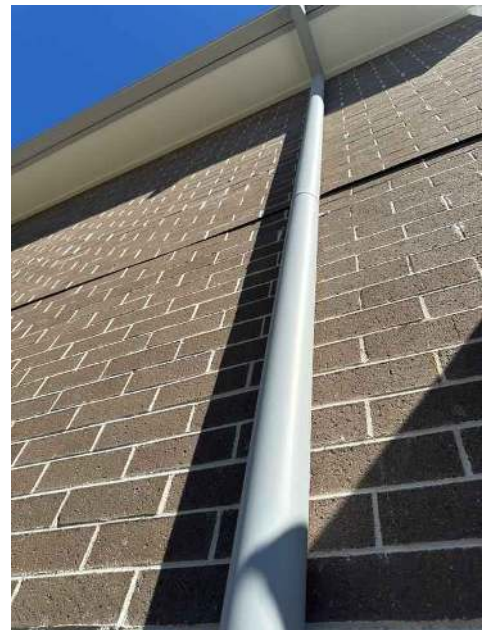
## 6.1.2 + General Painting Defects (External)

**REAR LEFT**

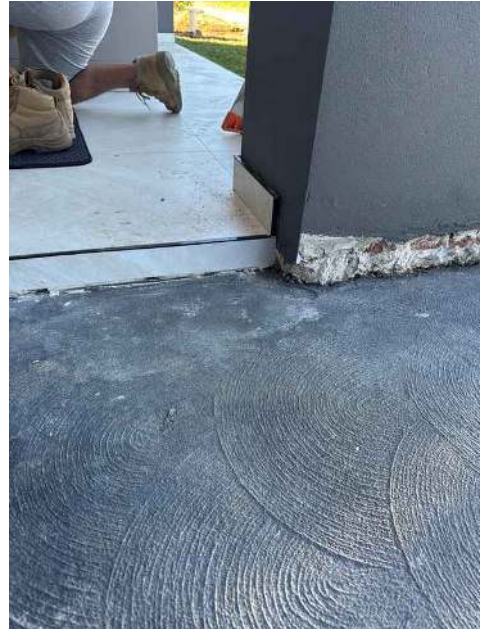
## 6.2.1 + General Tiling (External)

**+ CAULKING TO FLOOR/SKIRTING JOINTS**

Caulking is recommended to the floor/skirting joints to provide a good building practice.

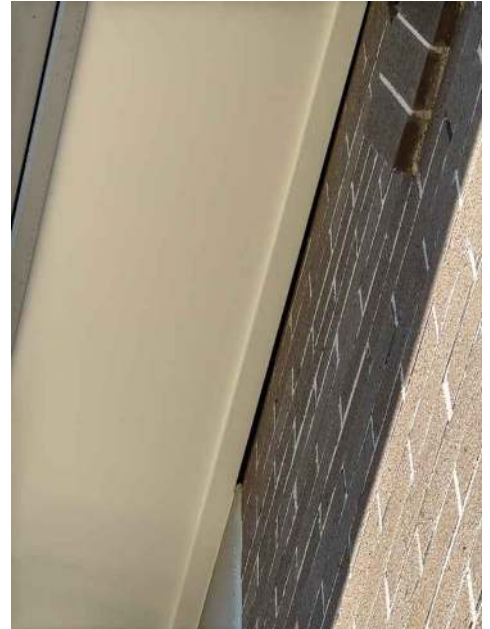
## 6.4.1 + Eaves

**+ DEFECTIVE SURFACE**

FRONT LEFT

Eave surface noted defective at one or more areas. Fixing/replacement required.

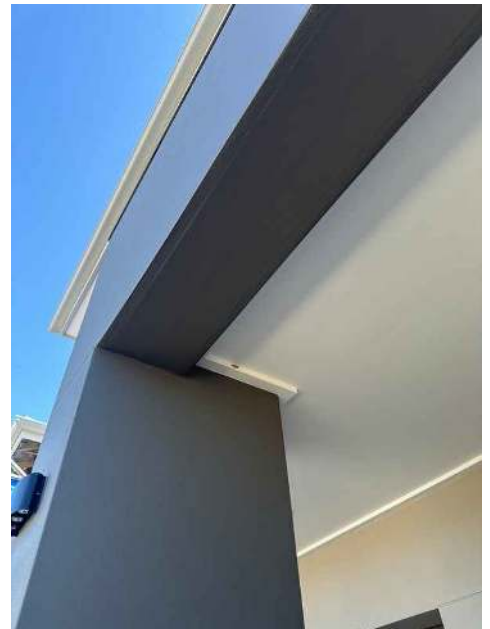
## 6.4.2 + Eaves

**+ DAMAGED/CRACKED**

Some eave linings noted damaged/cracked at the time of inspections and need fixing/replacement.

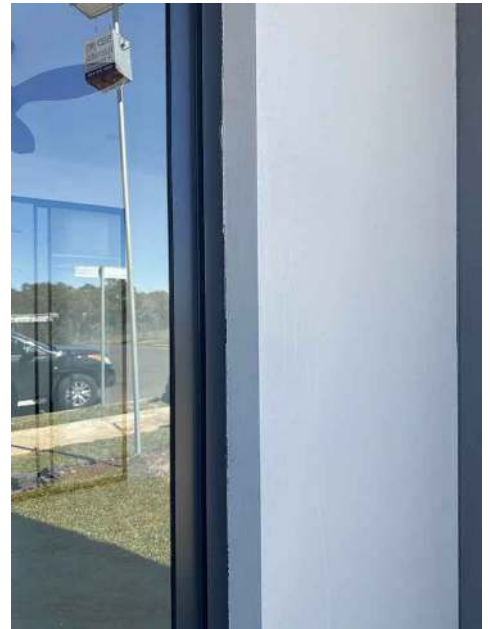
## 6.6.1 + Windows (External)

**+ CAULKING REQUIRED TO TOP/SIDES**

Where the gap between the window (or door) and the external cladding is excessive and can not be covered by the bottom/side flashings, such gaps must be caulked using the same colour proper caulking material.

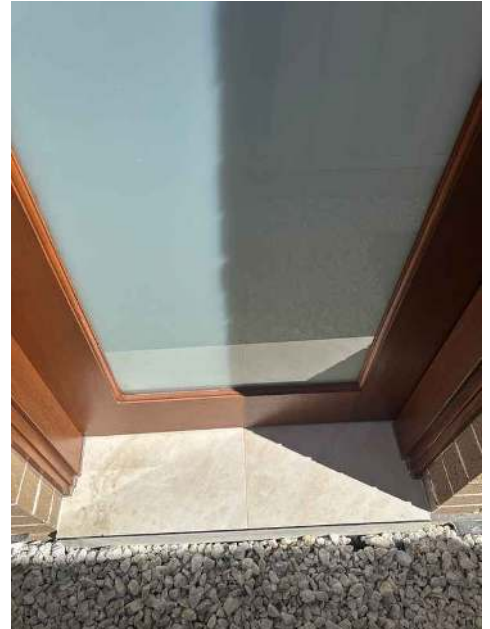
All external doors and garage/house door need a weather seal as a part of NCC and energy rating requirements. Weather door and window seals are designed to prevent draughts, rainwater infiltration and energy loss through external doors.

Window frame and door frame installations are defective if, due to the builder's workmanship, they leak or cause unhealthy or dangerous conditions, loss of amenity for occupants, undue dampness or deterioration of building elements.

Windows and doors are defective if, when closed, they allow the entry of water.

Windows and doors are defective if they are not sealed in accordance with the requirements of the Building Code of Australia, where required.

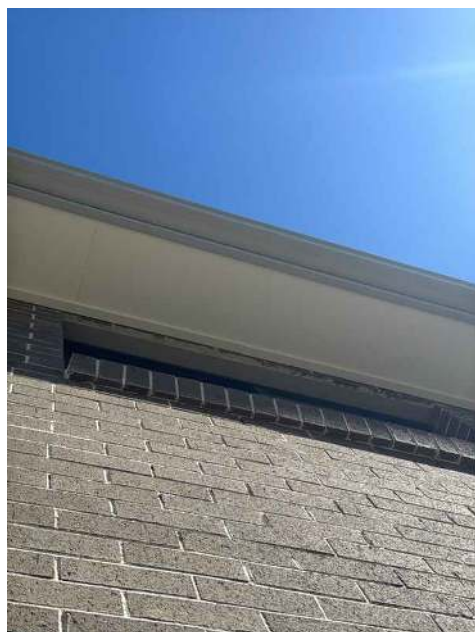
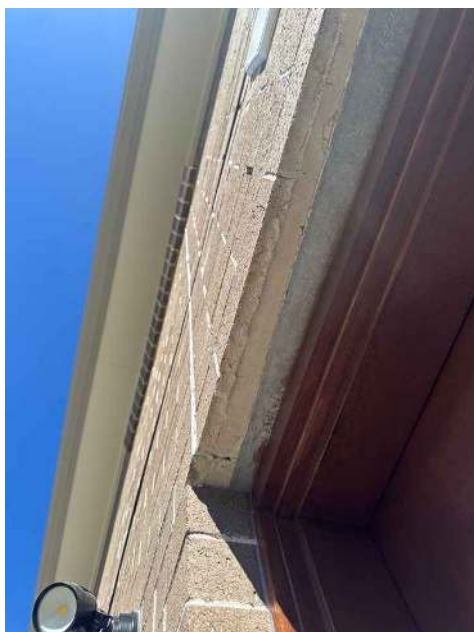
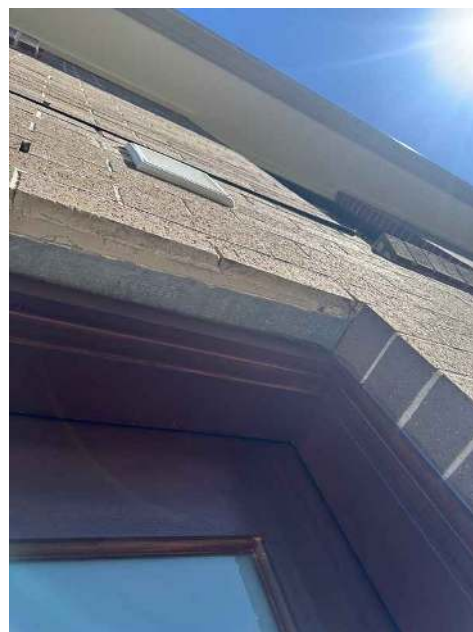
Excessive overhang of the brickwork was observed on the lintel.

Recommendation: Recommend further investigation by a structural engineer to assess the bearing and load transfer of the lintel, and rectify as required.

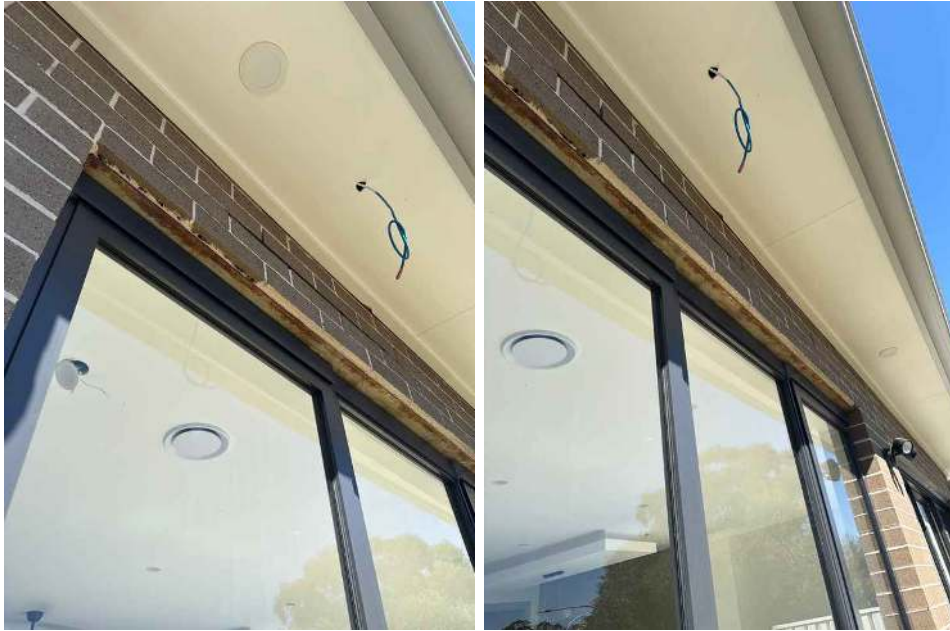
## 7.1.2 + Brickworks

**LINTEL RUST TEAR**

Rusting was observed to the rear lintel.

Recommendation: Recommend further investigation by a licensed builder to assess the extent of corrosion and treat/replace as required.

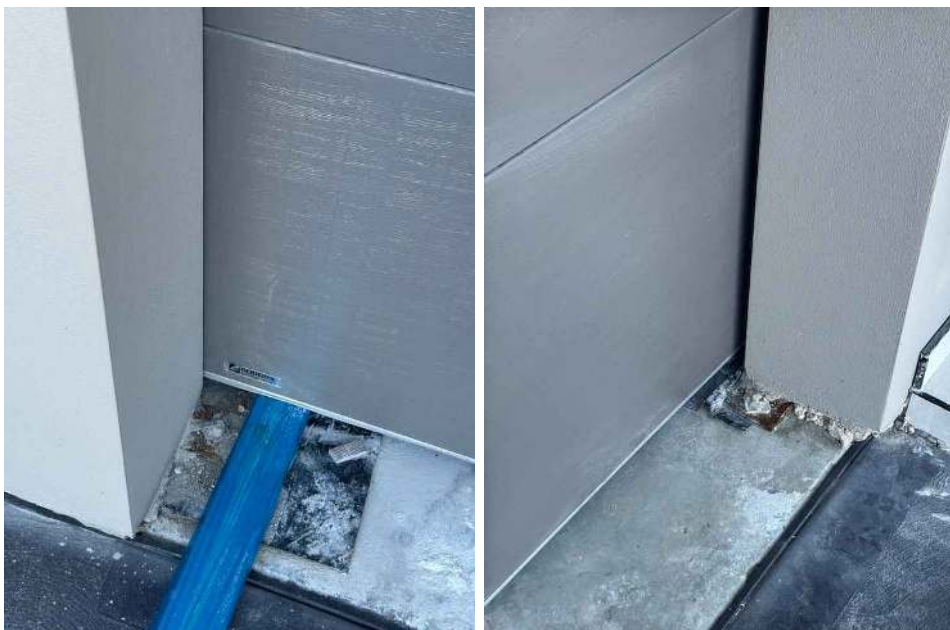
## 7.1.3 + Brickworks

**EXPOSED BEAM**

The base plate of the steel post is exposed and rusting.

Recommendation: Recommend a licensed contractor treat the affected area and provide appropriate protective coating/covering to prevent further corrosion.

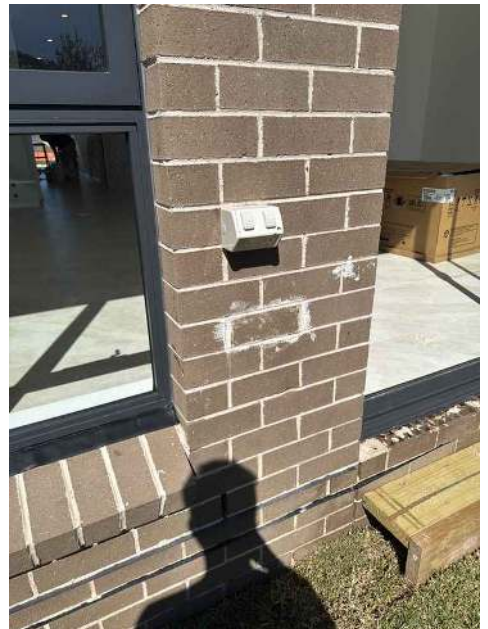
## 7.2.1 + Mortar

**SPOT CLEANING**

Remove mortar smears as required around the property

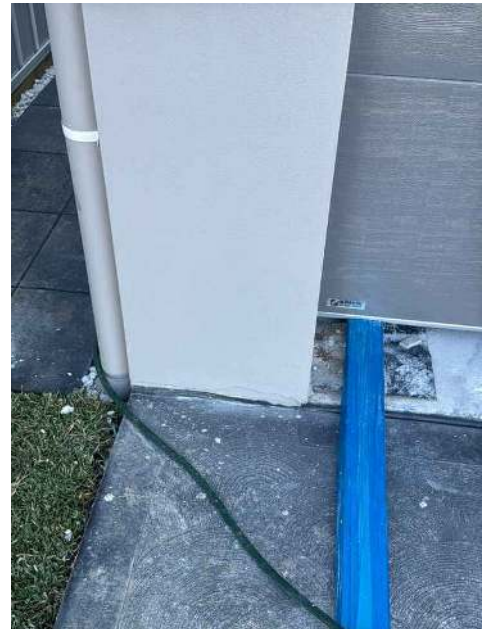
## 7.3.1 + Render

**+ DAMAGED/DEFECTIVE**

One or more parts of the render are damaged/defective and need repair/patching. Builder to ensure the colour integrity is maintained.

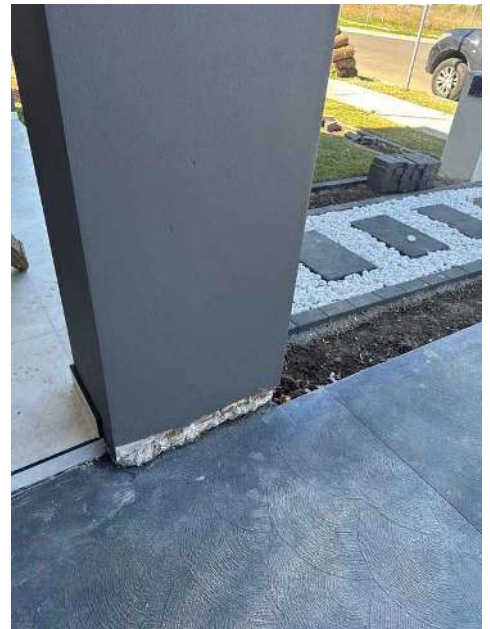
## 7.3.2 + Render

**COLOUR TOUCH UP**

Render requires paint touch up

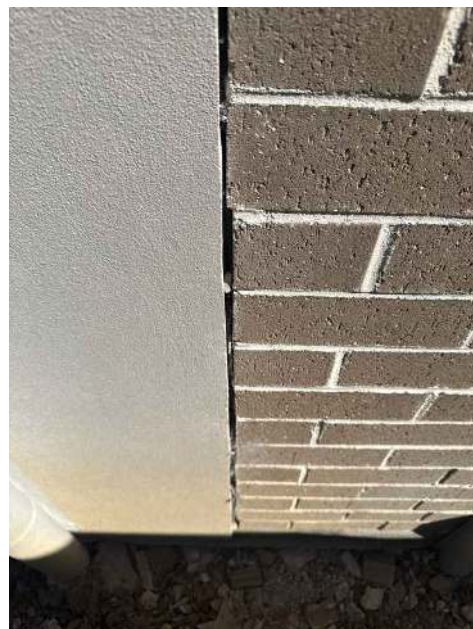
Mouldings and inflexible covering strips are defective if they are installed across movement control joints and are fixed or restrained on both sides.

Applied finishes are defective if they impede the performance of any damp-proof course or sub-floor ventilation required in accordance with the Building Code of Australia.

With the exception of paint and recommended mastic sealants, render or other applied finishes are defective if they cover movement control joints.

Unless documented otherwise, flexible mastic or sealant is defective if it does not match as close as practicable the colour of the adjacent surface and has not been used in accordance with the manufacturer's installation instructions.

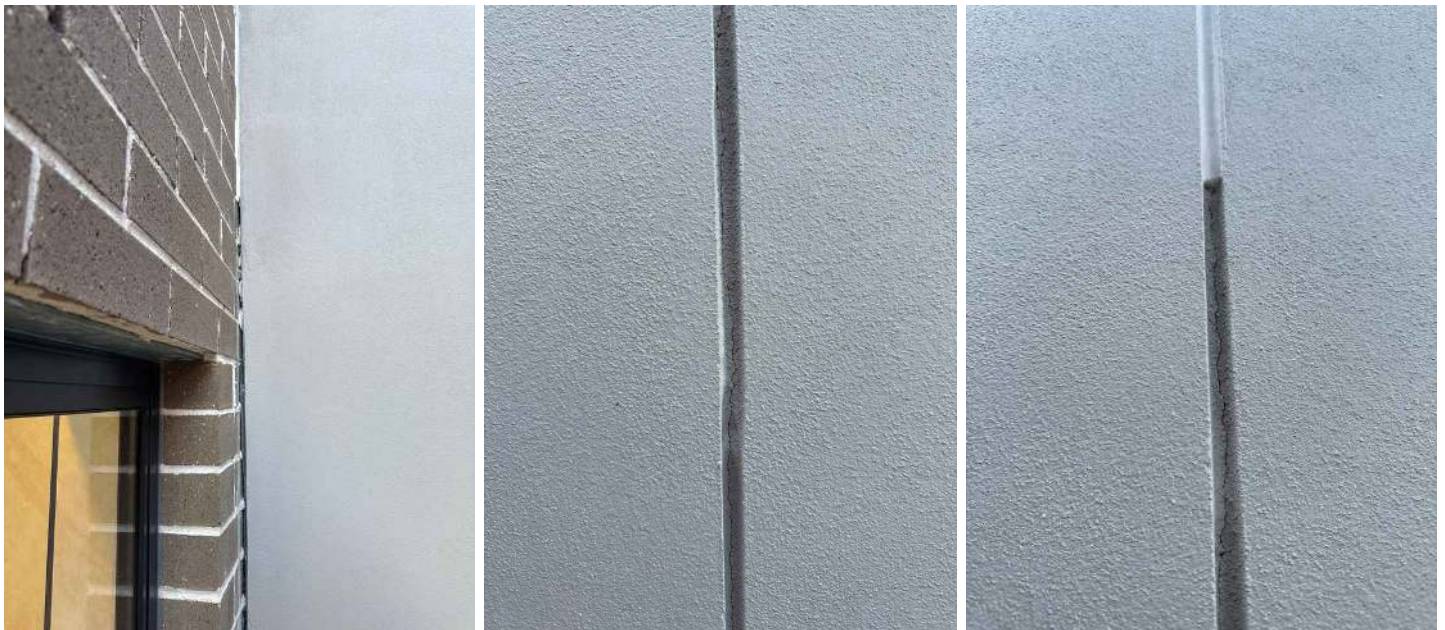
## 7.5.2 + Control Joints

**+ RENDER COVERED THE CONTROL JOINTS**

Render finish to be removed from control joints and be replaced by a flexible sealant.

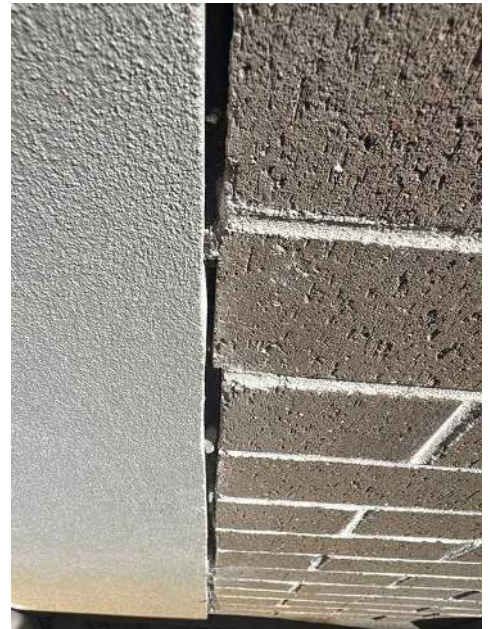
## 7.5.3 + Control Joints

**+ CLEAN INSIDE THE JOINTS**

Inside the joint should free of any rubbish/mortar/debris

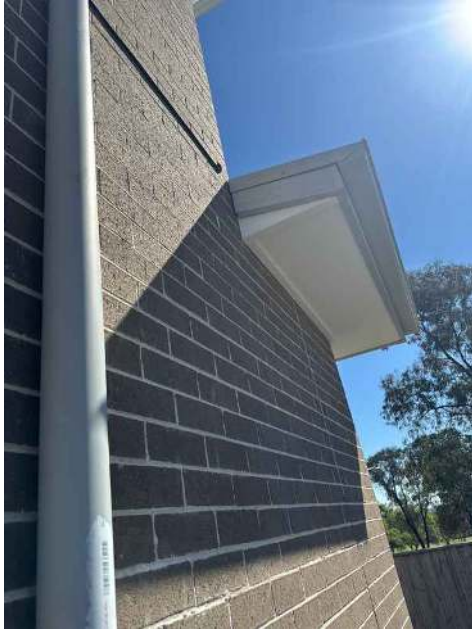
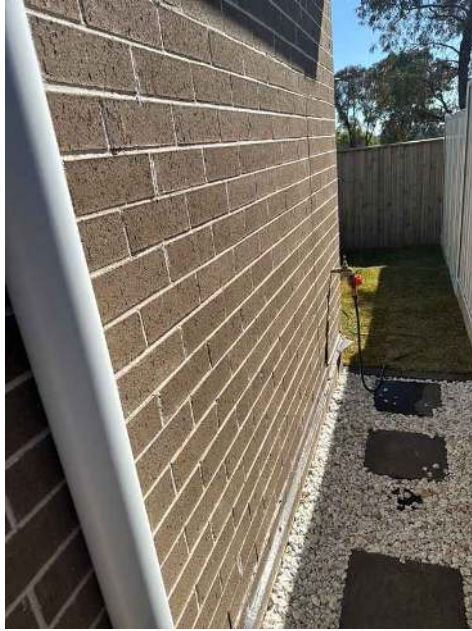
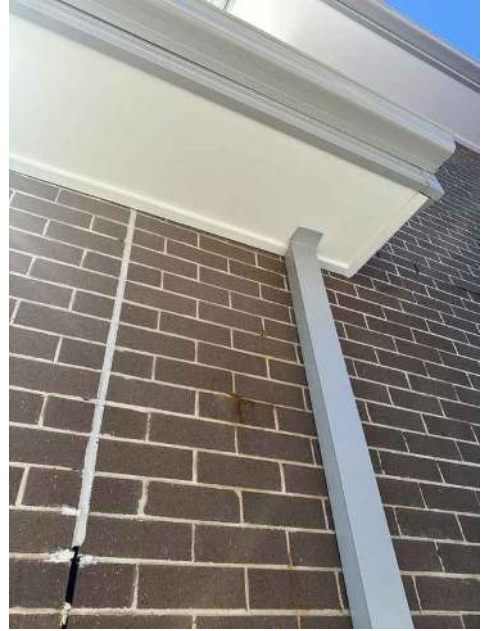
## 7.5.5 + Control Joints

**CHANGE IN HEIGHT**

No articulation joint has been provided at the point where there is a change in height of the brick wall.

Recommendation: Recommend a licensed bricklayer install an appropriately sized articulation joint at this location, in accordance with AS 3700 (Masonry Structures) Clause 4.8 and NCC Part 3.3.5 (Masonry Veneer), which require articulation joints to be provided at points of movement discontinuity, including changes in wall height, to accommodate differential movement.

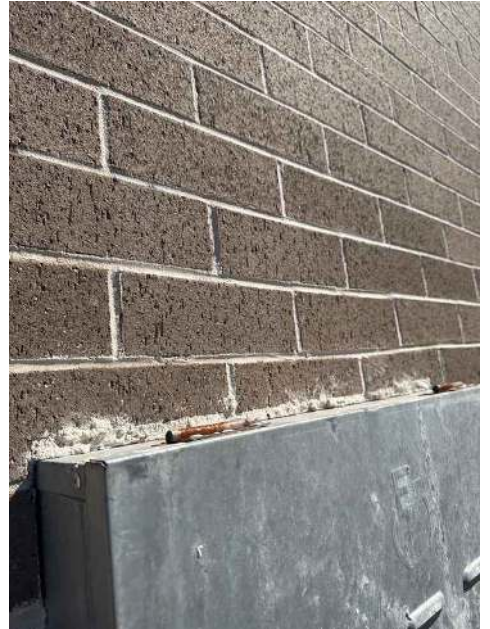
**+ CAULK AROUND METERBOX**

Around the metre box to be caulked.

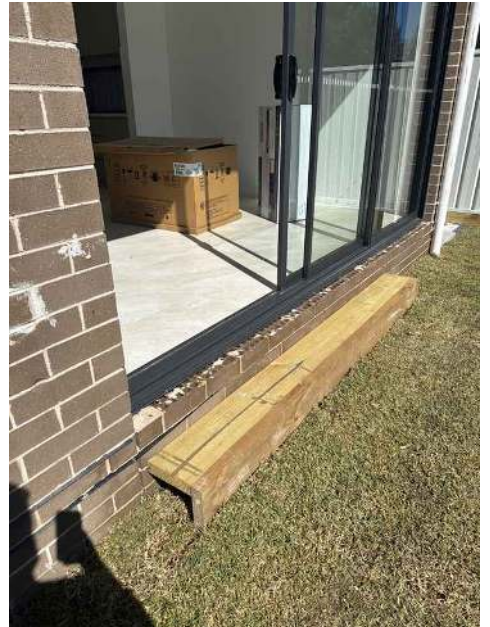
## 7.7.1 + Window Sills

**DOOR SILL INCOMPLETE**

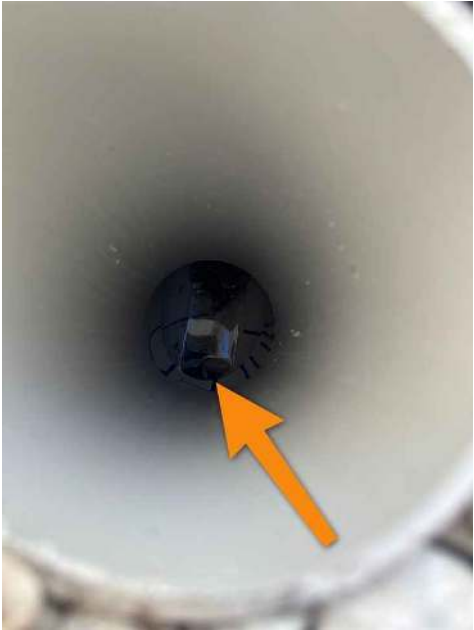
Ponding water was observed within the stormwater drain, indicating inadequate fall or a blockage.

Recommendation: Recommend a licensed plumber/drainer investigate the cause and rectify the fall/grade or clear any blockage, in accordance with AS/NZS 3500.3 (Plumbing and Drainage – Stormwater Drainage).

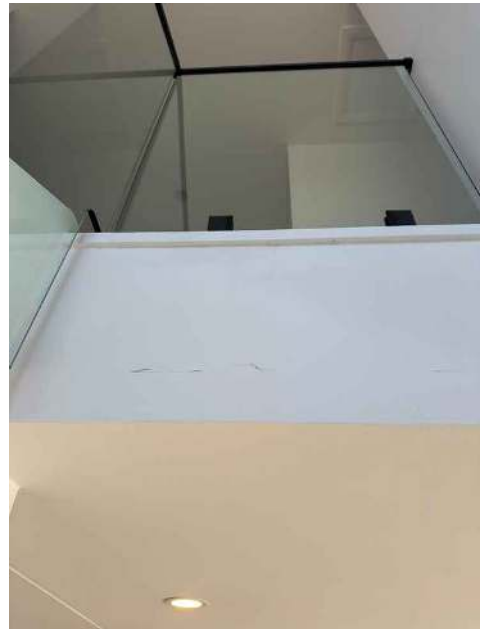
Minor paint defects, paint runs, smears, and marks require touch-ups prior to handover. Example photos shown. Builder to assess all areas and have rectified.

Examples shown, various areas.

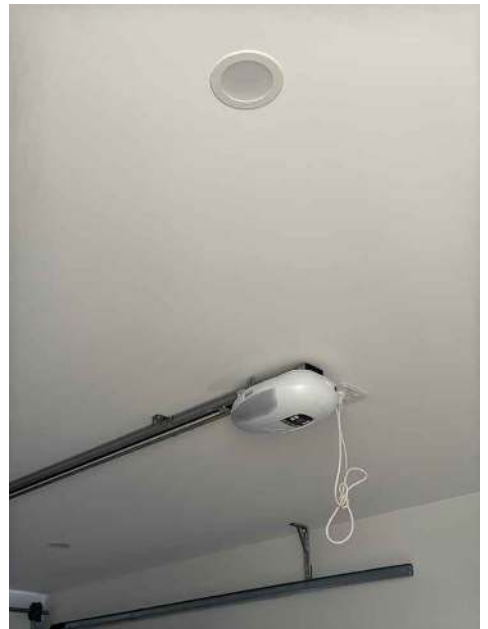
## 11.1.2 + General Painting Defects

**GARAGE**

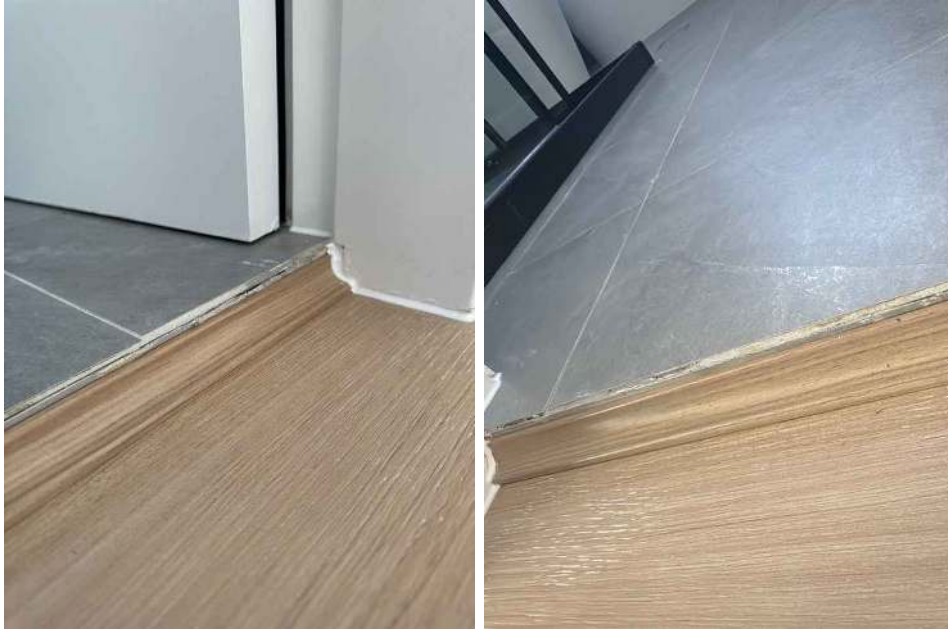
The floor tiles have been finished at a level above the water stop.

Recommendation: Recommend a licensed waterproofer/tiler rectify the tile level so the water stop remains higher than the surrounding floor tiles, in accordance with AS 3740 (Waterproofing of Domestic Wet Areas), which requires the water stop to be at a height above the finished floor level of the adjoining area to prevent water egress to adjoining rooms.

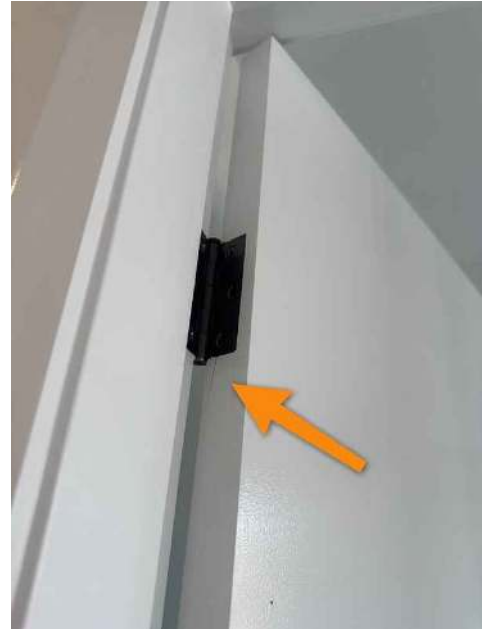
## FRONT ROOM DOOR

There is notable damage to the door and/or door frame.

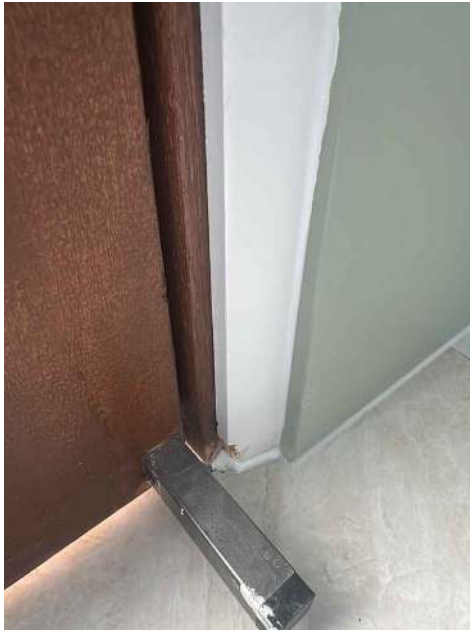
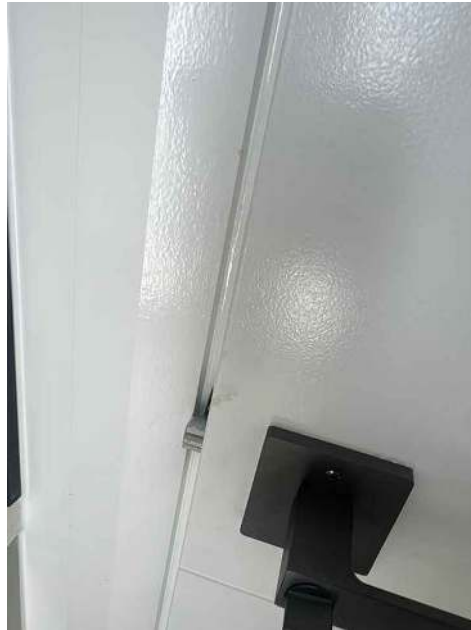
## 11.6.2 + Doors (Internal)

**+ DAMAGED 2**

## LAUNDRY

There is notable damage to the door and/or door frame.

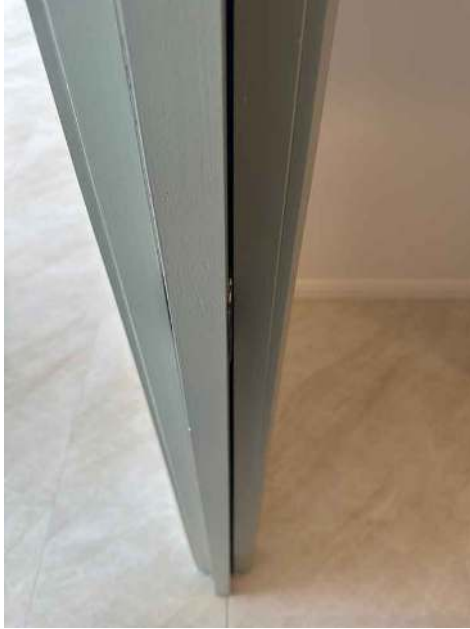
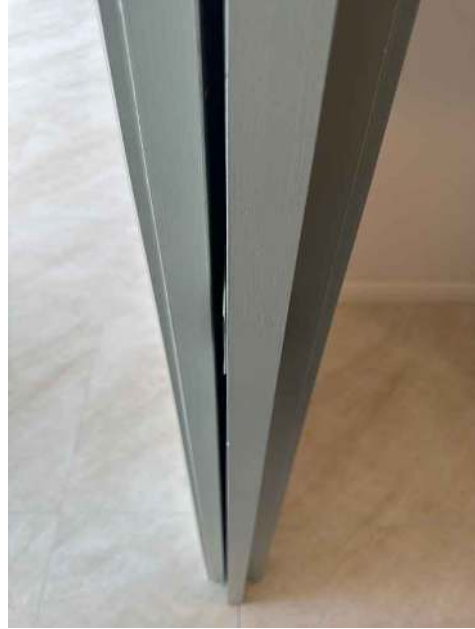
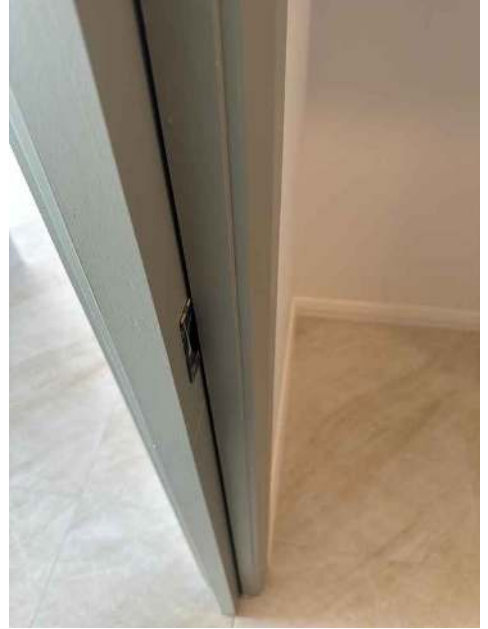
## 11.6.3 + Doors (Internal)

**+ CAVITY SLIDING DOOR GUIDES - ADJUSTMENT/INSTALLATION REQUIRED**

## KITCHEN

Door scraping sides of frame. Door surface was scratched. One or more internal cavity sliding door guides were missed. Cavity sliding door guides protect the door leaves from contacting the frame and scratching/damaging and needs repair.

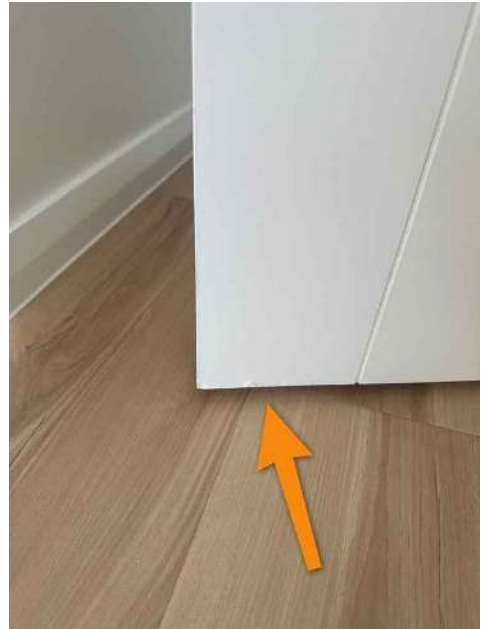
## 11.7.1 + Ceiling/Wall plaster

**+ PLASTER DAMAGED**

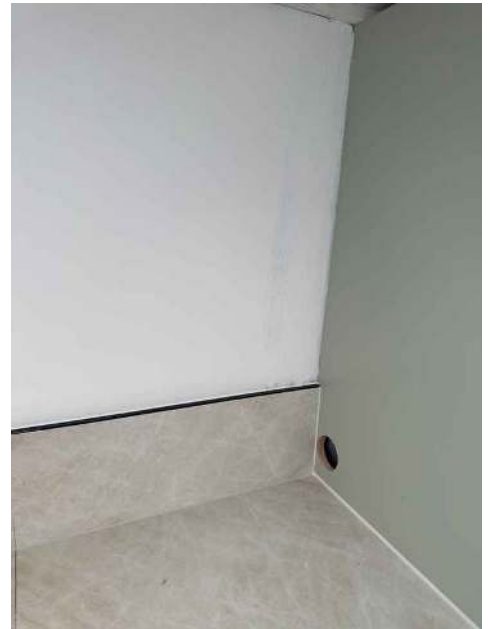
One or more areas of the wall/ceiling are damaged and need repair, patching, proper sanding and repainting.

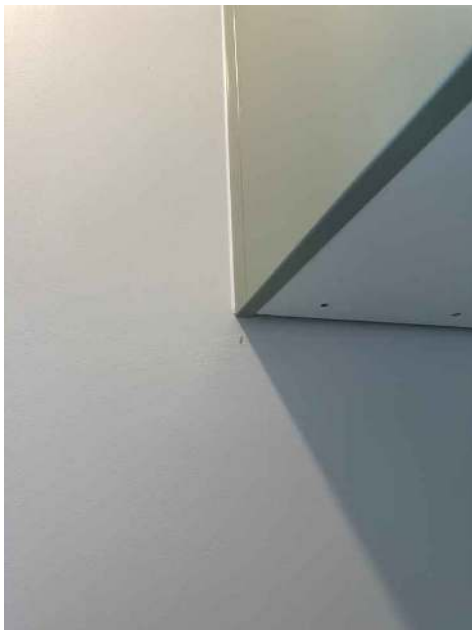
## 11.7.2 + Ceiling/Wall plaster

**+ PLASTER DAMAGED 2**

KITCHEN

One or more areas of the wall/ceiling are damaged and need repair, patching, proper sanding and repainting.

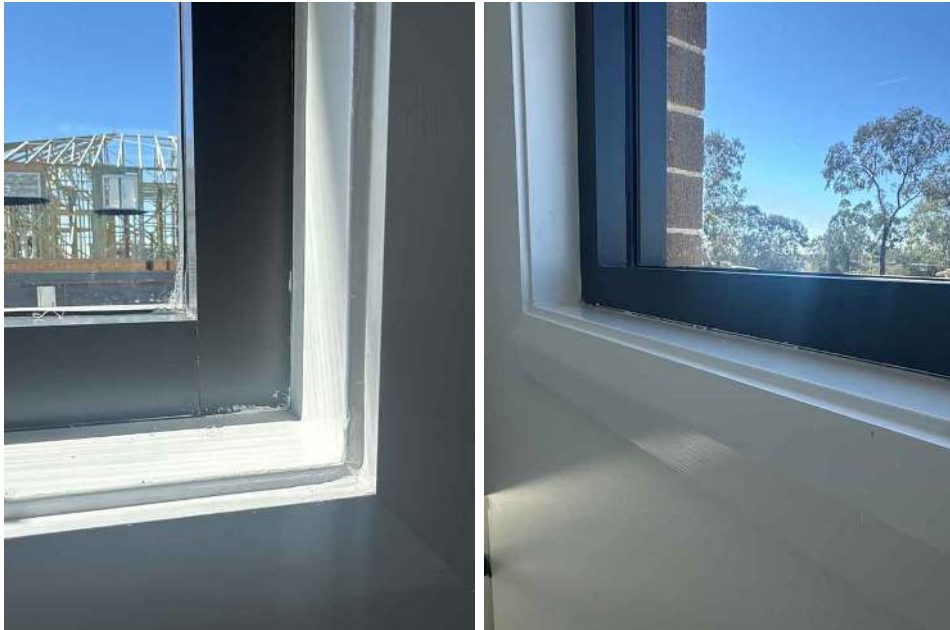
## 11.9.2 + Windows

**REMOVE SPLASHED PAINT FROM FRAMES AND WINDERS THROUGHOUT THE PROPERTY**

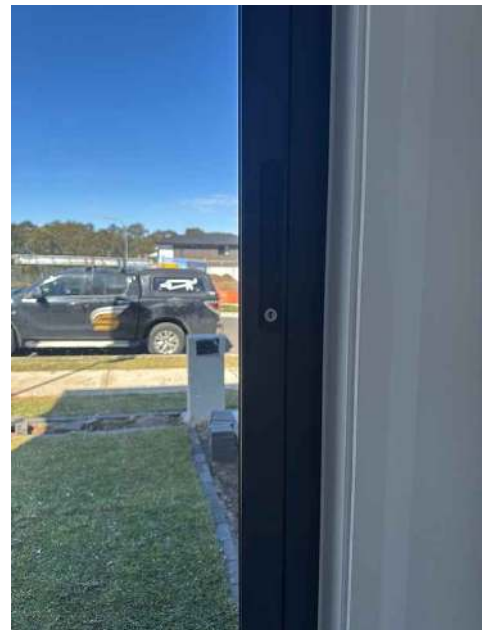
## 11.9.3 + Windows

**WINDOW NOT LATCHING FRONT**

The window is not latching correctly.

Recommendation: Recommend a licensed contractor adjust the latch mechanism to restore proper function.

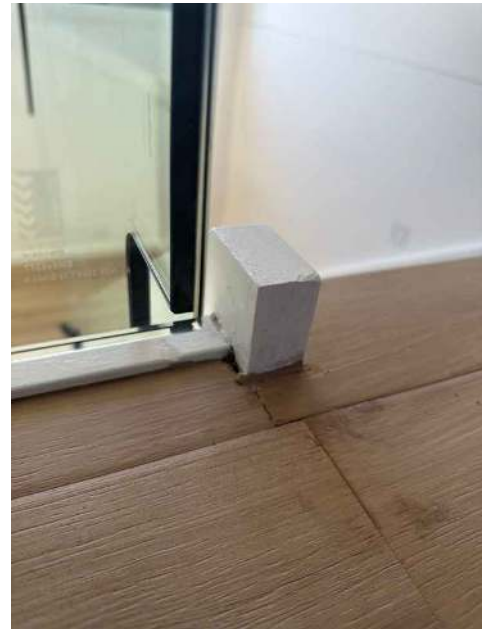
## 11.10.1 + Flooring - Timber

**+ CAULKING TO FLOOR/SKIRTING JOINTS**

Caulking is recommended to the floor/skirting joints to provide a good building practice.

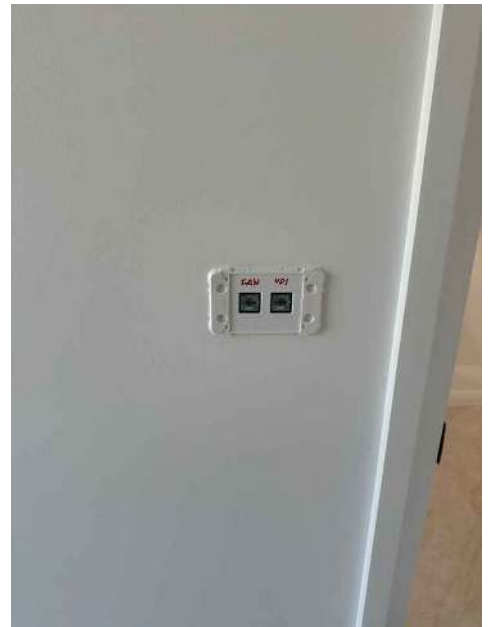
## 11.13.1 + Lights/switches/downlights

**+ NOT INSTALLED - SWITCH COVER PLATE**

One or more switch cover plate(s) were not installed at the time of the inspection. All the cover plates need to be installed prior to the handover to prevent any electric shock hazard.

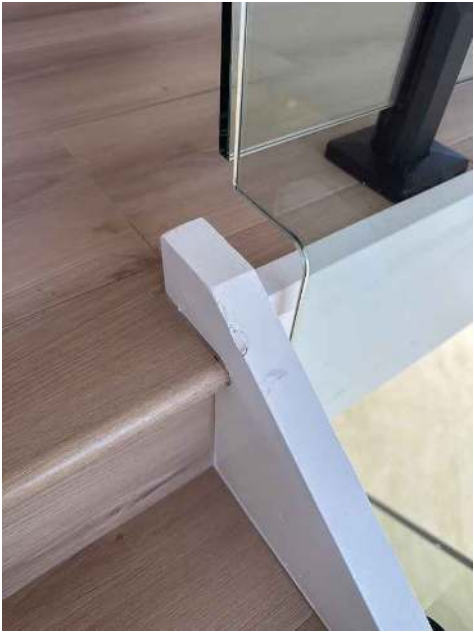
One or more sections of stairs noted damaged at the time of inspection. Recommended to sand, repair, patch, resand and then re-painting.

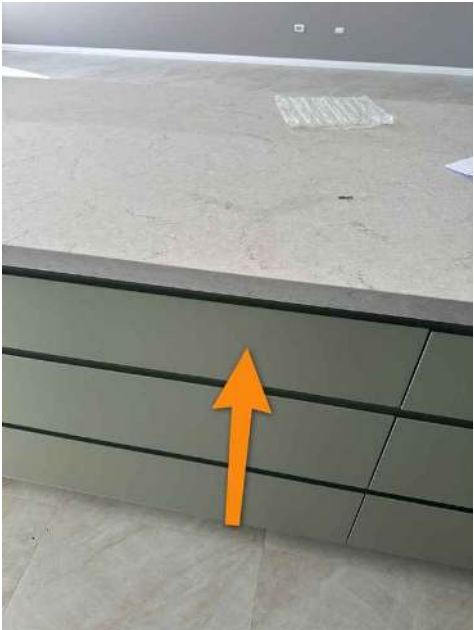
+ **DRAWERS NOT CLOSING PROPERLY**

One or more drawers of the cabinetry noted hard to close. Adjustment required.

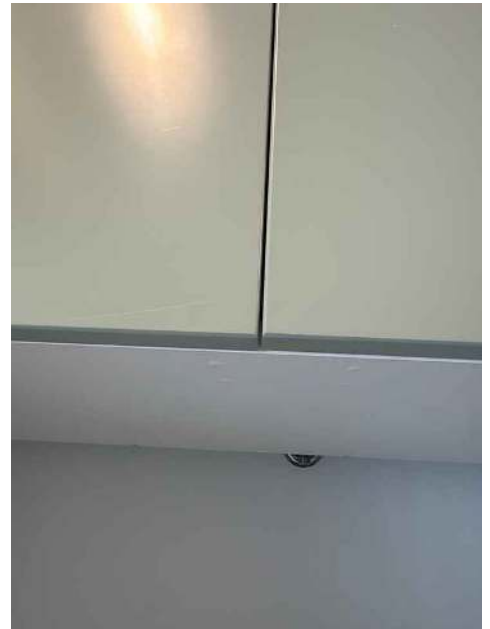
## 13.5.2 + Cabinetry

**+ SCRATCHED/DAMAGED**

One or more areas of the cabinets noted scratched, chipped or damaged. Fixing required.

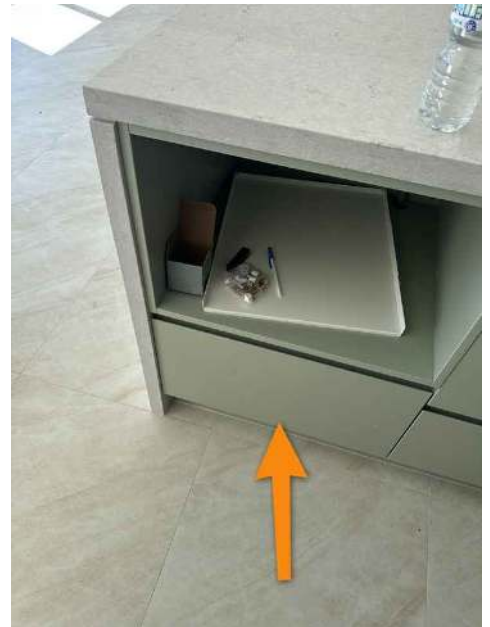
## 13.5.3 + Cabinetry

**+ DRAWERS NOT CLOSING PROPERLY 2**

One or more drawers of the cabinetry noted hard to close. Adjustment required.

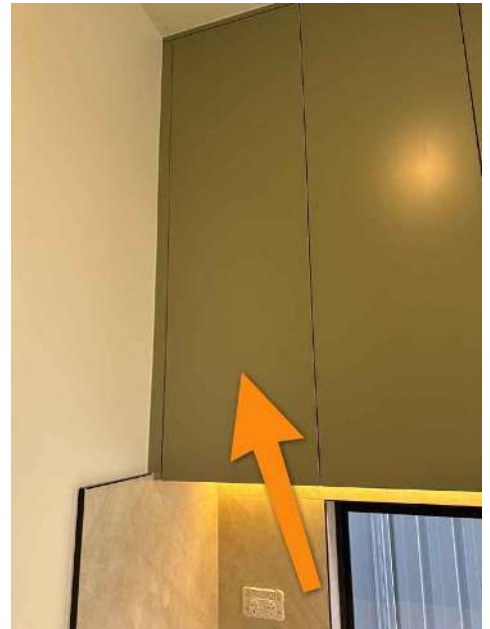
## 13.5.4 + Cabinetry

**+ INCONSISTENT GAPS - ADJUSTMENT REQUIRED**

Cabinet door and drawer fronts are defective if they are not aligned, or do not have consistent gaps between them at handover, and can be seen from a normal viewing position.

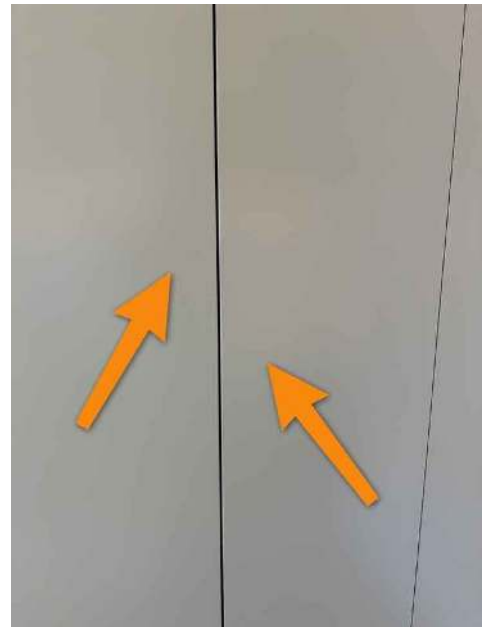
## 13.5.5 + Cabinetry

**PUSH OPEN NOT INSTALLED**
