## ROOF ONLY INSPECTION REPORT

Sample Property

### 3: ROOF LEAK INVESTIGATION

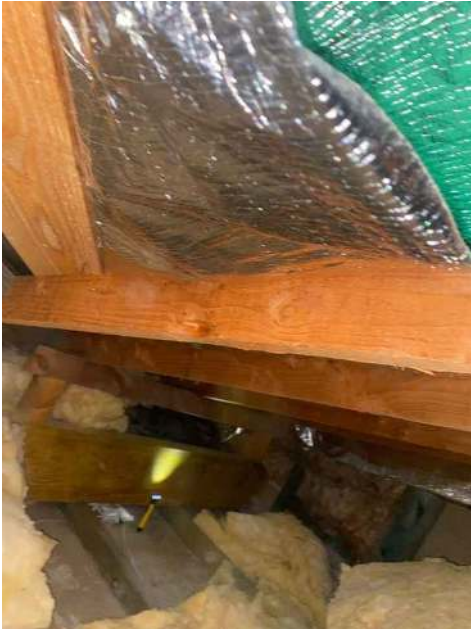
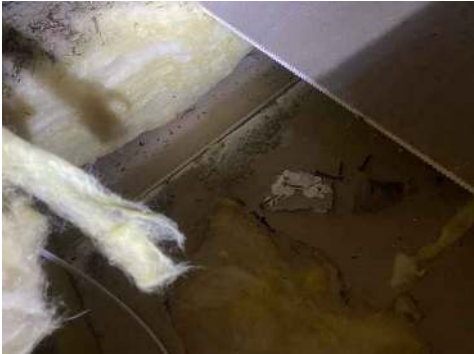
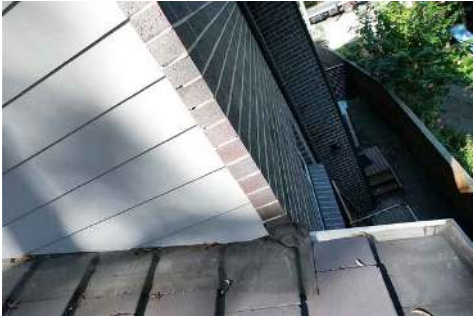
3.1.1 Views  
**VIEW**

General Advice/Maintenance Items

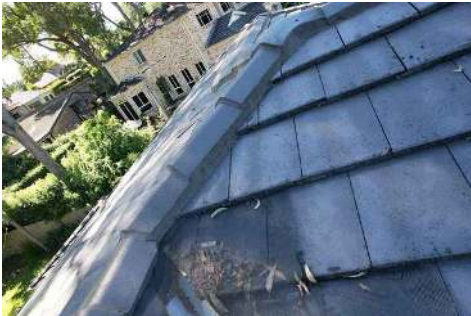
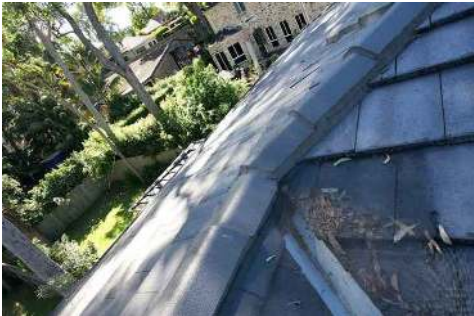
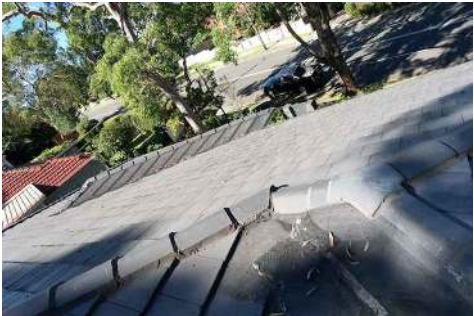
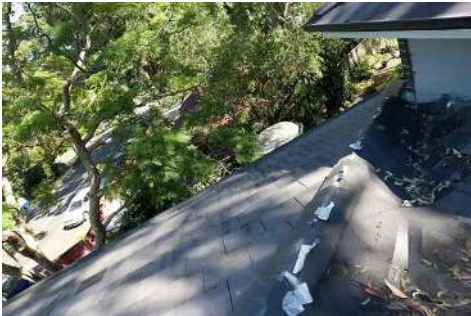
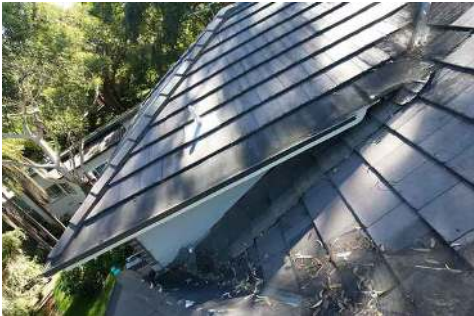
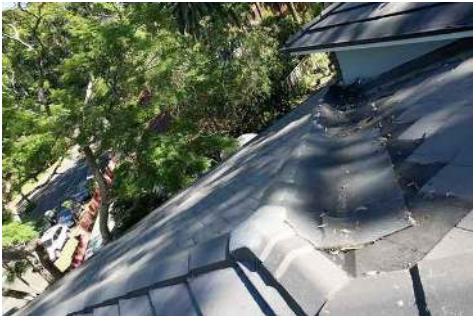
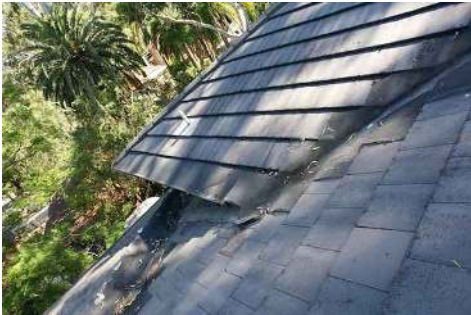
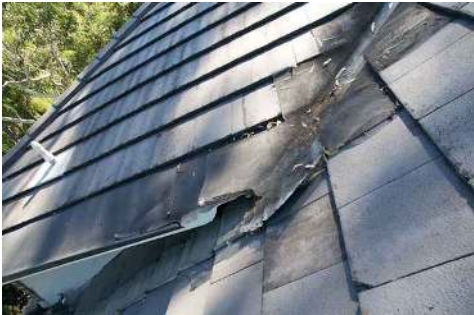
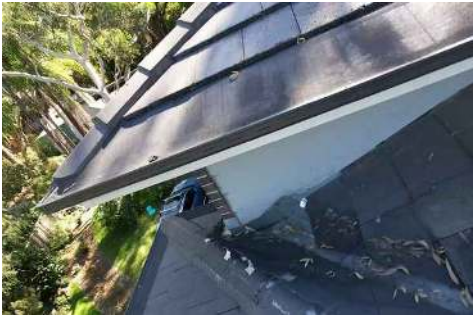
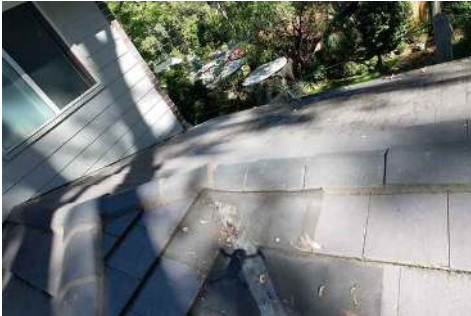
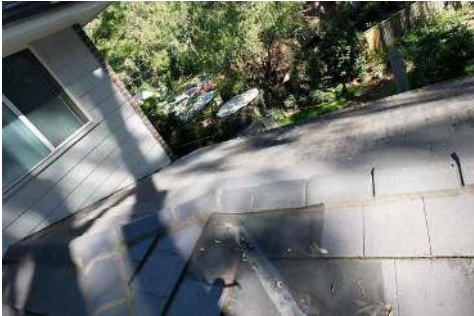
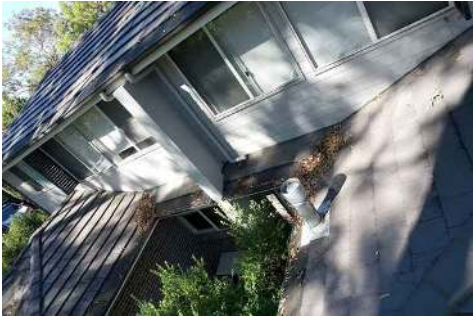
### 3.1.2 Views

The valley gutter installation, as observed, is discharging directly towards the wall cladding with no flashing installed beneath the cladding or on the adjoining roof surfaces. This arrangement is non-compliant, as it does not provide an adequate waterproofing detail at the roof-wall junction and does not satisfy the NCC performance requirements for weatherproofing of roofs and external walls, nor the intent of relevant roof drainage and cladding standards (such as AS/NZS 3500 for roof drainage and AS 1562 for roofing and wall cladding interfaces).

The NCC requires that roofs and external walls be constructed to prevent the entry of water that could cause unhealthy or damaging conditions, including at valley terminations and roof-wall junctions. Allowing a valley gutter to discharge towards or near the wall cladding without appropriate flashings or a compliant termination detail presents a foreseeable risk of moisture penetration behind the cladding and consequent damage, and therefore does not meet these performance requirements.

It is recommended that both sides of the roof be fully rectified by a suitably qualified roofing plumber, with all roof drainage components, flashings, spreaders, valleys, and sarking brought into compliance with the requirements and performance intent of the NCC for roof drainage and weatherproofing, and the applicable Australian Standards for roofing, cladding, and stormwater systems. All remedial works should follow relevant manufacturer installation instructions as well as Australian Standards to ensure a durable and compliant outcome.

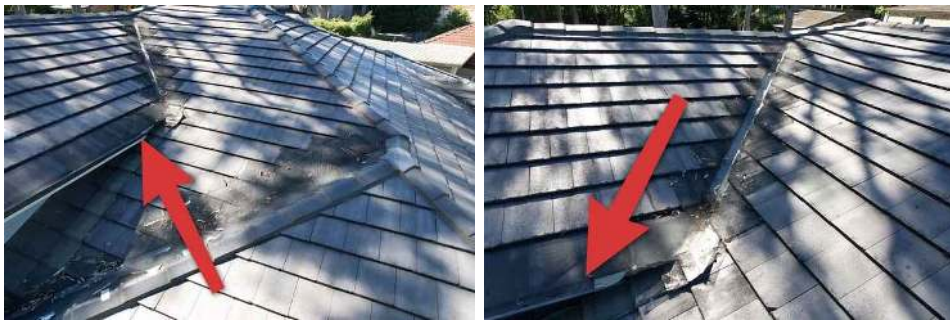
**GUTTER DISCHARGE**

Three sections of the roof were observed to be discharging onto a single valley gutter, increasing the concentrated flow load on that valley. This arrangement can contribute to overflow risk if the valley and downstream drainage are not sized and detailed in accordance with the applicable standards and NCC roof drainage provisions.

The NCC requires roof drainage systems to be designed and constructed so that they safely collect and dispose of surface water without causing dampness or damage to the building, including at valleys and their terminations to gutters or box gutters. This requirement aligns with the intent of AS/NZS 3500 roof drainage provisions and relevant roofing/cladding standards (such as AS 1562), which address the sizing and configuration of valleys and gutters to accommodate contributing roof catchment areas.

The upper gutter should be directed into the left roof tiles via a suitable spreader to distribute the discharge evenly over the roof surface and reduce concentrated flow into the valley. This arrangement is consistent with good roofing practice and the intent of NCC roof drainage provisions and AS/NZS 3500 and AS 1562 for roof water distribution and drainage design.

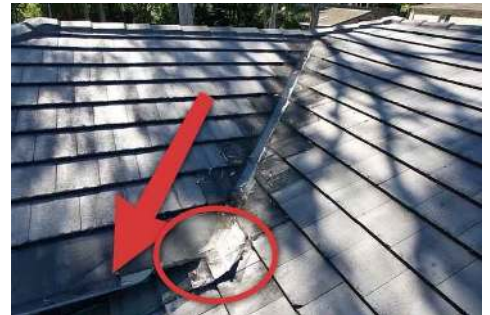
**FLASHING**

The valley gutter flashing at the end termination is non-compliant, as it does not provide an adequate weatherproof junction between the valley, roof covering, and adjacent building elements. This arrangement does not satisfy the NCC performance requirements for roof drainage and weatherproofing of roofs and walls, and is inconsistent with the intent of relevant roofing and drainage standards, including AS/NZS 3500 for roof drainage design and AS 1562 for the design and installation of roof and wall cladding interfaces.

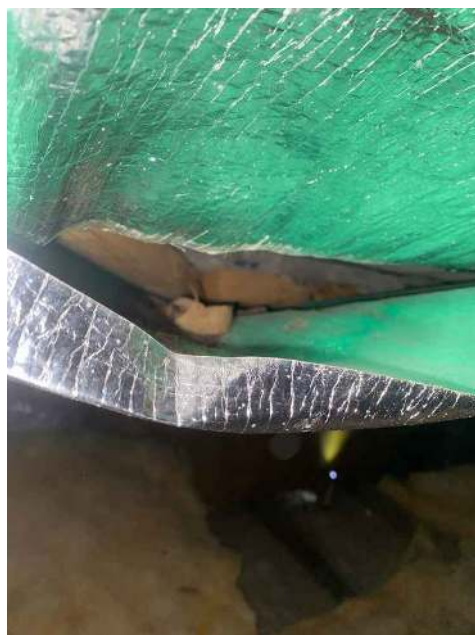
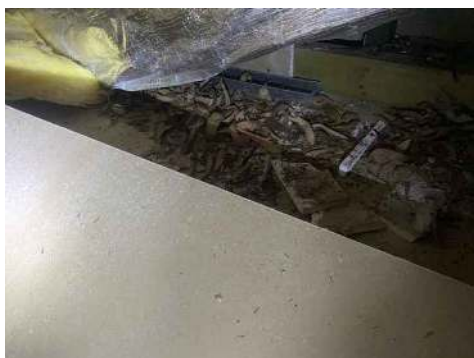
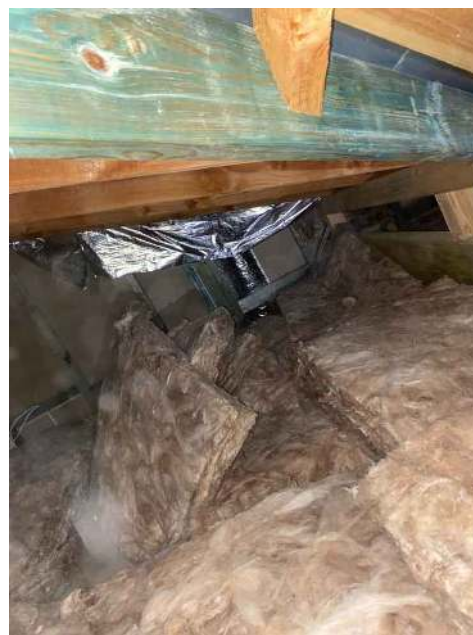
**SARKING ROOF SPACE**

The sarking within the roof space is sagging in several areas to both dwellings. The degree of sagging appears greater than is typically acceptable for pliable building membranes, which are intended to be installed in a reasonably taut manner in accordance with the general intent of AS/NZS 4200 (Pliable building membranes) and AS 4200.1/4200.2 installation requirements.

Excessive sagging can reduce the effectiveness of the sarking in shedding condensation and incidental moisture to the gutters and may allow debris and moisture to accumulate. Further assessment and rectification by a suitably qualified roofing contractor are recommended to ensure the sarking is re-fixed or replaced as necessary to restore compliance with the NCC weatherproofing and condensation management provisions and the relevant sarking standards.

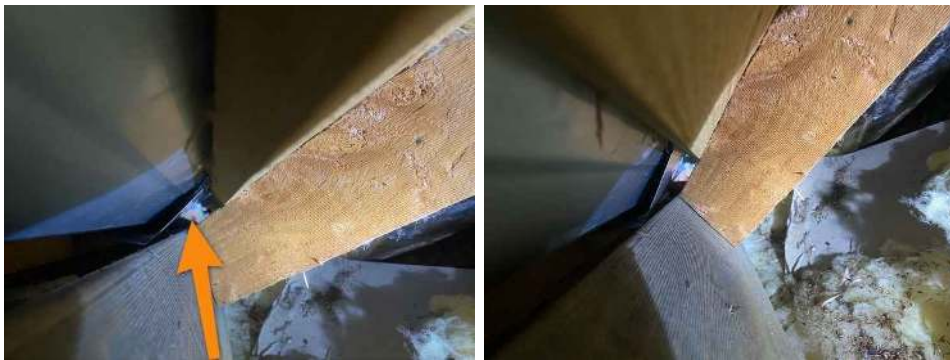
**HOLE UNDER VALLEY**

In the vicinity of the reported leak, an opening was identified in the roof space beneath the valley gutter where external light can be seen passing through. This indicates a discontinuity in the roof envelope at this location, likely associated with an inadequate or missing flashing or roof covering element.

This hole is located directly below the valley gutter and corresponds with an area of concentrated water flow from the contributing roof sections. As a result, roof runoff is able to enter the roof space at this point, causing localised water ingress and dampness to the surrounding structure and linings.

The observed opening is therefore considered the probable source of the leak and a significant defect in the roof drainage and weatherproofing system. Rectification by a suitably qualified roofing plumber is recommended, including proper repair of the hole, provision of appropriate flashings, and confirmation that valley discharge and sarking details are compliant and watertight in this area.
