## FIXING (INC. WATERPROOFING) INSPECTION

Sample Property

17/09/2026

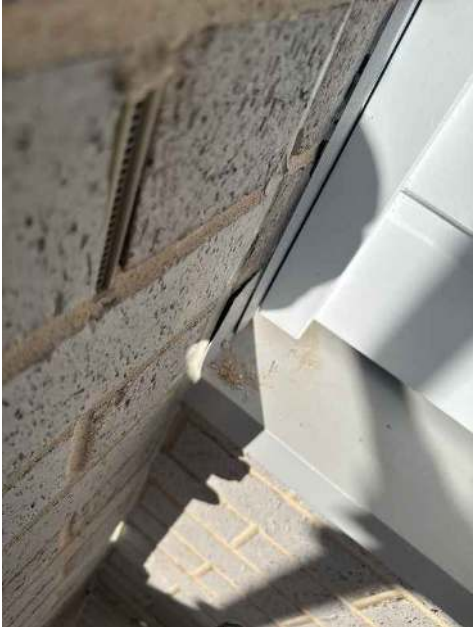
FRONT BALCONY

+ SEALING DEGRADED

Part(s) of roof cladding/penetration flashing sealings are degraded. Re-sealing to be applied to avoid any water damage.

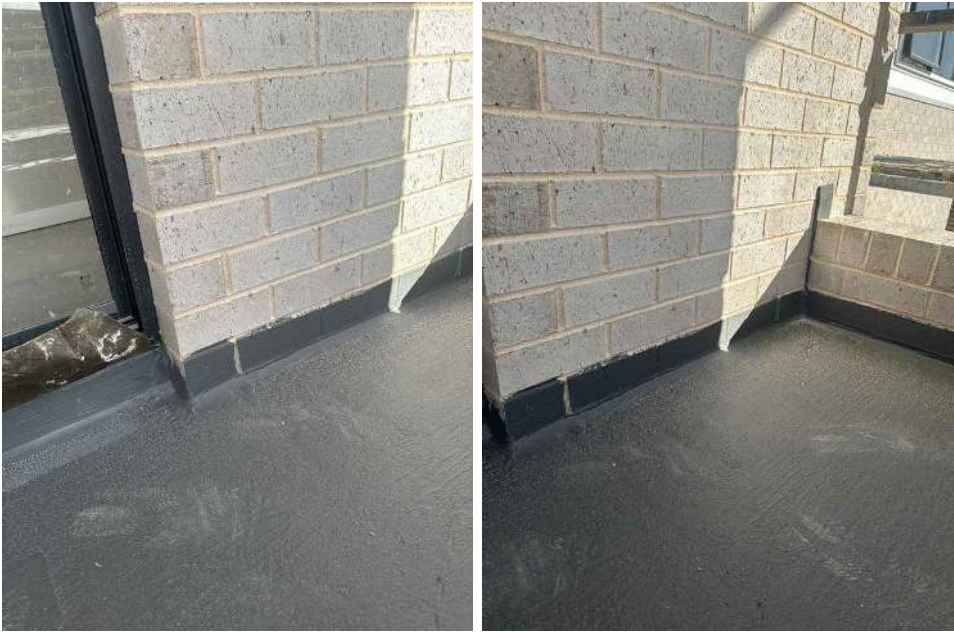
The weephole is positioned at floor level, creating a risk of water bypassing the waterproofing membrane at this location.

Recommendation: Recommend a licensed builder/waterproofer rectify the weephole position to ensure it sits above the membrane upturn, preventing water from bypassing the waterproofing system.

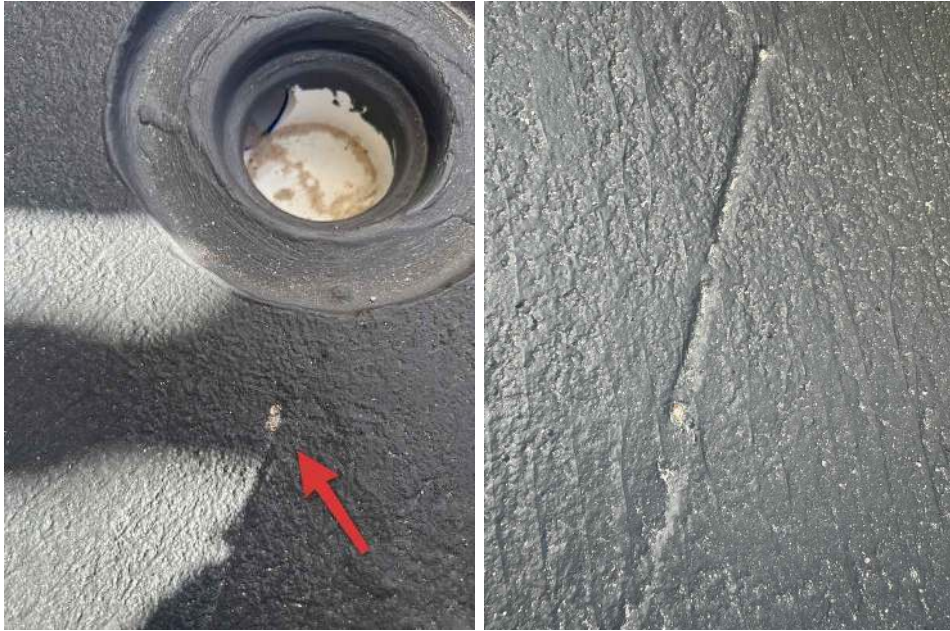
## 11.2.2 + Waterproofing

**DAMAGED**

Damage was observed to the waterproofing membrane on the balcony.

Recommendation: Recommend a licensed waterproofer rectify the damaged section of membrane to prevent water penetration.

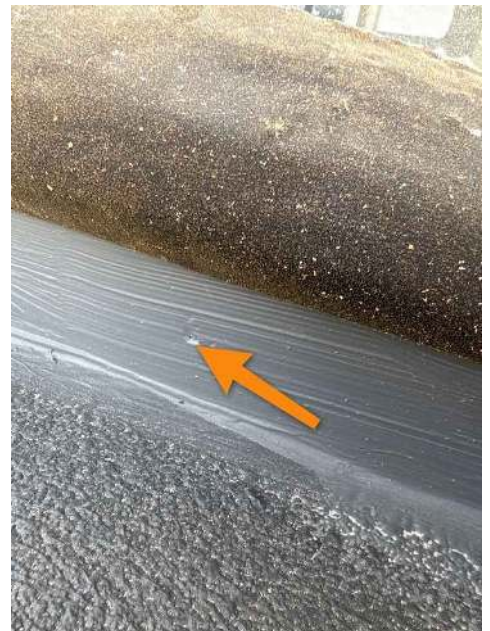
## 11.2.3 + Waterproofing

**PINHOLE**

A pinhole was observed in the waterproofing membrane at the upturn on the balcony.

Recommendation: Recommend a licensed waterproofer rectify the pinhole to ensure a continuous, watertight membrane.

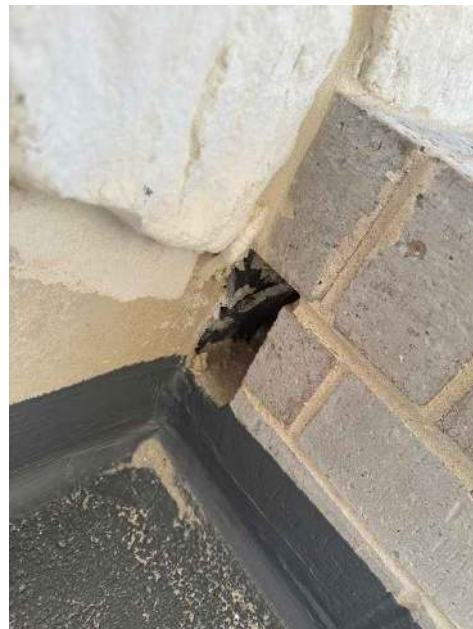
## 11.2.4 + Waterproofing

**OVERFLOW**

The waterproofing membrane must terminate inside the overflow outlet, in accordance with AS 4654.2 (Waterproofing Membranes for External Above-Ground Use), to ensure a continuous, watertight seal at the penetration.

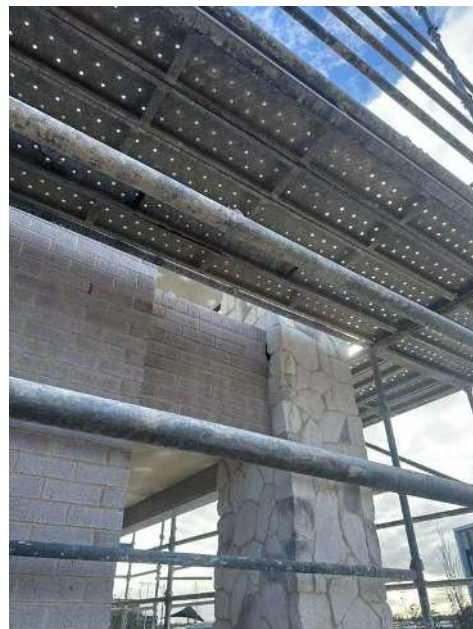
## 11.2.5 + Waterproofing

**OVERFLOW LOCATION**

A column is positioned in a manner that blocks/obstructs the overflow outlet.

Recommendation: Recommend further investigation by a licensed plumber/builder to assess whether the overflow can function effectively, and rectify as required to ensure the overflow is unobstructed.

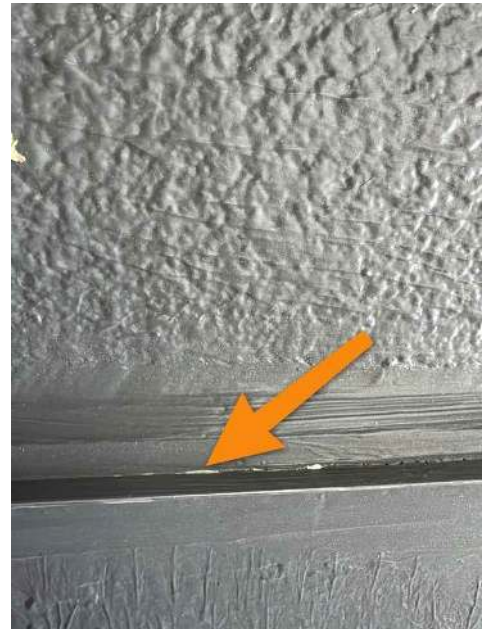
## 18.9.1 + Waterproofing

**MEMBRANE TRANSITION**

Gaps were observed in the waterproofing membrane at the transition between the water stop and the recess.

Recommendation: Recommend a licensed waterproofer rectify the membrane transition to ensure continuous coverage, in accordance with AS 3740 (Waterproofing of Domestic Wet Areas).

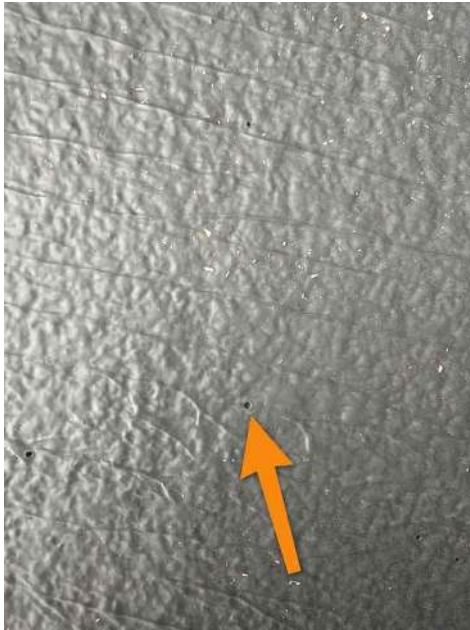
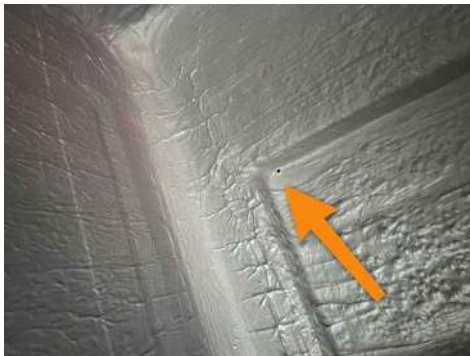
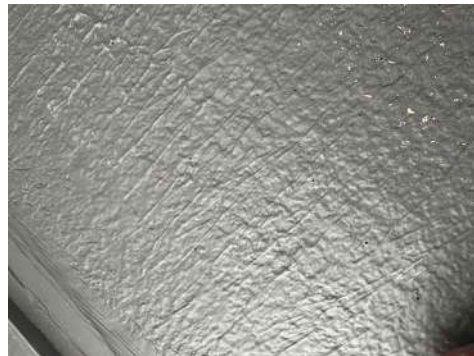
## 22.9.1 + Waterproofing

**PINHOLES**

Pinholes were observed in the waterproofing membrane within the shower recess.

Recommendation: Recommend a licensed waterproofer rectify the pinholes prior to tiling to ensure a continuous, watertight membrane, in accordance with AS 3740 (Waterproofing of Domestic Wet Areas).
