OWNER INSPECTIONS

## PRE-PURCHASE INSPECTION (BUILDING & PEST)

Sample Property

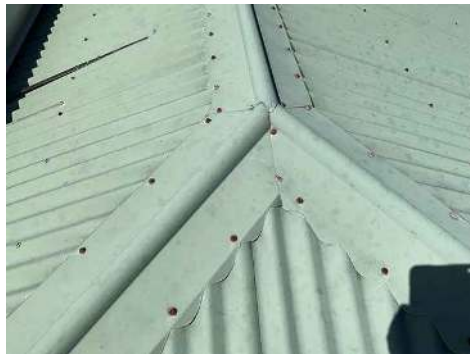
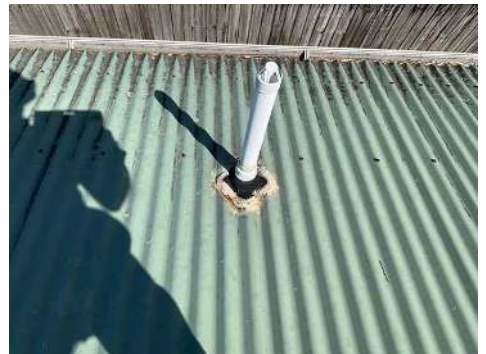
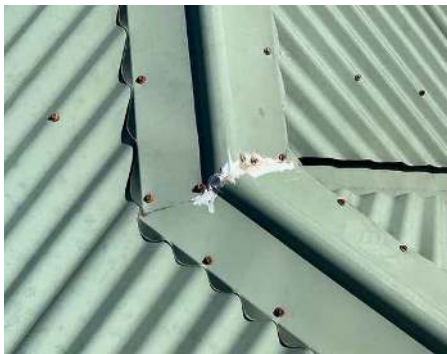
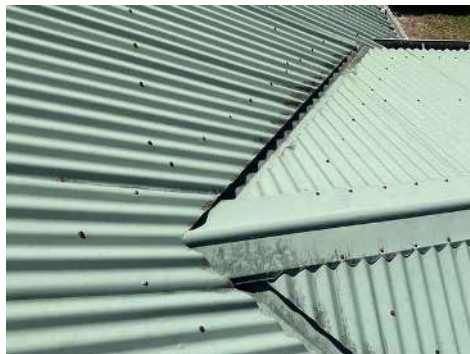
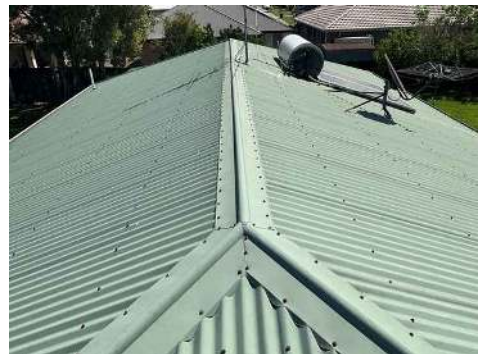
#### + General: + General Views of the Roof

The roof sheets look fine. Rusty screws to roof should be replaced to prevent any more deterioration

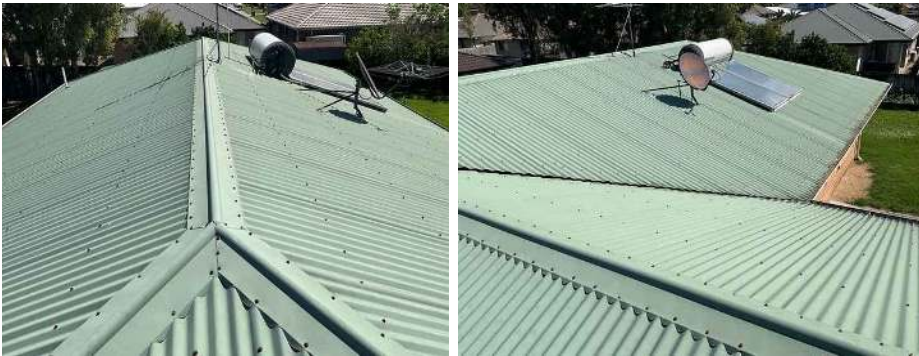
#### + Roof Covering (Metal): Antenna/Satellite Dish Penetration

Satellite dish mounts have penetrated roof coverings which could allow moisture intrusion if not kept sealed. Recommend periodic monitoring to ensure sealant used is in good condition and reapply as needed.

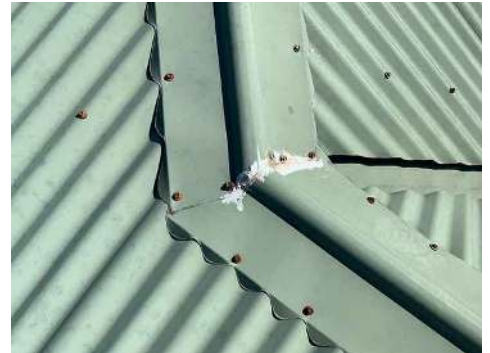
**SEALANT DEGRADED/FAILED**

One or more areas of the sealant were noted as degraded and/or failed which could allow water intrusion into the building. Recommend re-sealing to eliminate moisture problems. Images do not represent all affected areas as additional areas will need repair.

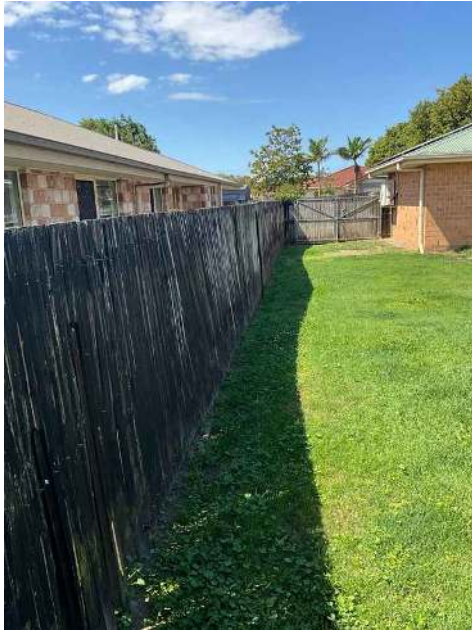
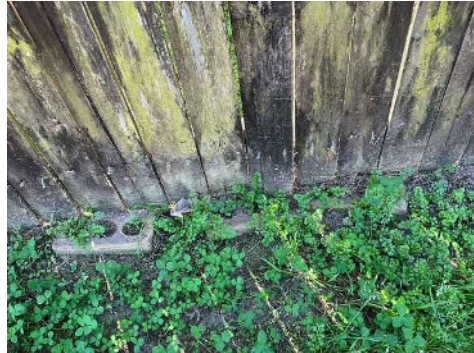
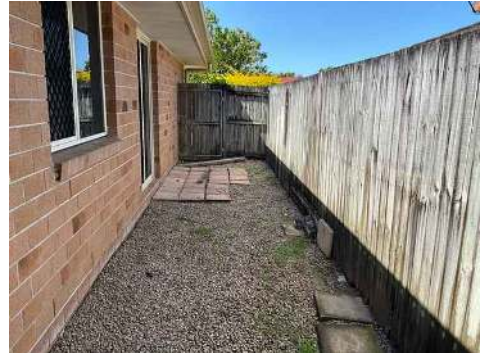
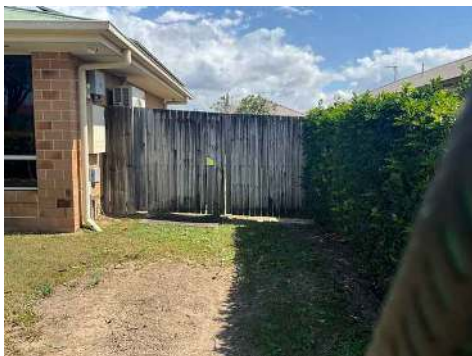
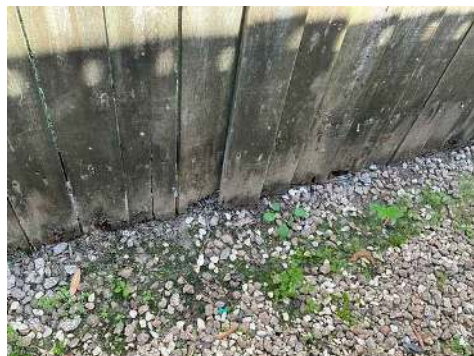
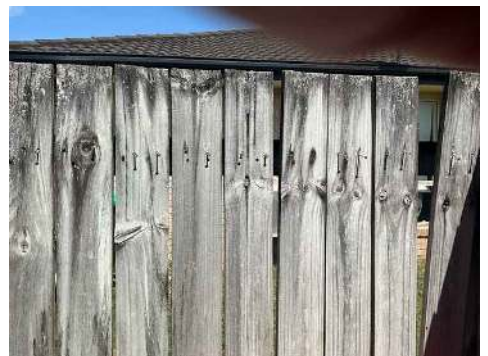
## 7.8.1 + Fence / Gate

**UNSTABLE/NOT STRAIGHT**

Contact a qualified professional.

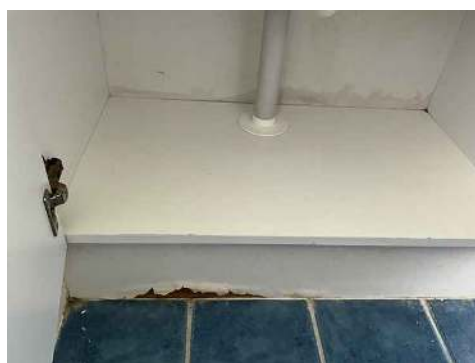
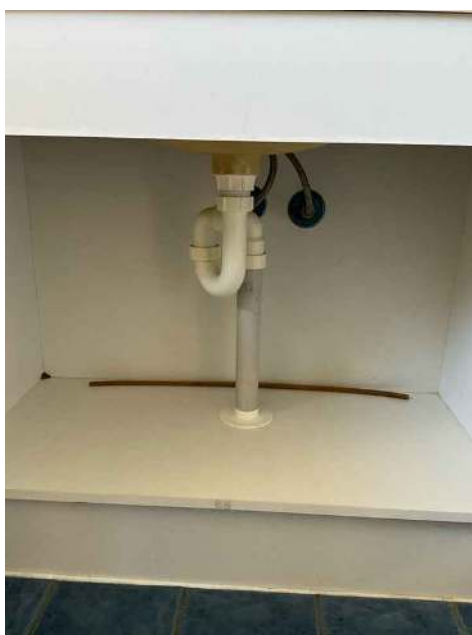
## 11.22.1 Sealants (Internal)

**SEALANT REQUIRED**

Contact a qualified professional.
