## INSURANCE DAMAGE ASSESMENT

Sample Property

28/08/2026

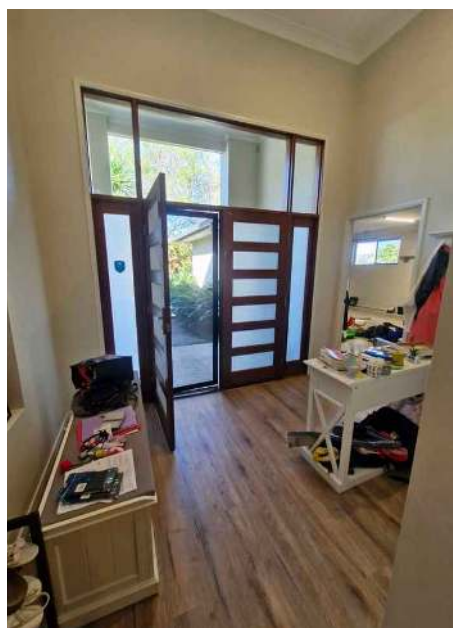
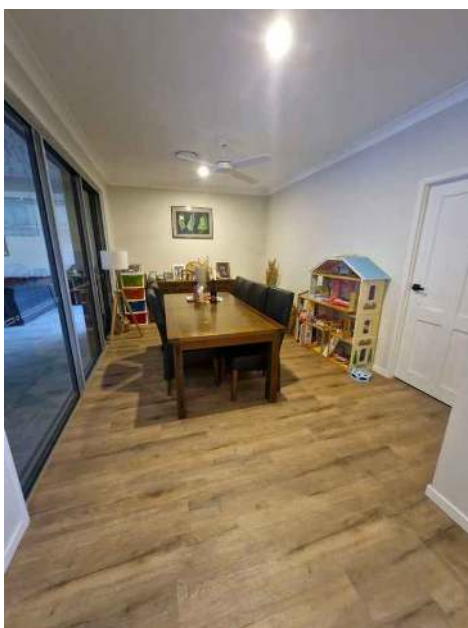
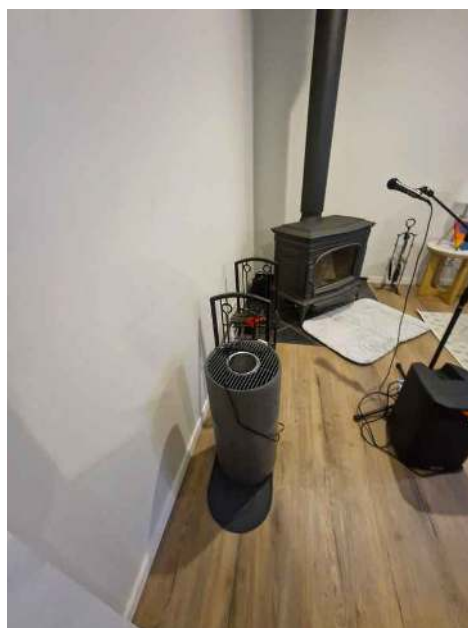
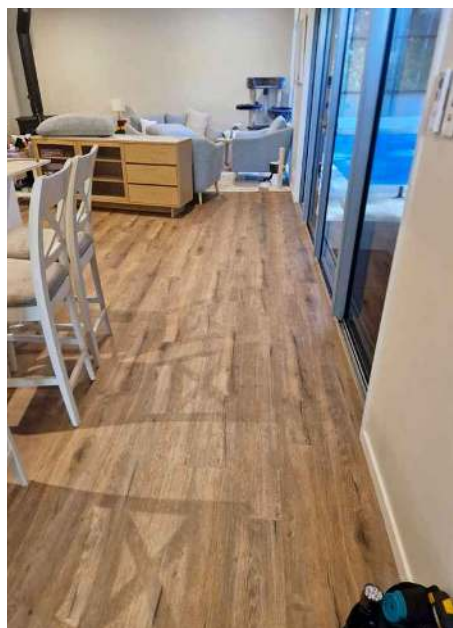
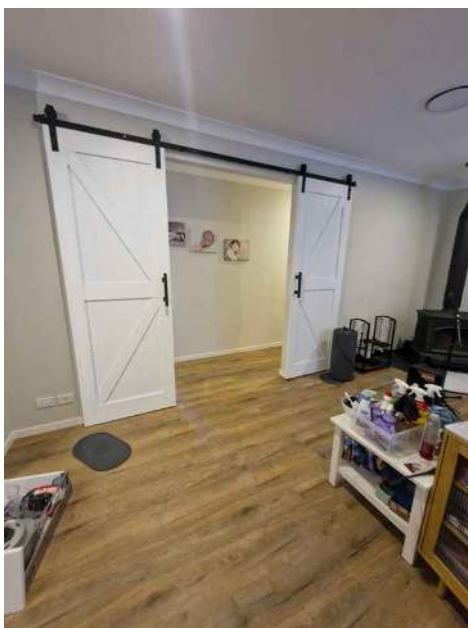
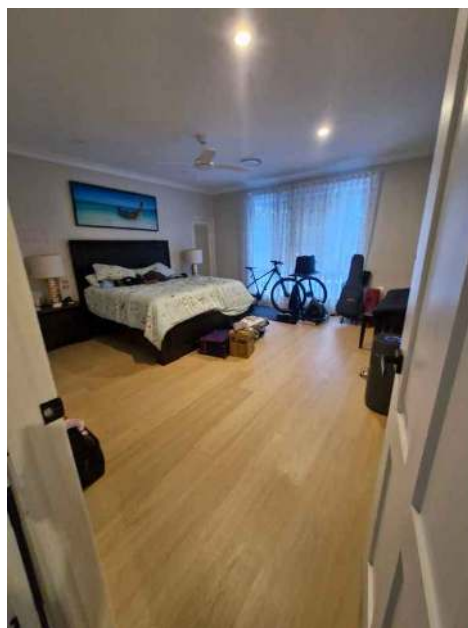
| 2.1 | Inspection summary |

The inspection was conducted to assess building damage reportedly resulting from a failed flexible water supply hose located under the kitchen sink.

Based on information provided at the time of inspection, the flexible hose failed during the night, resulting in water escaping into the kitchen cabinetry and subsequently spreading the floor areas, including the kitchen, entry area, living area and hallway leading to the bedrooms and a bedroom wall.

At the time of inspection, visible water-related damage was identified to various building finishes and components within the affected areas. Moisture readings were undertaken where accessible to assist in determining the extent of moisture impact.

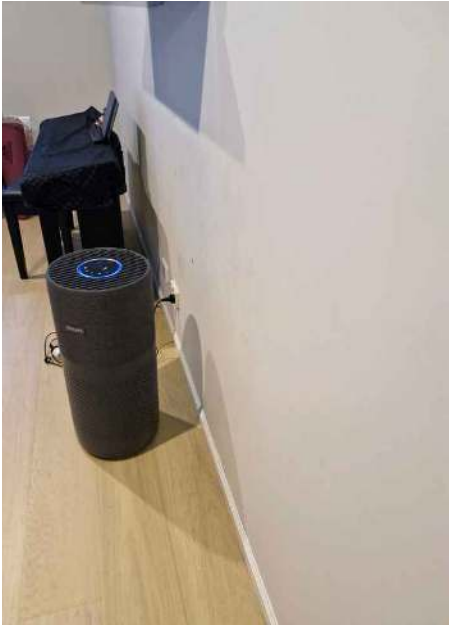
I attended the property on 28/08/26 to complete a visual inspection.

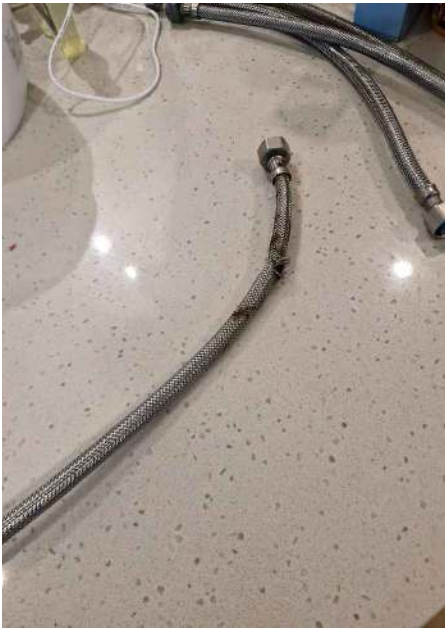
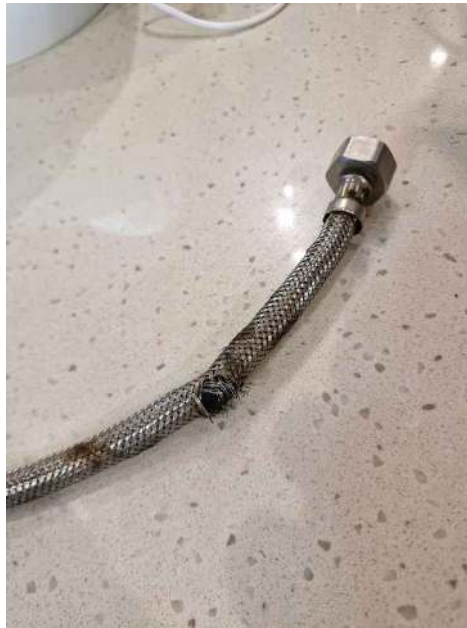
| 3.1 | Cause of damage |

##### **Cause of damage : Flexible water supply hose damage**

The flexible water supply hose located within the kitchen sink cabinet have failed/ruptured, resulting in a significant water leak, water escaped from the damaged hose and caused water damage to the surrounding kitchen cabinetry and flooring.

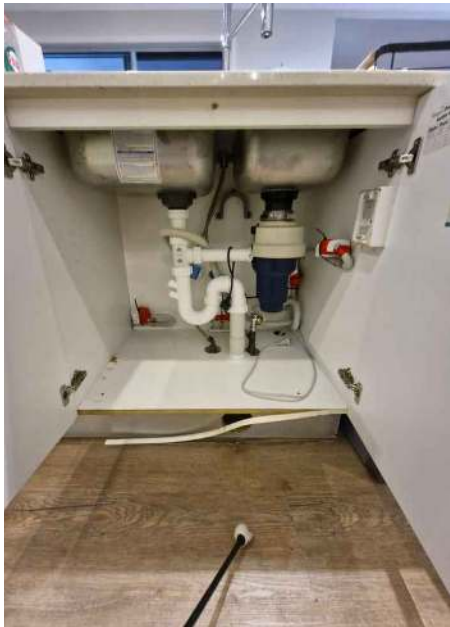
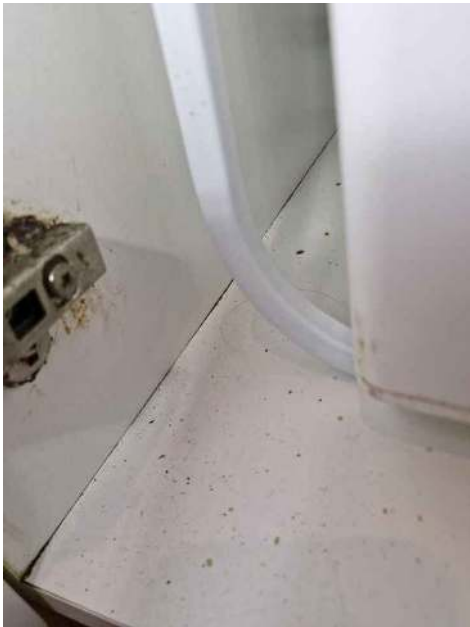
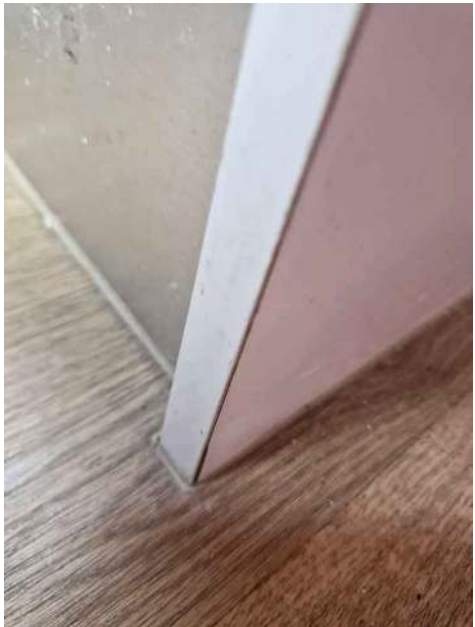
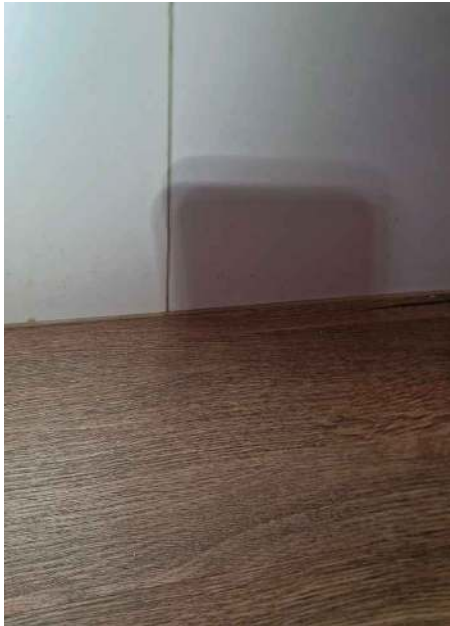
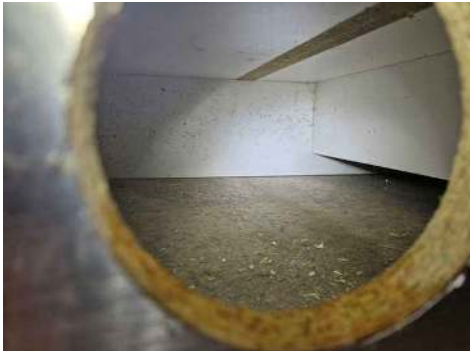
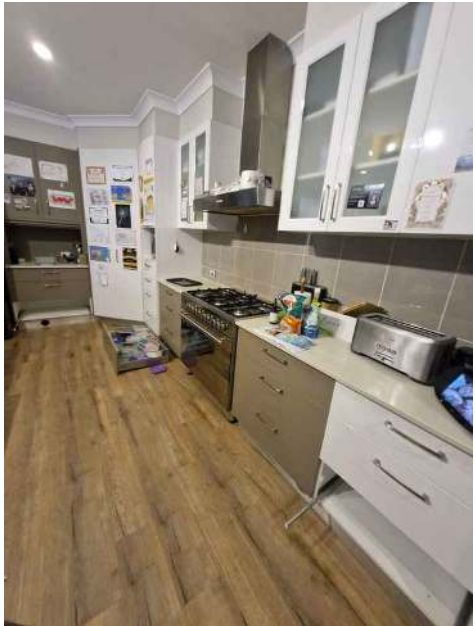
| 4.1 | Kitchen cabinetry |

### Water Damage to Kitchen Cabinetry

Water-related damage was observed to the internal components of the kitchen sink cabinet as a result of the reported water escape.

The cabinet base and adjacent cabinetry components showed evidence consistent with exposure to water.

It is recommended that the affected cabinetry be assessed and replaced by a qualified cabinetmaker

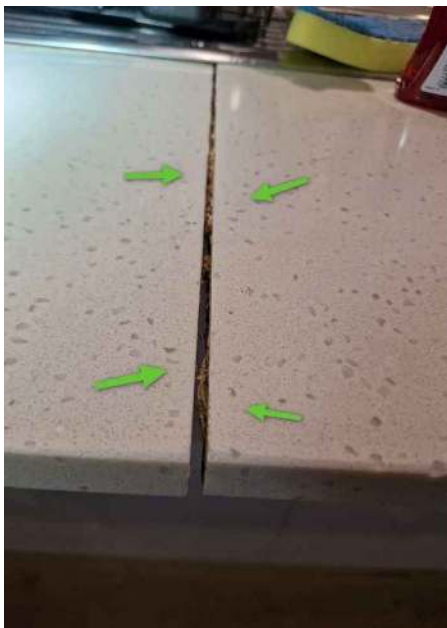
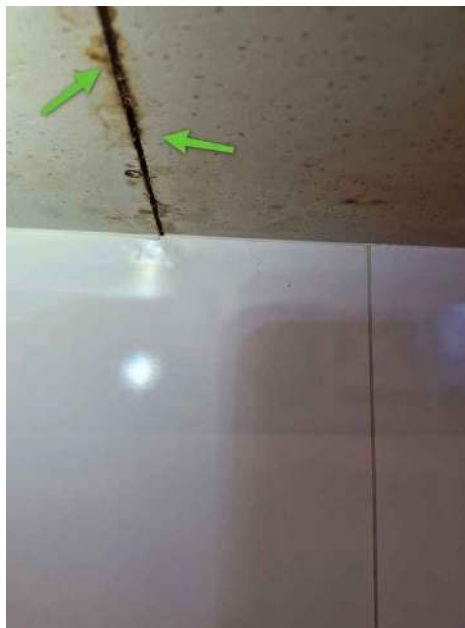
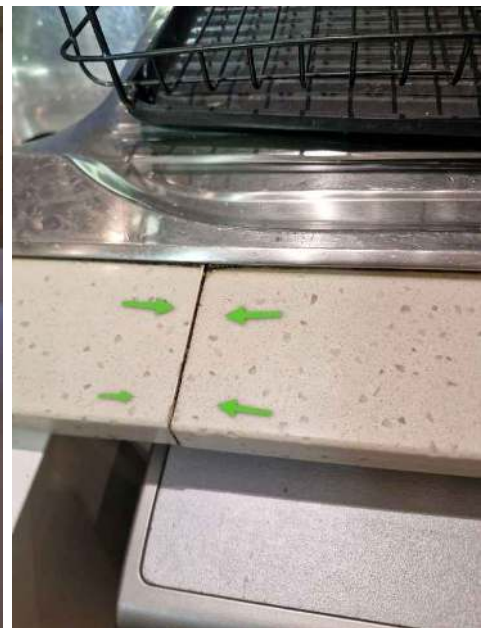
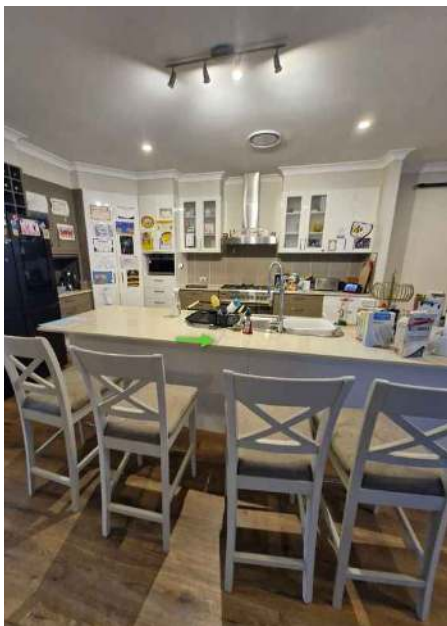
### 5.1 Bench top issue

The kitchen island bench top joint is moved, at the time of the inspection there is a gap. Recommend to engage a qualified builder/ bench top installer to inspect to rectify.

The observed gap to the bench top doesn't appear to be directly related to the reported water leak. The gap may have been caused by an existing installation issue, poor jointing or connection, or movement of the bench top or cabinetry.

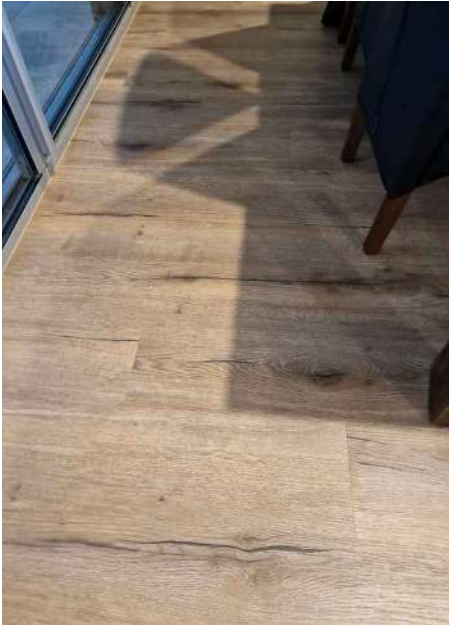
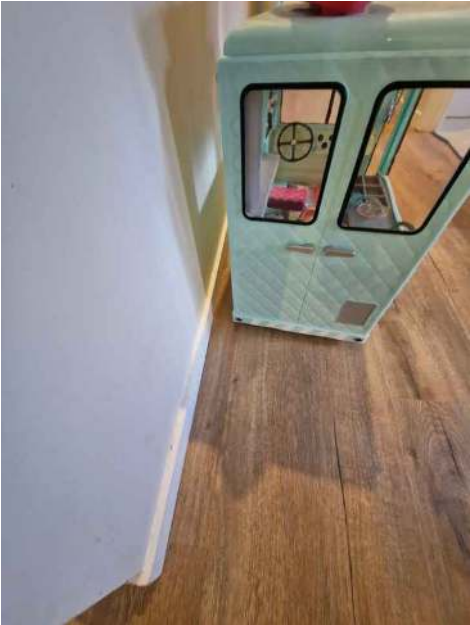
| 6.1 | Timber flooring defects |

Due to water damage the kitchen area and extended into the dinning, family entry ,garage, hallway floors.

The flooring is damaged and need to be replaced.

Professional water drying is recommended prior to reinstallation works.

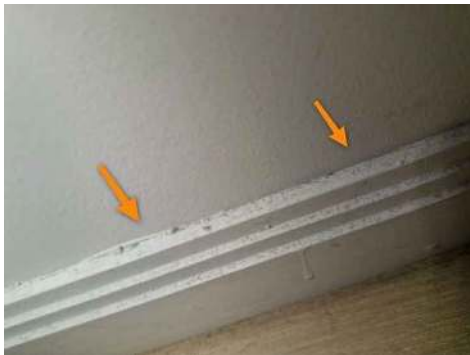
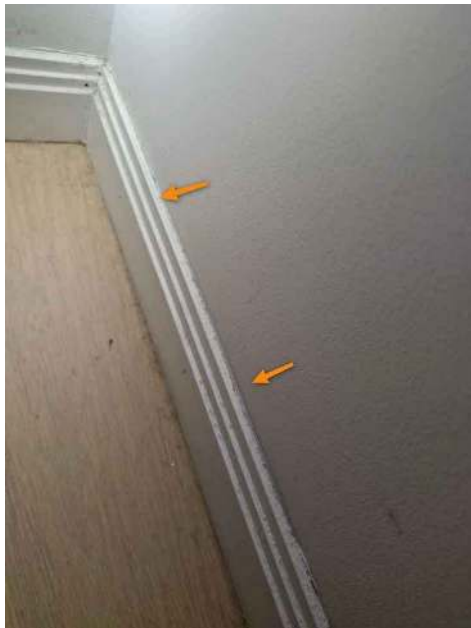
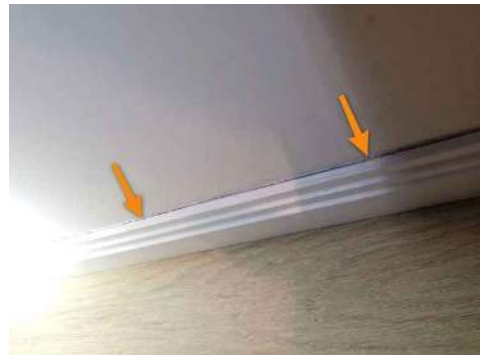
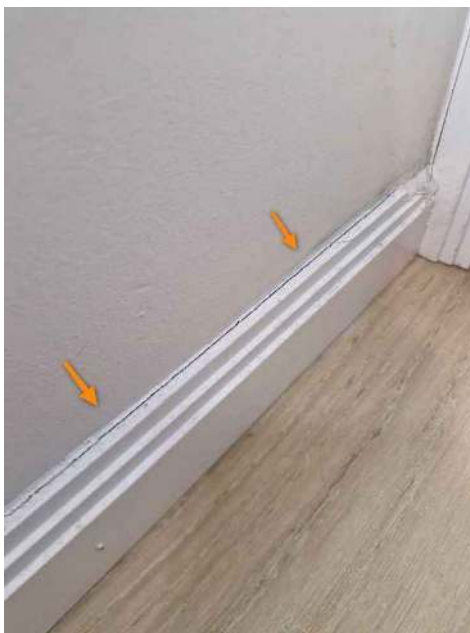
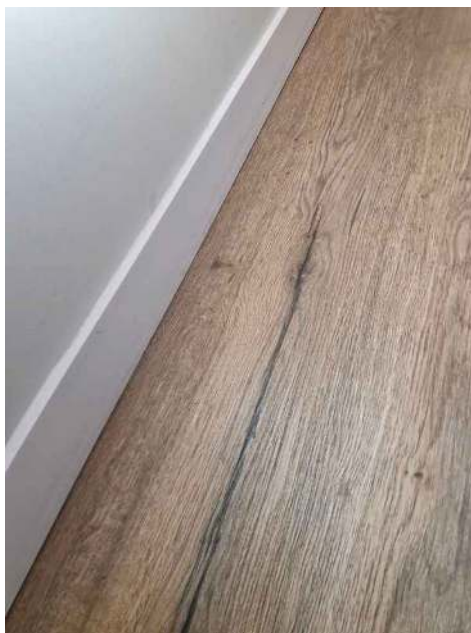
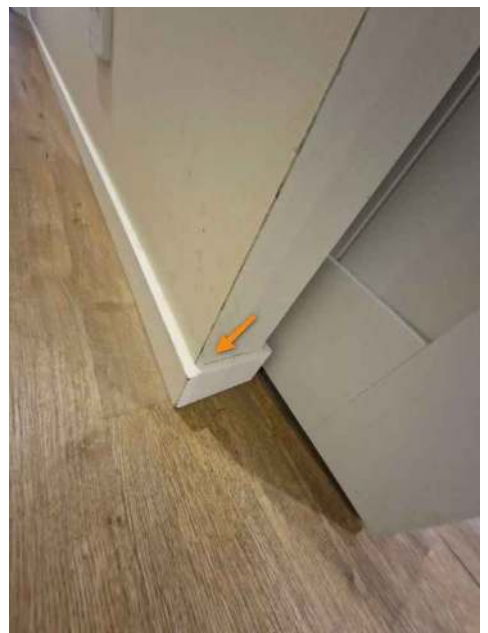
#### 7.1.1 Skirting defects

Showing examples of skirting defects and damages

Contact a qualified professional.

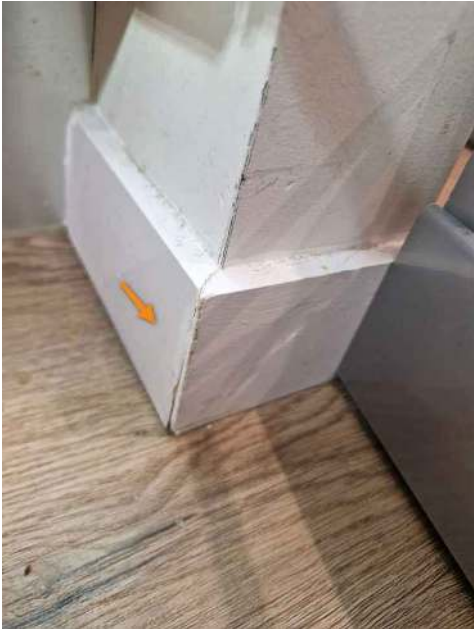
#### **SKIRTING DEFECTS**

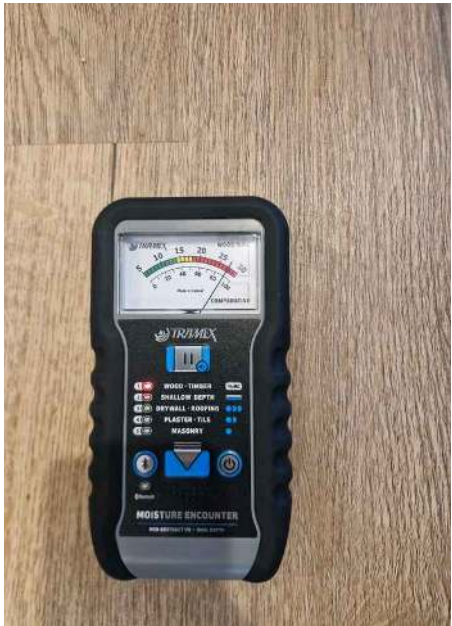
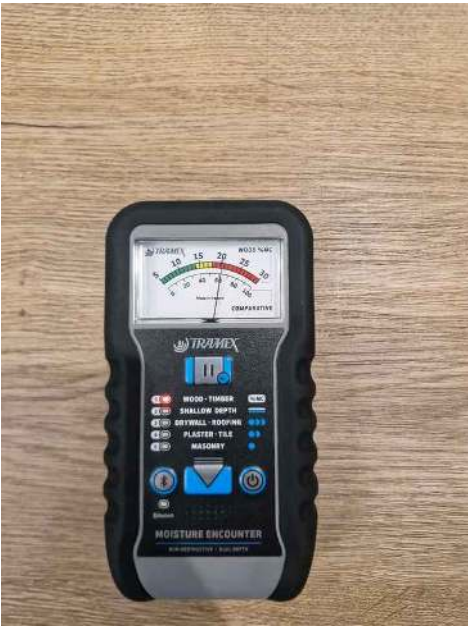
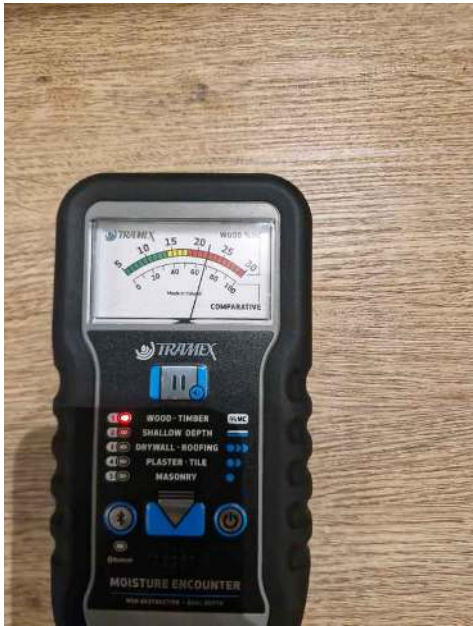
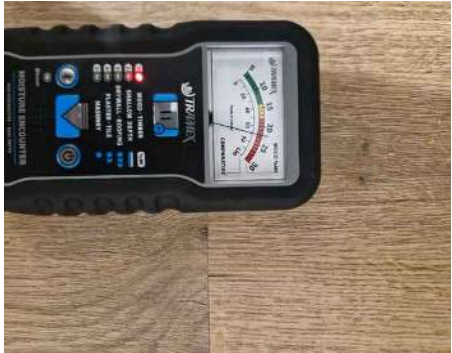
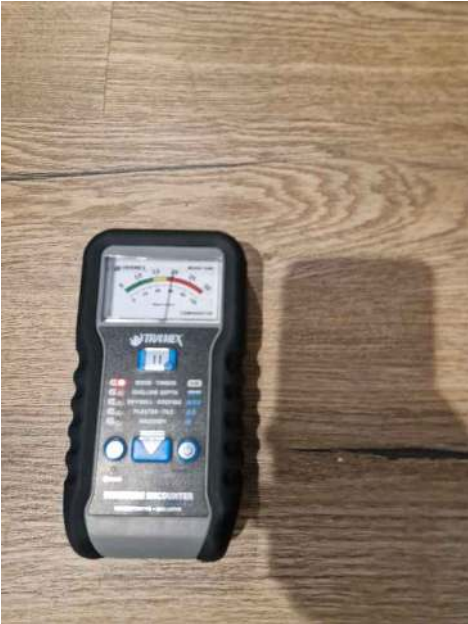
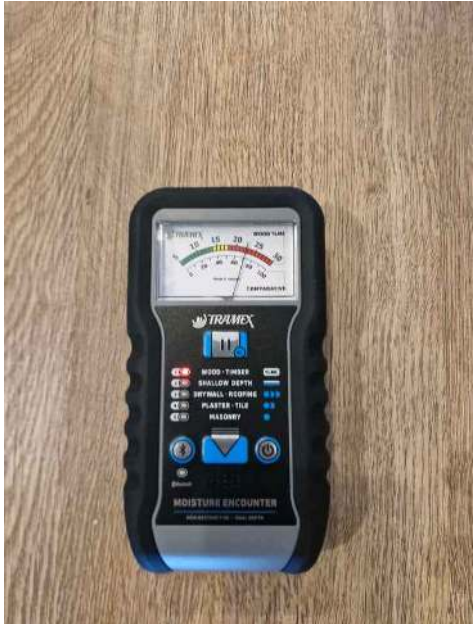
| 8.1 | Moisture meter reading |

Moisture meter reading : Moisture meter showing

This happened on 10/08/26 and about 18 days later , At the time of the inspection, moisture meter reading high moisture in the kitchen floor, family, dining, and hallway floor.

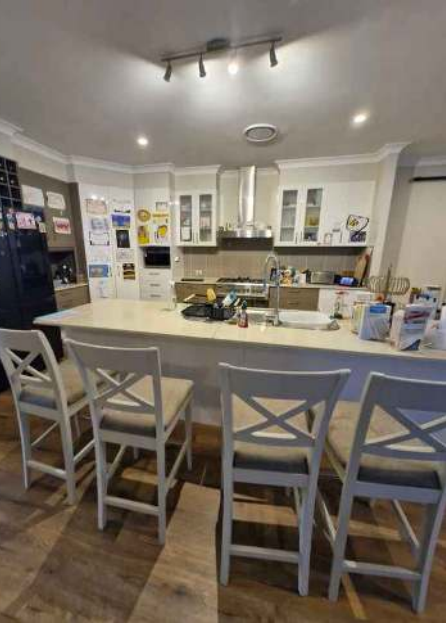
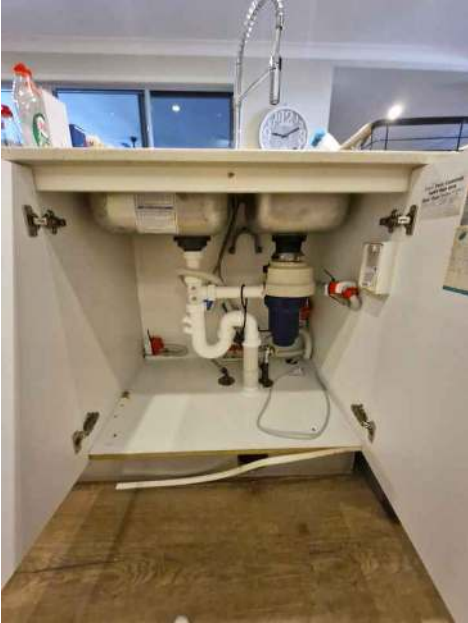
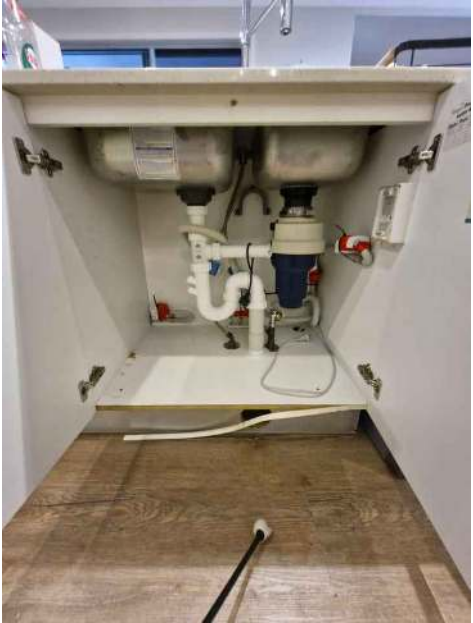
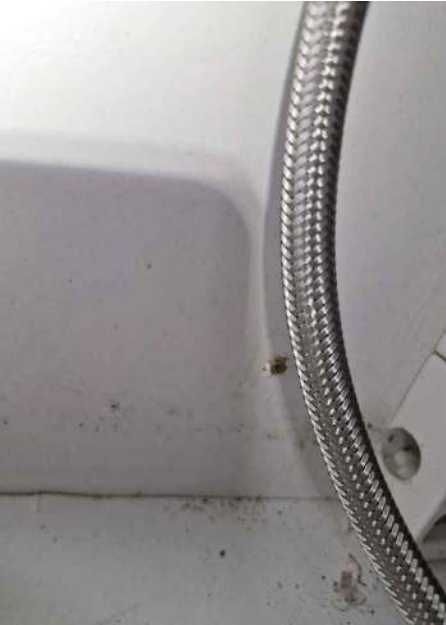
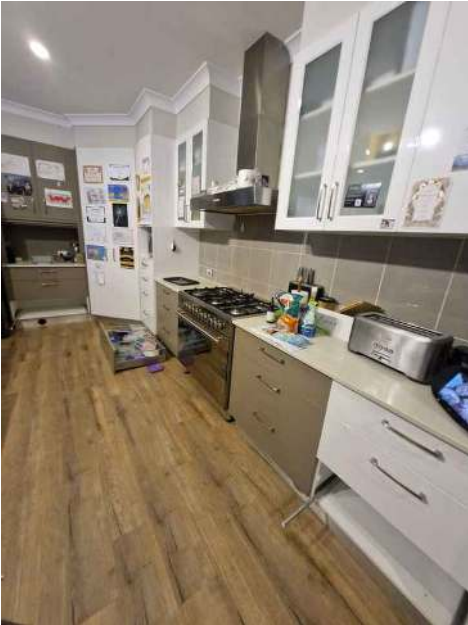
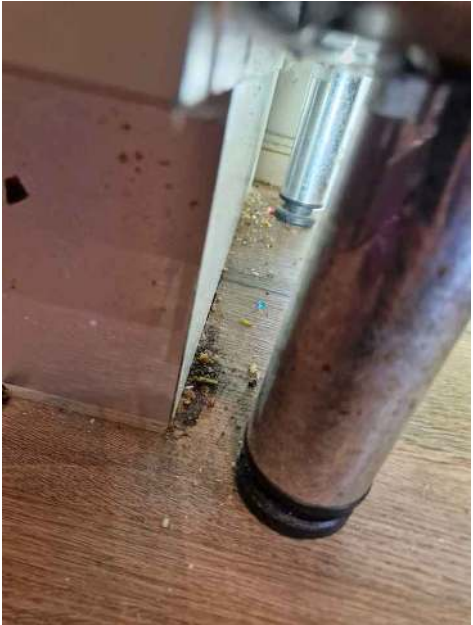
| 10.1 | Kitchen |

Kitchen : Floor and cabinetry

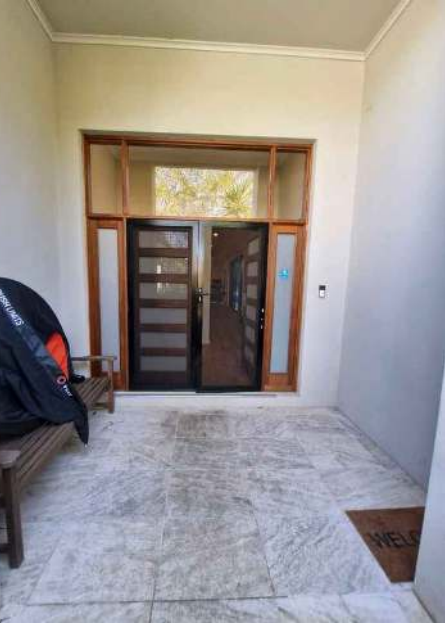
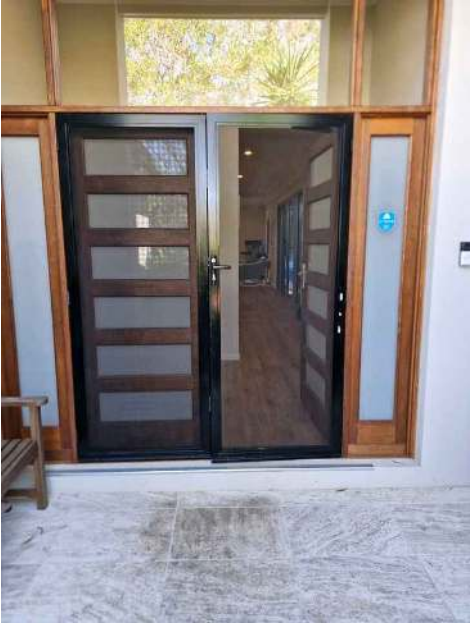
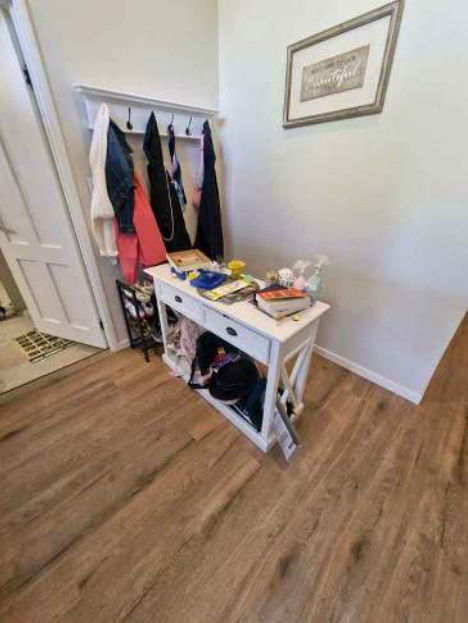
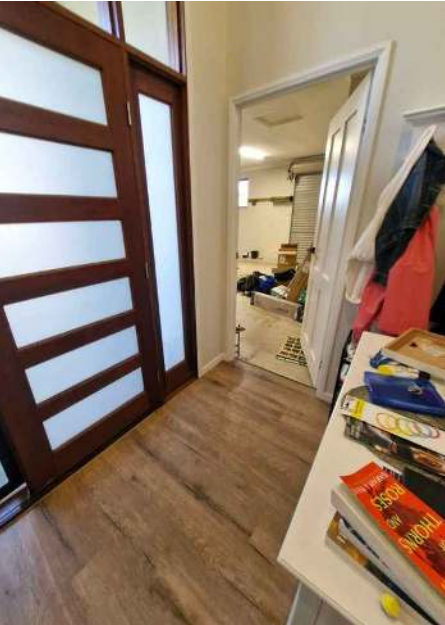
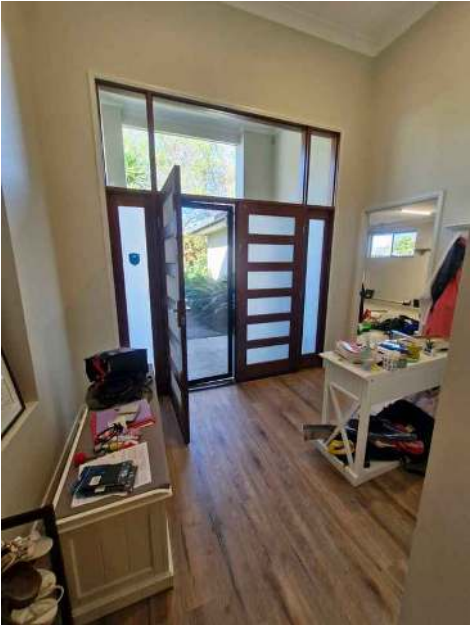
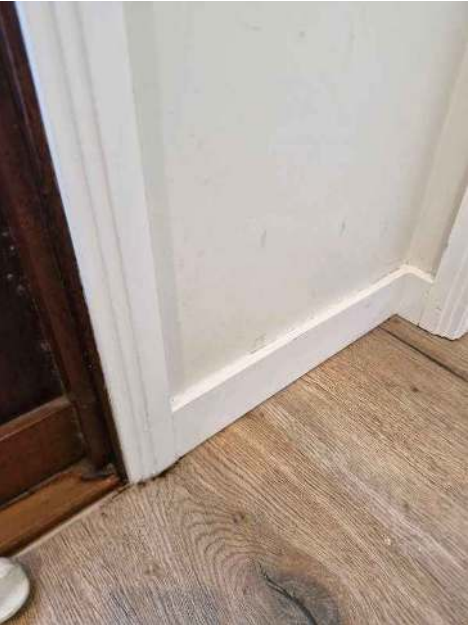
| 10.2 | Entry |

Entry: Entry

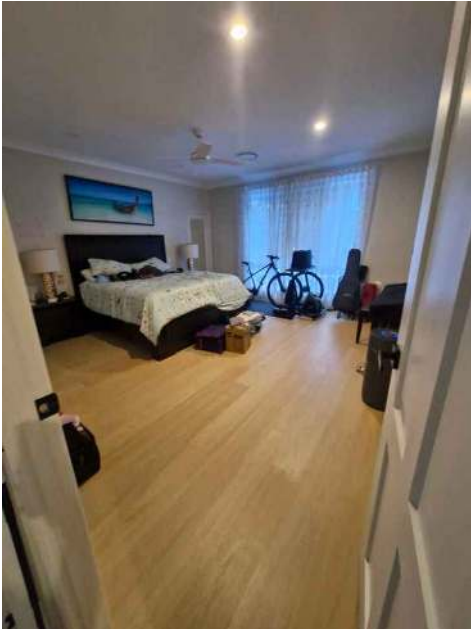
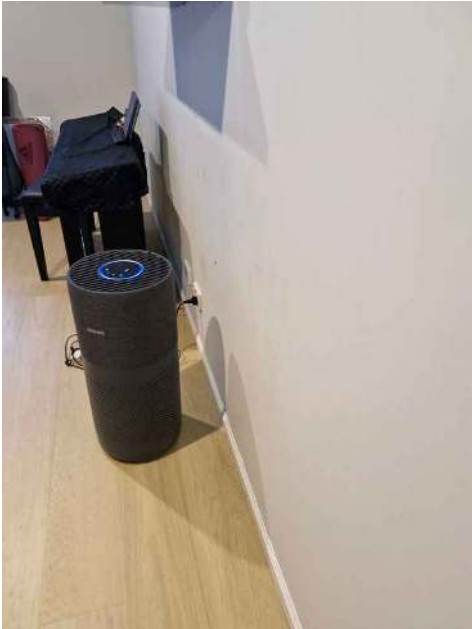
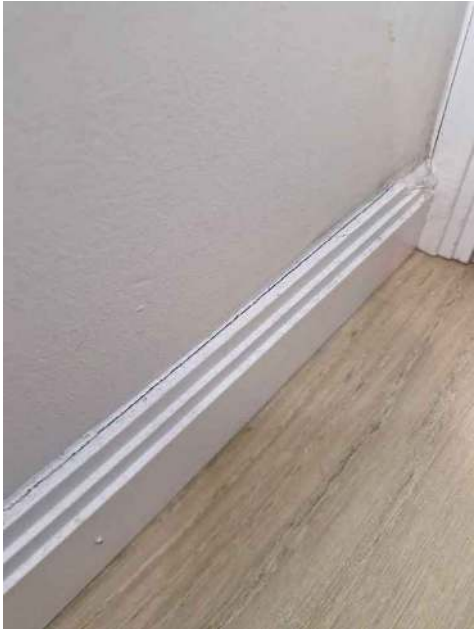
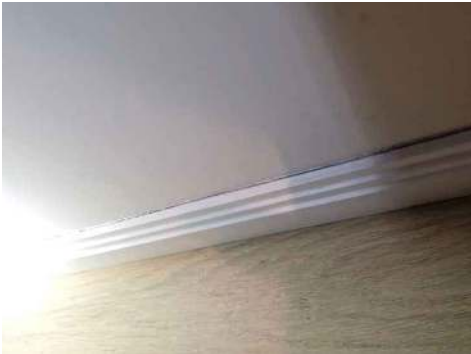
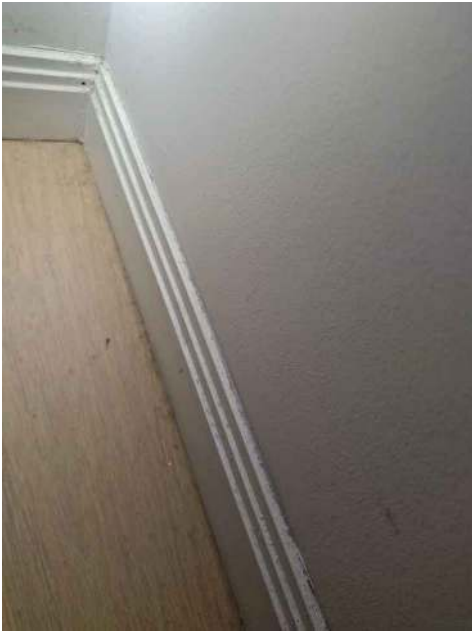
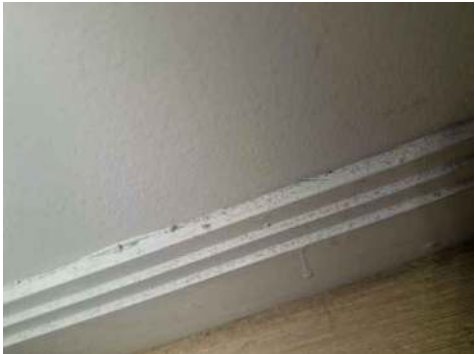
### 10.7.1 Bedroom

#### **GENERAL VIEW**

Contact a qualified professional.
