## FRAME INSPECTION

Sample Property

14/09/2026

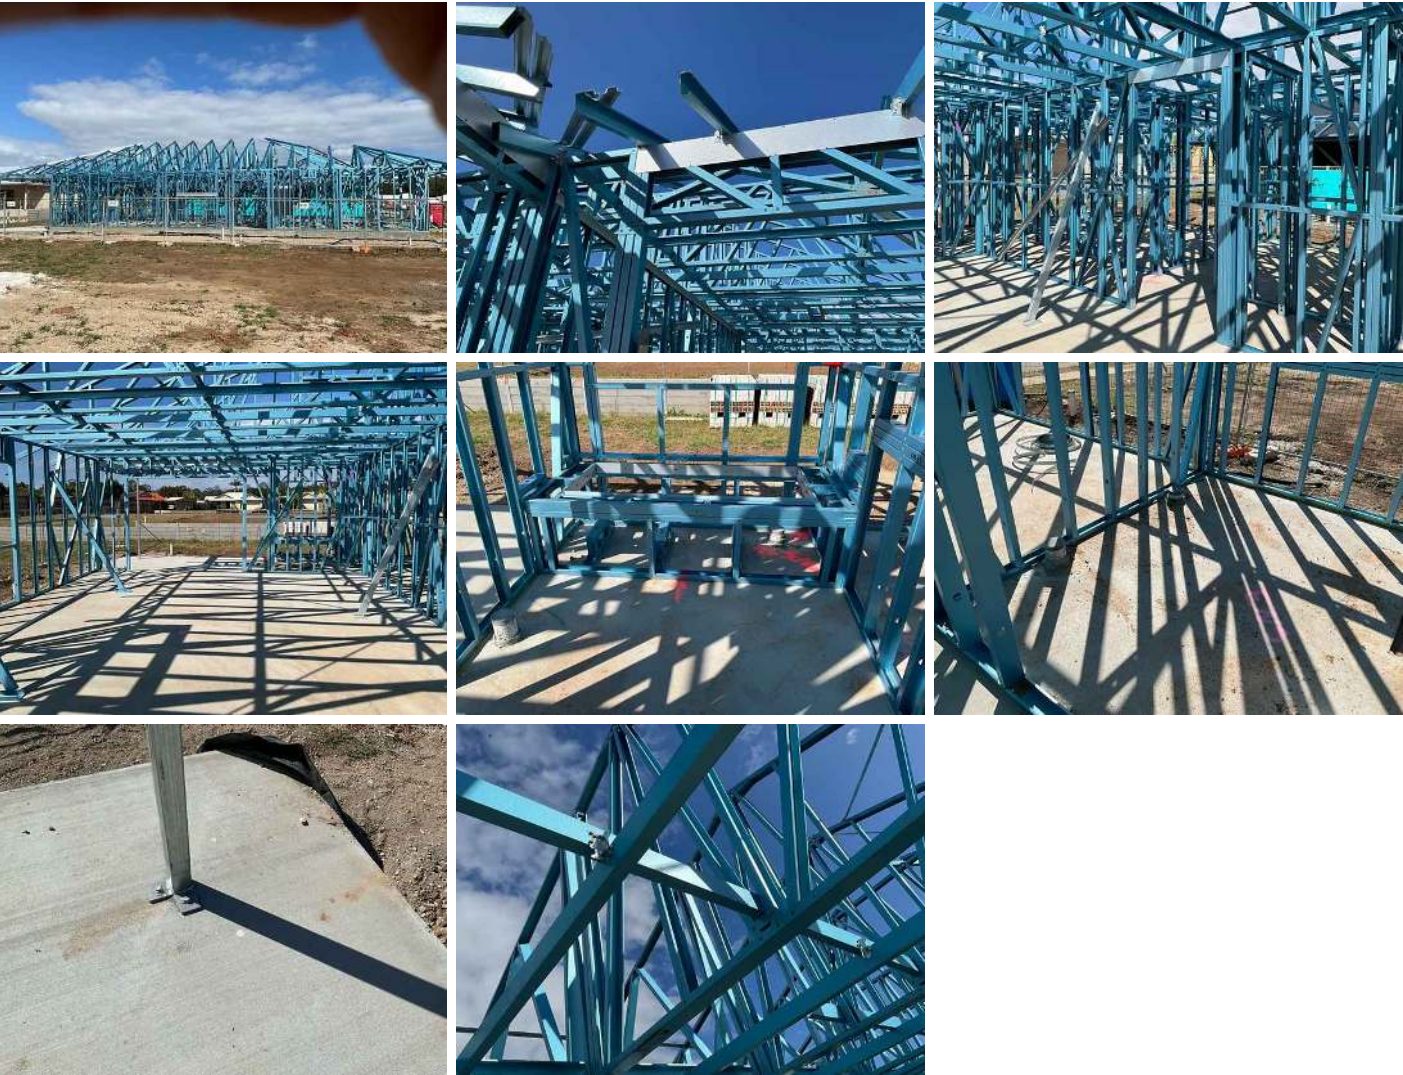
### 2.1.1 Inspection Summary

Frame is visually fine and built to engineers plans

#### OVERALL CONDITIONS - MID LEVEL/ACCEPTABLE

The frame was generally observed to have been constructed to an acceptable standard with some minor defects noted that require repair.

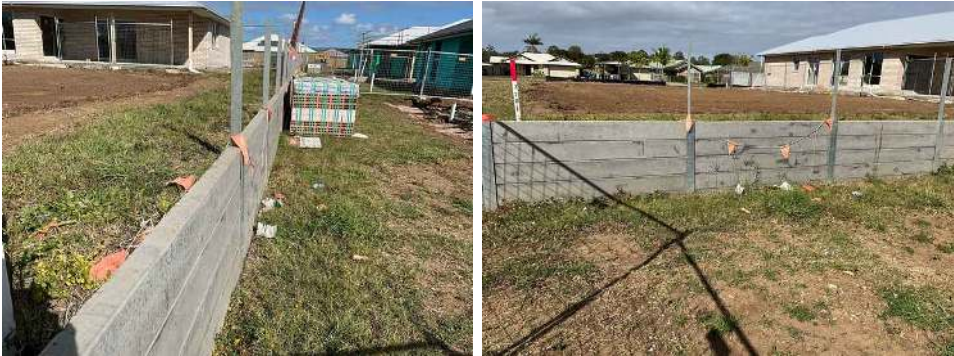
3.1.1 Structural Elements  
**+ VISUALLY FINE**

The constructed retaining walls appear to be in good visual condition.

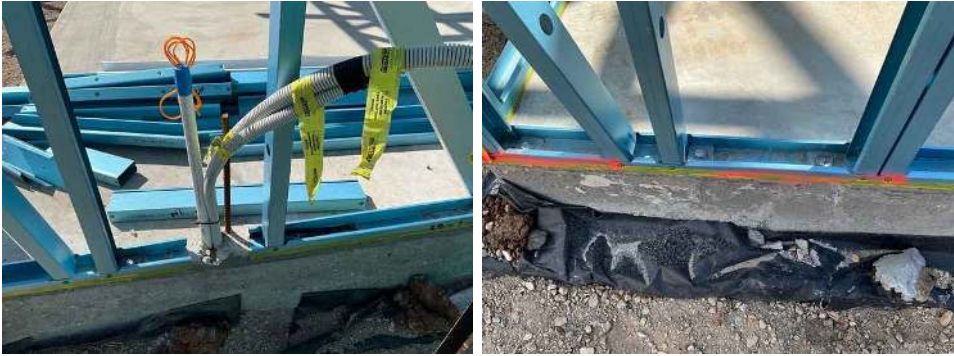
The vapour barrier has been extended to the top edge of the slab as per design and was visible at the time of inspection.

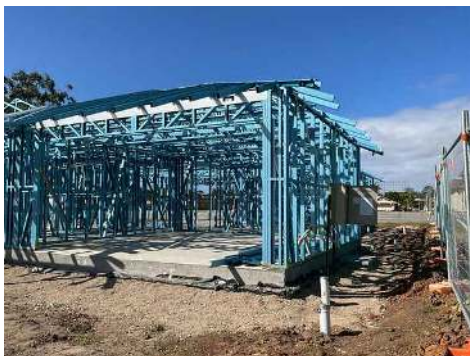
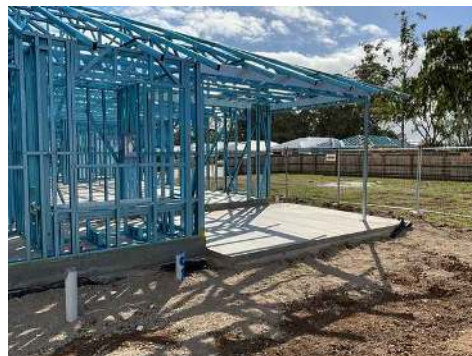
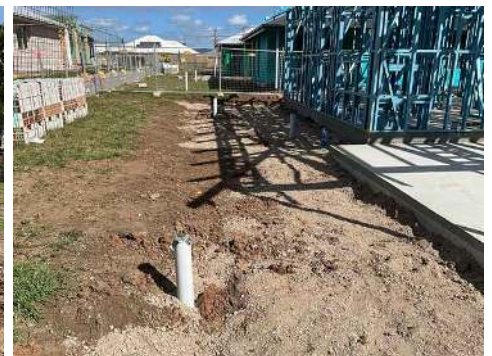
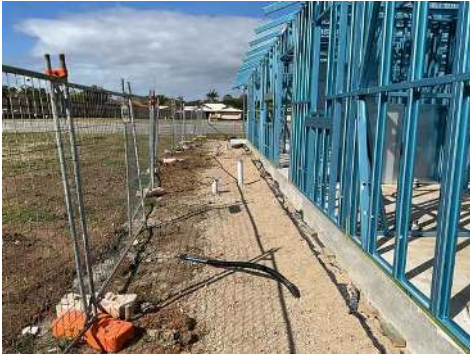
The site has not been graded. If the site remains ungraded during construction, rainwater can flow towards the building, accumulating and seeping under the slab. This can lead to moisture issues, compromising the foundation and causing potential long-term damage. The site is required to be graded in accordance with ABCB Housing Provisions (2022) - Section 3.3.3 at 'handover'.

- (i) 25 mm over the first 1 m from the building in low rainfall intensity areas for surfaces that are reasonably impermeable (such as concrete or clay paving); or
- (ii) 50 mm over the first 1 m from the building in any other case.

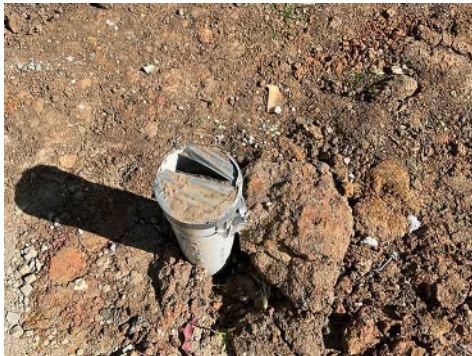
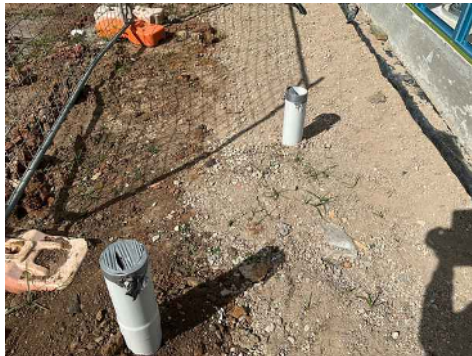
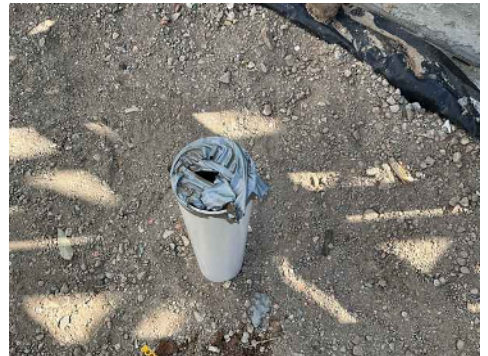
**Observation:** The stormwater pipe(s) have been left uncapped, which may allow construction materials and debris to enter, potentially causing blockages in the stormwater system. This can obstruct water flow and lead to drainage issues, possibly resulting in property damage.

**Recommendation:** The stormwater pipe(s) should be capped to prevent debris entry. A CCTV inspection is recommended to confirm the pipes are clear of any obstructions before further work or handover.

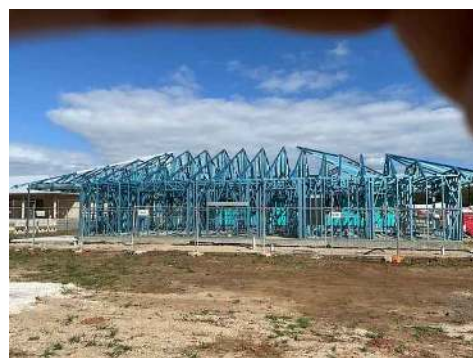
The roof bracings appear visually in good condition with no obvious signs of damage or misalignment observed during the inspection.

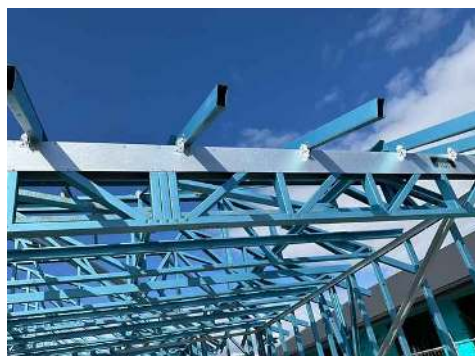
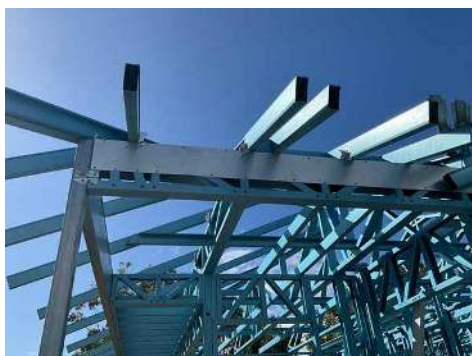
#### 7.4.1 + Triple grips (Truss tie)

Triple grips (truss tie) were visually fine at the time of inspection.

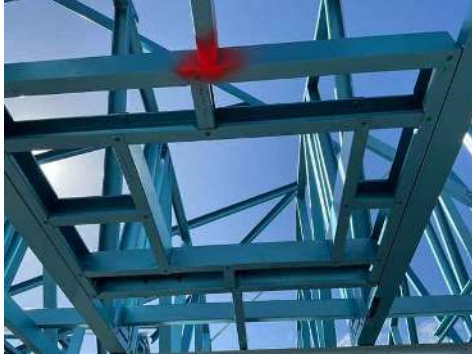
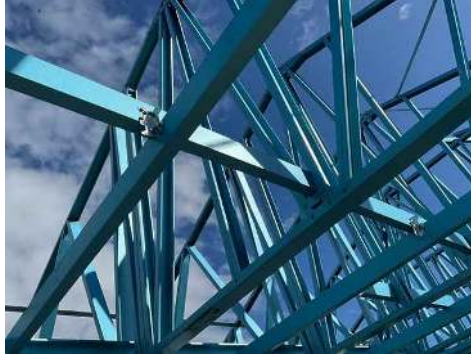
## 7.5.1 + Truss boots

**+ APPEAR FINE**

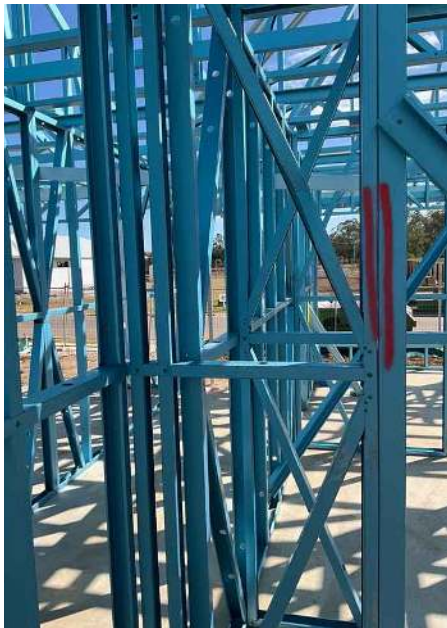
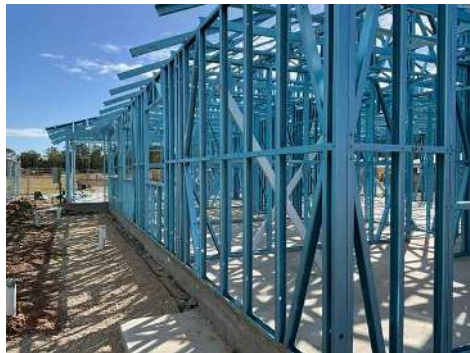
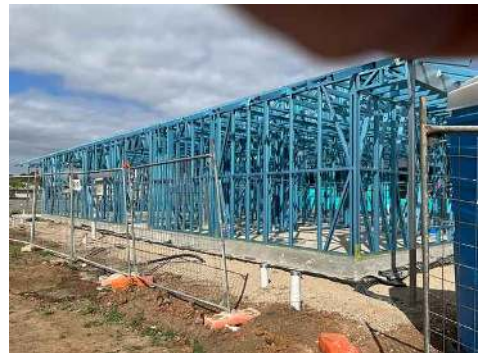
#### + General: BRACING INFORMATION

Bracing works to maintain rigidity of the structure in all points, prevent any displacements or other ways of deformation . Bracing shall be provided to stud walls to resist horizontal forces (wind, storm, earthquakes, etc.) applied to the building. Appropriate connections shall also be provided to transfer these forces through the framework and subfloor structure to the building foundation.

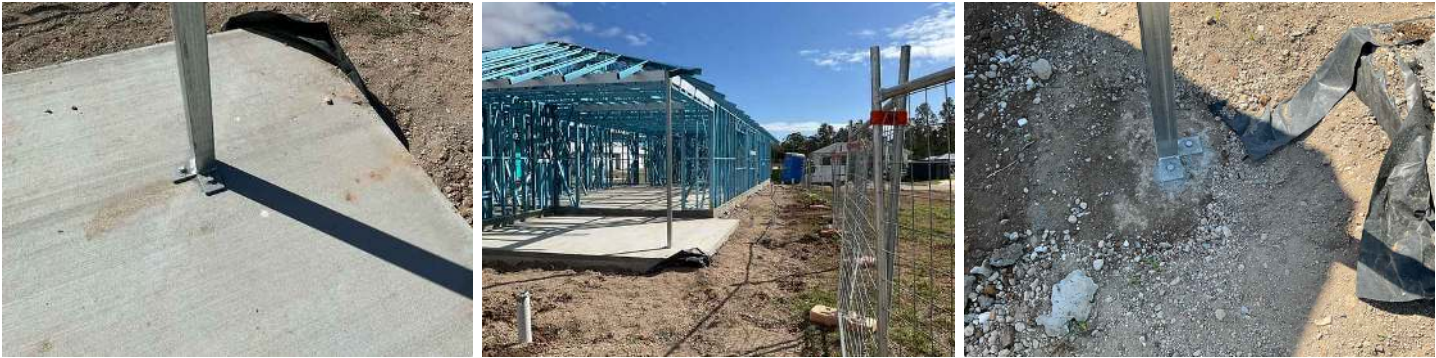
11.4.1 + Steel columns/posts

+ **APPEAR FINE**

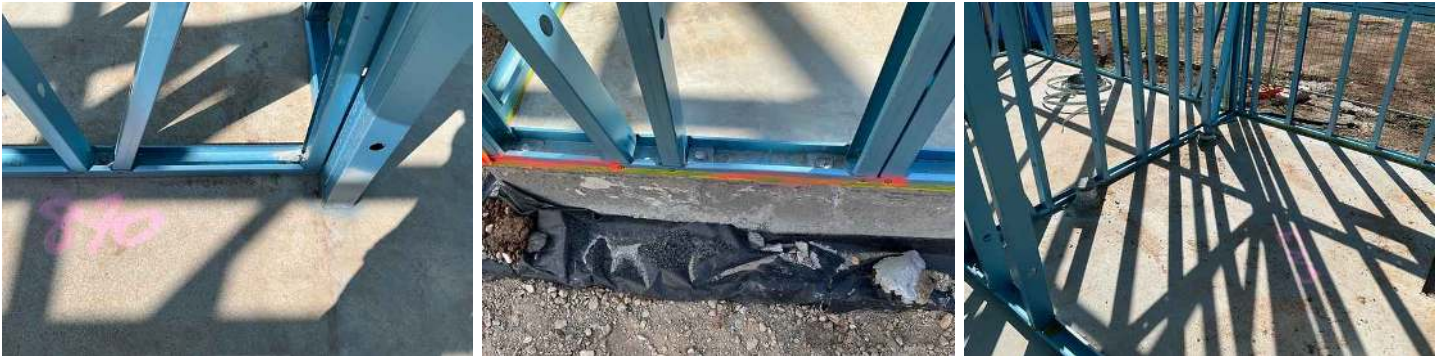
BOTTOM PLATE TO FLOOR

Tie down bolts appear fine and to regulations
