OWNER INSPECTIONS

## PRE-PURCHASE INSPECTION (BUILDING & PEST)

Sample Property

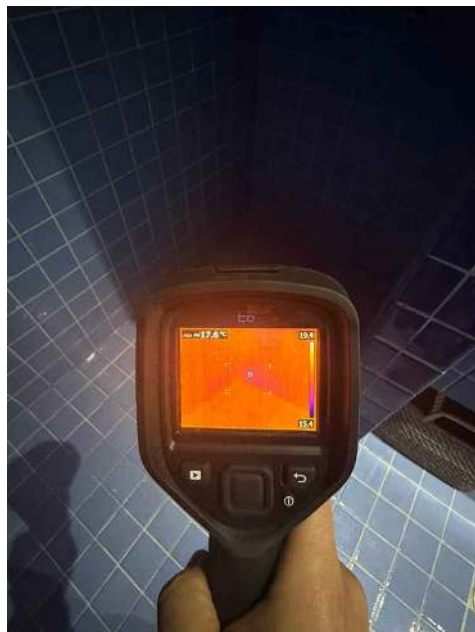
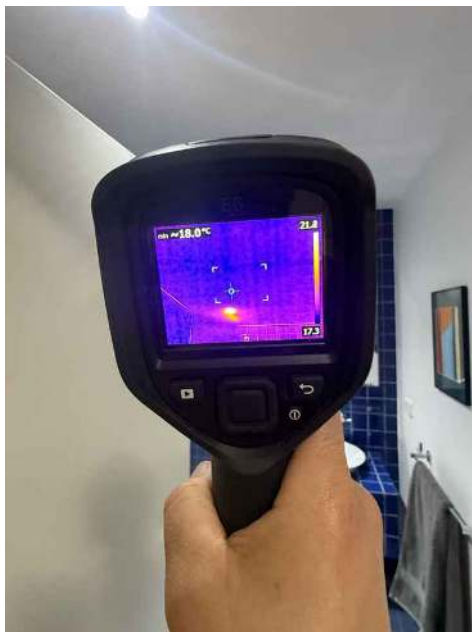
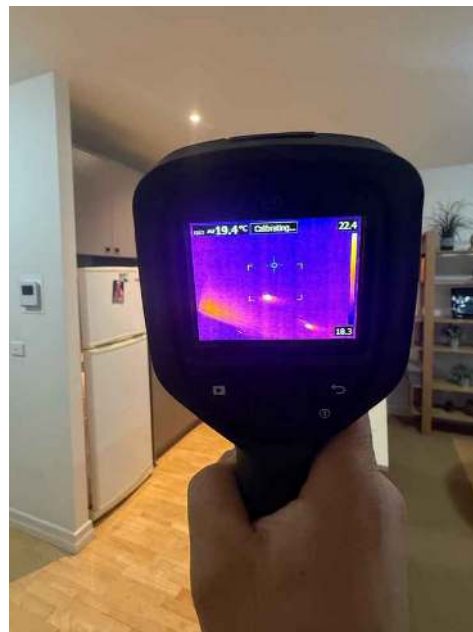
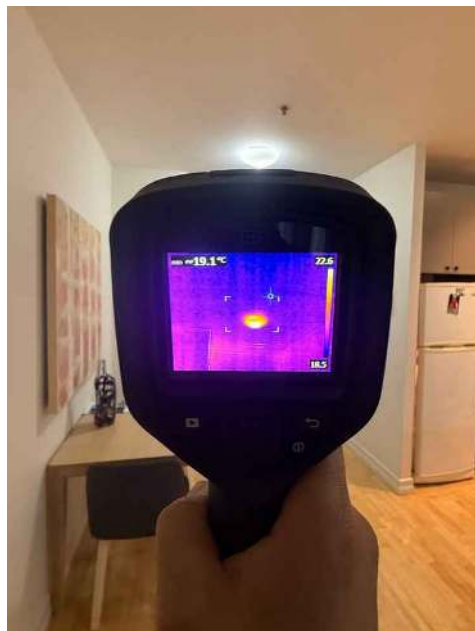
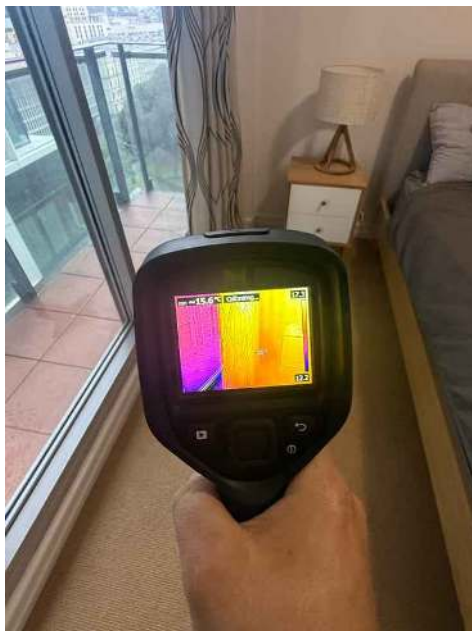
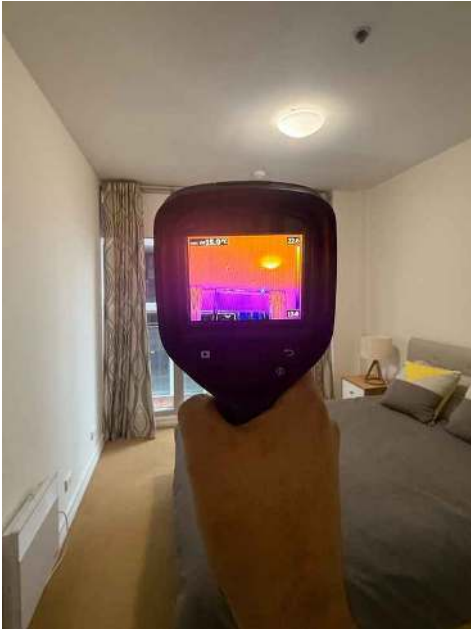
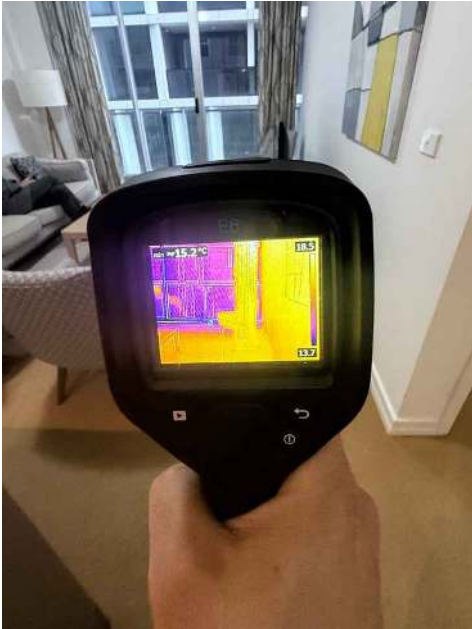
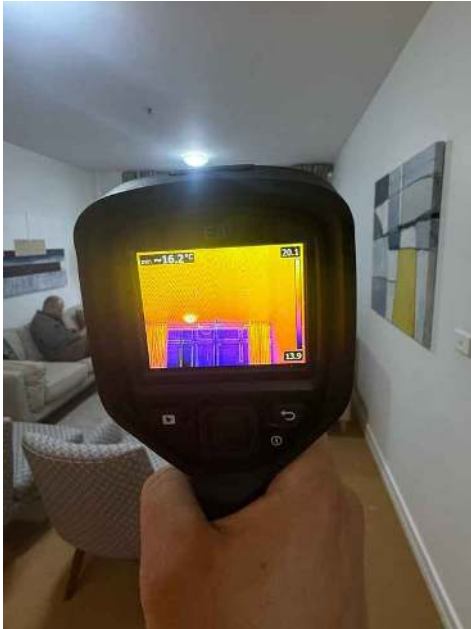
# 4: THERMAL AND MOISTURE METER ASSESSMENT

Contact a qualified professional.

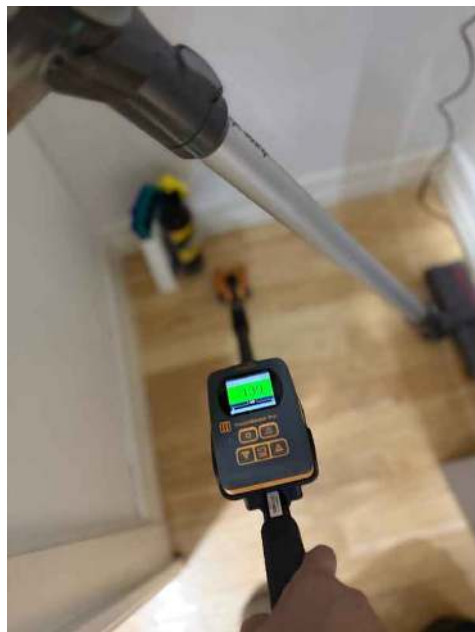
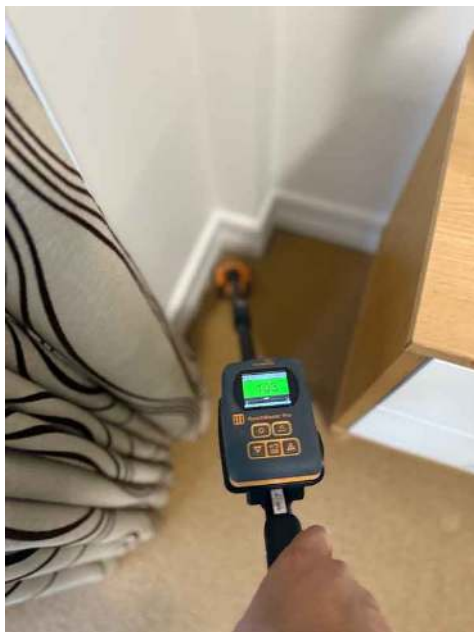
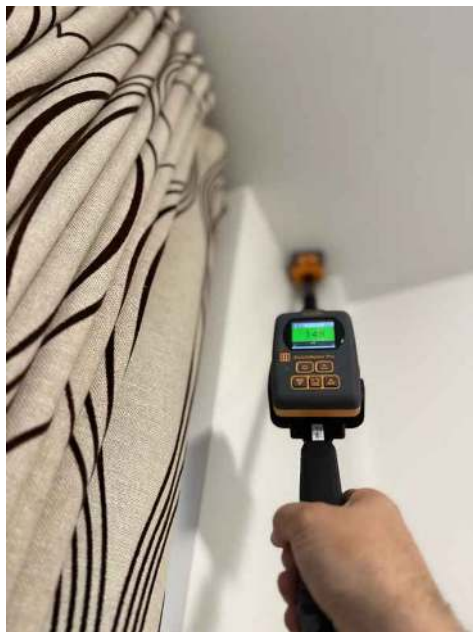
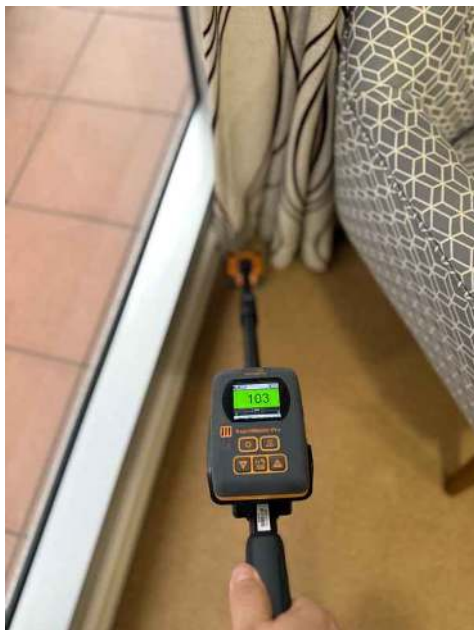
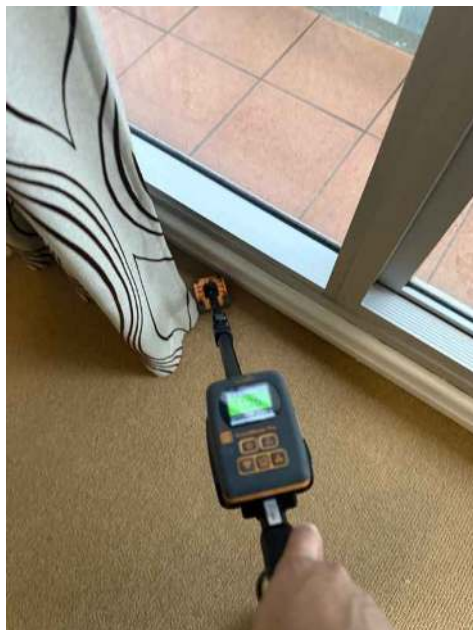
## 4.2.1 Moisture meter scanning

**MOISTURE METER SCANNING – NO ELEVATED READINGS TO PLED AREAS**

Contact a qualified professional.

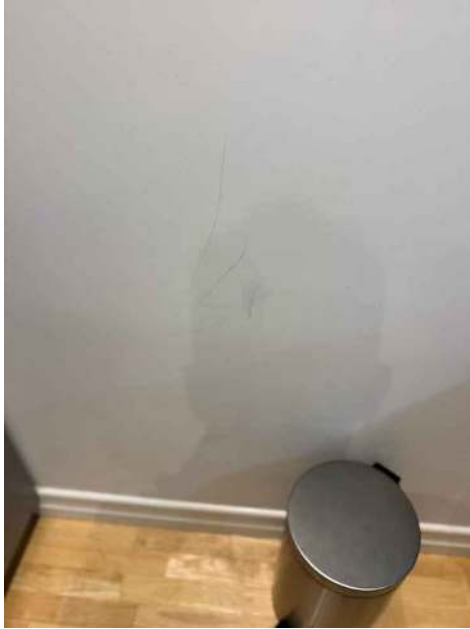
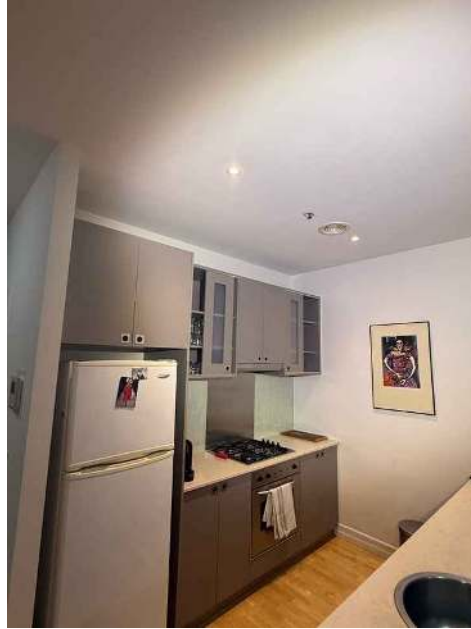
## 7.2.1 General Painting Defects (Internal)

**GENERAL WEAR AND TEAR – AGE CONSISTENT**

Contact a qualified professional.

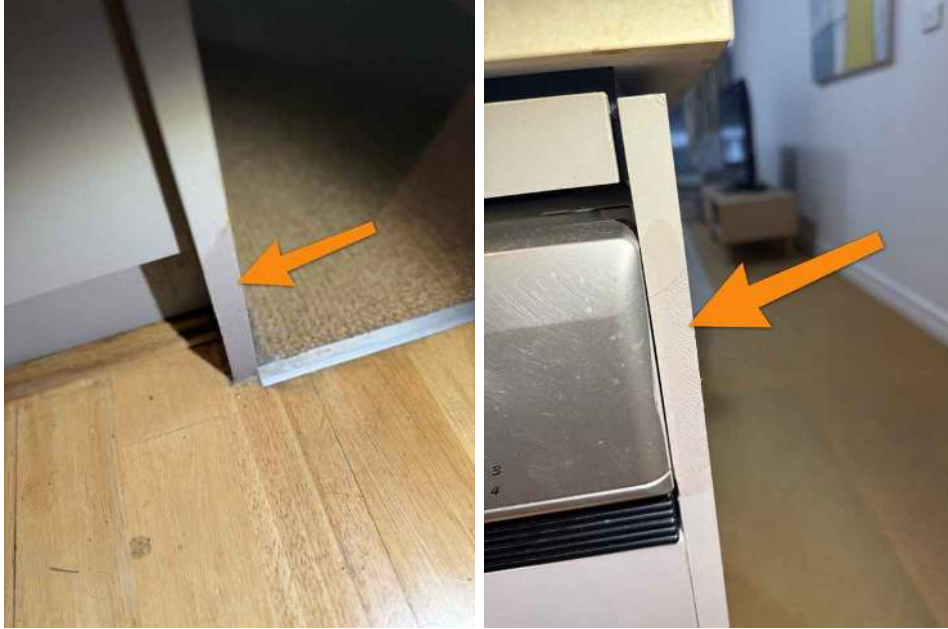
## 7.10.1 Cabinetry/Vanities/Through

**CABINETRY – GENERAL WEAR AND TEAR**

Contact a qualified professional.

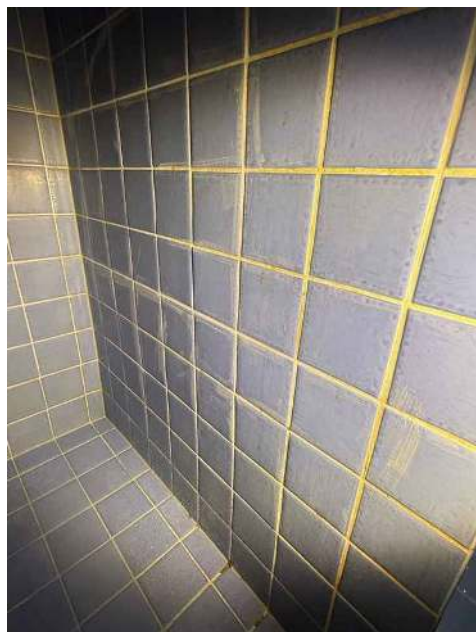
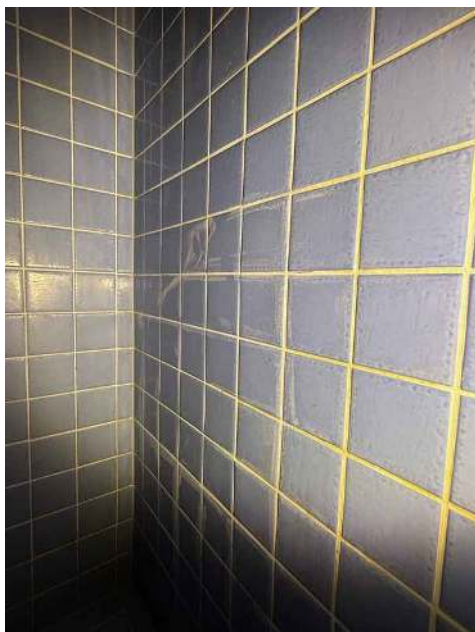
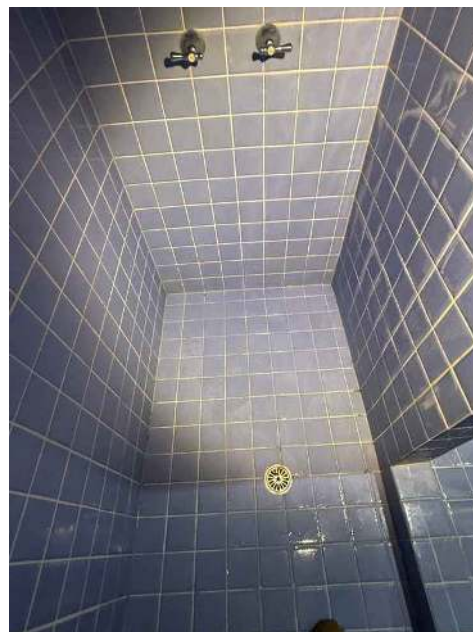
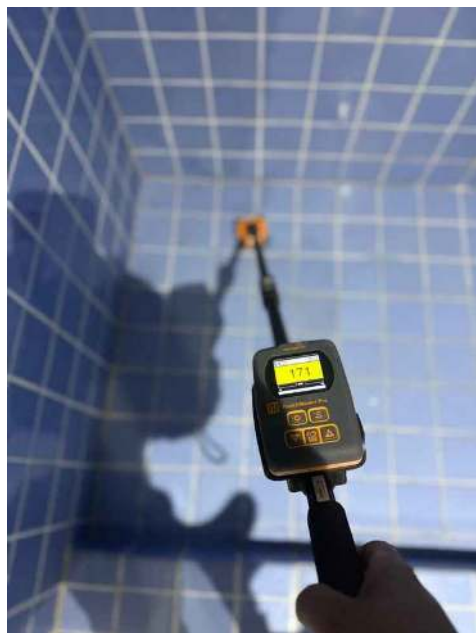
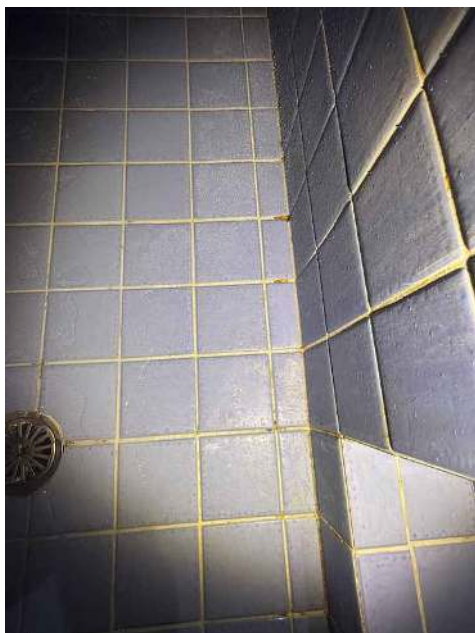
## 7.13.1 Shower

**SHOWER GROUT – MAINTENANCE AND SEALING RECOMMENDED**

Contact a qualified professional.

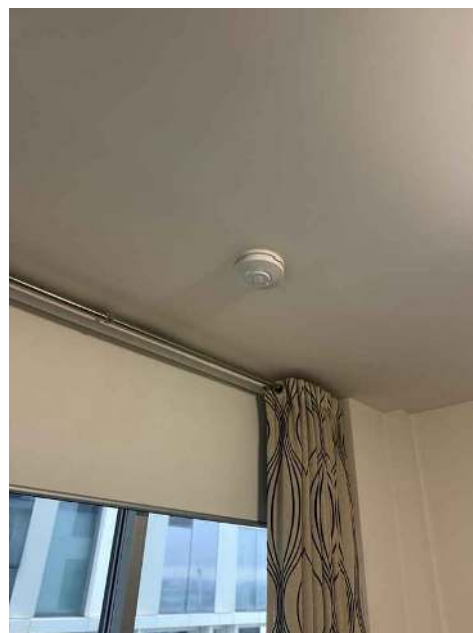
#### + INSTALLED BUT NOT TESTED

Smoke detectors are visually identified as installed, yet not tested (Out of building inspection scope of work). **Recommend changing the batteries when you take possession of the property and every 6 months afterwards.** You will want to test them monthly. Detectors older than 10 years should be replaced.
