OWNER INSPECTIONS

## INVESTIGATION REPORT

Sample Property

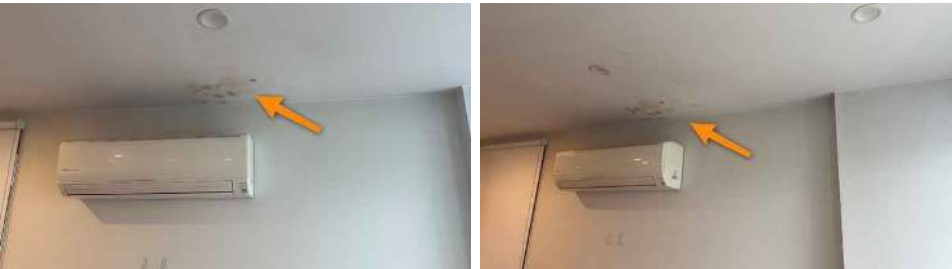
4.5.1 Ceiling

MOLD AND CEILING DAMAGE

Living Room Ceiling – Moisture Damage and Mould

Localised mould growth, staining, bulging and unevenness were observed to the living room ceiling. The affected area was dry at the time of inspection, with evidence consistent with previous moisture exposure. The area above the affected ceiling is a balcony. Access to the balcony was not available during this inspection, therefore the source of the moisture and condition of the balcony could not be assessed. The observations are limited to the visible condition of the ceiling at the time of inspection.

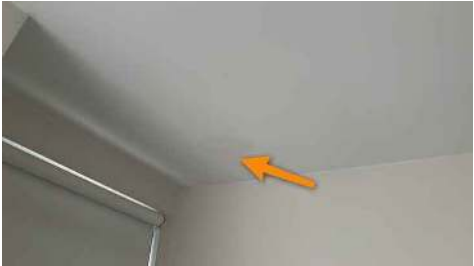
5.6.1 Ceiling

PREVIOUS MOISTURE DAMAGE IN CEILING

1ST FLOOR

Water stains and damage observed in the ceiling corner above a window, indicating previous moisture intrusion. The non-porous ceiling tile material suggests water penetration from above, likely from the roof. This type of damage can indicate past roof leaks or inadequate flashing around the window opening.

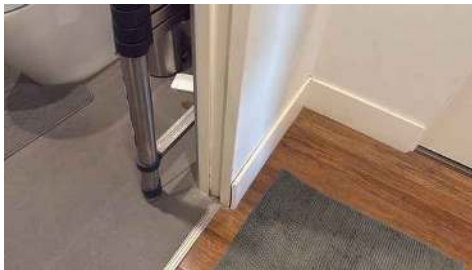
## 6.4.1 Floors

**SKIRTING DAMAGED**

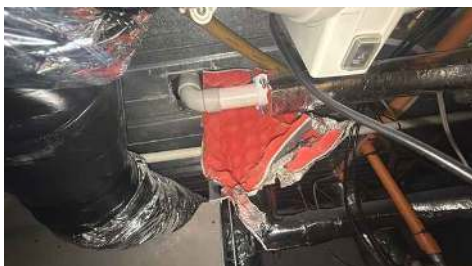
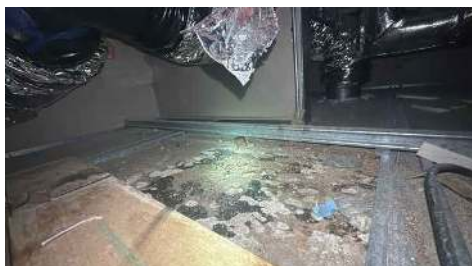
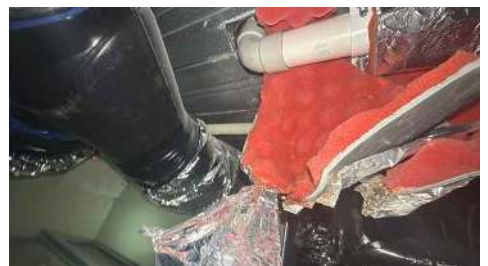
## 6.5.1 Roof internal

**PREVIOUS ROOF REPAIRS WITH CEILING DAMAGE AND MOLD**

**ROOF SPACE**

Previous repairs have been made to the roof, and evidence of ceiling damage and mold growth was observed during inspection. This indicates past water intrusion issues that may not have been fully resolved. A roofing professional should evaluate the repair quality and assess whether the underlying moisture problem has been adequately addressed to prevent future damage.
