## PRE-LISTING INSPECTION (BUILDING ONLY)

Sample Property

18/11/2025

The inspection was confined to the ground floor, where earlier water ingress occurred after Yarra Valley Water mains failure caused water to enter the lower level flooring. All skirtings in the affected areas were replaced as part of the remedial works, and this assessment focused solely on reviewing the repairs.

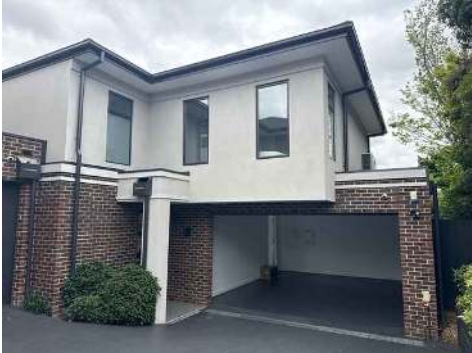
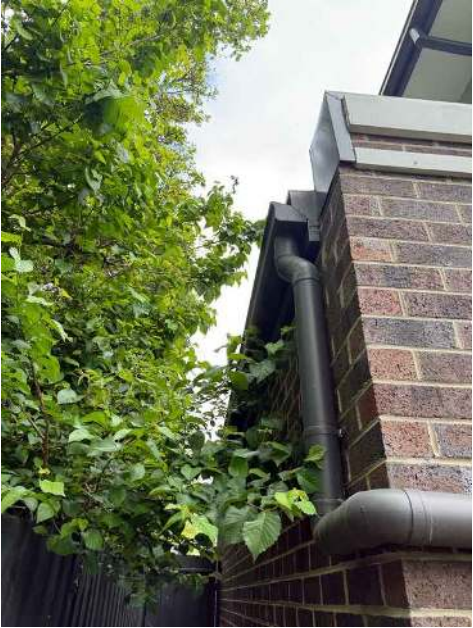
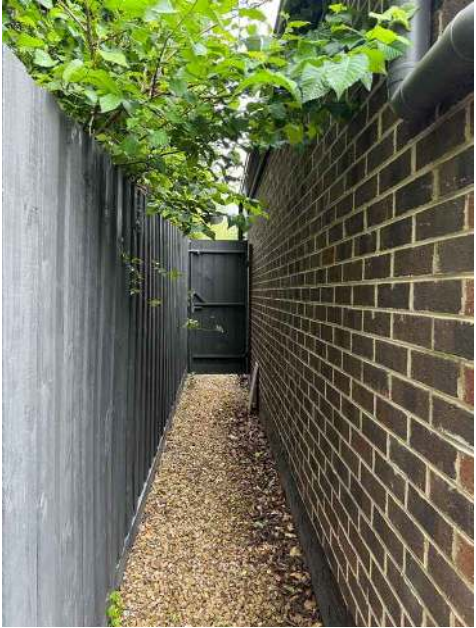
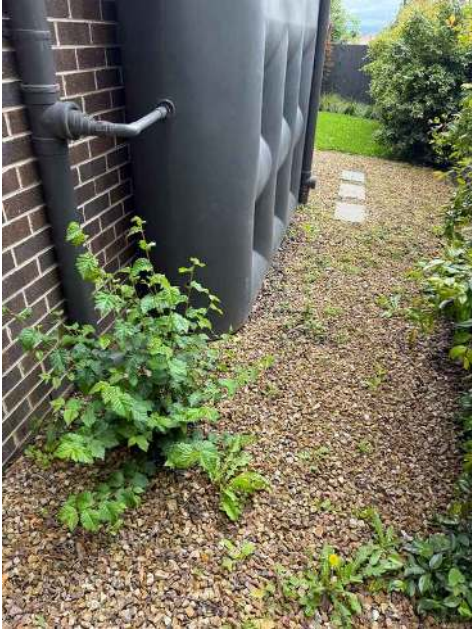
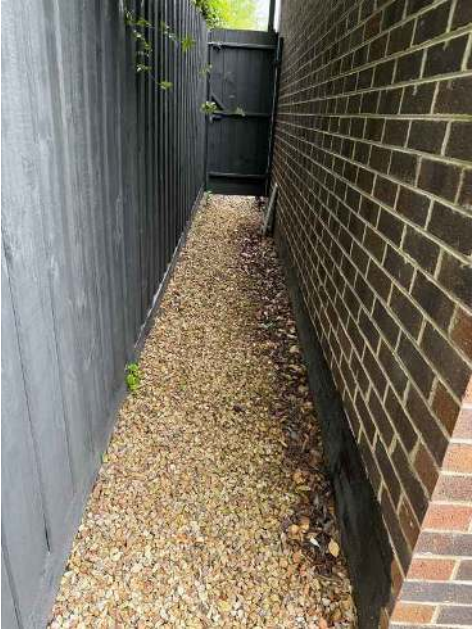
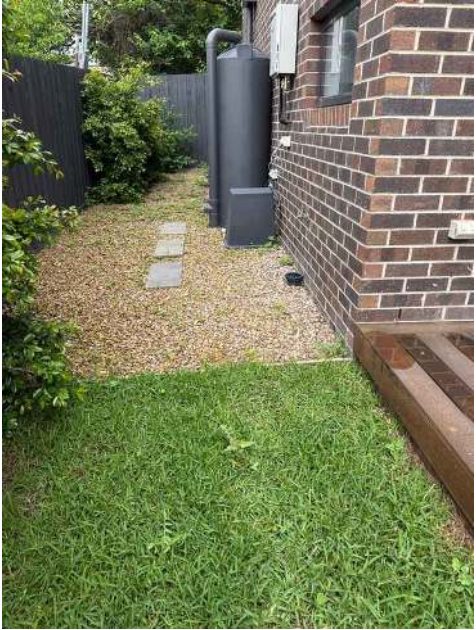
The ground floor presents in very good condition following the previous water ingress event. There were no visible signs of residual moisture damage, and the replaced skirtings have been installed to an acceptable standard. Moisture scanning throughout the ground level returned normal readings, and the thermal imaging assessment did not identify any areas of concern. The flooring is even, stable, and free from distortion or staining that would suggest unresolved issues.

Overall, the re      ial works appear to have been effective, and the home presents to a high standard. No defects associa      with the earlier water mains incident were observed during this inspection.

Recommendation

Contact a qualified professional.

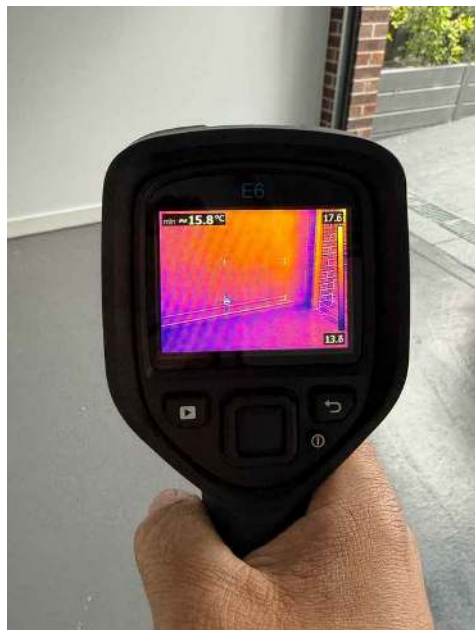
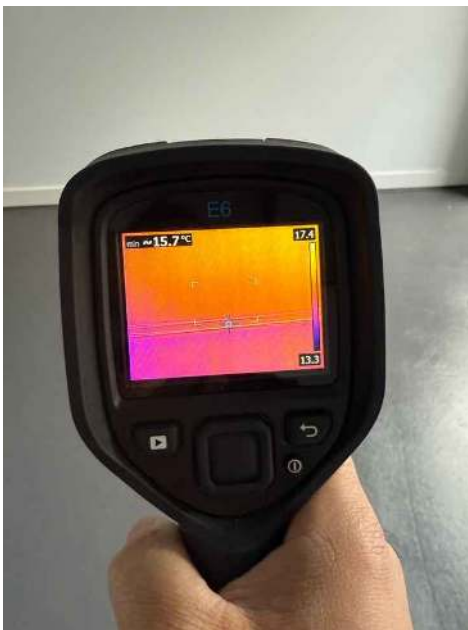
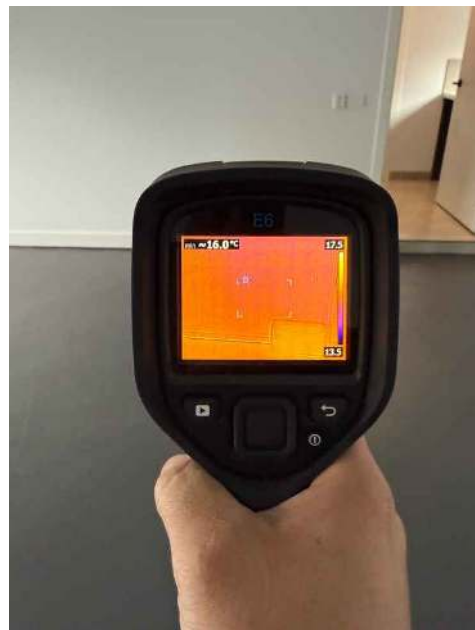
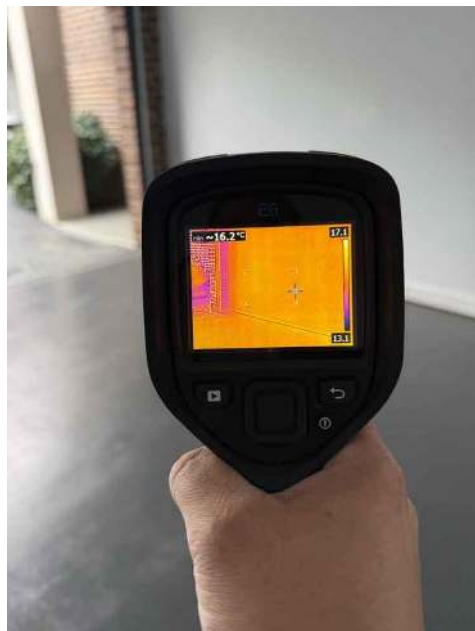
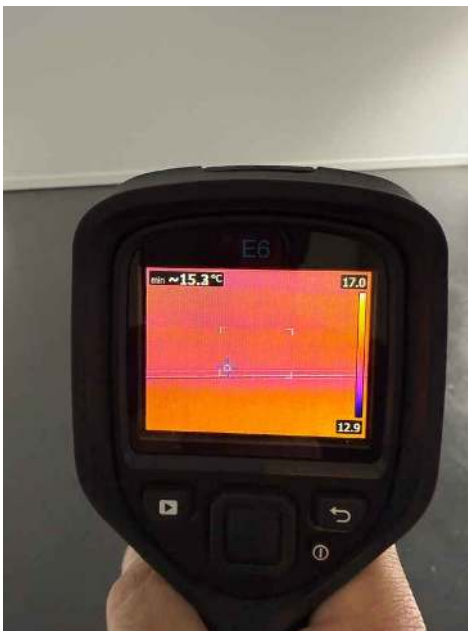
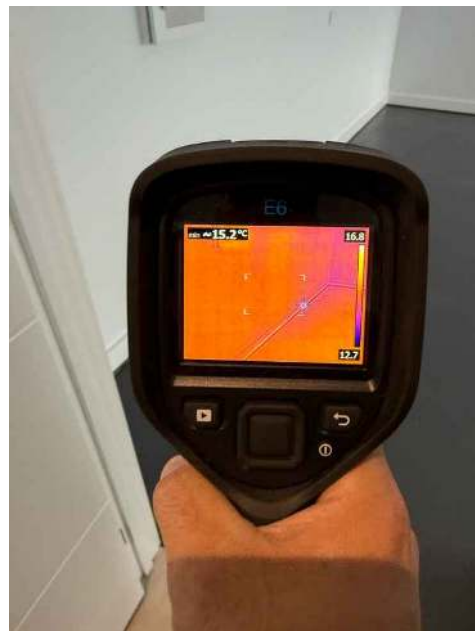
No abnormal heat signatures or areas of concern were detected during the thermal imaging scan. Only minor thermal leakage was observed, which is typical for a h

Overall, the readings were consistent with normal thermal behaviour and did not suggest hidden moisture, insulation gaps, or other underlying issues.

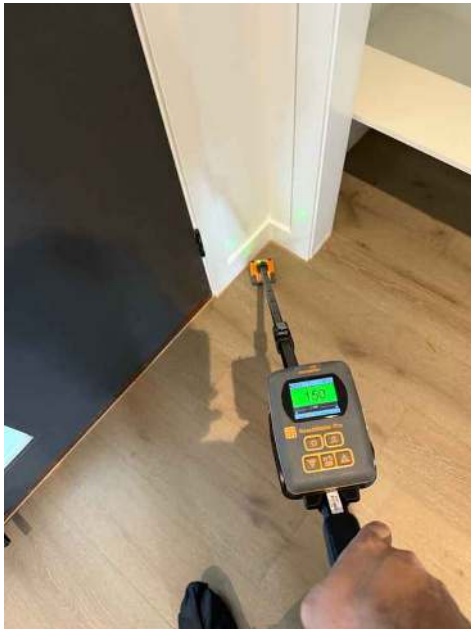
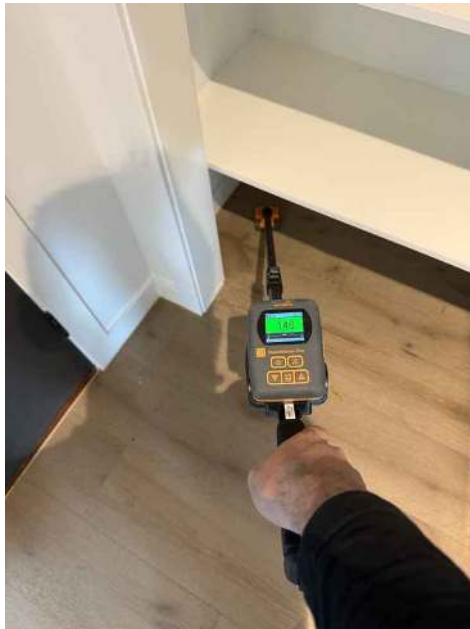
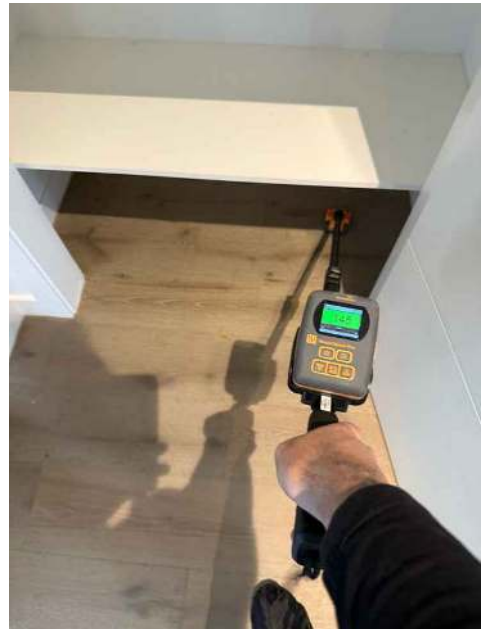
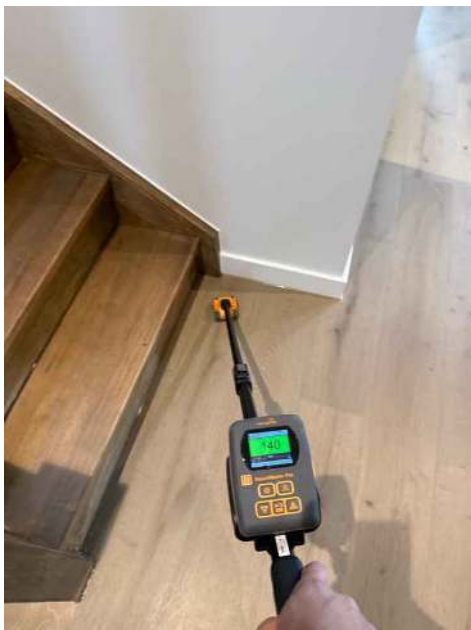
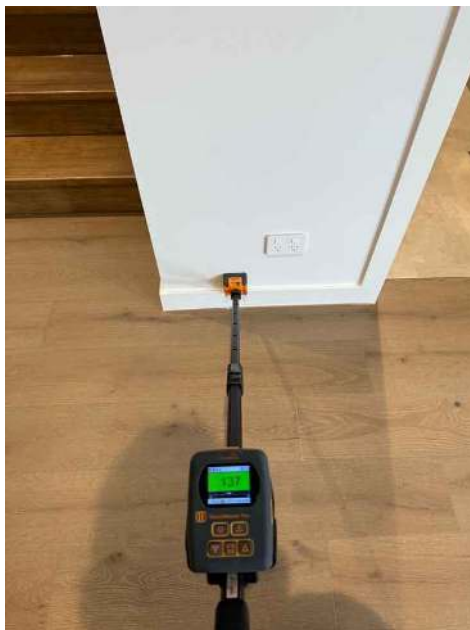
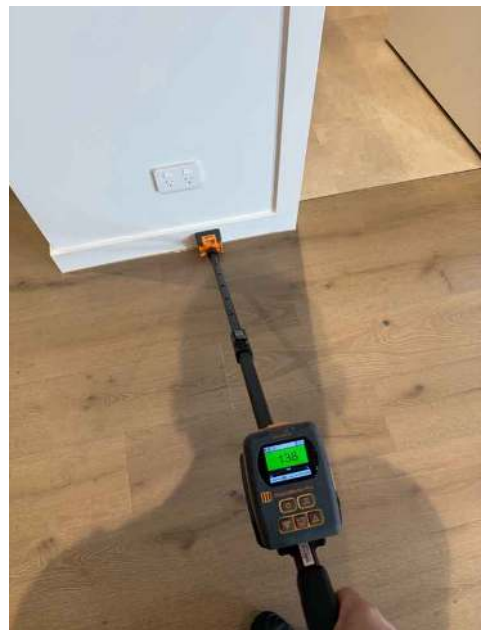
## 5.2.1 Moisture scanning

Moisture scanning was carried out on the water main incident. No elevated indications of concern during the

roughout the ground floor, including moisture readings were detected.

The results were consistent with a dry environment and did not suggest any ongoing moisture issues.

Recommendation

Contact a qualified professional.
