OWNER INSPECTIONS

## LOCK-UP (PRE-PLASTER) INSPECTION

Sample Property

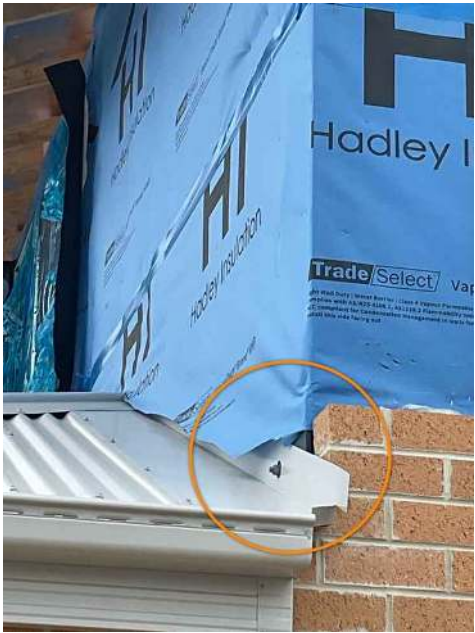
3.1.1 + Sarking  
**+ OVERLAP SARKING OVER FLASHING**

Front. Lap sarking over flashing

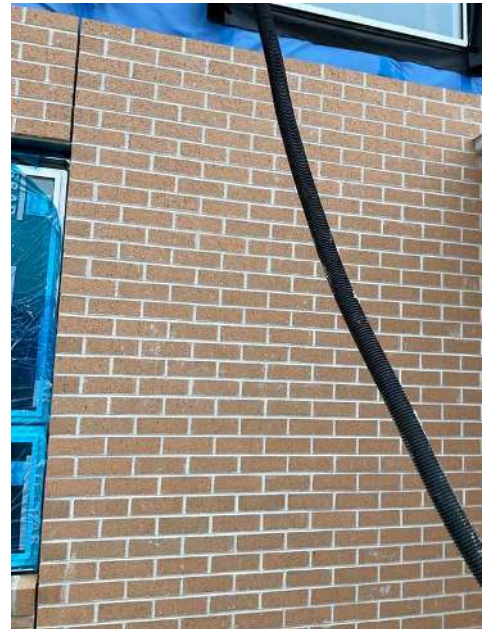
Brickwall yet to be washed by acid. A hydrochloric acid solution is commonly used to remove mortar stains from clay brickwork.

**3.07:** Unless documented otherwise, masonry faces are defective if they are not cleaned and free of excess mortar.

**3.11:** Stains, mortar smears and damage caused by cleaning are defective if they are visible from a normal viewing position.

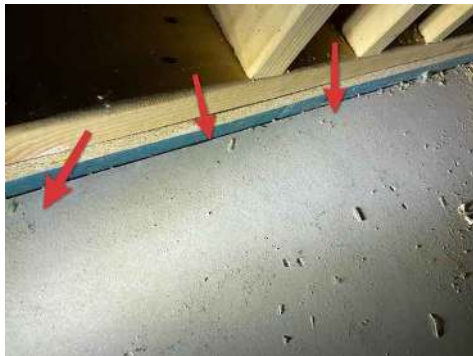
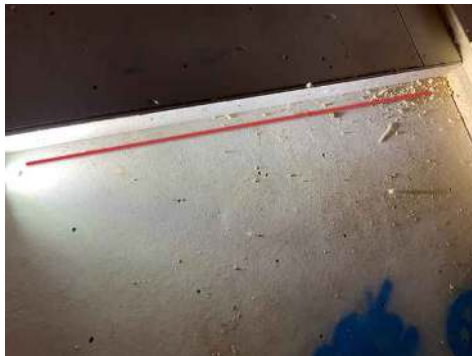
#### **SHOWER FC FLOORING NOT NAILED AT EDGES PROPERLY**

The FC sheet has pre marked dots where nails must be installed. For shower flooring It is critical the correct fixing method is followed to prevent movement at floor/ wall junctions.

Ensure all shower flooring is properly nailed.

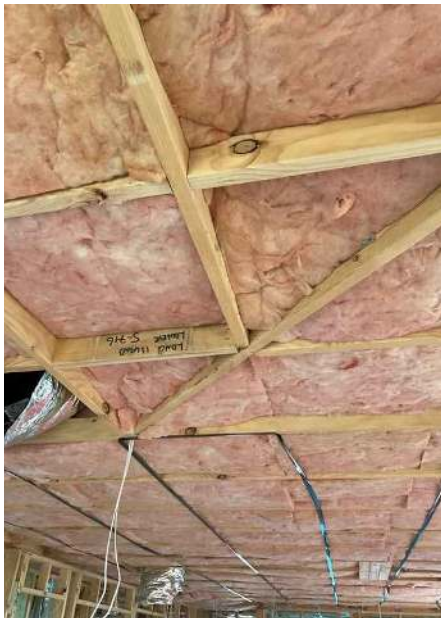
#### Gas Pipes: Access is limited by insulation batts

Access is limited by insulation Matt's.

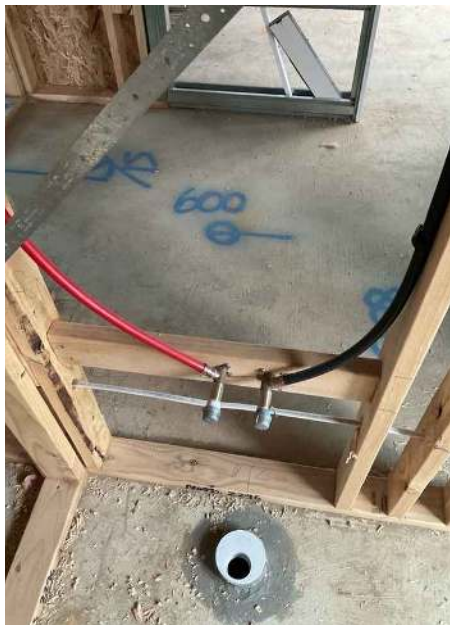
#### Water Pipes: Pressure Test Required

Plumber to confirm all lines have been pressure tested prior to plastering works progressing.

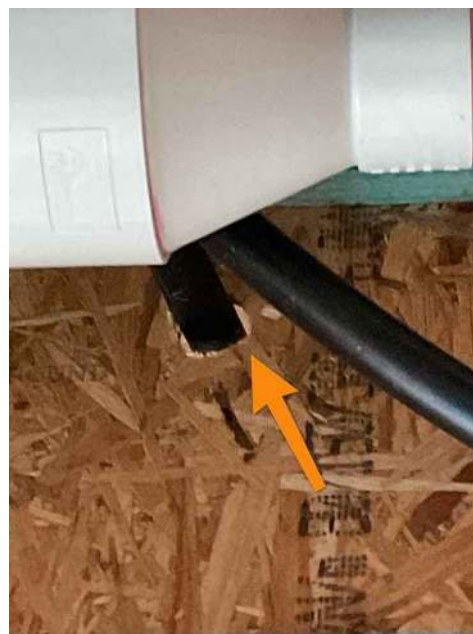
Water pipes not secured, siliconed at I joists. Must be secured at 600mm centres.

Silicon to be applied around all holes where water pipes passing by through the stud/plates/noggings to secure loose pipes and preventing future water hammering.

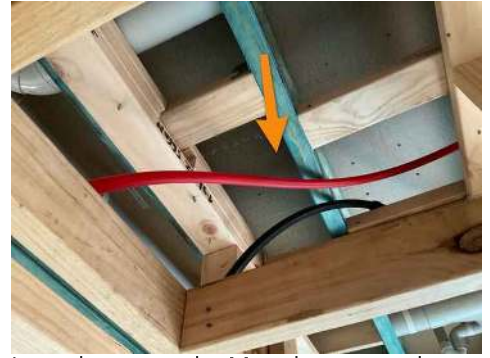
#### + NOT SECURED

One or more pipes are not fully secured. All pipes need to be secured to timber frame using clips to prevent movement and water hammering. An additional clip is required.

Laundry example. Must be secured at 600mm centres to prevent water hammer

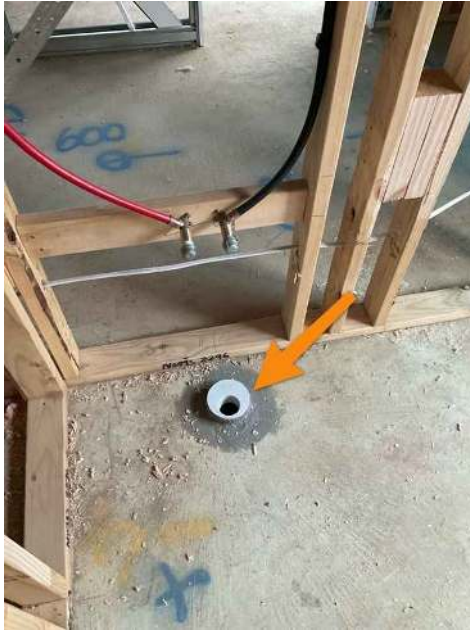
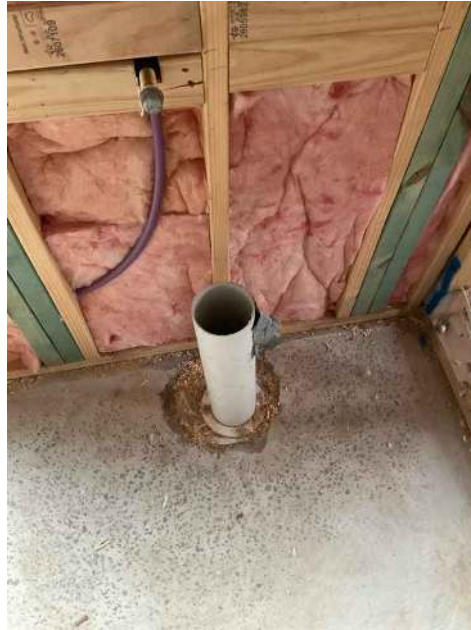
#### + SEWER PIPES NOT CAPPED

One or more sewer pipes are not capped. The material and debris can fall into the pipes and block the sewerage system. Cappings to be installed ASAP.

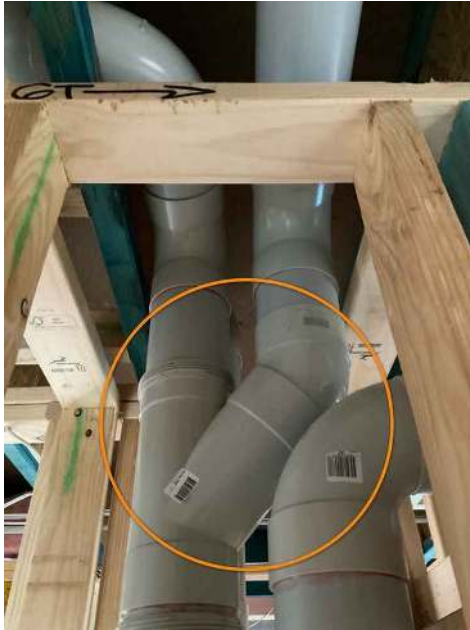
Ground Floor

**JUNCTIONS INSTALLED WITHIN 600MM EXCLUSION ZONE OF STACK VOID**

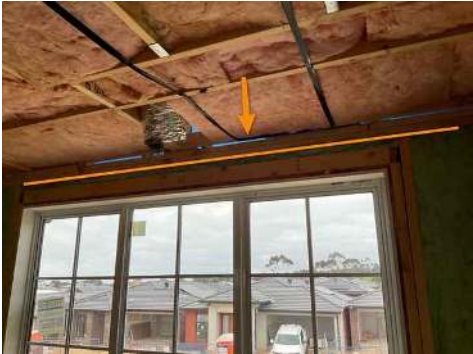
Master Bedroom front.

### + SOME INSULATION BATTS MISSING

The insulations are installed, however, one or more insulation batts were missing at the time of inspection. Builder to ensure all insulation batts are installed prior to the commencement of plaster installation.

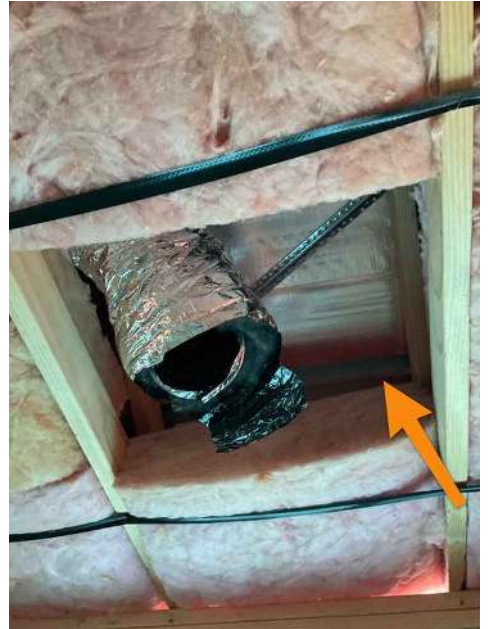
**CEILING PENETRATIONS NOT INSULATED**

Where the insulation has been removed for services, it must be replaced.

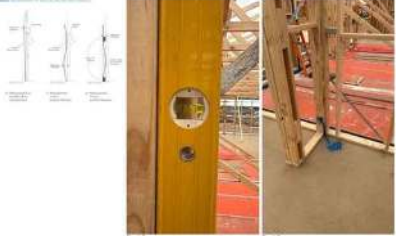
**Guide to Standards and Tolerances - 4.02**

Posts and wall frames are defective if they deviate from vertical by more than 5 mm over a 1.8 m height (refer to diagram E).
