INVESTIGATION REPORT

1234 Main Street
Melbourne, VIC 3000

Buyer Name
22/02/2023 9:00AM

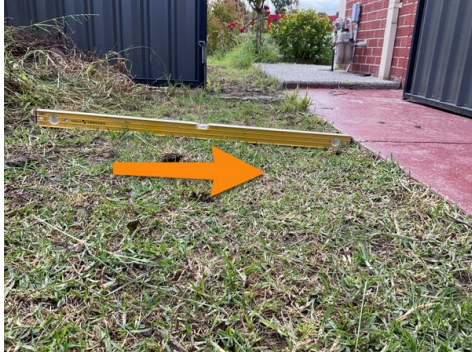
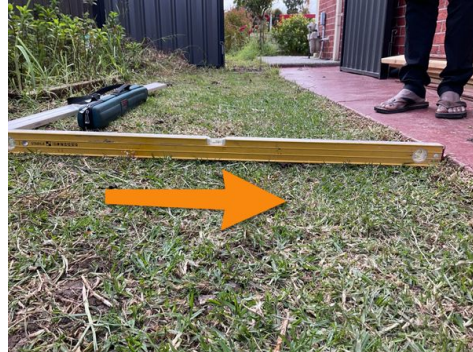
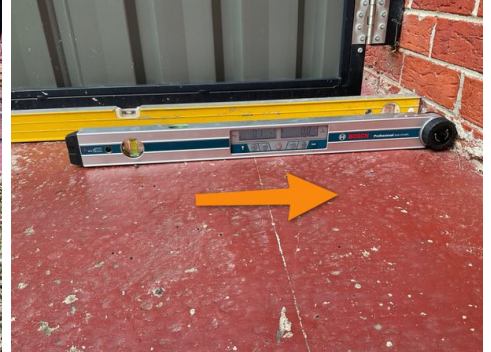
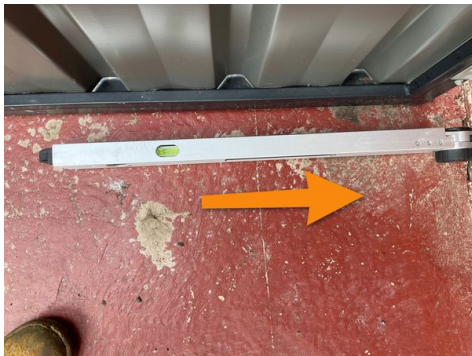
2.2.1 Surface water

GROUND AND PAVING SLOPED TOWARDS DWELLING

The ground and concrete paving to the right hand side of the property is sloping towards the dwelling. It is important to direct surface water away from the dwelling. Underneath the concrete paving may not be sloped away from the dwelling, therefore it is important to ensure surface water to the areas adjacent to the concrete paving also does not grade towards the paving. Recommend a spoon drain and silt pits to channel surface water away from the dwelling to these areas.

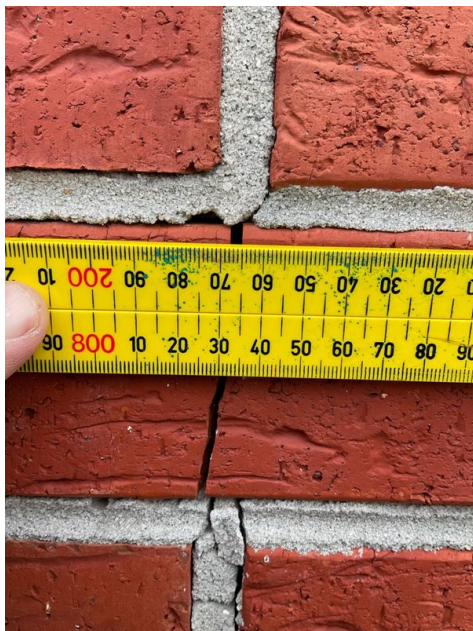
CRACKING - MAJOR - CATEGORY 2 (1MM - 5MM)

Brick and/or stone veneer showed cracking in one or more places. Cracks are wide enough to allow moisture intrusion to the supportive wall leading to internal and termite damage.

Right of window. 2.5mm

A Structural Engineer is required to determine the significance of the cracking.

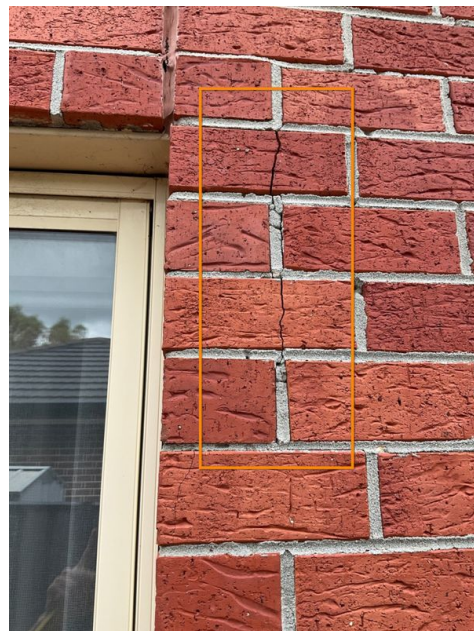
Right of window. 300mm long

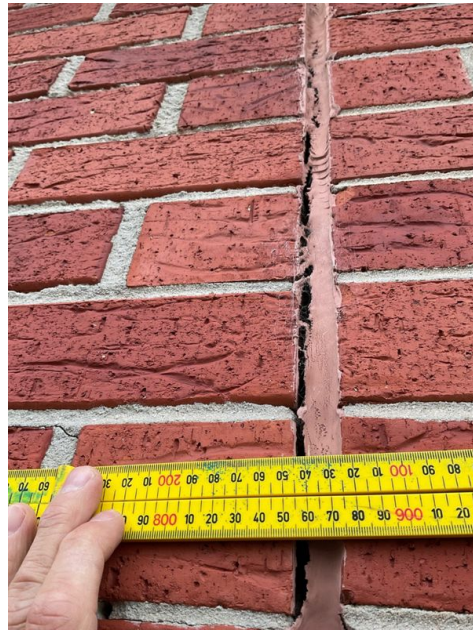
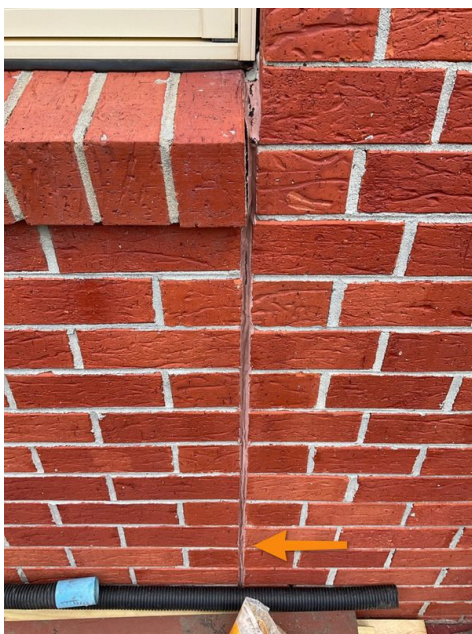
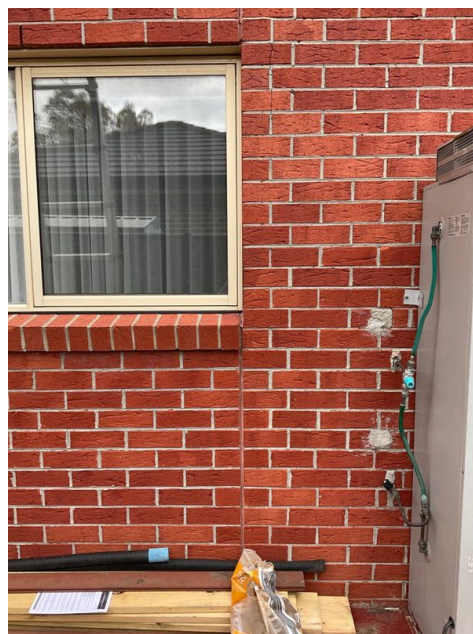
3.1.2 + Wall Claddings

MOVEMENT NOTED TO ARTICULATION JOINT AT RIGHT FRONT OF THE PROPERTY.

Movement noted to the articulation joints, which may be related to the surface water drainage issue.

Folding of Aj. Right Front

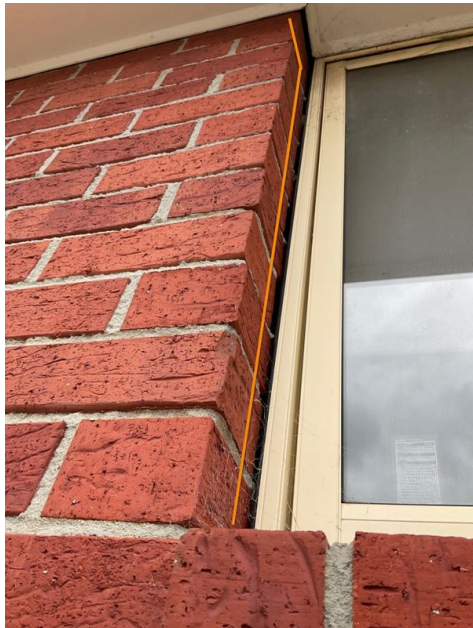
GAP TO WINDOWS

Large gaps are evident to the property at window and door openings. Recommend sealing these gaps

7-10mm. Right Front

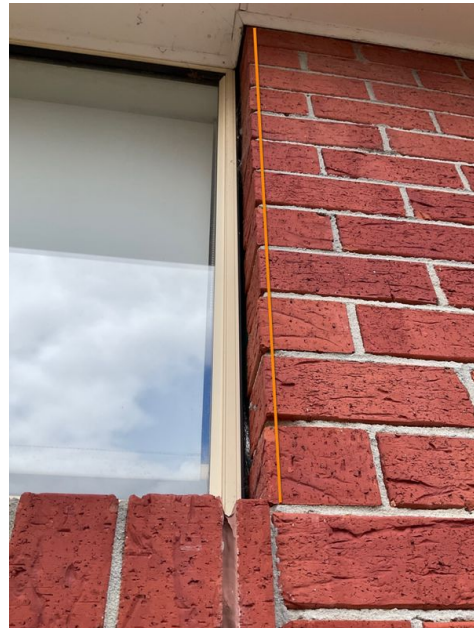
7-10mm. Right Rear

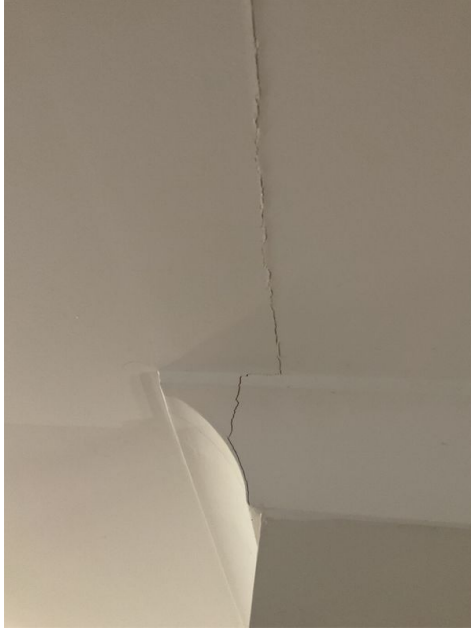
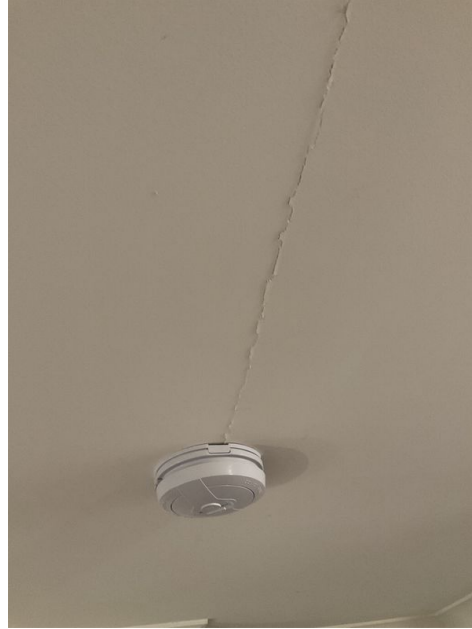
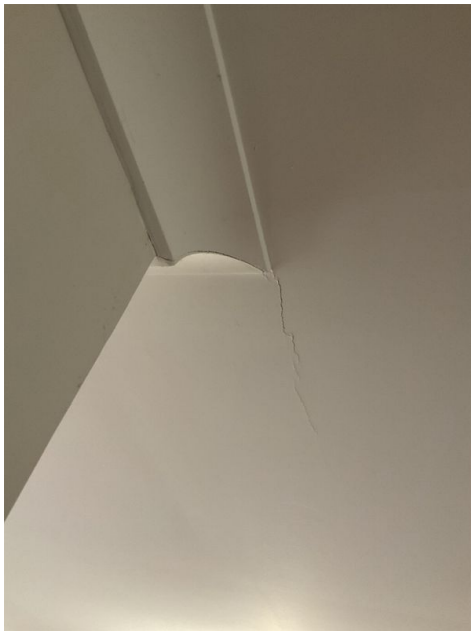
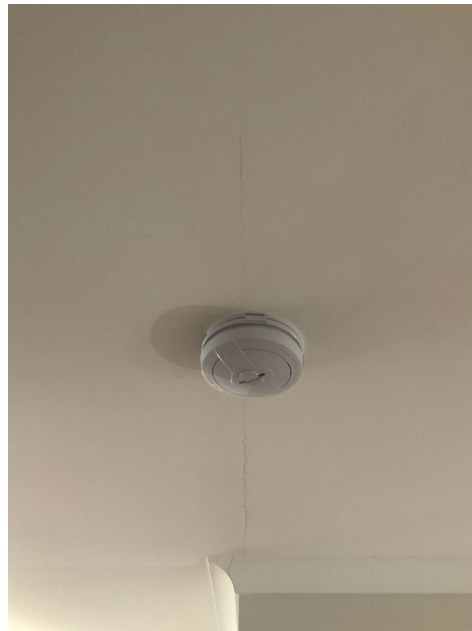
4.1.1 Cracks

MINOR CRACKS

Cracks noted to the rumpus room ceiling. Due to the movement evidence to the exterior of the dwelling, it is of my opinion that these are ground movement cracks that relate to the surface water issue on the right hand side of the property.
