OWNER INSPECTIONS
1300 471 805
booking@ownerinspections.com.au
https://www.ownerinspections.com.au/

PRE-PURCHASE INSPECTION (BUILDING & PEST)

Sample Property

21/08/2026

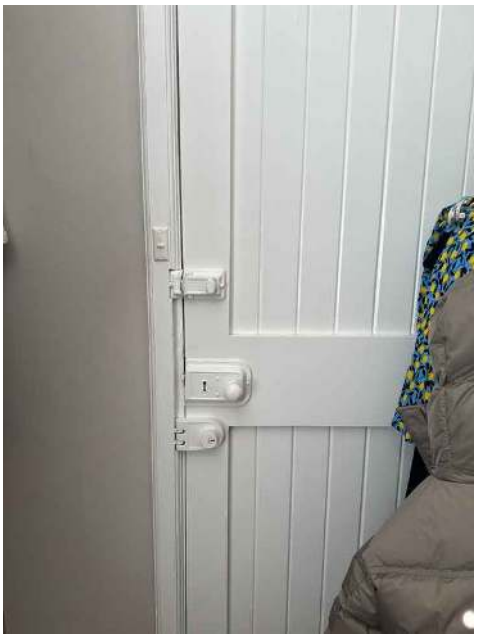
LOCKED DOOR

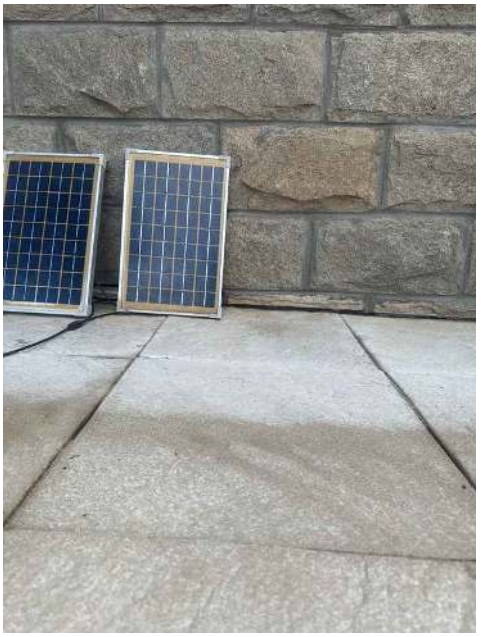
6.2.2 + Cladding (Masonry)

BRICKWORK CONDITION

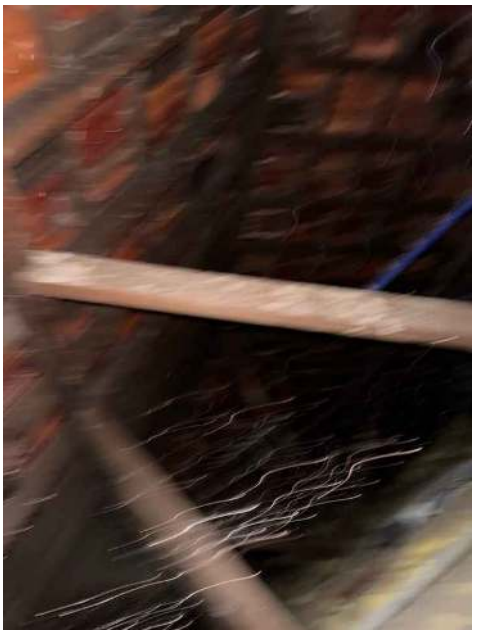
General views of the roof space
