INVESTIGATION REPORT

Sample Property

21/08/2026

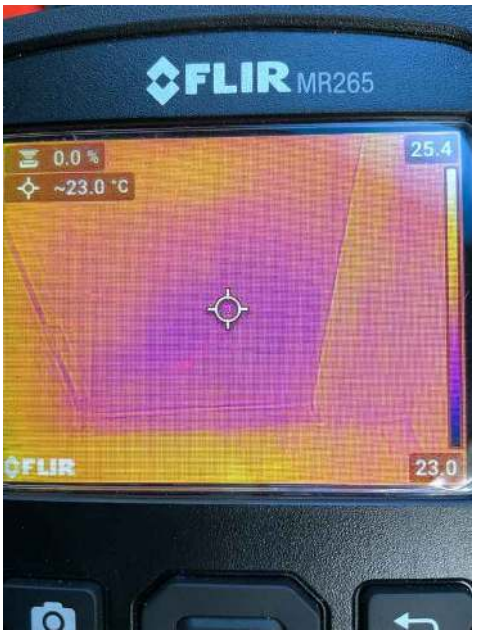
Ensuite water leak: **Water leak**

On inspection. It was found that initial the tenant had noticed a water leak to ensuite.

Remedial work is currently underway way to rectify the problem.

On a closer look there was mould found under carpet at the doorway to the ensuite. At a closer look area was dry yet mouldy. Possibly created by original water leak.

There was no other signs of water leaks at this point.

FLIR MR265
0.0 %
~23.0 °C
25.4
23.0
FLIR
