DRUG RESIDUE TESTING

Sample Property

25/09/2026

1.1.1 Drug residue test - General: Information

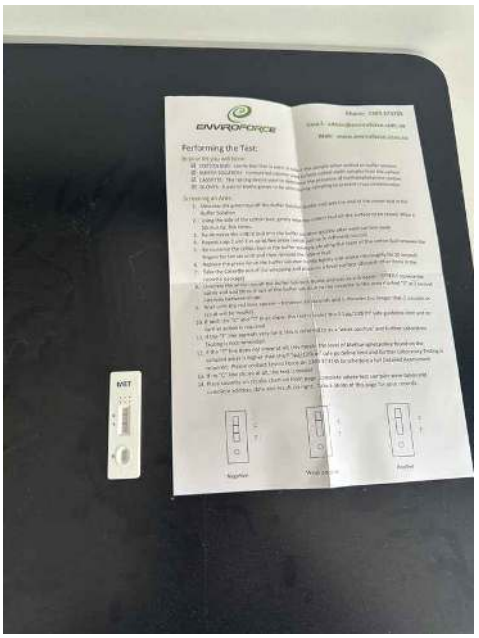
1.1.1 General

1. Kitchen, power point: no positive reaction. PASS
2. Upstairs, Room 1: no positive reaction. PASS
3. Room 2: no positive reaction. PASS
4. Garage: no positive reaction. PASS

All four locations returned a PASS result. None showed a positive reaction for methamphetamine residue.

The screening kit did not detect methamphetamine residue at any of the locations sampled. Based on these results, no further action is recommended at this time.
