PRE-PURCHASE INSPECTION (BUILDING ONLY)

Sample Property

Inspector
Ibrahim Durdu
Registered Building Practitioner
1300 471 805
booking@ownerinspections.com.au

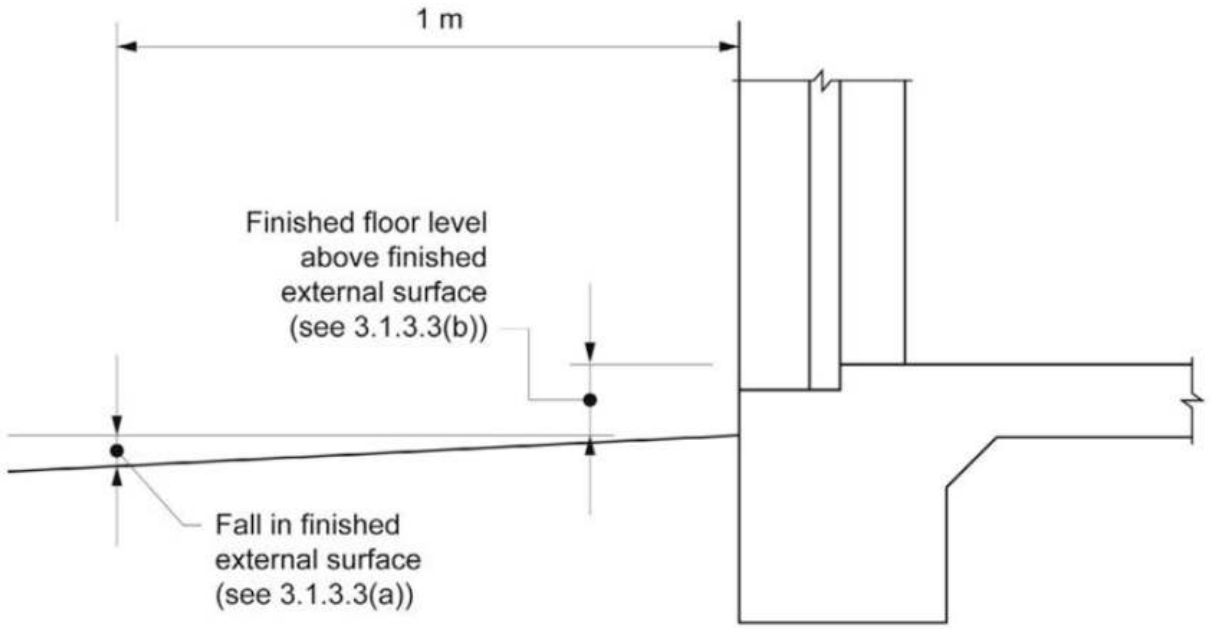
Figure 3.1.3.2 Site surface drainage

Grading is sloping towards the home in some areas. This could lead to water intrusion and foundation issues. It put the building in the risk of termite attack. Recommend ensuring proper drainage was installed to facilitate water movement away from home.
