FIXING (INC. WATERPROOFING) INSPECTION

Sample Property

17/09/2026

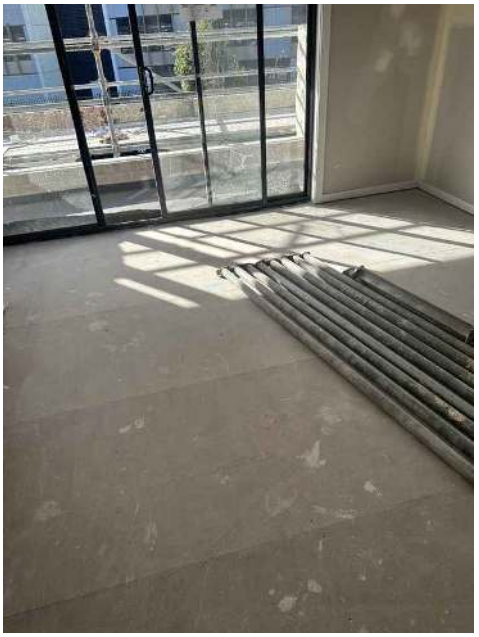
+ GENERAL VIEW

General view(s) of the area at the time of inspection.

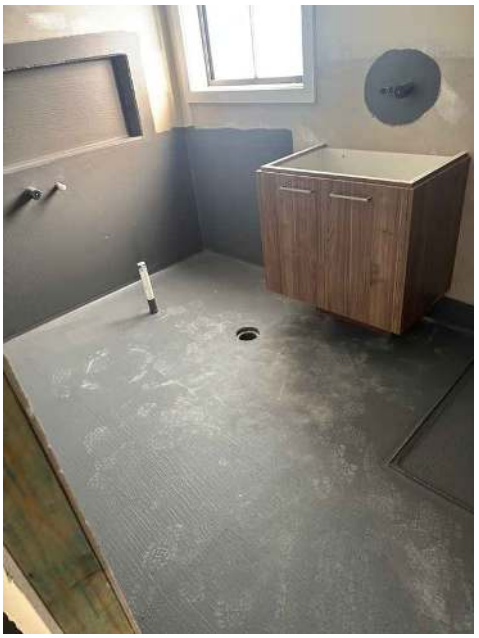
+ GENERAL VIEW

General views of Bathroom at the time of inspection.

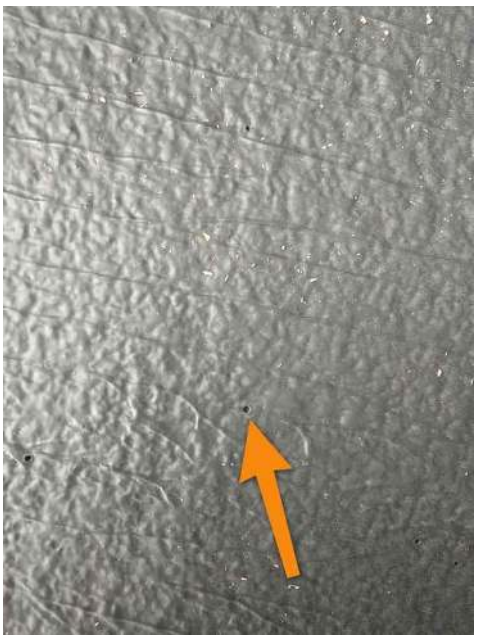
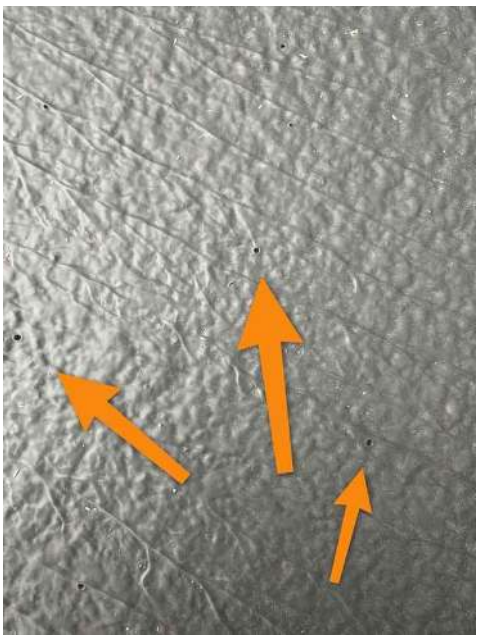
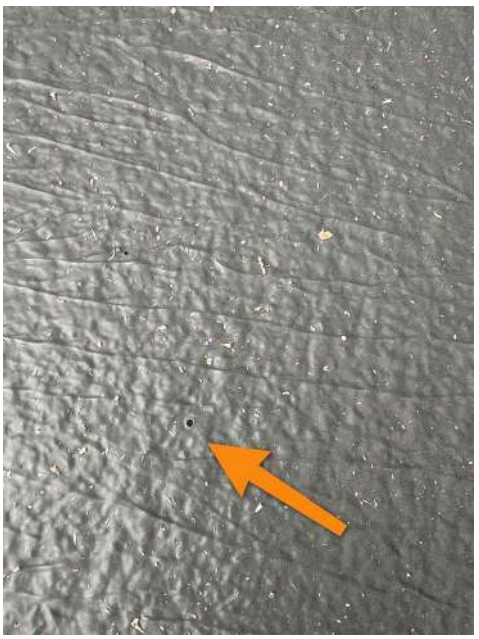
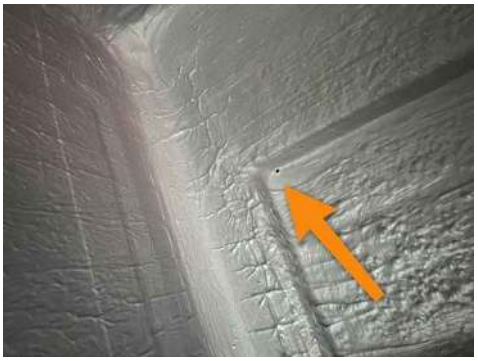
22.9.1 + Waterproofing

Pinholes were observed in the waterproofing membrane within the shower recess.

Recommendation: Recommend a licensed waterproofer rectify the pinholes prior to tiling to ensure a continuous, watertight membrane, in accordance with AS 3740 (Waterproofing of Domestic Wet Areas).
