PRE-PURCHASE INSPECTION (BUILDING & PEST)

Sample Property

08/09/2026

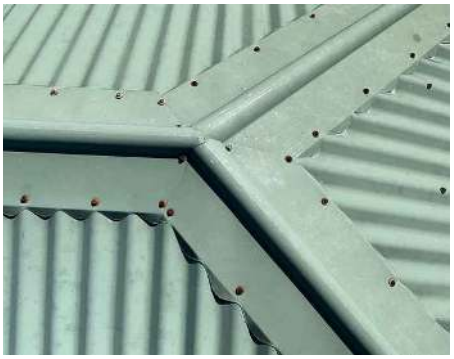
+ General: + General Views of the Roof

The roof sheets look fine. Rusty screws to roof should be replaced to prevent any more deterioration

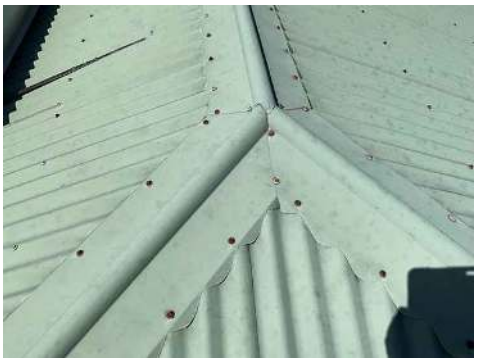
Roof has rusty screws and has been siliconed/repaired before

Contact a qualified professional.

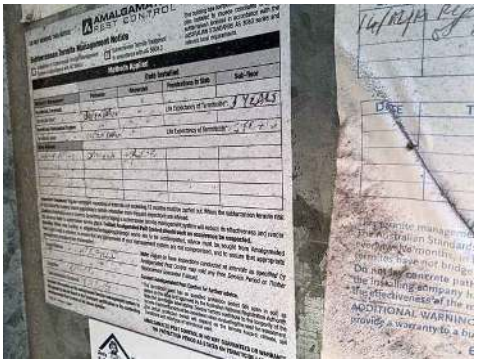
Termite notice found but unable to read

Contact a qualified professional.
