INVESTIGATION REPORT

Sample Property

Suburb withheld, QLD

04/09/2026

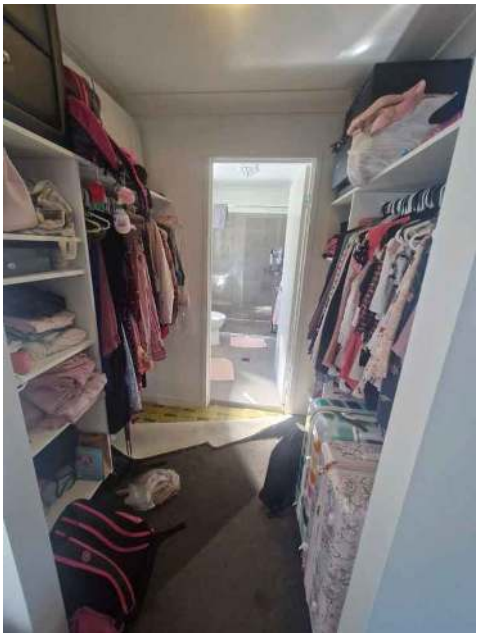
STORED MATERIALS & FURNITURE

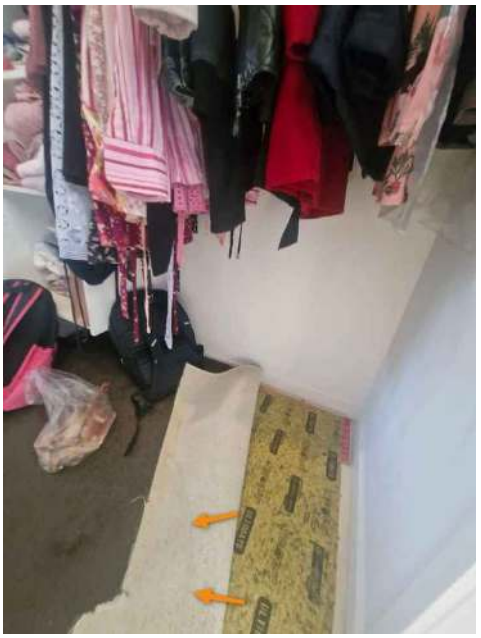
2.4.1 Floors

DRY MOISTURE MARK

Dry moisture marks were observed on the skirting and yellow tongue flooring walking robe. The affected door jamb at the time of the inspection, indicating evidence of previous moisture exposure.

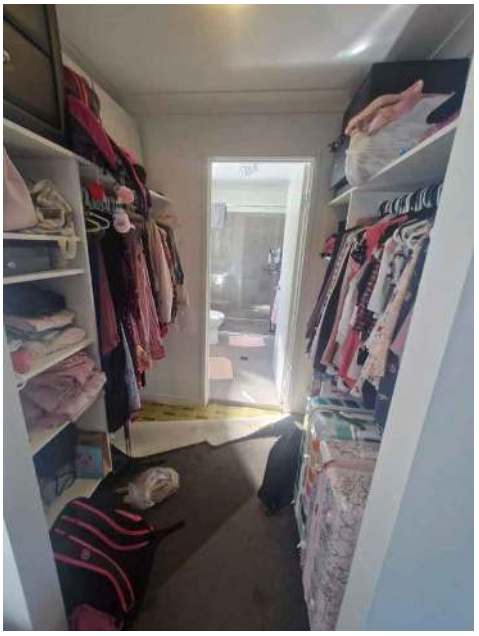
STORED MATERIALS & FURNITURE

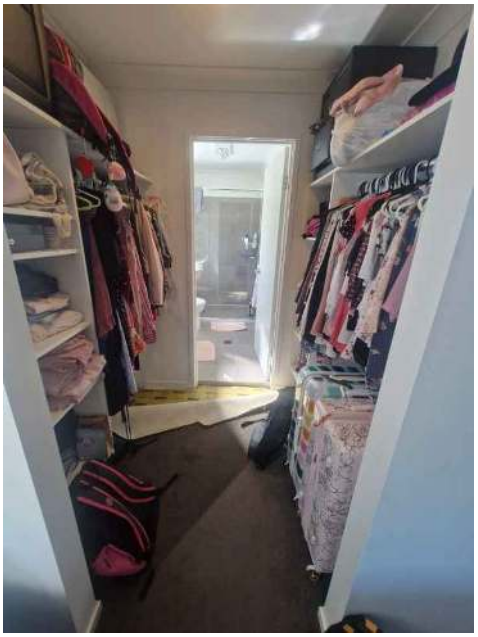
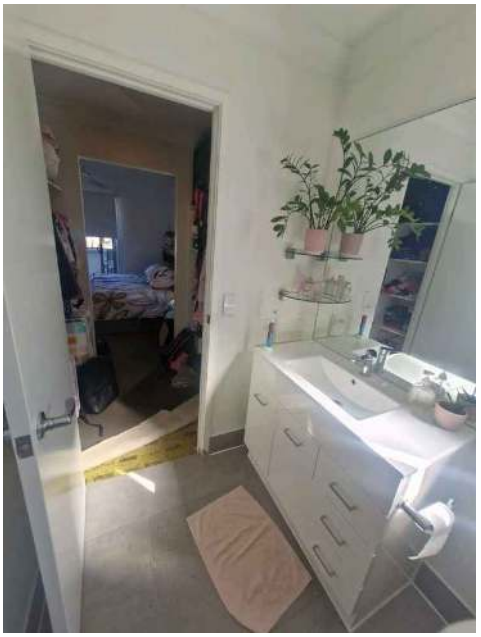
GENERAL VIEWS OF THE AREA/ROOM

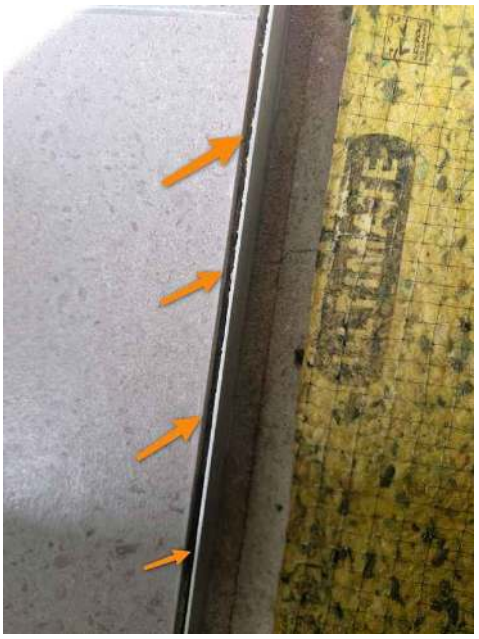
FLOOR

Gap between the tile floor and edga angle. Recommend to engage a qualified tiler to seal completely the gap, to prevent water from penetration the floor.
