# PRE-LISTING INSPECTION (BUILDING ONLY)

Sample Property

18/11/2025

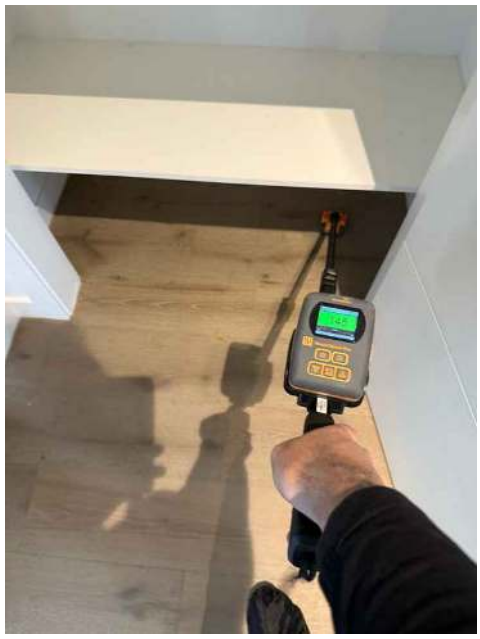
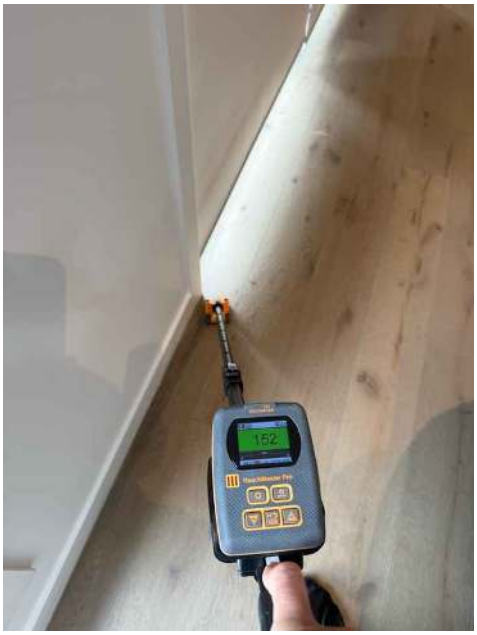
5.2.1 Moisture scanning

Moisture scanning was carried out throughout the ground floor, including all areas previously affected by the water main incident. No elevated moisture readings were detected, and there were no other indications of concern during the assessment.

The results were consistent with a dry environment and did not suggest any ongoing moisture issues.
