WITNESS EXPERT REPORT (VCAT)

1234 Main St. Melbourne VIC 3000

Buyer Name
16/10/2021 9:00AM

Inspector
Maison Azdari
Registered Building Practitioner & Pest Inspector
1300 471 805
booking@ownerinspections.com.au

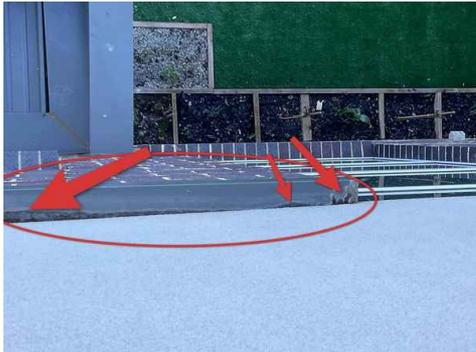
Front

+ INSUFFICIENT OR NEGATIVE SLOPE

National Construction Codes (NCC) - 3.5.4.8 Parapet capping:

(b) The top of the capping must slope a minimum of 5 degrees.

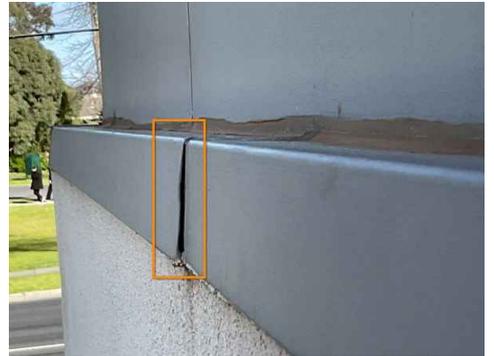
Right

+ SEALANT REQUIRED TO THE JOINTS

National Construction Codes (NCC) - 3.5.4.8 Parapet cappings:

(c)(iii) Capping must have sealant installed between laps.

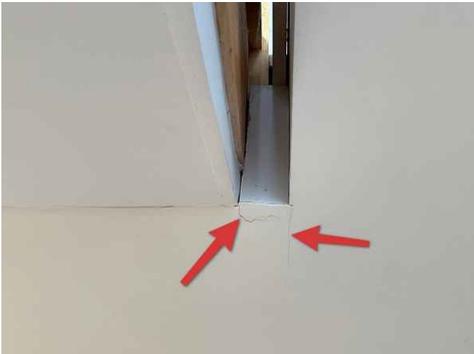
Stairs

Cracking at junctions between dissimilar materials is defective if it exists at handover or exceeds 1 mm in width within the first 12 months of completion and can be seen from a normal viewing position.

After the first 12 months, cracking that exceeds 2 mm is considered defective⁴.

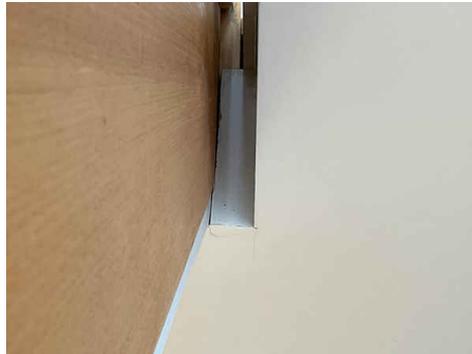
Several cracks were noted on the walls/skirtings/cornices throughout the dwelling and marked using the flagging tape as a defect according to *GUIDE TO STANDARDS AND TOLERANCES 2015*. These defects must be rectified prior to the handover.

The cracks to the stairs area seem to be structural cracks, however, it needs a further inspection and investigation by a registered engineer to find out the exact source of the crack reason and estimate the cost of repair.

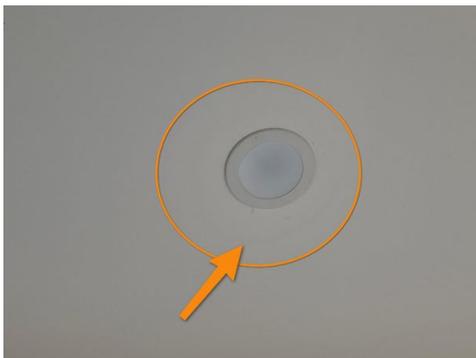
Dinning

10.3.4 + Ceiling/Wall plaster
WATER STAIN NOTED

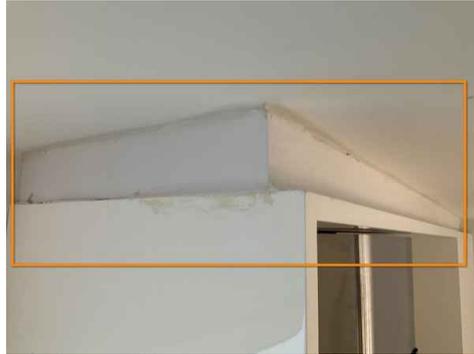
Kitchen

The quality of plaster over the kitchen overhead cabinet is poor. Replace the plaster and paint with the same colour as the dwelling walls.

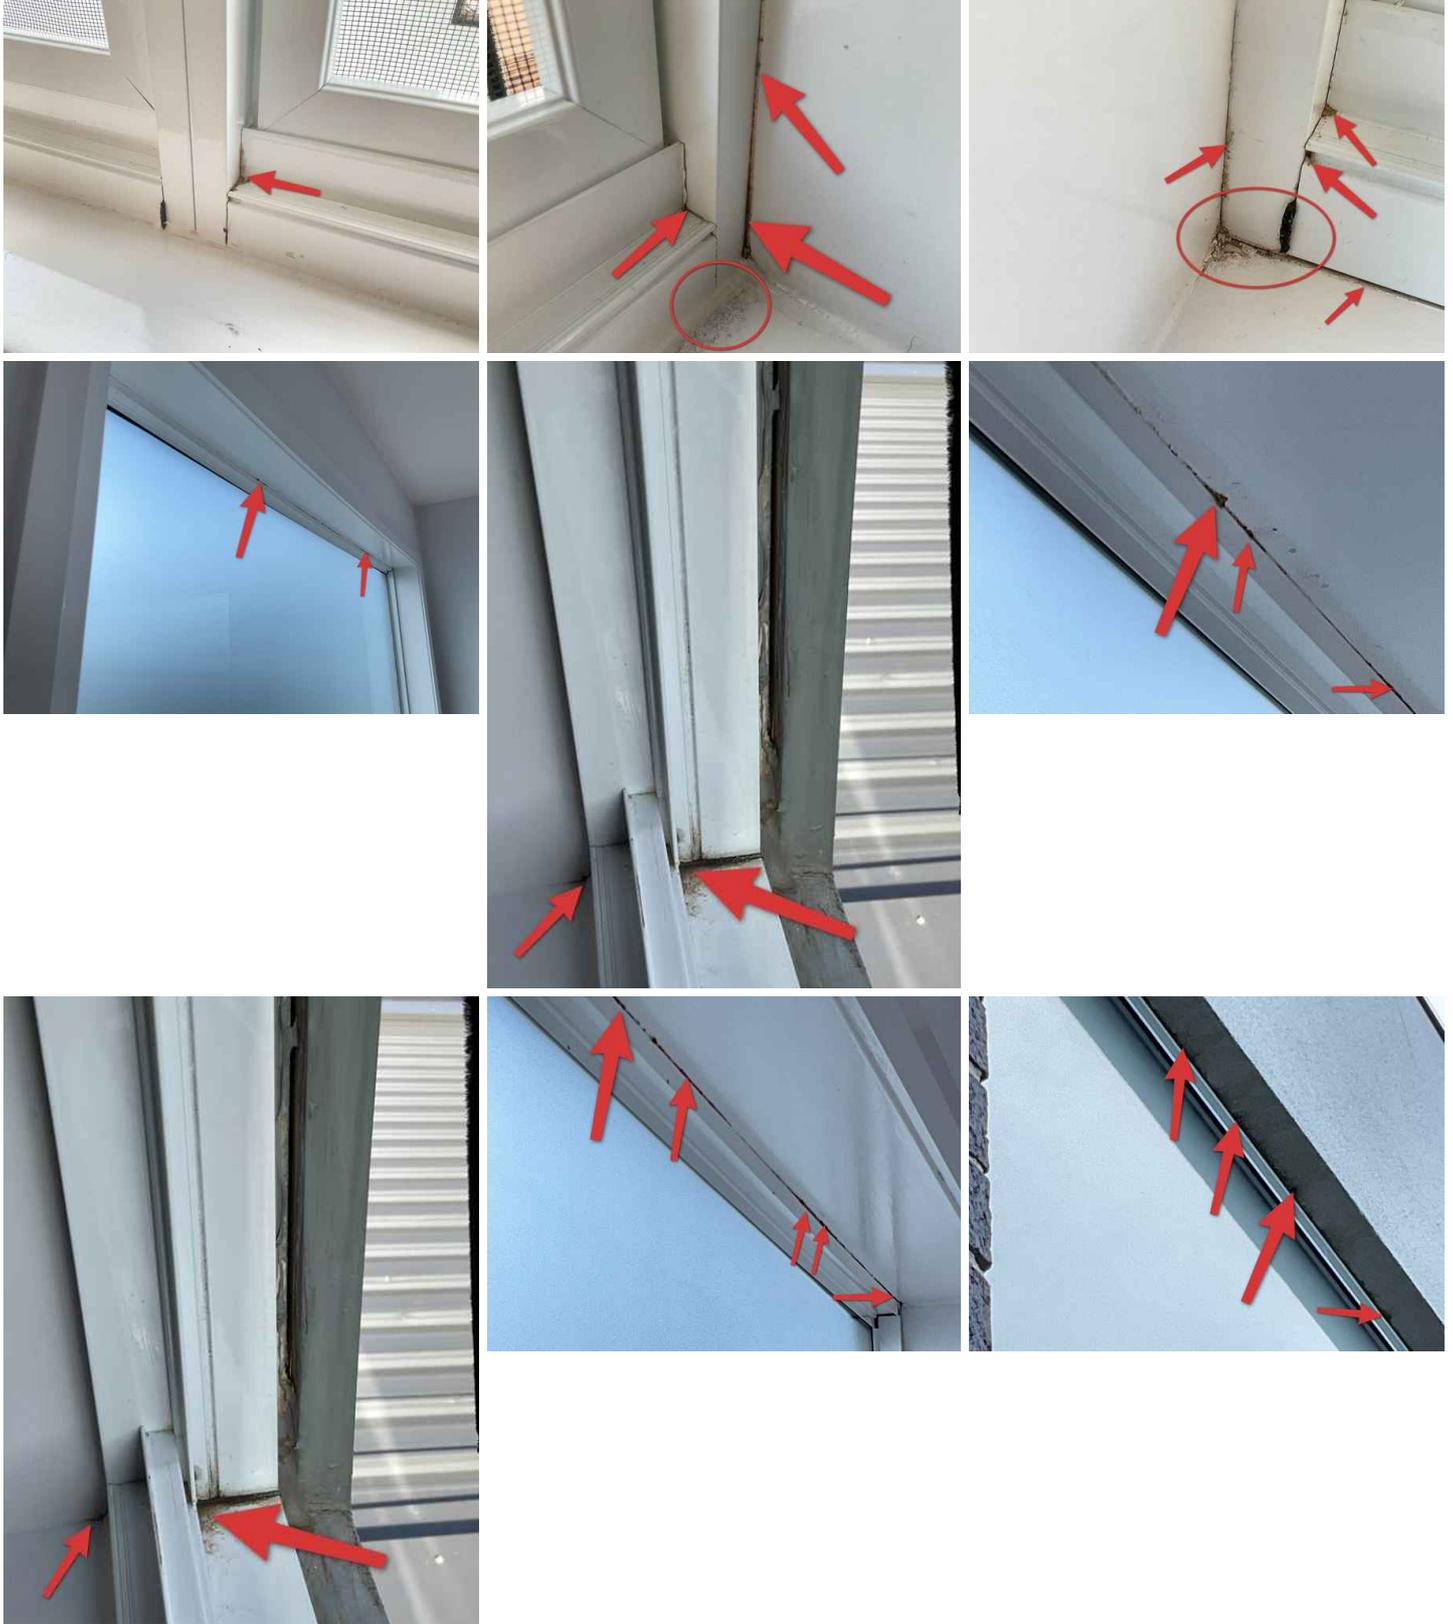
Mould noted in on the windows surface of bedroom 1 and 2 due to lack of caulking between the windows external and cladding joints. The joints to be caulked properly and the moulds to be removed for the health and safety of the residents.

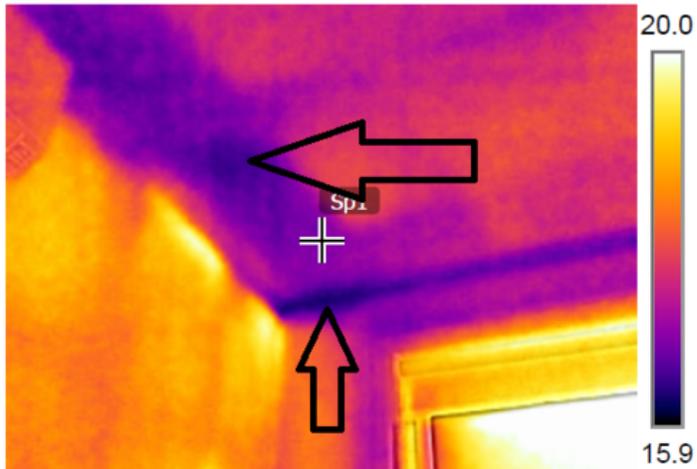
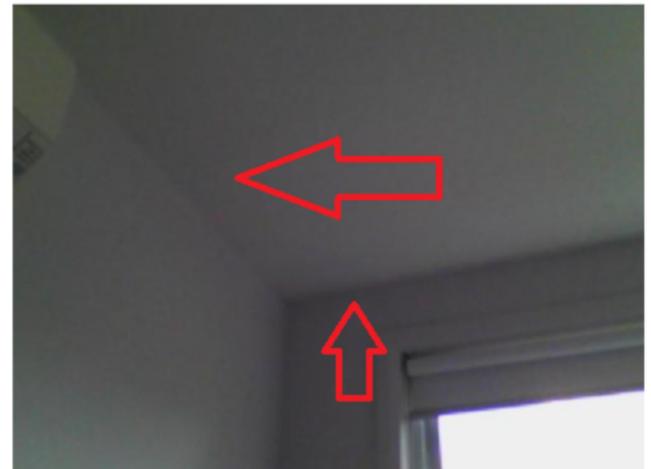
MOISTURE NOTED IN BEDROOM 2

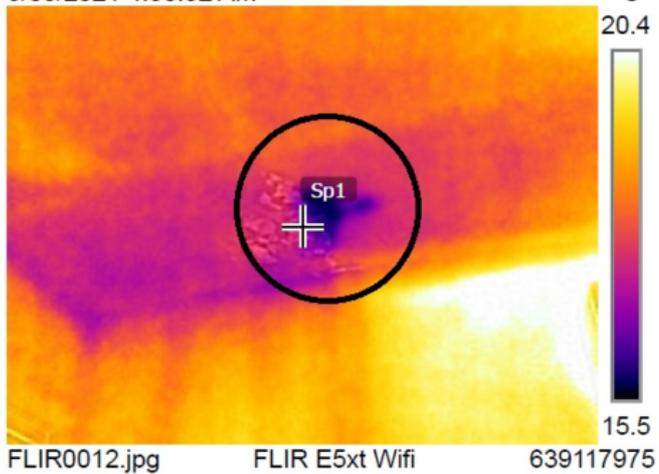
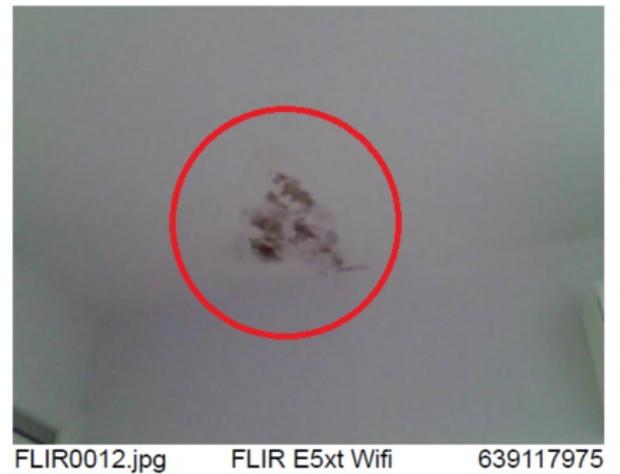
Bedroom 2 Ceiling - Water leak and mould

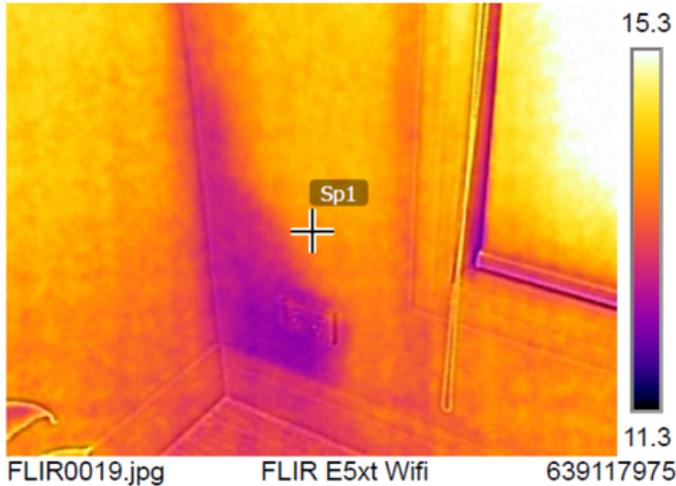
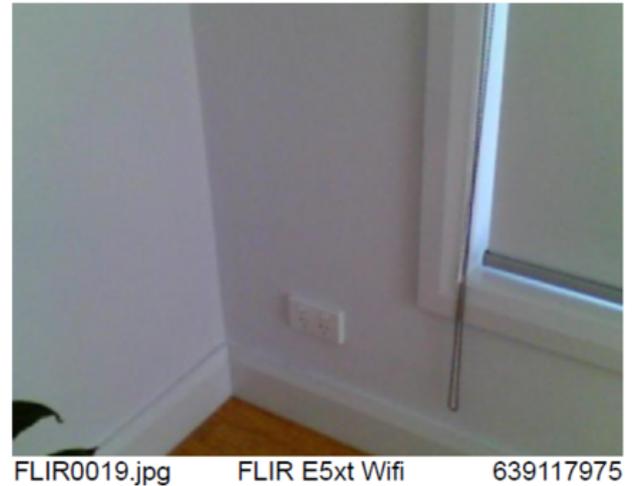
MOISTURE NOTED IN RETREAT AREA

Several moistures affected areas were detected in the retreat area southern wall. The source of the moisture seems to be from the negative grading flashing outside where the water stocks and can penetrate to the building slowly.

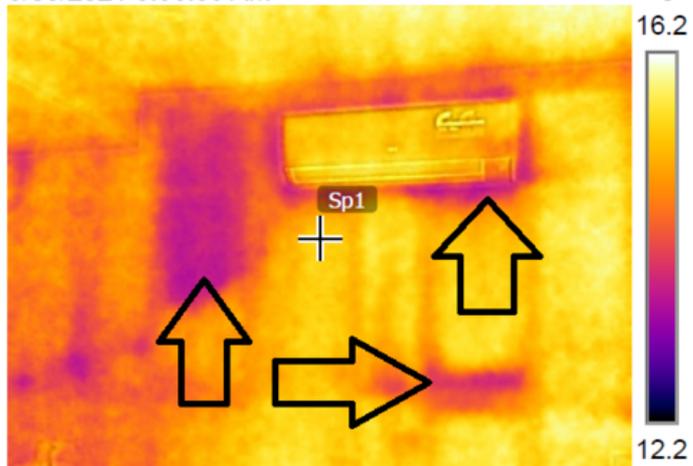
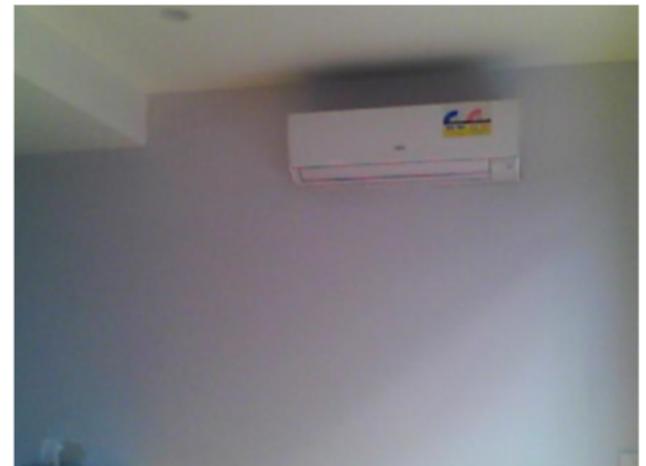
MOISTURE NOTED IN DINNING ROOM

Moisture was detected behind the dining room western sidewall (On the boundary). The source of the moisture is from the roof cladding and/or roof capping where the water can leak from the fixing members. (No silicon noted around the fasteners in the roof to prevent water from leaking inside).

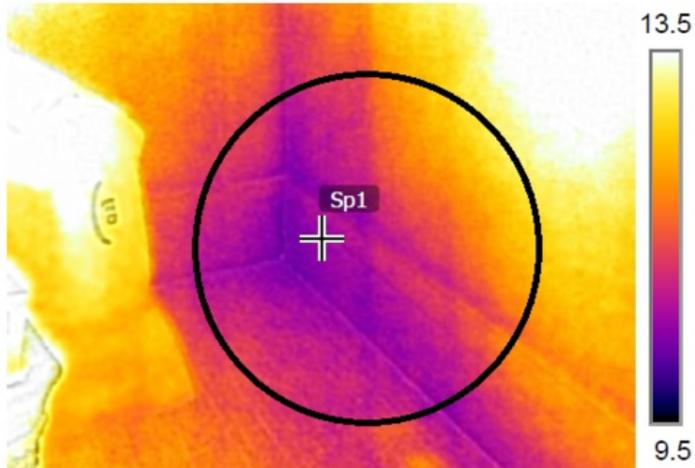
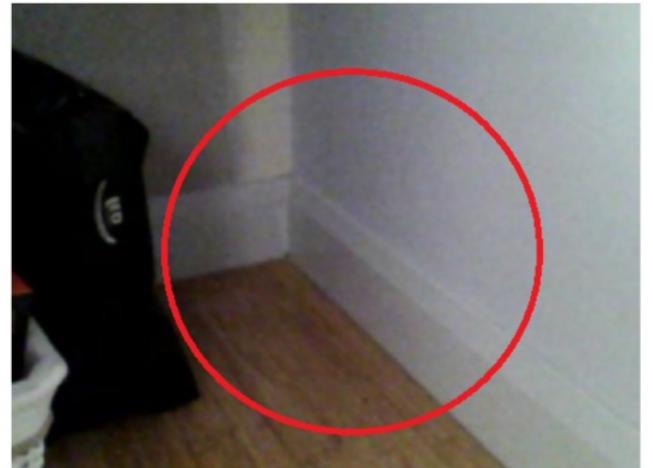
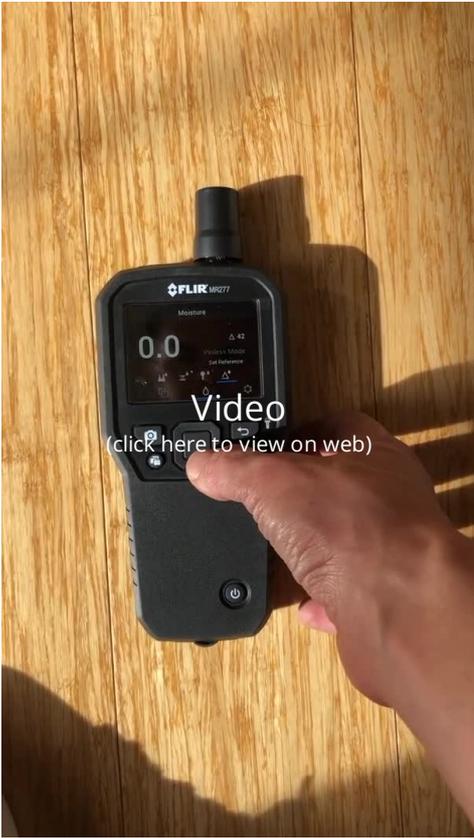
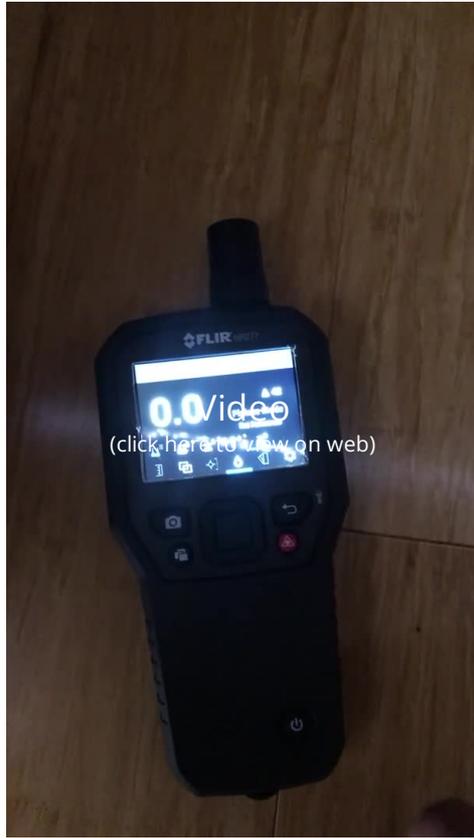
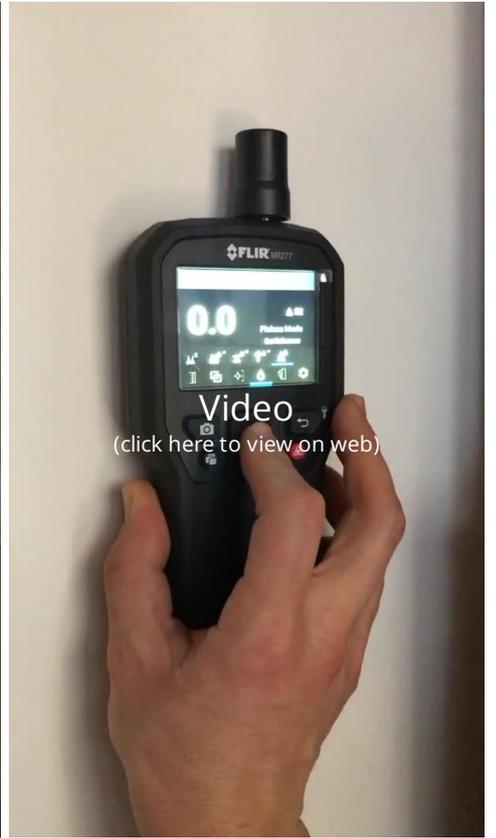
10.6.5 Water Leak/Damage

MOISTURE NOTED UNDER THE STAIRS SPACE

Moisture is found in the southern wall and floor in the space under the stairs. This area is located exactly under the retreat area and the affected area is in the line with the affected area upstairs. The moisture is leaking from the roof and travelling all the way to the ground floor.

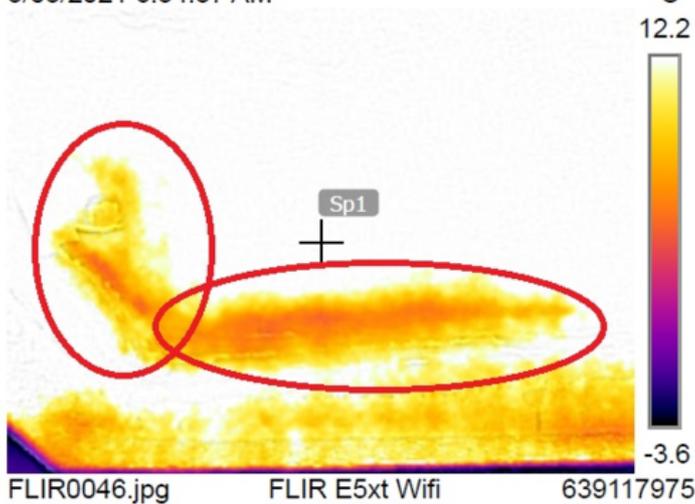
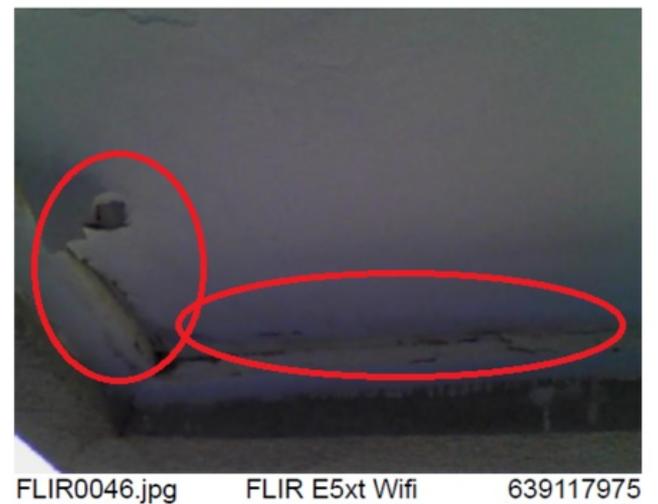
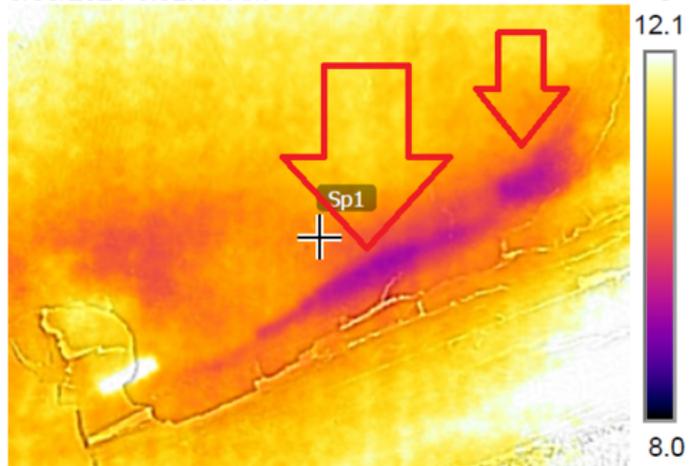
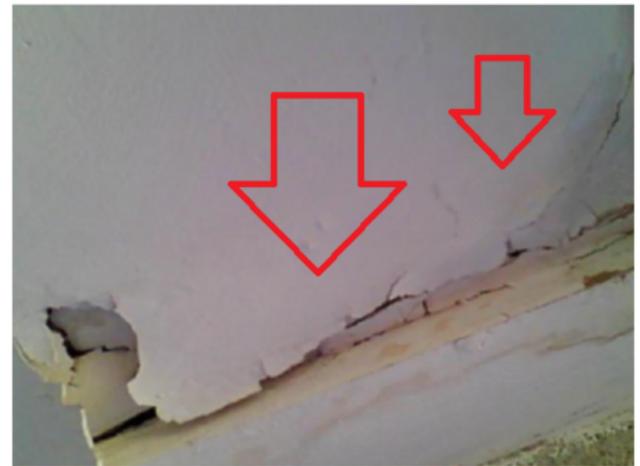
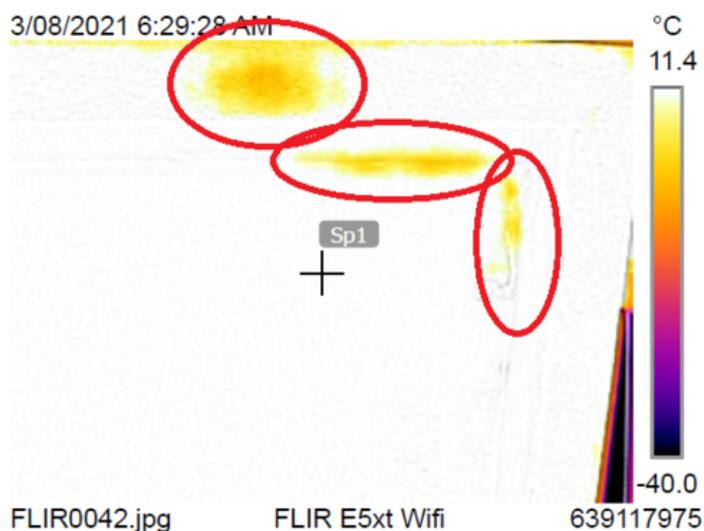
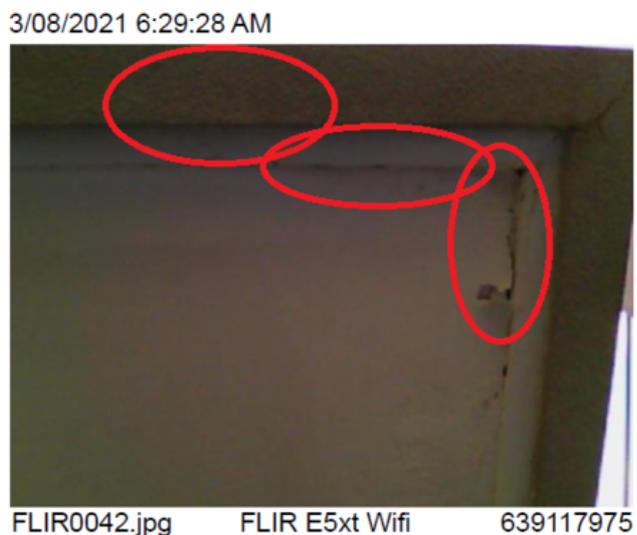
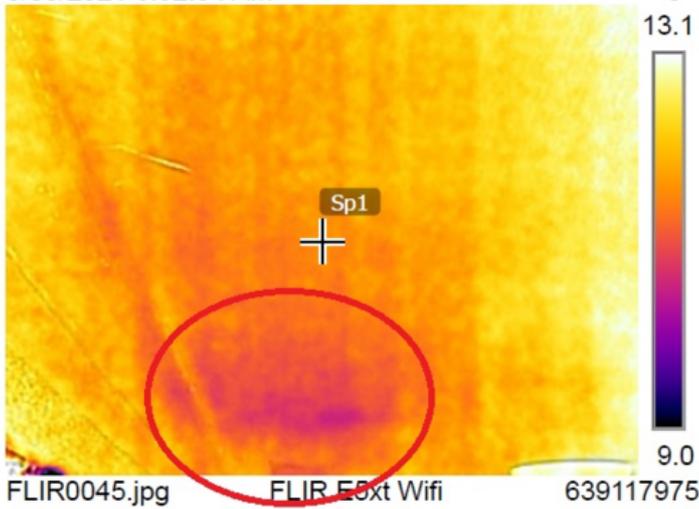
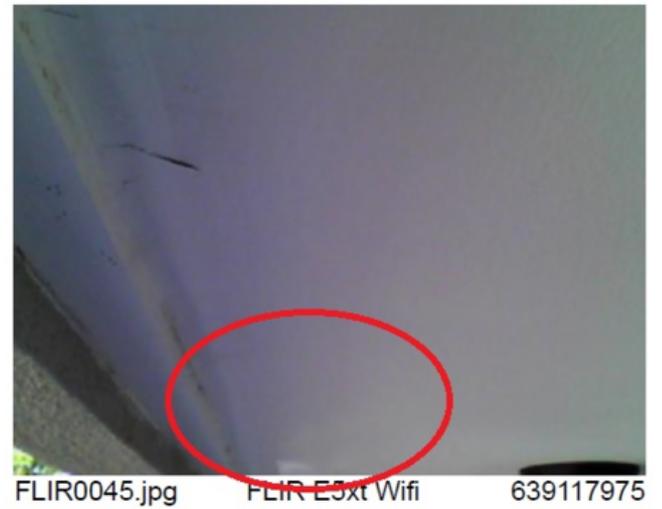
10.6.6 Water Leak/Damage

MOISTURE NOTED IN GARAGE FRONT (CARPORT) CEILING

The outdoor ceiling in front of the garage (carport) had several water/moisture affected areas. This area is located under bedroom2 which also has clear evidence of water/moisture damage/effect.

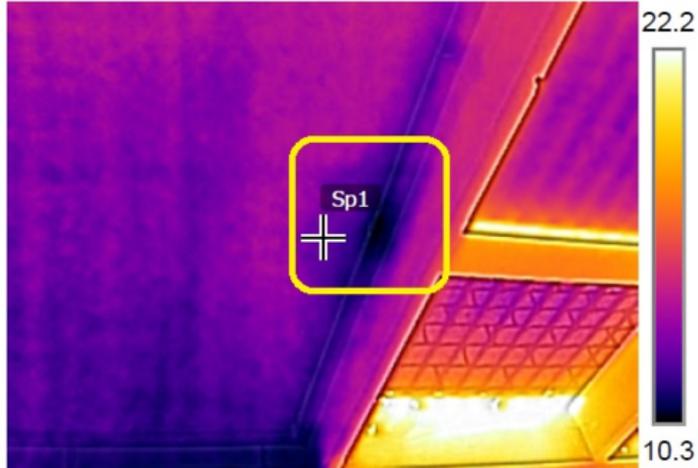
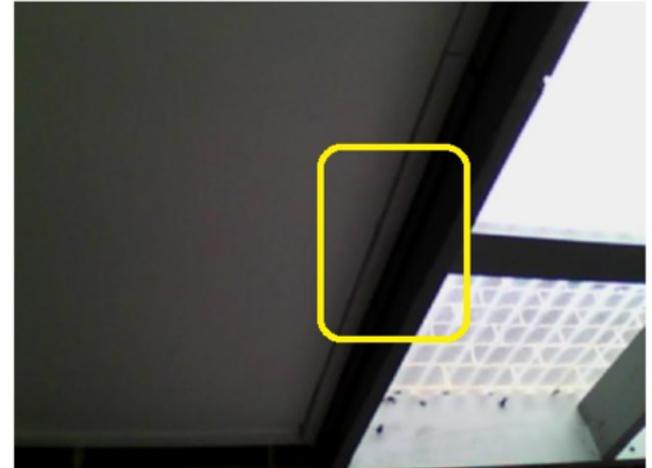
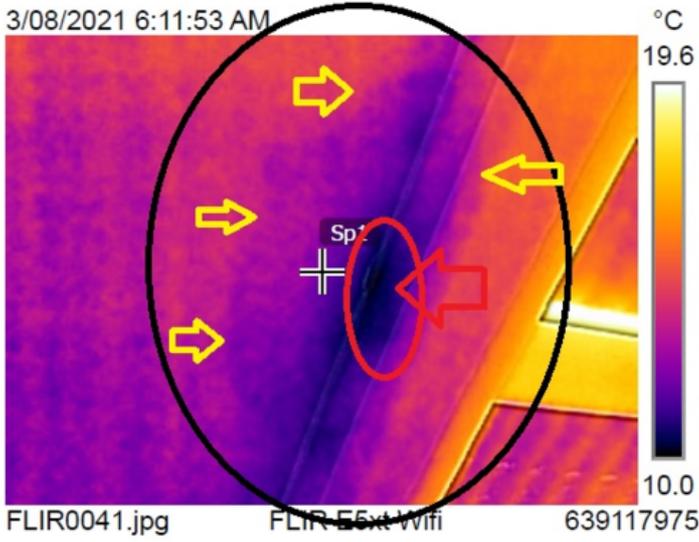
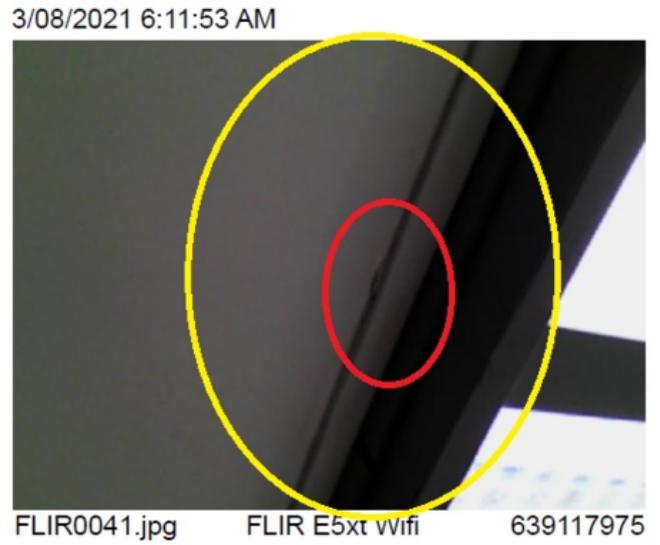
10.6.7 Water Leak/Damage

MOISTURE NOTED IN THE EAVES

Water stain and moisture evidence were noted in the backyard and front yar eaves.

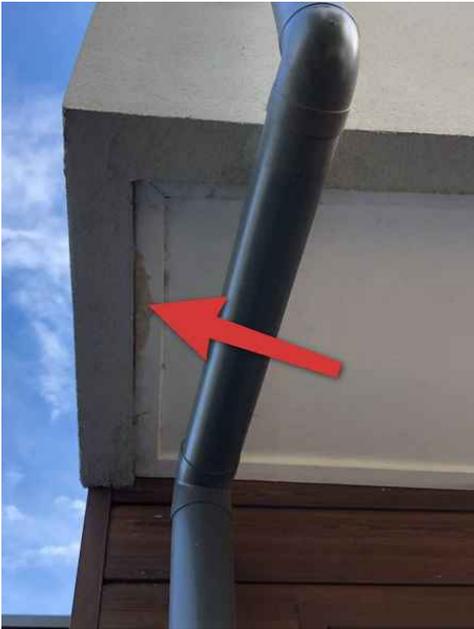
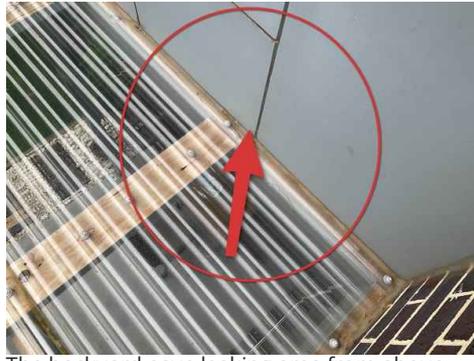
The backyard eave leaking area from above

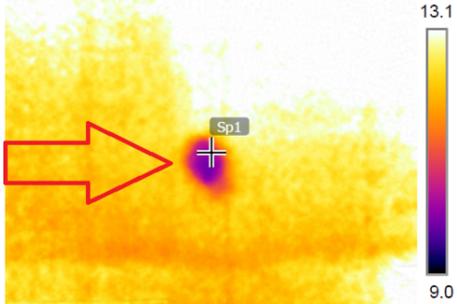
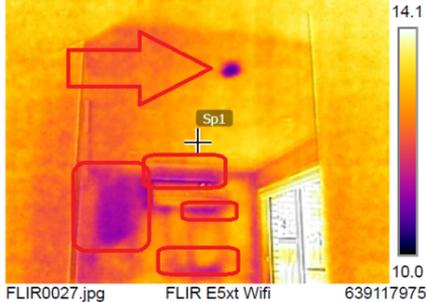
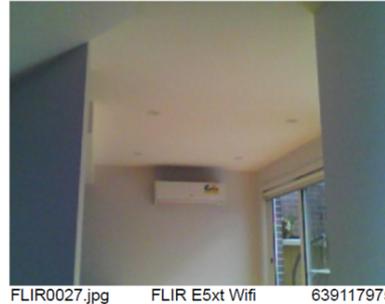
10.6.8 Water Leak/Damage

MOISTURE/LEAK NOTED IN THE DENNING ROOM CEILING

A very clear water stopping was noted on the dining room ceiling plaster which can cause water damage in the near future. This spot is located exactly 1.35m from the backyard sliding door which is the location of plaster joints. When water leaks to the ceiling area, it usually finds its way out from the plaster joints or downlight holes. This era is located under the air conditioner unit on the roof. The roof, fasteners and all joints are to be resealed and ceiling plaster to be replaced.

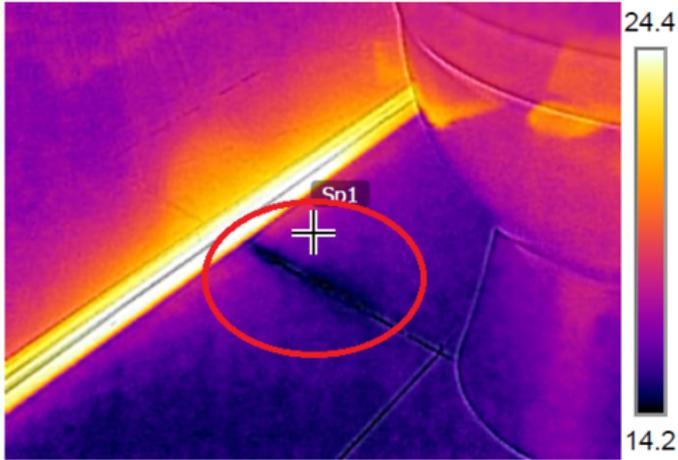
WATER LEAKING FROM SHOWER

The bathroom shower leaks from the external grouts. The water travels from underneath the grout and shower screen and comes to the surface outside the shower hub.

This must be fixed to prevent further water damage to the building.
