## EXPERT BUILDING DEFECTS REPORT

| Site Address | Sample Property, Suburb withheld |
| Building Consultant | Philip Lowry |

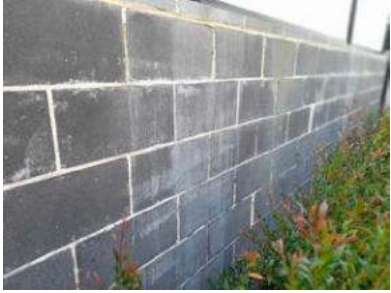
| ITEM # | SITE PHOTOS | SITE PHOTOS | SITE PHOTOS |
|---|---|---|---|
| 1. | <br>1. Marking/staining to eastern boundary retaining wall | <br>2. Marking/staining to eastern boundary retaining wall | <br>3. Marking/staining to northern boundary retaining wall |

| ITEM # | COMMENT |
|---|---|
| 1. | <p><b>1.3 Conclusion:</b></p> <p><b>SITE:</b></p> <ol style="list-style-type: none"> <li>1. There were marking/staining to boundary and site retaining walls (Photos 1 to 6)</li> <li>2. There were loss of coatings, surface damage to retaining walls and missing mortar/grouting (Photo 4 to 7)</li> <li>3. Driveway and dwelling pathways and concrete areas paint finish is peeling in areas (8 to 9)</li> <li>4. Entry stair to property overhang the allotment boundary on to council nature strip and are a safety/liability issue. Requires site survey to confirm stair and boundary location and finished levels (additional item) (Site photo 10)</li> <li>5. Cracked grout joint and gap at boundary point to tile joint in on entry stairs (Site Photo 11)</li> <li>6. The stair treads and risers vary greater than 10mm in the flight with treads varying in width from 270mm wide to 400mm in width and the stair risers vary in height from 190mm to 197mm to the entry stairs (Site Photos 12 to 14)</li> <li>7. The side 'northern' stairs to garage have not been tiled and are unfinished and stair treads vary in width and the stair risers vary in height are not to NCC deemed to satisfy standard for tread and risers (Site Photos 15 to 18)</li> <li>8. There are no visible isolation/movement joints installed on either side of the side of the northern stairs to garage or to the southern stairs adjacent the dwelling (additional item) (Site Photos 19 to 23)</li> <li>9. The OSD tank not fully supported and overhanging tank support concrete plinth (additional item) (Site Photo 25)</li> <li>10. No termite management system sign in Switchboard area (only Photo voltaic system sign observed on electrical switchboards weatherproof lid /cover) (additional item) (Site Photo 26)</li> </ol> <p>Reference is made to the Home Building Act 1989 - 18B (1)(a) to (f). This requirement has not been met, so it is my opinion, that the builder is in breach of the Home Building Act.</p> |

| ITEM # | COMMENT |
|---|---|
| 1. | <p>1.4 <u>Recommended scope of works:</u><br/> <b>SITE</b></p> <ol style="list-style-type: none"> <li>1. Allow all insurance for the rectification works approximates for a \$100,000.00 contract are - <ol style="list-style-type: none"> <li>(i) HOW \$4,000.00</li> <li>(ii) Public liability \$500.00</li> <li>(iii) workers compensation insurance (subcontractors to cover their own workers insurances)</li> <li>(iii) Contract works insurance \$500.00</li> </ol> </li> <li>2. Safely gain access to the site boundary and site retaining walls</li> <li>3. Suitably protect surrounding areas from the work area</li> <li>4. Supply and install site fencing where necessary to restrict access to the site</li> <li>5. Allow site skip bin/s at \$400 per bin to be suitably placed on the site to allow owner vehicle access to and from the garage to the site</li> <li>6. Remove retaining wall masonry units where there is a loss of coatings and surface damage to retaining wall units</li> <li>7. Supply and install suitably matching masonry wall units to retaining walls where masonry units removed</li> <li>8. Point up all new work and mortar beds and joints where there is missing mortar/grouting</li> <li>9. High pressure clean all existing and new work so there are no mortar stains or marking to the retaining walls</li> <li>10. Supply Survey to front stairs and site to confirm all levels and boundary lines</li> <li>11. Supply engineer to inspect the entry stairs, side northern stairs, southern stairs and the OSD tank</li> <li>12. Engineer to supply a detailed scope of works for stair locations and OSD tank within the site for the new isolation joints, reinforcement and concrete for the new stairs and OSD tank pad</li> <li>13. Remove/demolish the entry stair, side northern stair and southern stair to the dwelling ensuring any water pipes/services are protected and dispose concrete waste to bin/s</li> <li>14. Where water and gas service pipes installed to the exterior of dwelling were unprotected allow to move or install wrapping around pipes before the concreting phase</li> <li>15. Supply and install new formwork and steel reinforcement to engineers detail</li> <li>16. Supply and install concrete to the stairs and the concrete pad to the OSD tank</li> <li>17. Allow inspection of site by licenced pest controller to determine a method of termite protection to the dwelling according to AS3660.2-2000 Termite management - In and around existing buildings and structures</li> <li>18. Licenced pest controller to install physical/chemical barriers and install sign to dwelling meter box</li> <li>19. Builder to clean and leave work area, access points and points of travel in a tidy state</li> </ol> <p>1.5 <u>Estimate cost:</u> \$25,072.30 (note this cost includes all other building rectifications insurances)</p> |

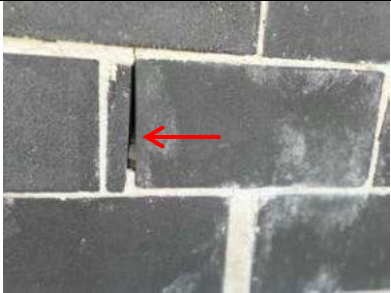
| ITEM # | SITE PHOTOS | SITE PHOTOS | SITE PHOTOS |
|---|---|---|---|
| | <br>4. Mortar missing from perp joint at masonry closer | <br>5. Damage to retaining wall units | <br>6. Marking/staining to southern boundary retaining wall |

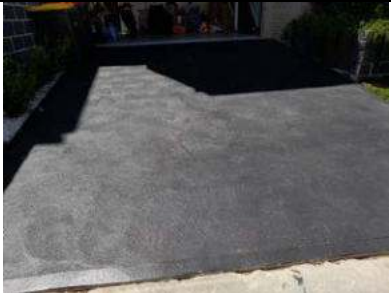
| ITEM # | SITE PHOTOS | SITE PHOTOS | SITE PHOTOS |
|---|---|---|---|
| | <br>7. Front driveway to dwelling | <br>8. Paint delamination to surface coating | <br>9. Paint delamination to surface coating |

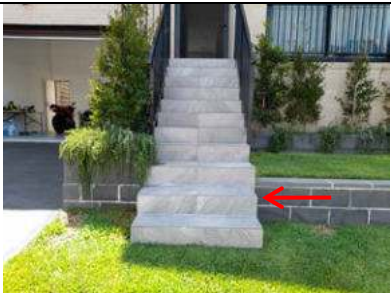
| ITEM # | SITE PHOTOS | SITE PHOTOS | SITE PHOTOS |
|---|---|---|---|
| | <br>10. Entry stair to property overhang the allotment boundary onto council nature strip | <br>11. Crack or gap at boundary point to tile joint in on entry stairs | <br>Entry stair tread 270mm width |

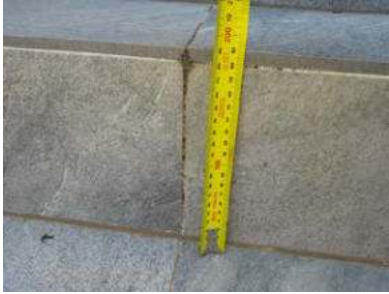
| ITEM # | SITE PHOTOS | SITE PHOTOS | SITE PHOTOS |
|---|---|---|---|
| 1. | <br>13. Riser 190mm in height | <br>14. Riser 197mm in height | <br>15. Side northern stairs to garage |

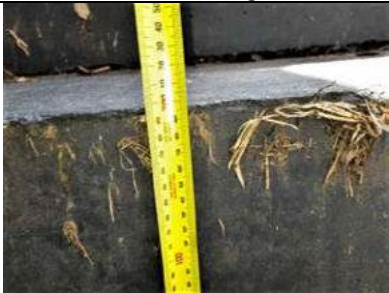
| ITEM # | SITE PHOTOS | SITE PHOTOS | SITE PHOTOS |
|---|---|---|---|
| | <br>16. 195mm riser to side 'northern' stairs to garage | <br>17. 205mm riser to side 'northern' stairs to garage | <br>18. 65mm riser to side northern stairs to garage |

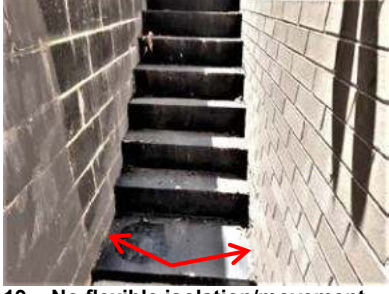
| ITEM # | SITE PHOTOS | SITE PHOTOS | SITE PHOTOS |
|---|---|---|---|
| | <br>19. No flexible isolation/movement joint visible to boundary retaining wall or dwelling wall | <br>20. No flexible isolation/movement joint visible to path against northern dwelling masonry wall | <br>21. Southern stairs adjacent the dwelling |

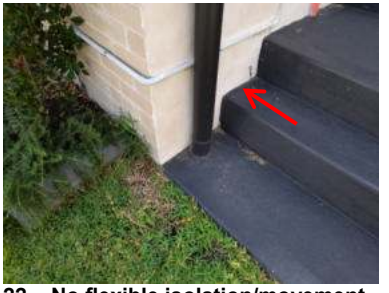
| ITEM # | SITE PHOTOS | SITE PHOTOS | SITE PHOTOS |
|---|---|---|---|
| | <br>22. No flexible isolation/movement joint visible against dwelling wall | <br>23. No flexible isolation/movement joint visible against southern boundary wall | <br>24. OSD water tank |

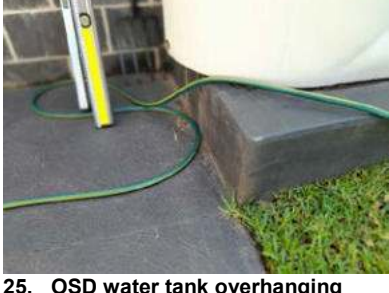
| ITEM # | SITE PHOTOS | SITE PHOTOS | SITE PHOTOS |
|---|---|---|---|
| | <br>25. OSD water tank overhanging concrete plinth | <br>26. No termite management system sign in Switchboard area (solar panelPhoto voltaic system sign observed in switchboard cover) | This space deliberately blank |

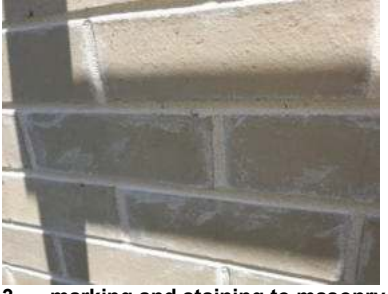
| ITEM # | BUILDING EXTERIOR PHOTOS | BUILDING EXTERIOR PHOTOS | BUILDING EXTERIOR PHOTOS |
|---|---|---|---|
| 2. | <br>1. marking and staining to masonry and at weep holes | <br>2. marking and staining to masonry wall | <br>3. marking and staining to masonry |

| ITEM # | COMMENT |
|---|---|
| 2. | <p><b>2.3 Conclusion:</b><br/> <b><u>BUILDING EXTERIOR</u></b></p> <ol style="list-style-type: none"> <li>1. Paint staining and making to masonry walls and at weep hole and fretting to some mortar joints (require high pressure cleaning) (Building exterior Photos 1 to 5)</li> <li>2. Marking and staining to panelling below master bedroom balcony apron tile (additional item) (Building exterior Photo 6)</li> <li>3. Apron tile/s attached to the vertical face of the second story tiled master bedroom balcony do not have 90% coverage of tile adhesive to apron tiles (additional item) (Building exterior Photo 6 to 7)</li> <li>4. Tile adhesive under apron tiles under ground floor front entry balcony not 90% coverage (additional item) (Building exterior Photo 8)</li> <li>5. Concrete chipped at entry to garage door opening (not repaired before internal floor coating applied) (Photo 9)</li> <li>6. Instantaneous hot water system installation not vertical/plumb (Building exterior Photo 10)</li> <li>7. Water pump for recycled water system is not connected to dwelling and requires protective shroud to system (Building exterior Photo 11)</li> <li>8. Generally water and gas service pipes installed to the exterior of dwelling are unprotected - <ol style="list-style-type: none"> <li>d) Copper pipes are embedded or cast into concrete structures</li> <li>e) Pipes and fittings installed above the ground are not protected against the heating effects of solar radiation or other heat sources</li> <li>f) Pipes located in wall penetrations are not sealed sufficiently to prevent the transfer of moisture from the outer wall to the inner wall (Building exterior Photos 12 to 14) (additional item)</li> </ol> </li> <li>9. Window temporary plastic protectors on 2<sup>nd</sup> storey windows have not been removed from bedroom 3 &amp; 2 aluminium windows and doors and remain uncleaned (Building exterior Photo 15 to 18)</li> <li>10. Sill and head flashing not visible to dwelling windows or doors where visually accessible (additional item) Part 13.4.4 indicates where in the NCC silicone cannot act as the primary barrier to weatherproofing a dwelling (Building exterior Photos 19 to 23)</li> <li>11. Rear Façade damaged with marking and fixing points visible to main bedroom wall on balcony and requires painting and timber moulding where moulding not suitably installed Building exterior (Photos 24 to 29)</li> <li>12. No sealant or timber weather stops to internal corners of external wall claddings (additional item) (Building exterior Photos 30 to 34)</li> <li>13. Damp proof course flashing not flush and projecting from rear external wall of dwelling (Building exterior Photo 35)</li> </ol> <p>Reference is made to the Home Building Act 1989 - 18B (1)(a) to (f). This requirement has not been met, so it is my opinion, that the builder is in breach of the Home Building Act.</p> |

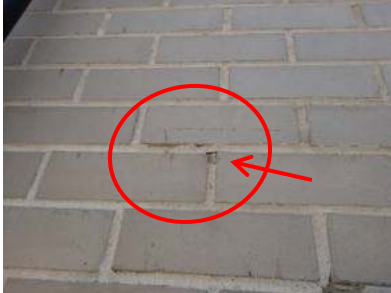
| ITEM # | BUILDING EXTERIOR PHOTOS | BUILDING EXTERIOR PHOTOS | BUILDING EXTERIOR PHOTOS |
|---|---|---|---|
| | <br>4. Fretting, gouging to mortar joints | <br>5. marking and staining to masonry | <br>6. marking and staining to panelling below master bedroom balcony apron tile |

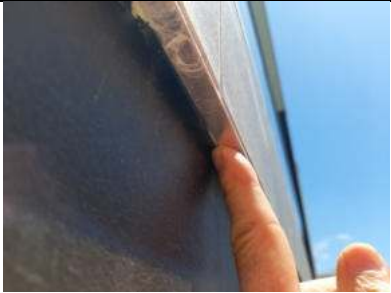
| ITEM # | BUILDING EXTERIOR PHOTOS | BUILDING EXTERIOR PHOTOS | BUILDING EXTERIOR PHOTOS |
|---|---|---|---|
| | <br>7. Tile adhesive under apron tiles to master bedroom balcony not 90% coverage | <br>8. Tile adhesive under apron tiles under ground floor front entry balcony not 90% coverage | <br>9. Concrete chipped at entry to garage door opening |

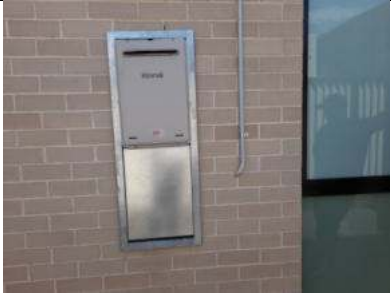
| ITEM # | BUILDING EXTERIOR PHOTOS | BUILDING EXTERIOR PHOTOS | BUILDING EXTERIOR PHOTOS |
|---|---|---|---|
| | <br>Instantaneous hot water system | <br>11. recycled water pump not connected to dwelling and requires protective shroud | <br>13. pipes embedded into concrete structures |

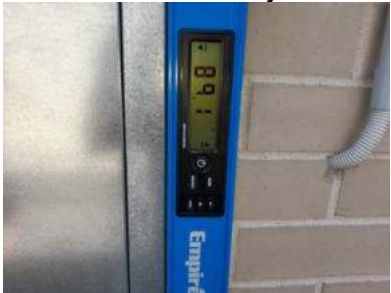
| ITEM # | BUILDING EXTERIOR PHOTOS | BUILDING EXTERIOR PHOTOS | BUILDING EXTERIOR PHOTOS |
|---|---|---|---|
| | <br>10. Instantaneous hot water system unit not vertical/plumb digital level reading 89 degrees | <br>12. pipe penetrations not sealed to prevent moisture ingress | <br>14. pipe penetration not suitably sealed to prevent moisture ingress |

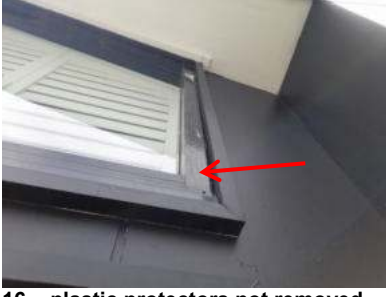
| ITEM # | BUILDING EXTERIOR PHOTOS | BUILDING EXTERIOR PHOTOS | BUILDING EXTERIOR PHOTOS |
|---|---|---|---|
| 2. | <p>15. plastic protectors not removed from aluminium windows bedroom 3</p> | <p>16. plastic protectors not removed from bedroom 3 aluminium windows</p> | <p>17. plastic protectors not removed from bedroom 3 aluminium doors</p> |

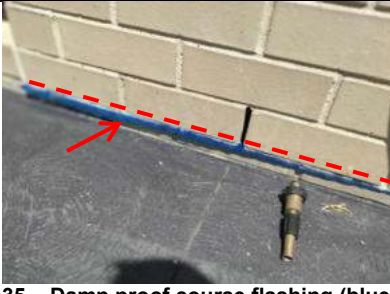
| ITEM # | BUILDING EXTERIOR PHOTOS | BUILDING EXTERIOR PHOTOS | BUILDING EXTERIOR PHOTOS |
|---|---|---|---|
| | <p>33. no timber stop and no sealant to wall panel internal corner of bed 2 balcony</p> | <p>34. no timber stop and no sealant to wall panel internal corner of bed 2 balcony</p> | <p>35. Damp proof course flashing (blue) not flush and projecting out from rear external wall of dwelling</p> |

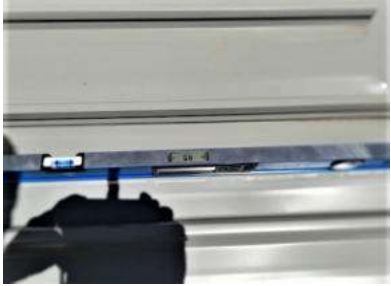
| ITEM # | ROOF EXTERIOR PHOTOS | ROOF EXTERIOR PHOTOS | ROOF EXTERIOR PHOTOS |
|---|---|---|---|
| 3. | <br>1. Cliplok sheeting on lower roof 0.8 degree fall below 1 degree minimum fall | <br>2. Cliplok sheeting on lower roof | <br>3. Damage/buckling to some roof sheets on lower roof above living room |

| ITEM # | COMMENT |
|---|---|
| 3. | <p><b>3.3 Conclusion:</b><br/> <b><u>ROOF EXTERIOR</u></b></p> <ol style="list-style-type: none"> <li>1. Cliplok roof sheeting on lower roof (above living room) was 0.8 degrees in pitch in areas and below minimum 1 degree pitch for Cliplok roof sheeting (Roof exterior Photos 1 to 2)</li> <li>2. Damage/buckling to some roof sheets on lower roof above living room (Roof exterior Photo 3)</li> <li>3. Part of sheeting on lower roof has no guttering and is draining onto lowest roofs flashings (Roof exterior Photo 4 to 5)</li> <li>4. No overflashing/pressure flashing to capping and silicone oversealing exposed to UV radiation (Roof exterior Photos 6 to 7 )</li> <li>5. Flashings not terminated and sealed on lower roof (Roof exterior Photo 7 to 8)</li> <li>6. Flashings sealant on lower and upper roof exposed to UV radiation (Roof exterior Photos 9 to 11)</li> <li>7. Rivet spacings not 40mm minimum spacings on upper roof (Roof exterior Photo 12)</li> <li>8. Screw fixings to longitudinal cappings on lower and upper roofs not maximum 500mm spacings (Photos 13 to 14)</li> <li>9. No back guttering/cappings to upper roof sheeting where roof changes length (Roof exterior Photo 15)</li> <li>10. Capping on upper roof not installed in direction of stormwater flow or fall (Roof exterior Photo 16)</li> <li>11. Decktite flashing on upper roof deflecting and not allowing total drainage above to solar panel roof penetration and silicone exposed to UV radiation at Decktite flashing (Roof exterior Photo 17)</li> <li>12. No falls to guttering on upper roof (Roof exterior Photo 18)</li> <li>13. Gutter sealed with no downpipe on upper roof and will drain on wall claddings on front elevation over front of garage below (Roof exterior Photo 19)</li> <li>14. Down pipe spreader on lower roof draining on roof flashing (Roof exterior Photo 20)</li> <li>15. Downpipe draining upper roof to lowest roof has no spreader on lowest roof to suitably drain stormwater and lower roofs drainage capacity is not large enough to drain upper roof stormwater catchment area (Roof exterior Photo 21)</li> </ol> <p>Reference is made to the Home Building Act 1989 - 18B (1)(a) to (f). This requirement has not been met, so it is my opinion, that the builder is in breach of the Home Building Act.</p> |

| ITEM # | COMMENT |
|---|---|
| 3. | <p><b>3.4 Recommended scope of works:</b><br/> <b><u>ROOF EXTERIOR</u></b></p> <ol style="list-style-type: none"> <li>1. Safely gain access to the roof exterior of the dwelling</li> <li>2. Install safety barriers where required by Work safe Australia</li> <li>3. Suitably protect surrounding roof surface areas from the work area</li> <li>4. Carefully remove lower roof flashings where required to gain access to affected roof sheeting and carefully set aside for later reinstallation</li> <li>5. Carefully remove damaged lower roof sheeting where sheeting is below 1 degree in pitch and set aside undamaged roof sheeting for later reinstallation</li> <li>6. Make suitable adjustments to the roof framing to allow a minimum roof pitch of 1 degree</li> <li>7. Supply new roof sheeting where existing roof sheeting is damaged and cannot be reinstalled</li> <li>8. Carefully reinstall only undamaged roof sheeting to lower roof</li> <li>9. Supply new flashings where existing flashing is damaged and cannot be reinstalled</li> <li>10. Reinstall flashings to lower roof to code requirements</li> <li>11. Supply flashing materials matching existing roof flashings to dwelling to suit flashing rectifications</li> <li>12. Supply flashing to areas where flashing is not terminated on lower roof to code requirements ensuring sealants applied are not exposed to UV radiation</li> <li>13. Remove sealant where oversealed on upper roof where exposed to UV radiation ensuring sealant is sandwiched between existing flashing overlaps</li> <li>14. Supply and install rivets to flashings on lower and upper roofs where spacings are greater than 40mm</li> <li>15. Remove flashing and reinstall flashing where overlap/s are not in direction of stormwater flow</li> <li>16. Supply and install suitable screw fixings to all cappings where spacings between fixings are greater than 500mm in length</li> <li>17. Carefully remove all gutters on lower and upper roofs where falls are less than 1:100 or less than 10mm per 1metre of fall</li> <li>18. Remove and reinstall/adjust all gutter brackets to achieve 1:100 fall for gutterings</li> <li>19. Supply new guttering on lower roof where gutterings were not installed to the lower roof</li> <li>20. Reinstall all gutterings to lower and upper roofs ensuring gutterings have suitable falls to outlets</li> <li>21. Supply and install gutter outlet and downpipe to the small gutter on the upper roof on the western side of the dwellings roof</li> <li>22. De-energise the solar array on the upper main roof and make safe</li> <li>23. Locally remove solar panel/s array covering solar panel electrical cable penetrating roof sheeting to gain access to the cable decktite flashing and safely store for later reinstallation</li> <li>24. Carefully disconnect and remove the cable penetrating the roof sheeting and place aside for later reinstallation</li> <li>25. Supply and install continuous back guttering/soaker gutter over roof penetration above cable penetration continuous up to roof apex to allow full drainage above penetrations</li> <li>26. Reinstall cable penetrating the roof sheeting on new backguttering with new decktite flashing installed on backguttering</li> <li>27. Supply and install continuous back guttering/soaker gutter up to roof apex to upper roof sheeting where roof changes length on the western side of the upper roof</li> <li>28. Remove down pipe spreader on lower roof draining on roof flashing</li> <li>29. Supply and install down pipe spreader on lower roof draining on roof flashing (Roof exterior Photo 20)</li> <li>30. 15. Supply and install down pipe spreader on lowest roof that drains upper roof</li> </ol> |

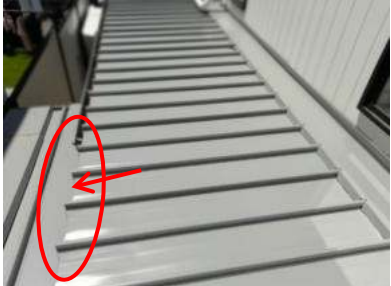
| ITEM # | ROOF EXTERIOR PHOTOS | ROOF EXTERIOR PHOTOS | ROOF EXTERIOR PHOTOS |
|---|---|---|---|
| | <br>4. No guttering to part of lower roof above living room | <br>5. Lower roof has no guttering to part of the roof and roof sheets draining on to roof flashings of lowest roof | <br>6. Lower roof - No over-flashing/ pressure flashing to capping upturn and silicone over-sealing exposed to UV radiation |

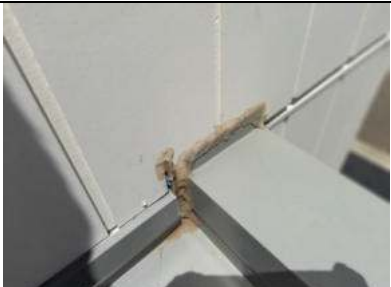
| ITEM # | ROOF EXTERIOR PHOTOS | ROOF EXTERIOR PHOTOS | ROOF EXTERIOR PHOTOS |
|---|---|---|---|
| | <br>7. apron flashing not terminated, no overflashing_/_pressure flashing | <br>8. apron flashing not terminated and sealed | <br>9. Silicone exposed to UV radiation breakdown on lower roof |

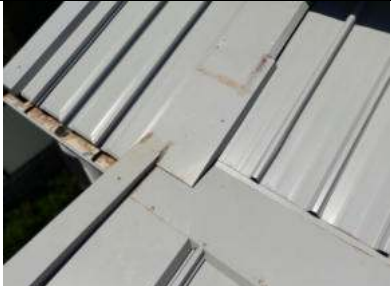
| ITEM # | ROOF EXTERIOR PHOTOS | ROOF EXTERIOR PHOTOS | ROOF EXTERIOR PHOTOS |
|---|---|---|---|
| | <br>10. Silicone exposed to UV radiation breakdown on upper roof | <br>11. Silicone exposed to UV radiation breakdown on upper roof | <br>12. Rivet spacing's not 40mm minimum spacing's on upper roof |

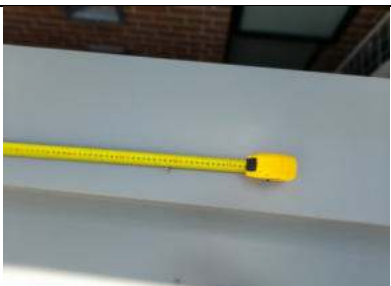
| ITEM # | ROOF EXTERIOR PHOTOS | ROOF EXTERIOR PHOTOS | ROOF EXTERIOR PHOTOS |
|---|---|---|---|
| | <br>13. Screw fixings to all longitudinal cappings on lower and upper roofs not maximum 500mm spacings | <br>14. Screw fixings to all longitudinal cappings on lower and upper roofs not maximum 500mm spacings | <br>15. No continuous back guttering/capping's up to apex of upper roof sheeting where roof changes length |

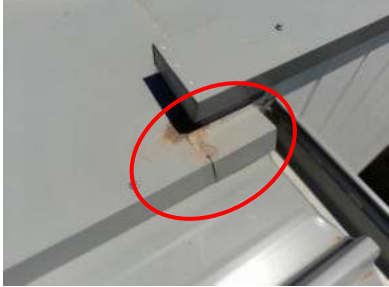
| ITEM # | ROOF EXTERIOR PHOTOS | ROOF EXTERIOR PHOTOS | ROOF EXTERIOR PHOTOS |
|---|---|---|---|
| 3. | <p>16. Capping on upper roof not lapped in direction of stormwater flow</p> | <p>17. Decktite flashing on upper roof deflecting and not allowing total drainage above to solar panel roof penetration and silicone exposed to UV radiation breakdown</p> | <p>18. Ponding and no falls - 0 degree falls to guttering on upper roof</p> |

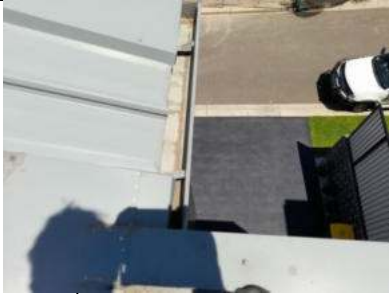
| ITEM # | ROOF EXTERIOR PHOTOS | ROOF EXTERIOR PHOTOS | ROOF EXTERIOR PHOTOS |
|---|---|---|---|
| | <p>19. 2<sup>nd</sup> storey Gutter above garage - outlet sealed with no downpipe connected on upper roof and will overflow/drain on wall claddings on front elevation over front of garage below</p> | <p>20. Down pipe spreader on lower roof draining on roof flashing</p> | <p>21. Downpipe draining upper roof to lowest roof has no spreader on lowest roof to suitably drain stormwater</p> |

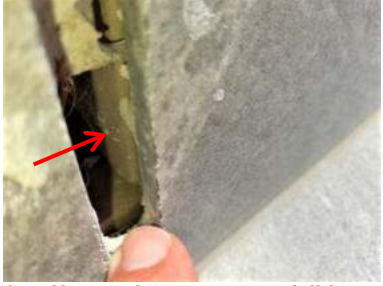
| ITEM # | BUILDING INTERIOR PHOTOS | BUILDING INTERIOR PHOTOS | BUILDING INTERIOR PHOTOS |
|---|---|---|---|
| 4. | <p>15. No membrane turn-up visible adjacent weephole under kitchen balcony sliding door unit</p> | <p>16. Weephole location under kitchen balcony sliding door unit</p> | <p>17. Laundry door dead bolt not latching to keeper, Thumb latch loose</p> |

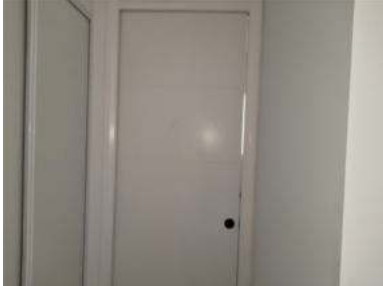
| ITEM # | BUILDING INTERIOR PHOTOS | BUILDING INTERIOR PHOTOS | BUILDING INTERIOR PHOTOS |
|---|---|---|---|
| | <p>18. Bare or starved painted areas to external of laundry door</p> | <p>19. Bare or starved painted areas to external of door 'close up'</p> | <p>20. Internal architrave to head of Laundry door not fixed flush to door frame</p> |

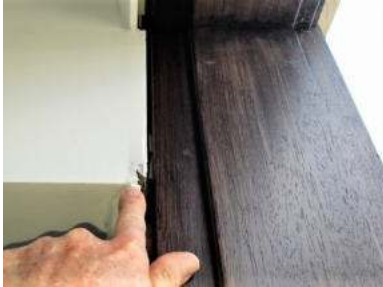
| ITEM # | BUILDING INTERIOR PHOTOS | BUILDING INTERIOR PHOTOS | BUILDING INTERIOR PHOTOS |
|---|---|---|---|
| | <p>21. Laundry bulkhead plasterboard chipped/damage</p> | <p>22. Scratching to vanity veneer</p> | <p>23. scratching, marking, staining to cupboard veneer</p> |

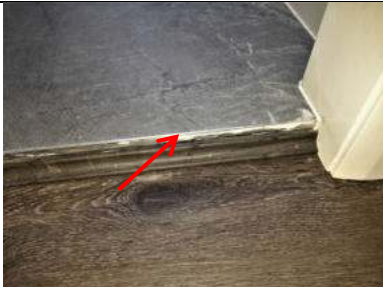
| ITEM # | BUILDING INTERIOR PHOTOS | BUILDING INTERIOR PHOTOS | BUILDING INTERIOR PHOTOS |
|---|---|---|---|
| | <p>24. Grouting not cleaned at tile angle at laundry entry</p> | <p>25. Latch tongue to bathroom door marking tile wall - ground floor bathroom</p> | <p>26. Tubular door latch marking tiling close up - ground floor bathroom</p> |

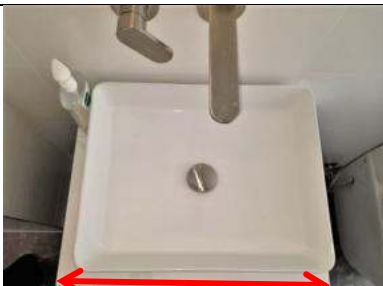
| ITEM # | BUILDING INTERIOR PHOTOS | BUILDING INTERIOR PHOTOS | BUILDING INTERIOR PHOTOS |
|---|---|---|---|
| | <p>27. Basin misaligned, not centrally fixed to vanity unit below - ground floor bathroom</p> | <p>28. Multiple holes for waste pipe and multiple screw fixing damaged inside vanity carcass - ground floor bathroom</p> | <p>29. Cupboard veneer scratched in ground floor bathroom</p> |

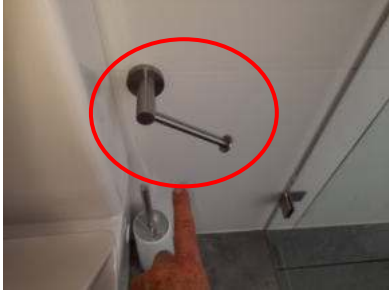
| ITEM # | BUILDING INTERIOR PHOTOS | BUILDING INTERIOR PHOTOS | BUILDING INTERIOR PHOTOS |
|---|---|---|---|
| 4. | <p>30. Loose toilet roll holder - ground floor bathroom</p> | <p>31. Loose toilet seat- ground floor bathroom</p> | <p>32. No waterproofing membrane upturn visible at water-stop to GF bathroom door opening - ground floor bathroom</p> |

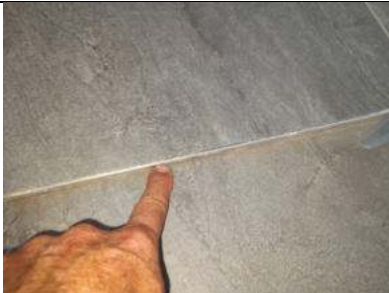
| ITEM # | BUILDING INTERIOR PHOTOS | BUILDING INTERIOR PHOTOS | BUILDING INTERIOR PHOTOS |
|---|---|---|---|
| | <p>33. No waterproofing upturn visible at shower recess water-stop - ground floor bathroom</p> | <p>34. Shower recess 5 mm fall per metre, minimum is 12.5mm fall per metre ground floor bathroom</p> | <p>35. Shower recess 5 mm fall per metre, minimum is 12.5mm fall per metre</p> |

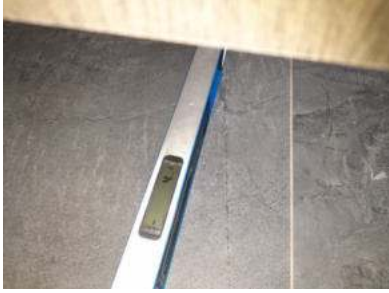
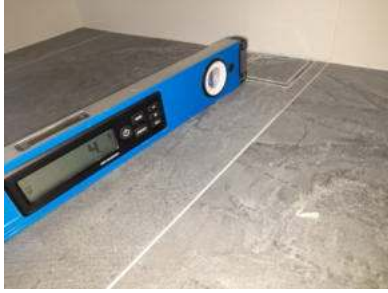
| ITEM # | BUILDING INTERIOR PHOTOS | BUILDING INTERIOR PHOTOS | BUILDING INTERIOR PHOTOS |
|---|---|---|---|
| | <p>36. Falls of 4mm per metre to floor waste under vanity, minimum is 12.5mm fall per metre GF bathroom</p> | <p>37. Falls of 4mm per metre to floor waste under vanity, minimum is 12.5mm fall per metre GF bathroom</p> | <p>38. no sealant between skirting to seal off conditioned spaces</p> |

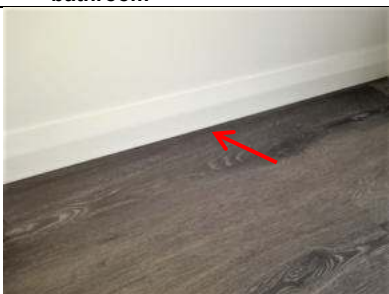
| ITEM # | BUILDING INTERIOR PHOTOS | BUILDING INTERIOR PHOTOS | BUILDING INTERIOR PHOTOS |
|---|---|---|---|
| | <p>39. no sealant between skirting to seal off conditioned spaces</p> | <p>40. Carpet cleaning receipt stating all stain marks not removed</p> | <p>41. Discolouration/markings/ staining to carpet on stairs</p> |

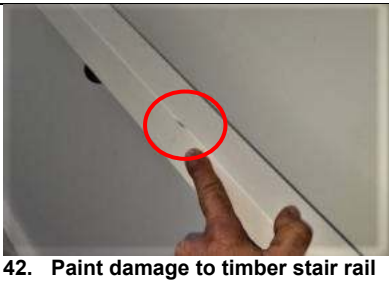
| ITEM # | BUILDING INTERIOR PHOTOS | BUILDING INTERIOR PHOTOS | BUILDING INTERIOR PHOTOS |
|---|---|---|---|
| | <p>42. Paint damage to timber stair rail</p> | <p>43. Paint marking/over runs to glass panels on timber balustrade</p> | <p>44. Paint patch repairs to stairwell wall visible from a normal viewing position</p> |

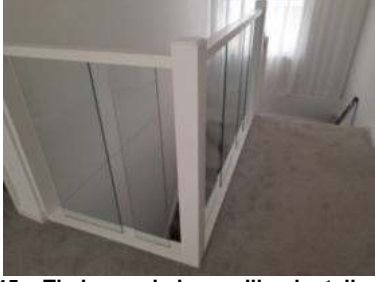
| ITEM # | BUILDING INTERIOR PHOTOS | BUILDING INTERIOR PHOTOS | BUILDING INTERIOR PHOTOS |
|---|---|---|---|
| 4. | <br>45. Timber and glass railing installed not a glass railing as described in the builders sales brochure | <br>46. Bedroom 3 door keeper, damage around keeper | <br>47. Protective film not removed from bedroom 3 & 2 aluminium doors |

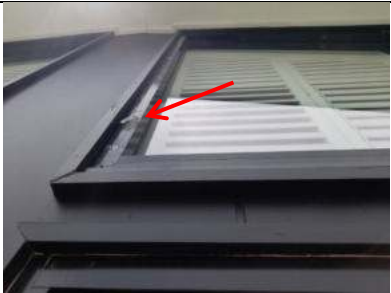
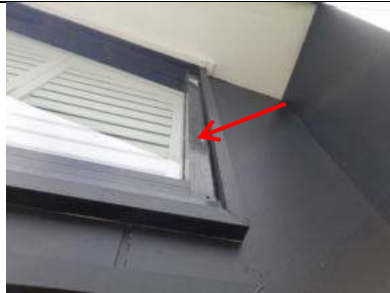
| ITEM # | BUILDING INTERIOR PHOTOS | BUILDING INTERIOR PHOTOS | BUILDING INTERIOR PHOTOS |
|---|---|---|---|
| | <br>48. Protective film not removed from bedroom 3 & 2 aluminium windows | <br>49. Protective film not removed from bedroom 3 & 2 aluminium windows | <br>50. Bedroom 3 & Bedroom 2 balcony - sealant not colour matching and exposed to UV radiation |

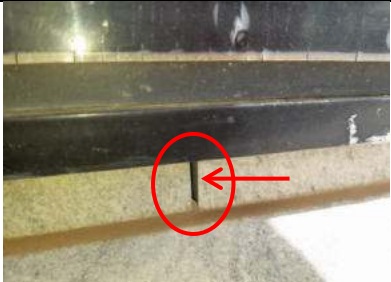
| ITEM # | BUILDING INTERIOR PHOTOS | BUILDING INTERIOR PHOTOS | BUILDING INTERIOR PHOTOS |
|---|---|---|---|
| | <br>51. Missing grout to tile under door hob upstand | <br>52. aluminium angle preventing drainage to free edge of balcony, angle not secured | <br>53. Carpet to Bedroom 2 marked at doorway, owner photo |

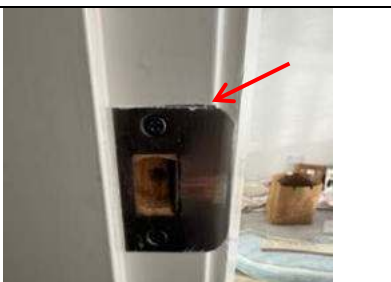
| ITEM # | BUILDING INTERIOR PHOTOS | BUILDING INTERIOR PHOTOS | BUILDING INTERIOR PHOTOS |
|---|---|---|---|
| | <br>54. Bedroom 2 door latch keeper damage around keeper, overpainted, owner photo | <br>55. Balcony rail anchor, no upturn of waterproof membrane, anchor cover plate loose, owner photo | <br>56. Bedroom 2 sub-sill installed to balcony sliding door too large for sliding door unit above it |

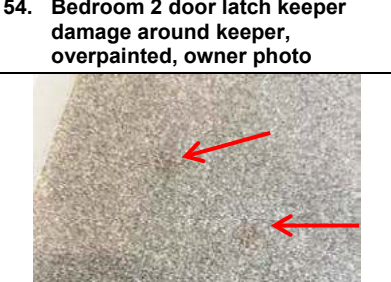
| ITEM # | BUILDING INTERIOR PHOTOS | BUILDING INTERIOR PHOTOS | BUILDING INTERIOR PHOTOS |
|---|---|---|---|
| | <br>57. Bedroom 1 Carpet marked during building phase by trades owner photo | <br>58. Bedroom 1 door keeper, damage around keeper | <br>59. Paint top coat missing in Bedroom 1 above carpet line |

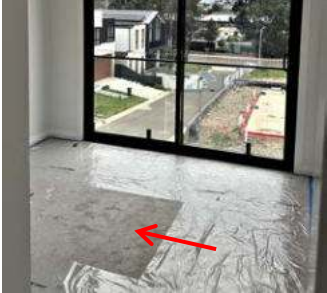
| ITEM # | BUILDING INTERIOR PHOTOS | BUILDING INTERIOR PHOTOS | BUILDING INTERIOR PHOTOS |
|---|---|---|---|
| | <p>63. Bedroom 3 Carpet unprotected, marked from passage of builders trades (owner photo)</p> | <p>64. Water-stop angle damaged and chipped tile to Ensuite entry</p> | <p>65. Waterproofing upturn not visible to water-stop at Ensuite door entry</p> |

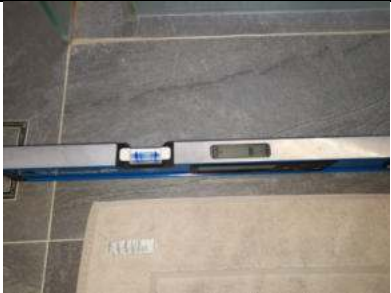
| ITEM # | BUILDING INTERIOR PHOTOS | BUILDING INTERIOR PHOTOS | BUILDING INTERIOR PHOTOS |
|---|---|---|---|
| | <p>66. 8mm fall to bathroom floor waste, minimum required fall is 12.5mm over metre</p> | <p>67. Channel drain has 4mm fall away from its own waste</p> | <p>68. No waterproofing upturn visible to water-stop in shower recess, silicone applied to waterstop</p> |

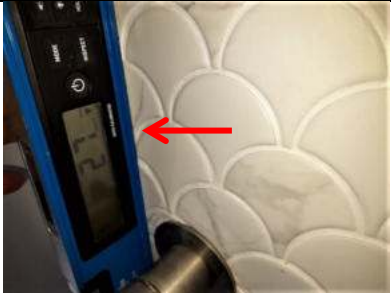
| ITEM # | BUILDING INTERIOR PHOTOS | BUILDING INTERIOR PHOTOS | BUILDING INTERIOR PHOTOS |
|---|---|---|---|
| | <p>69. Ensuite tiled Shower recess tile wall bulging/bowed at wall mixer</p> | <p>70. Toilet Seat installation is loose and crooked</p> | <p>71. Ensuite window chipped/paint damaged</p> |

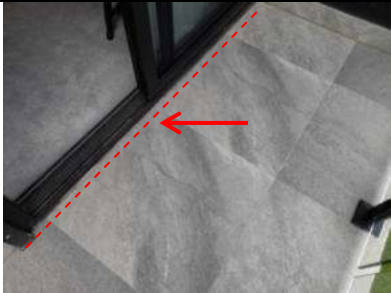
| ITEM # | BUILDING INTERIOR PHOTOS | BUILDING INTERIOR PHOTOS | BUILDING INTERIOR PHOTOS |
|---|---|---|---|
| | <p>72. No freeboard to master bedroom below balcony door frame</p> | <p>73. balcony door sill &amp; wall sealant not colour matching, exposed to UV radiation</p> | <p>74. Balcony tiles have sealant not colour matching, exposed to UV radiation</p> |

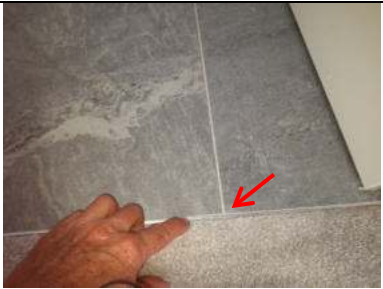
| ITEM # | BUILDING INTERIOR PHOTOS | BUILDING INTERIOR PHOTOS | BUILDING INTERIOR PHOTOS |
|---|---|---|---|
| | <p>78. No visible waterproofing upturn to water-stop at 2nd storey main bathroom door entry</p> | <p>79. Falls to floor waste main 2nd storey main bathroom 5 degrees and below 12.5 degrees minimum fall</p> | <p>80. Falls to floor waste main 2nd storey Bathroom 10 degrees, are below minimum 12.5 degrees</p> |

| ITEM # | COMMENT |
|---|---|
| 4. | <p><b>4.2 <u>Recommended scope of works:</u> Continued -</b></p> <p><b><u>MAIN BATHROOM</u> - (2nd Storey)</b></p> <ol style="list-style-type: none"> <li>1. Safely gain access to the master bedroom bathroom</li> <li>2. Suitably protect protect the surrounding areas from damage</li> <li>3. Safely cap off and de-energise all water and electrical services to the Ensuite bathroom allowing for later reactivation/commissioning</li> <li>4. Remove all fixtures from the bathroom and dispose to site waste bin</li> <li>5. Carefully remove all fittings and shower screen and store for later reinstallation</li> <li>6. Remove all wall and floor tiles from the bathroom and safely dispose</li> <li>7. Clean off the existing tile adhesive and membranes to the wall and floor surfaces</li> <li>8. Install waterproof membrane to AS 3740-2004 Waterproofing of wet areas within residential buildings</li> <li>9. Supply and install matching new wide format tiles cut to size according to AS3958.1-2007 Ceramic Tiles - Guide To The Installation of Ceramic Tiles and to 5.6.2 Thin-bed fixing and 5.6.4.2 Coverage and falls to NCC 2022 10.2.12 Construction of wet area floors — FALLS – 1:80</li> <li>10.2.18 Unenclosed showers (without hob or set down)</li> <li>10. Replace vanity with new vanity bench top overhangs equal on either side and tapsets spouts centre of the vanity</li> <li>11. Re-install mirror securely fixing/adhesing mirror frame to wall</li> <li>12. Reinstall all fixtures and fittings in a workman like manner</li> <li>13. Electrician to de-energise and remove bathroom IXL fan/light that is leaking water out of light cover</li> <li>14. Roof contractor to inspect leak location and determine source of leak</li> <li>15. Roof contractor to rectify leak</li> <li>16. Electrician to re-energise circuit and reinstall bathroom IXL fan/light and cover</li> <li>17. Paint/make good where necessary to surrounding/affected surfaces according to AS 2311 Guide to the painting of buildings</li> <li>18. Clean and leave work area, access points and points of travel in a tidy state</li> </ol> |

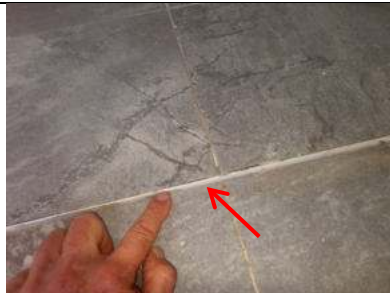
| ITEM # | BUILDING INTERIOR PHOTOS | BUILDING INTERIOR PHOTOS | BUILDING INTERIOR PHOTOS |
|---|---|---|---|
| | <p>81. Bath water inlet upstand has no waterproofing or upturn detail under floor cover plate (Owners photo)</p> | <p>82. No waterproofing upturn visible in 2nd storey Main bathroom shower recess</p> | <p>83. Bathroom IXL fan/light leaking water out of light cover, an electrical hazard</p> |
