OWNER INSPECTIONS

## EXPERT WITNESS REPORT

8 Example Street  
Googong, NSW 2620

Client Name  
JULY 19, 2024

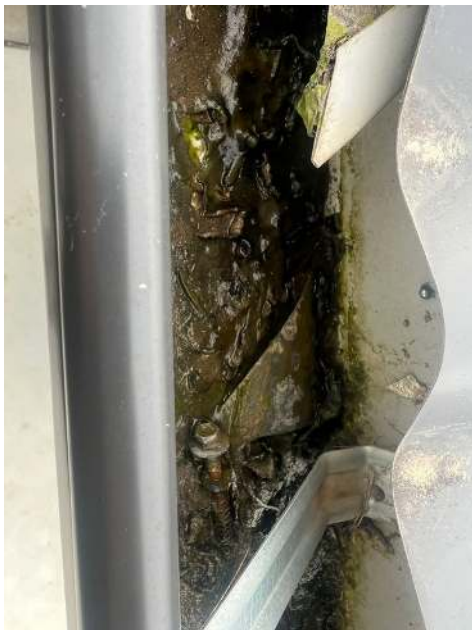
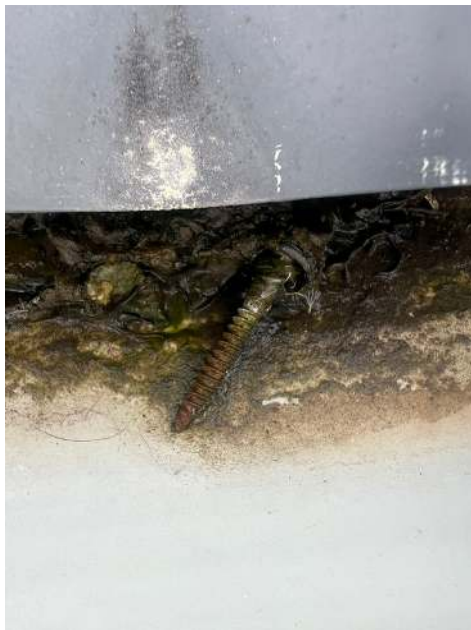
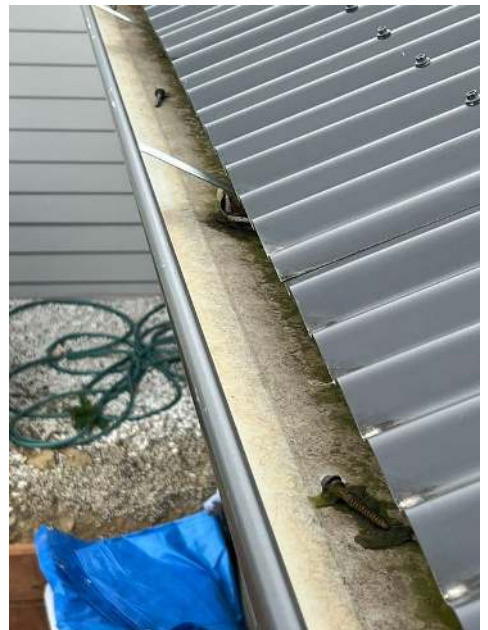
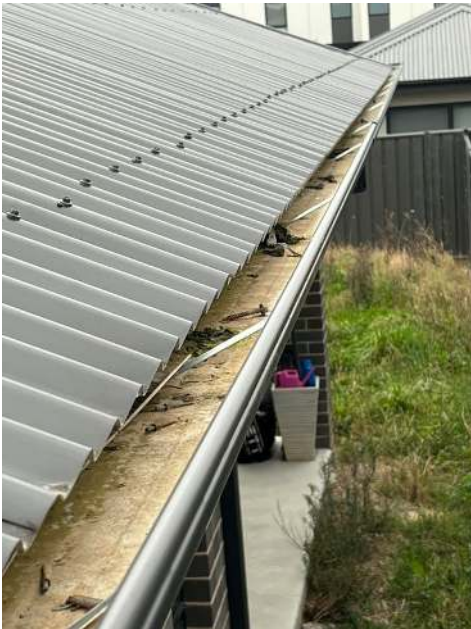
There is a significant amount of debris in the gutters around the dwelling. All debris must be removed from the gutters as soon as possible to prevent it from entering the downpipes and causing water damage.

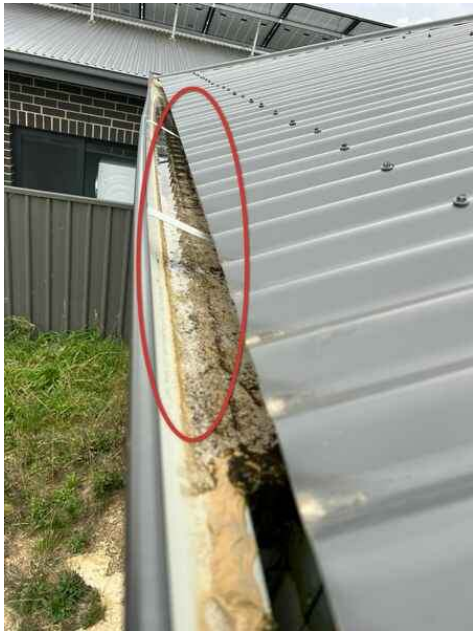
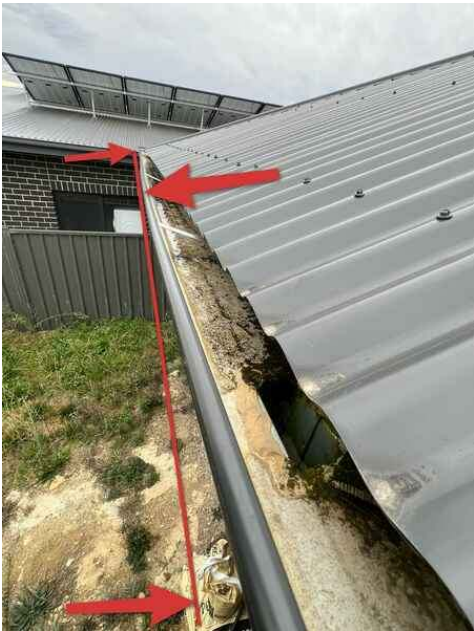
Alfresco

At the rear Alfresco, the slope of the gutter is negative, measuring 9mm/m away from the downpipe instead of the required minimum of 2mm/m towards the downpipe. This incorrect slope should be rectified to prevent potential defects such as water ponding in the gutter, which can lead to overflow during heavy rain, increased risk of water damage to the roof and surrounding structure, potential leakage into the dwelling, and accelerated deterioration of the gutter system due to stagnant water.

Gutters should be installed with the correct fall to avoid directing water away from downpipes or towards corners, which can lead to water damage and other associated issues. This ensures that water flows efficiently towards the downpipes without pooling in the gutters.

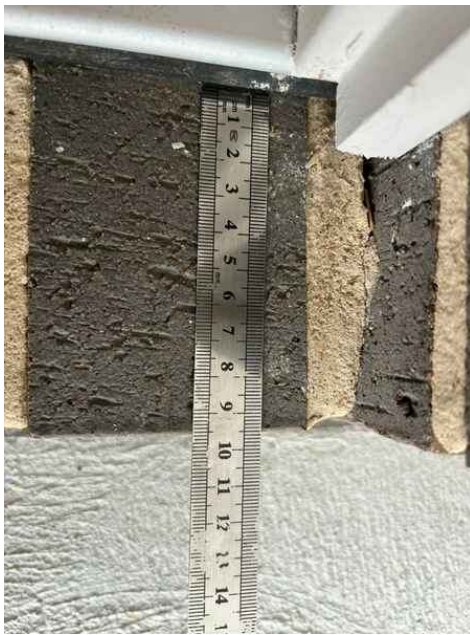
Bottom right

**NOT PARALLEL TO THE WALL**

- Bottom right: 95mm
- Bottom left: 105mm
- Left wall: 90mm
- Right wall: 75mm

These measurements highlight the misalignment and necessitate corrective action to ensure the door is properly aligned with the wall.

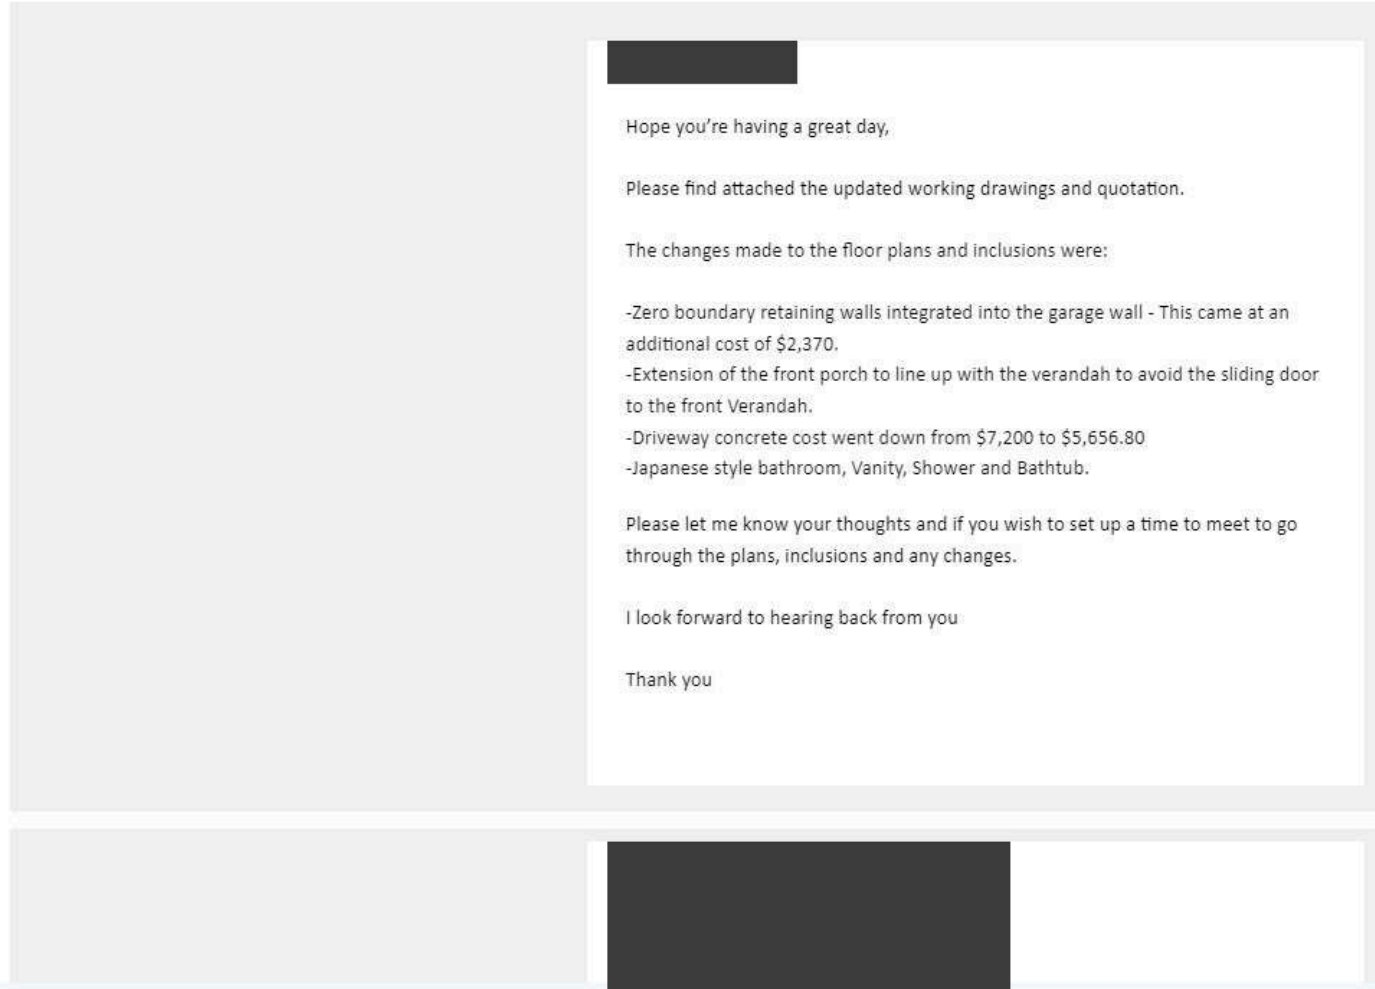
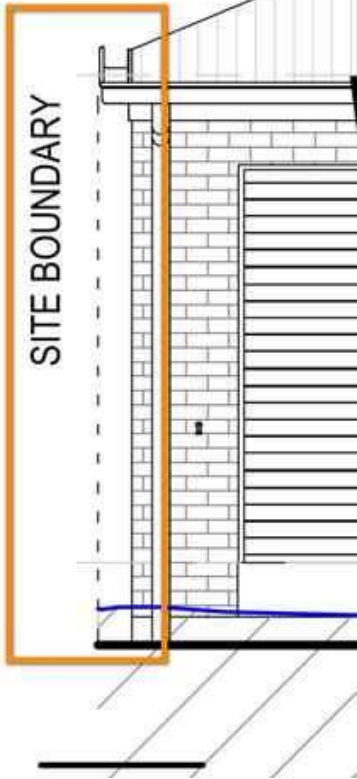
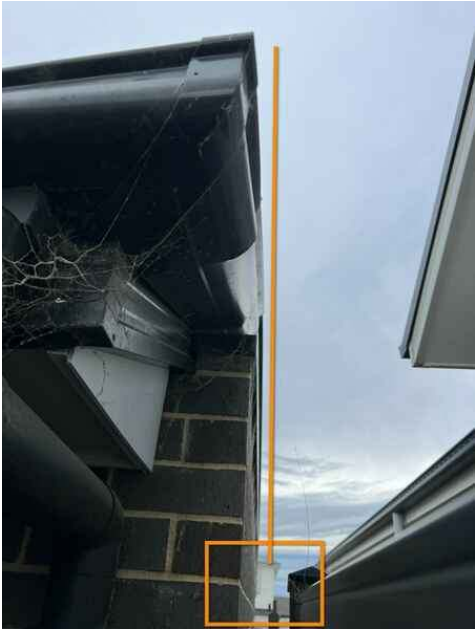
DEVIATION FROM THE PLANS - GARAGE BOUNDARY WALL

The approved plans show the garage's southern elevation gutter to be installed outside the wall, which positions the external garage wall 180mm from the boundary. However, the construction deviates from these plans as the gutter is installed on top of the garage wall, yet the wall has not been moved to align with the zero boundary. If the gutter had been installed outside the wall as per the plans, the wall could have been built on the boundary, potentially increasing the garage size by 0.18m x 5.5m (0.99m²). This discrepancy should be checked by the building surveyor.

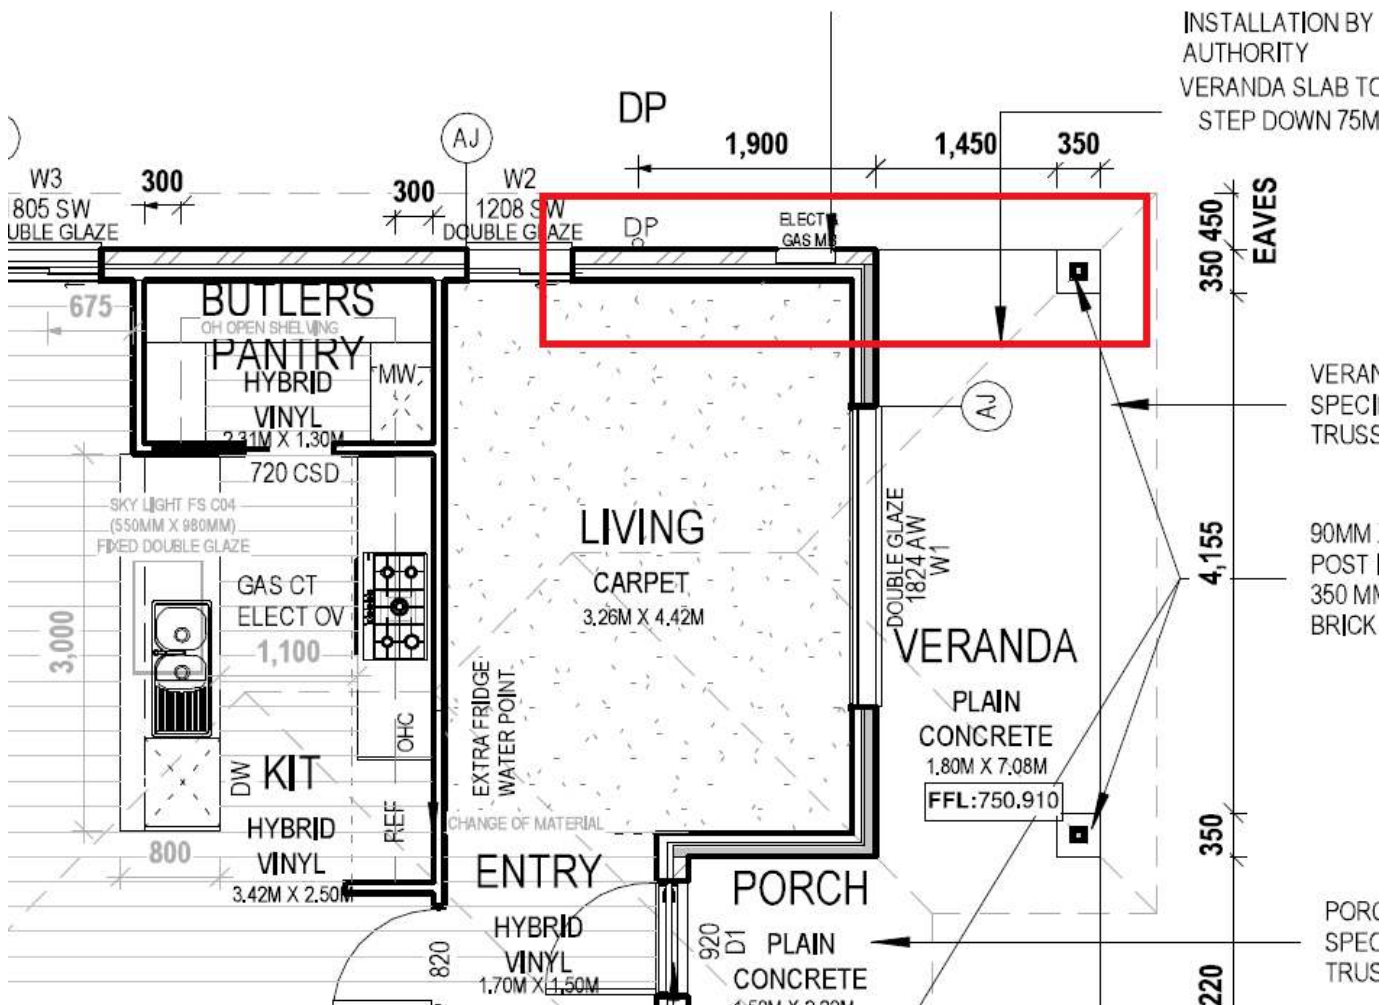
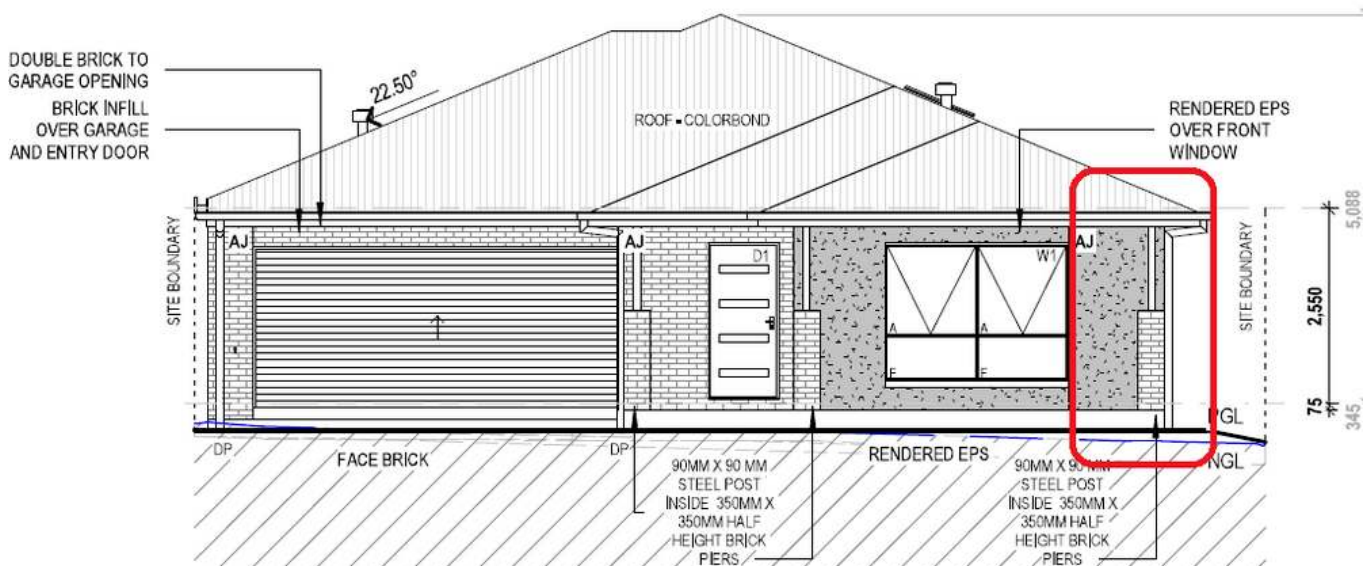
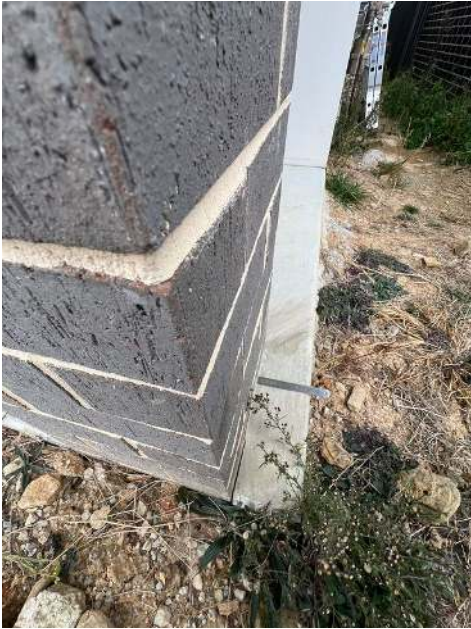
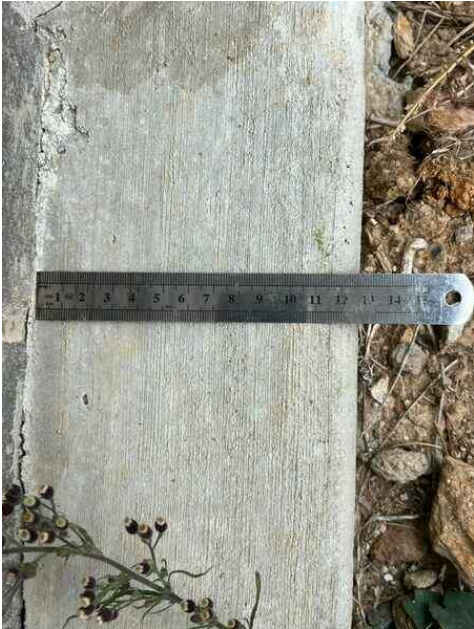
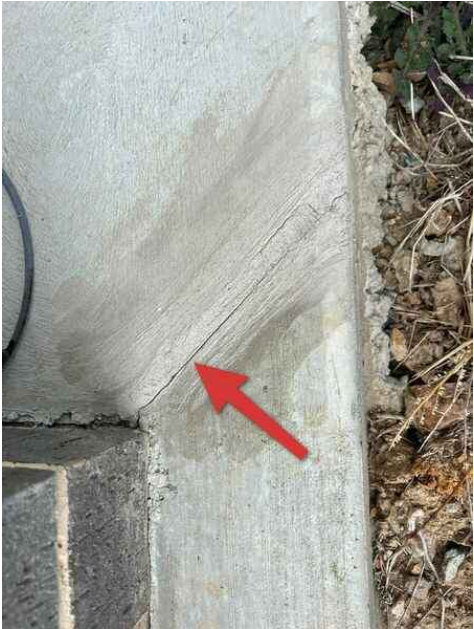
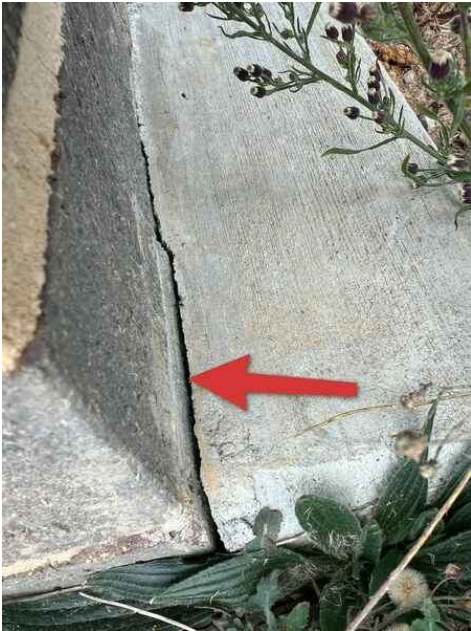
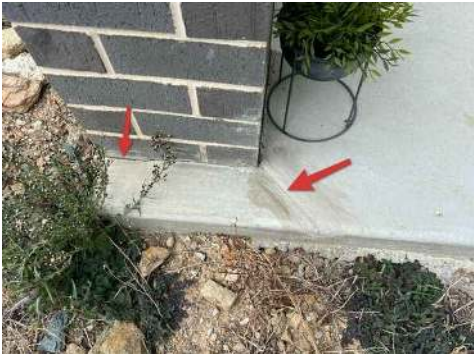
**DEVIATION FROM THE PLANS: RIGHT SIDE PILLAR MISALIGNMENT**

The right side pillar's external face is designed to align with the northern external wall as per the approved plans. However, the pillar has been constructed approximately 127mm inside the intended position. This deviation has led to inadequate support for a 127mm wide section of the concrete path, resulting in a 45-degree corner crack. The observed crack indicates tension at the edge of the pillar, suggesting structural stress that caused the initial crack and may lead to further deterioration. This issue requires immediate attention to prevent potential future structural damage.

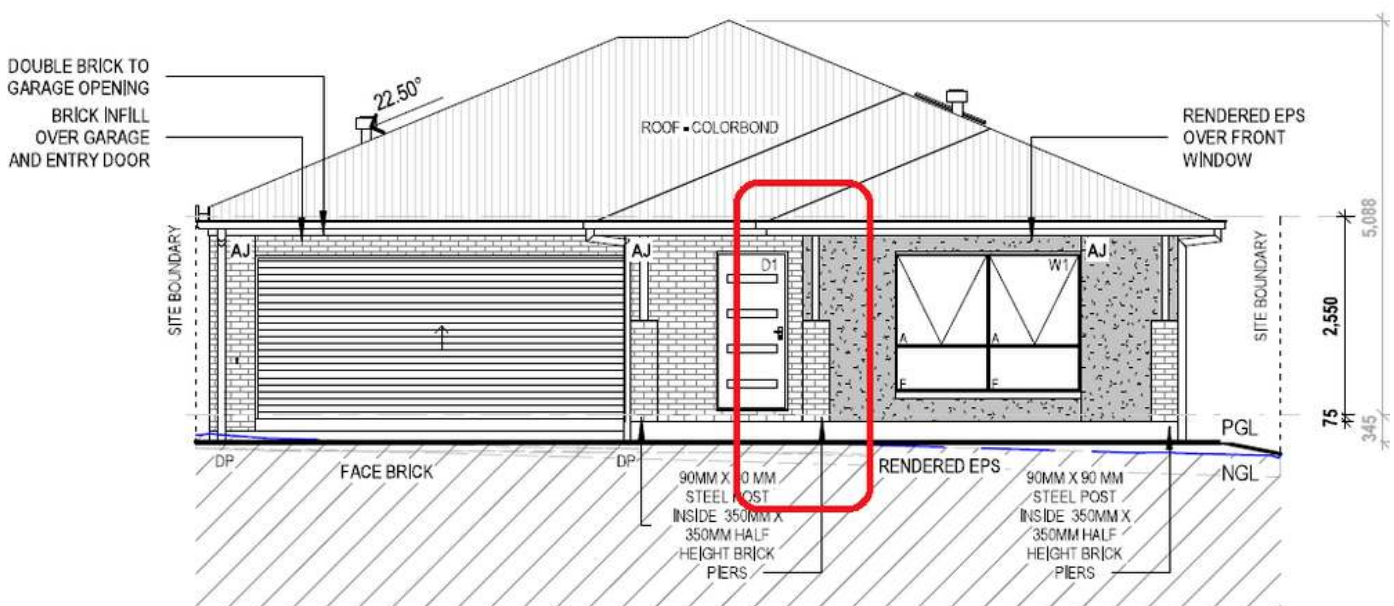
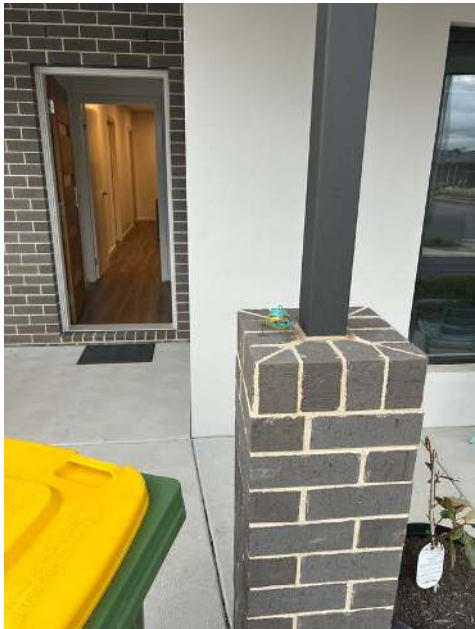
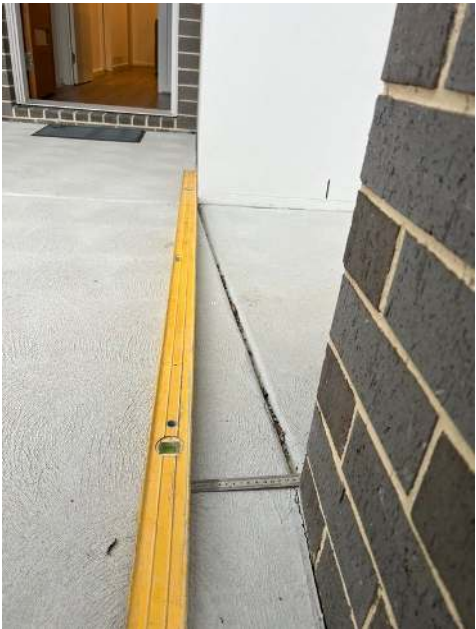
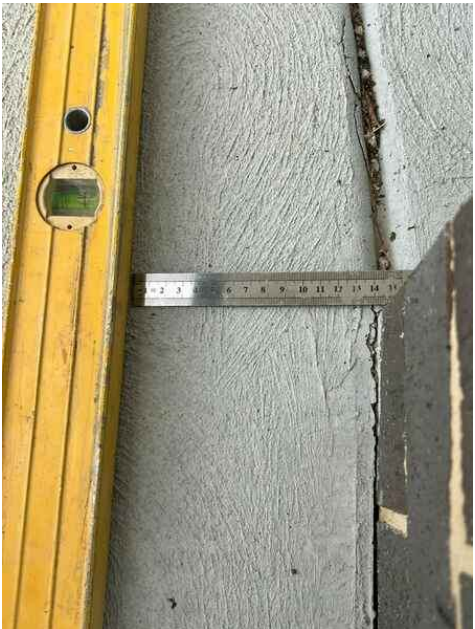
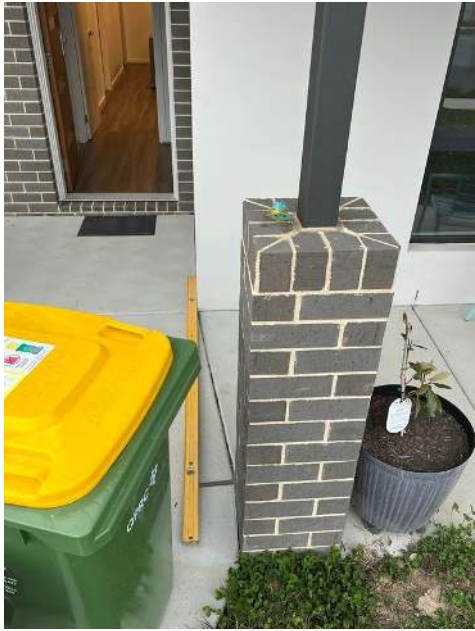
**DEVIATION FROM THE PLANS: MIDDLE PILLAR MISALIGNMENT**

The working drawings specify that the middle pillar's southern face should be flush with the adjacent wall next to the entry door. However, the middle pillar has been constructed approximately 140mm north of the intended position.

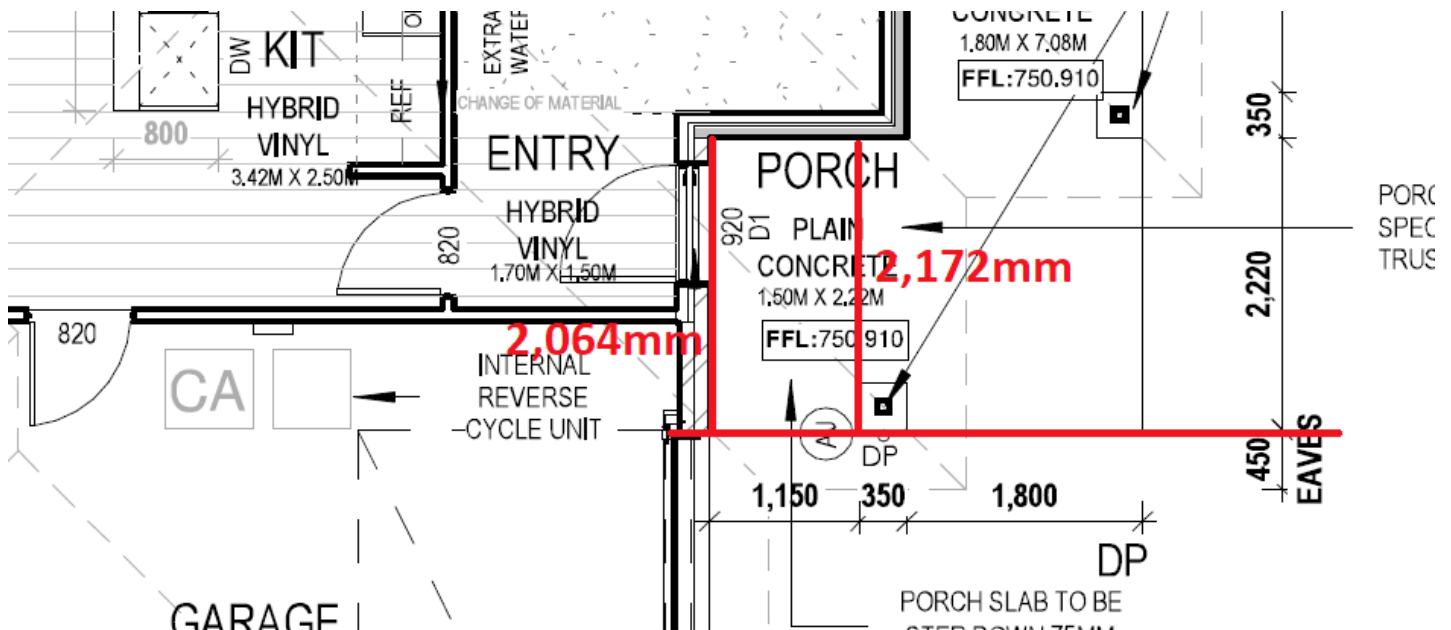
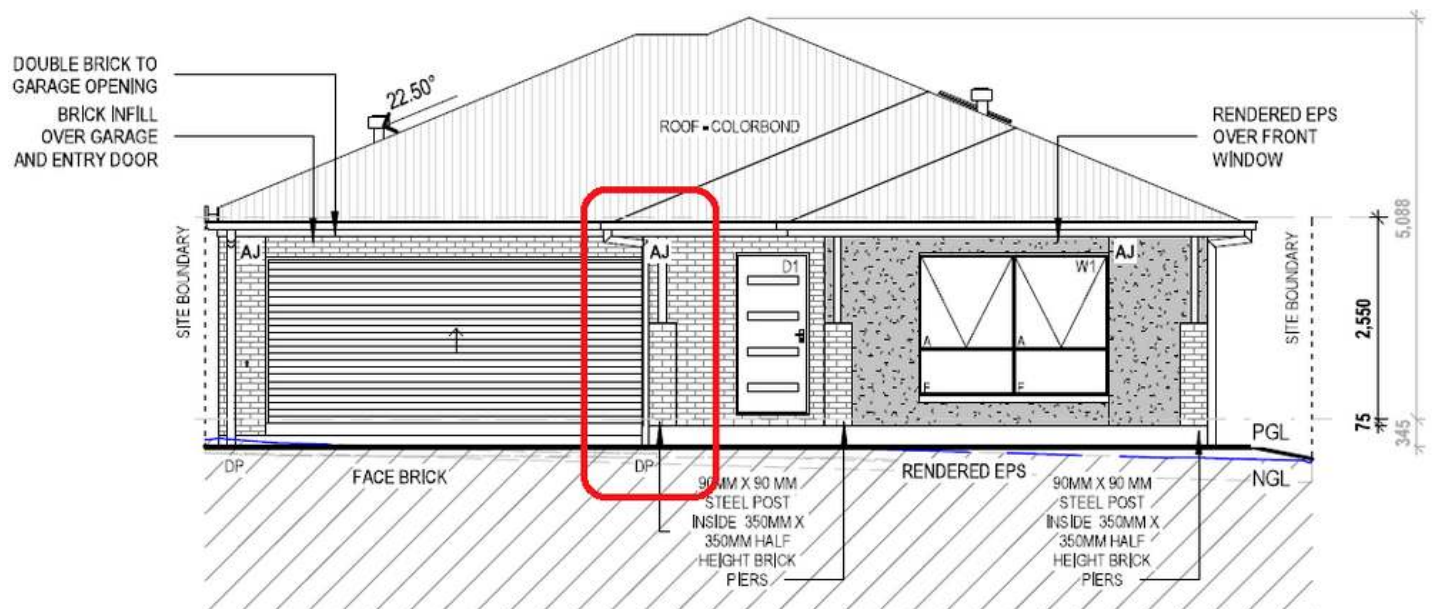
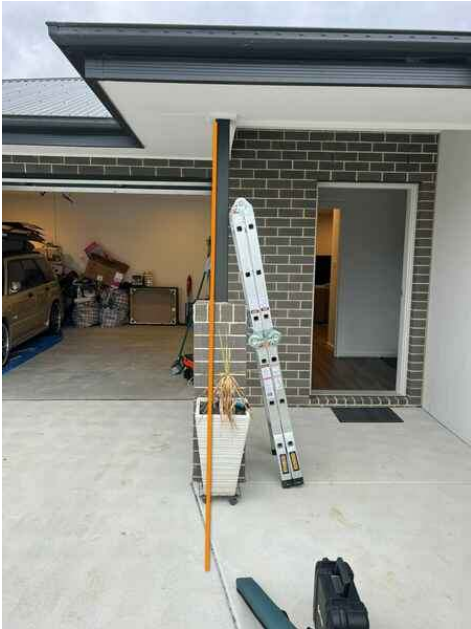
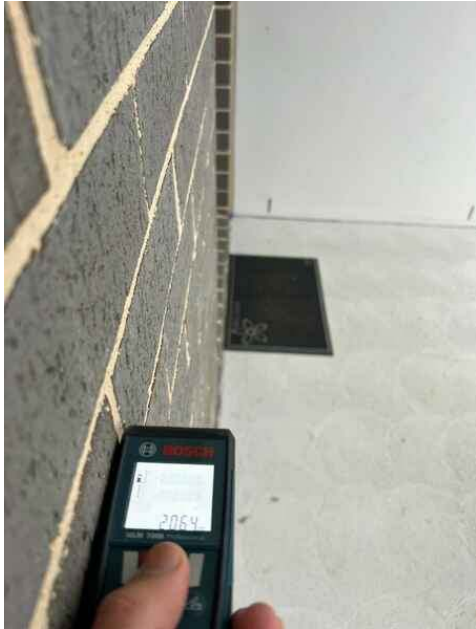
**DEVIATION FROM THE PLANS: LEFT PILLAR MISALIGNMENT**

According to the working drawings, the left pillar should be in line with the internal face of the garage door wall. However, the pillar is constructed 108mm south of its intended position. The distance between the southern face of the pillar and the internal face of the garage door wall adjacent to the entry door should be equal. Currently, there is a 2064mm distance from the garage door internal wall and a 2172mm distance from the pillar, indicating a 108mm deviation from the plans. This discrepancy needs to be addressed to ensure alignment with the approved design specifications.

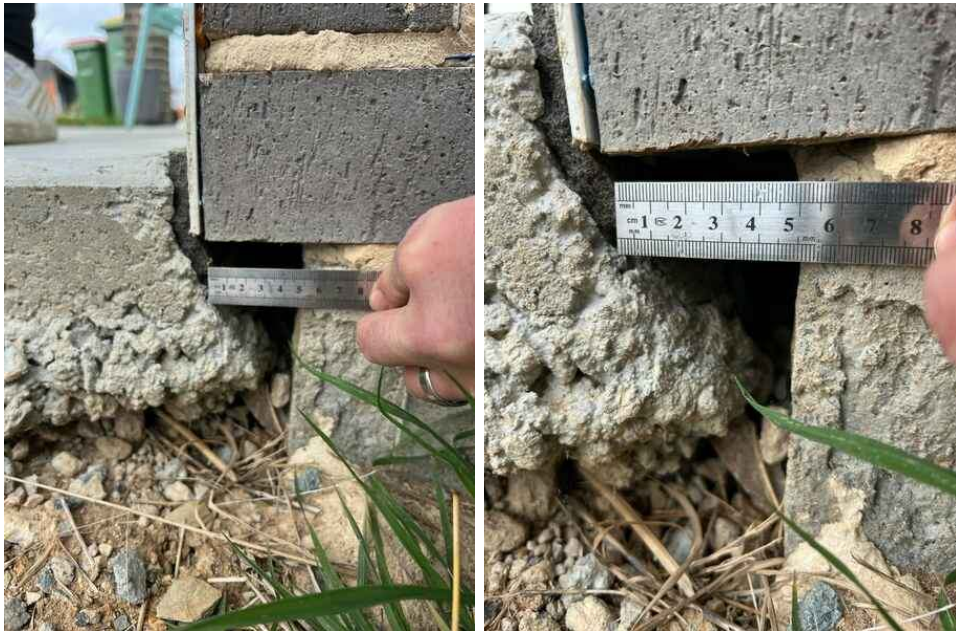
Note: The access to under the overhang brick is restricted by the Verandah Concrete. To rectify this issue, the verandah concrete to be removed and repoured after the rectification.

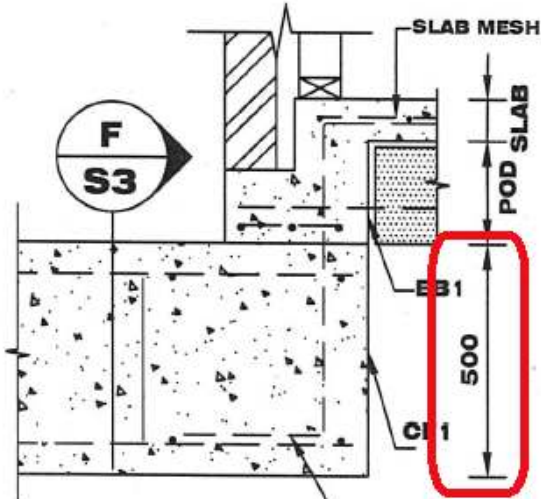
**CF1 TYPICAL**  
**CANTILEVED FOOTING**  
SCALE = 1:20

The construction deviates significantly from the approved engineering drawings, primarily due to the improper alignment and connection between the surface concrete and the CF1 edge beams. Without immediate remediation—such as underpinning or reconstructing the beams to extend properly beneath the slabs—the alfresco and verandah slabs are at risk of significant settlement, cracking, and long-term structural failure.

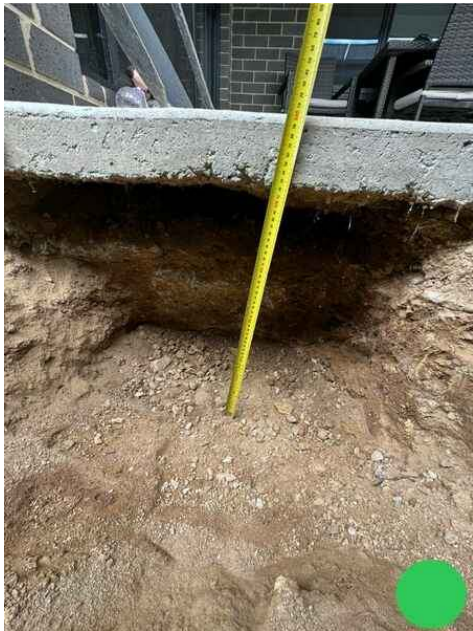
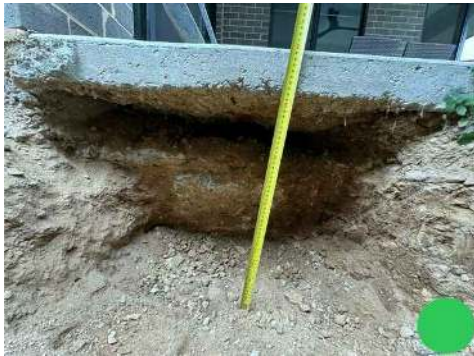
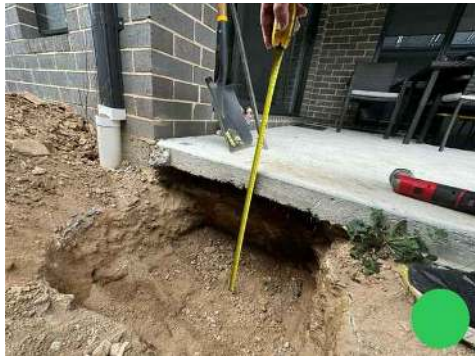
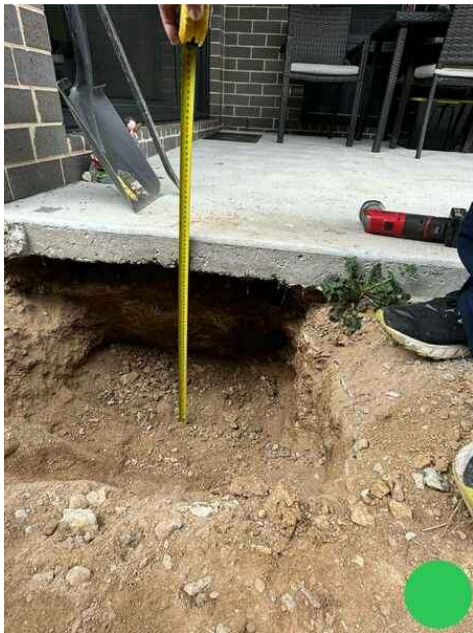
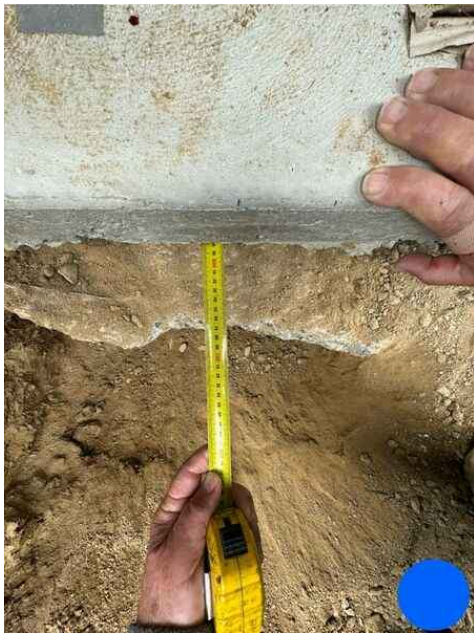
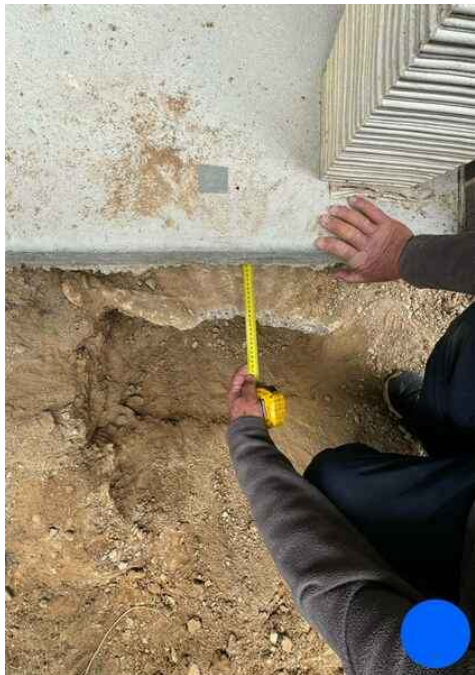
- A 300mm horizontal gap and 50mm vertical gap have been noted. Although smaller than other areas, this still presents a structural deficiency.

- **Slab Sinking and Settlement:** Over time, as the soil compacts or erodes, the unsupported sections of the alfresco and verandah slabs will begin to sink, leading to uneven surfaces and potential tripping hazards.

- **Cracking:** As the slabs settle unevenly due to insufficient support, they are likely to develop cracks, which could further undermine the stability of the structure.
- **Water Penetration:** Gaps between the concrete and the edge beams may allow water to penetrate beneath the slabs, further weakening the soil and accelerating the settlement process.
- **Misalignment with Piers:** In some areas, the edge beam CF1 is 500-600mm inside and not aligned with the bored piers, meaning that it cannot effectively transfer loads to the piers as designed. This could compromise the overall foundation integrity.

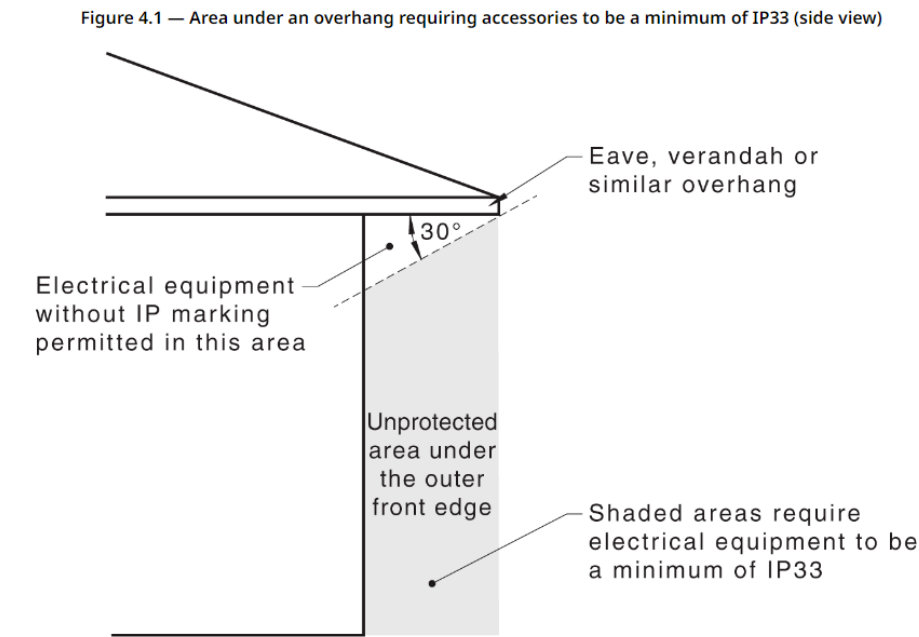
During the inspection of the alfresco area, it was observed that the installed power points and data points are not of the weatherproof type. These outlets are exposed to environmental factors common in outdoor settings, such as wind-driven rain, humidity, and condensation. The lack of appropriate weatherproofing poses safety risks and does not comply with the relevant Australian Standards.

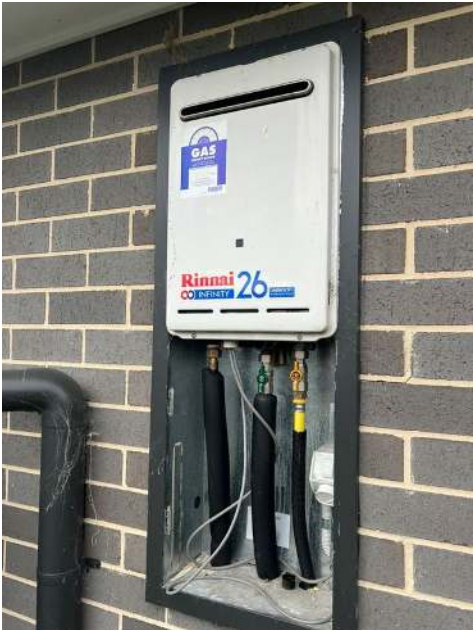
12.7.1 Plumbinb

**HOT WATER SYSTMET INSTALLED BY OWNER**

The homeowner claims the builder did not install the hot water system as specified in the contract, resulting in the homeowner having to pay a plumber to supply and install it. The expert cannot confirm this claim's validity. The homeowner is to provide relevant payment documents to NCAT.

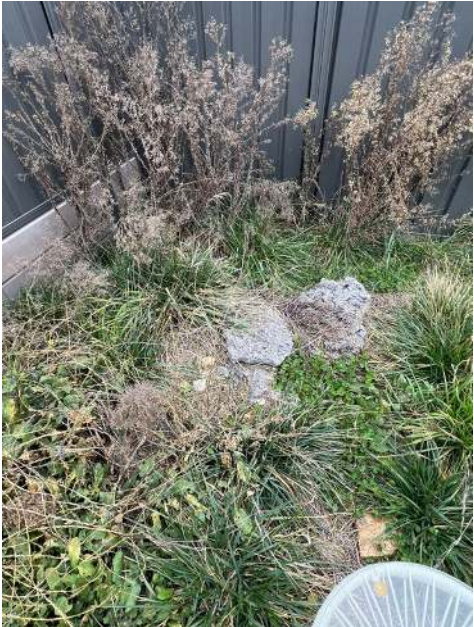
12.8.1 Site cleaning

Incomplete Work

Rubbish and concrete leftovers from the construction phase remain on the site, violating the builder's obligation to clean the site prior to handover.

According to standard building contracts—such as the Housing Industry Association (HIA) NSW Residential Building Contract—the builder is required to remove all construction debris and waste from the site upon completion of the works. This obligation is typically outlined in clauses related to site cleanup or completion. Additionally, under the Home Building Act 1989 (NSW), Section 18B(a) stipulates that builders must carry out work in a proper and workmanlike manner, which includes leaving the site clean and free of construction waste prior to handover.

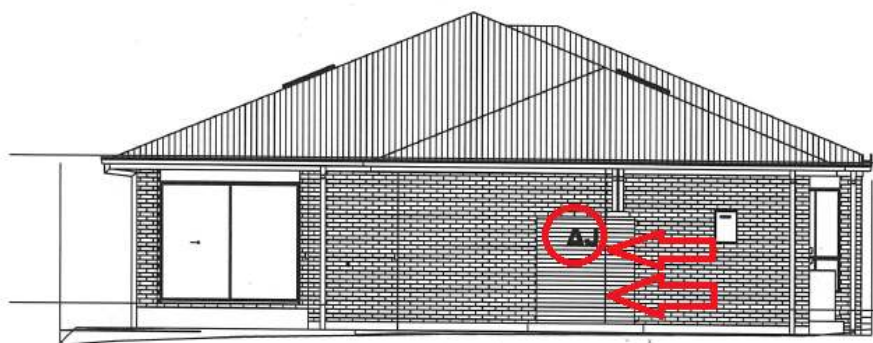
+ MISSING - NOT MATCHED WITH PLANS

**Defect:** The articulation joint specified on the plans at the rear of the building (where the water tank is located) has not been constructed.

**Potential Future Issues:** The absence of the required articulation joint may result in uncontrolled cracking of the brickwork over time. This can compromise the structural integrity of the wall, lead to water ingress, reduce the overall durability of the building, and potentially result in expensive repairs or remedial work in the future.

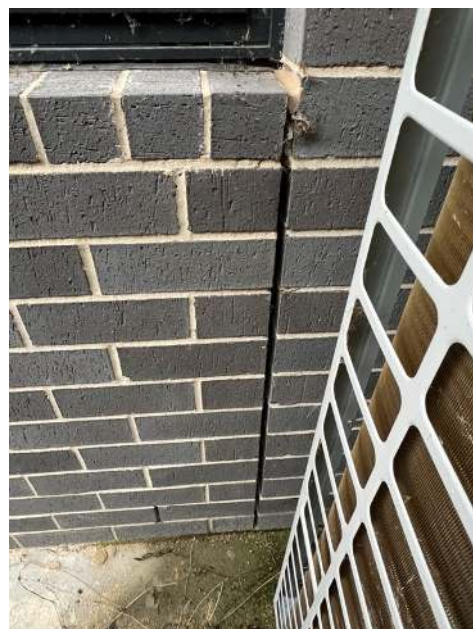
### 13.1.2 + Control Joints

Expansion joints in the masonry brickwork have not been sealed with mastic sealant, and mortar and debris have not been removed prior to sealing, which risks water ingress. Properly sealed expansion joints are essential for waterproofing, accommodating structural movement, and preventing masonry cracks and damage over time.

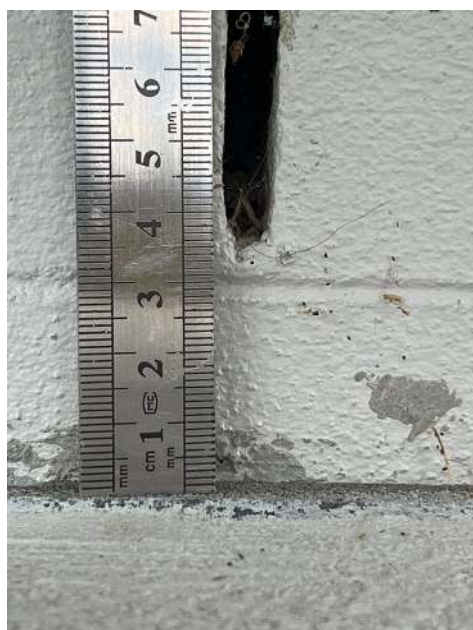
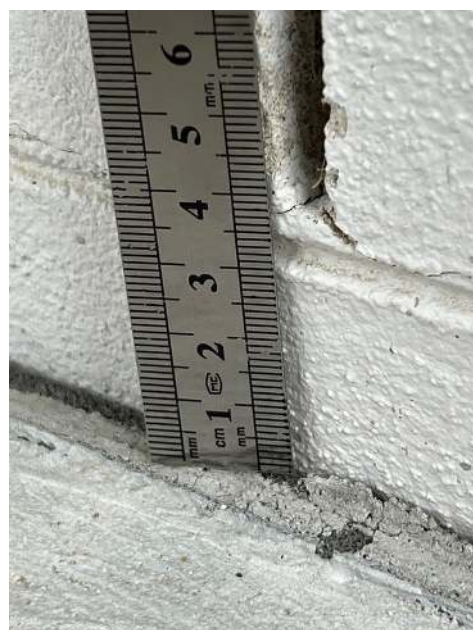
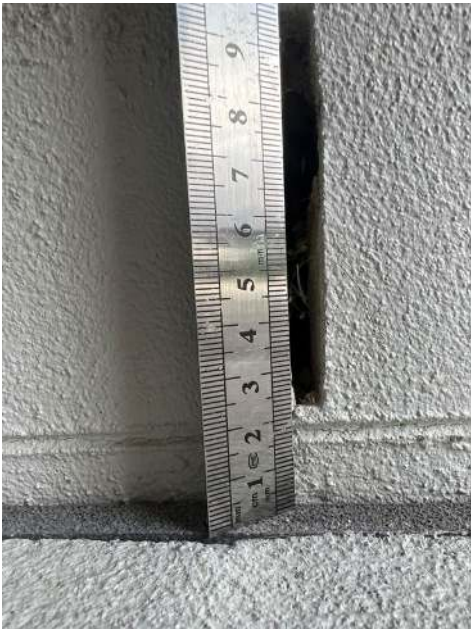
## 13.2.1 + Weep holes

**+ CLEARANCE LESS THAN 150MM (OR 75MM FOR GRADED SITES)**

**Defect:** The bottom of the weep holes is not positioned at the required minimum height of 150mm (or 75mm for graded sites) above the adjacent surface level. Rectification is required to meet this standard.

**Note:** The weep holes must also be situated on top of the damp proof course (DPC) to ensure proper moisture control.

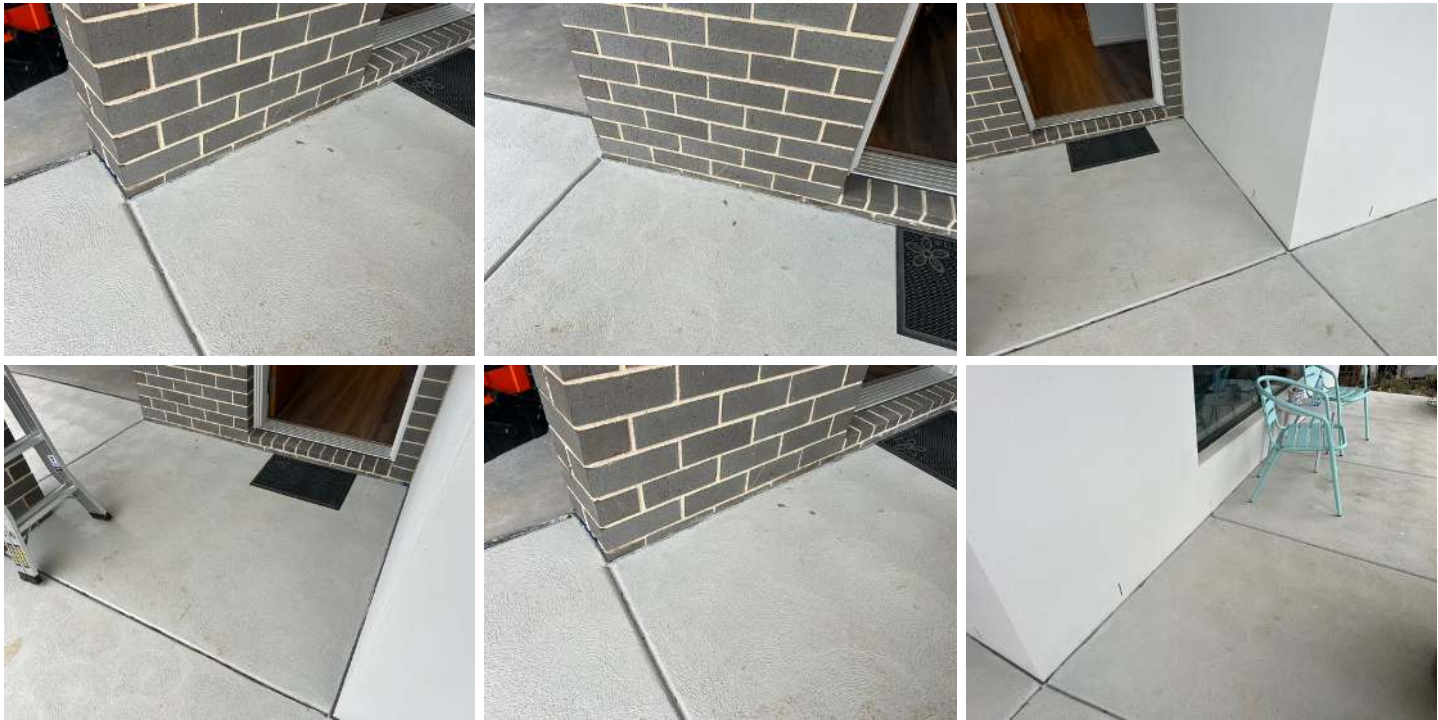
## 13.3.1 Pathway

**Defect:** There is no clearance between the bottom of the brick wall cladding and the adjoining paving. To comply with the NCC, the paving should be lowered to provide the required clearance to ensure proper moisture management and termite protection.

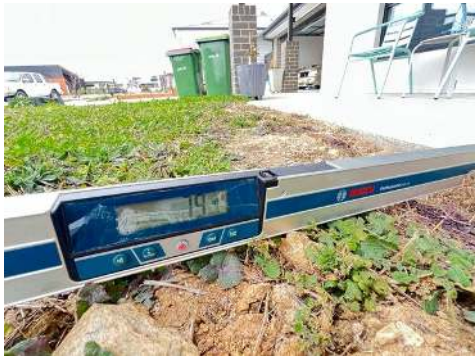
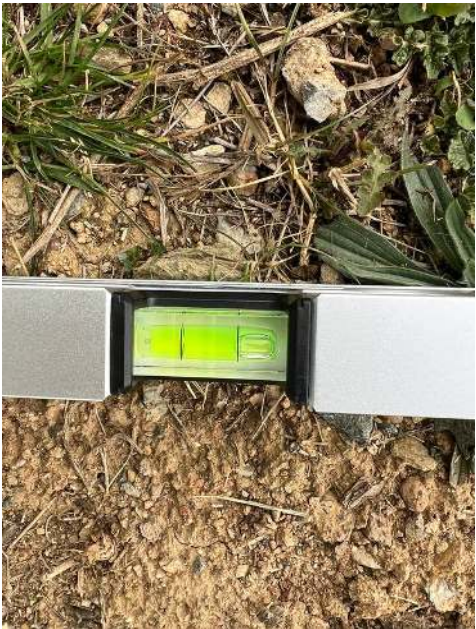
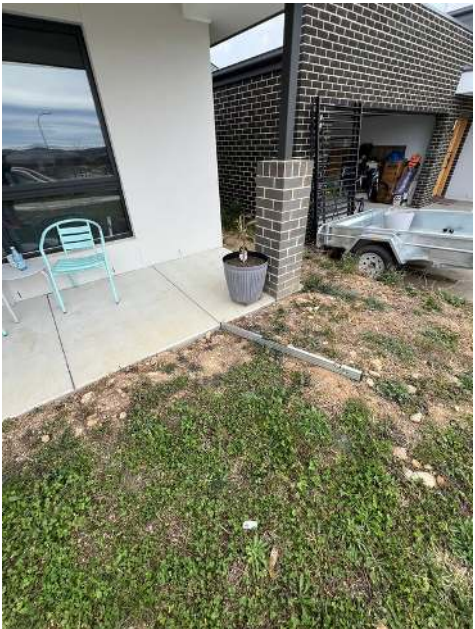
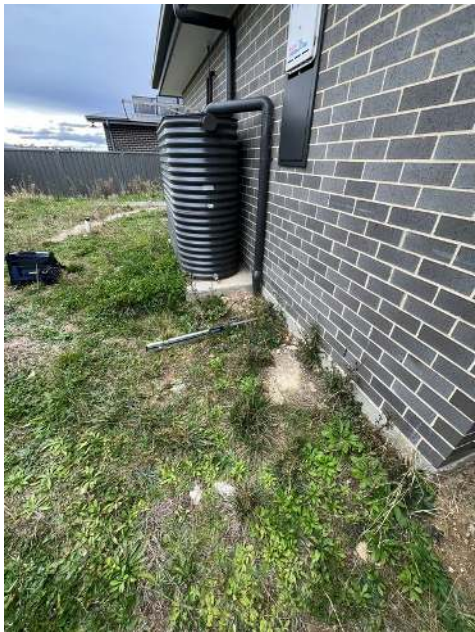
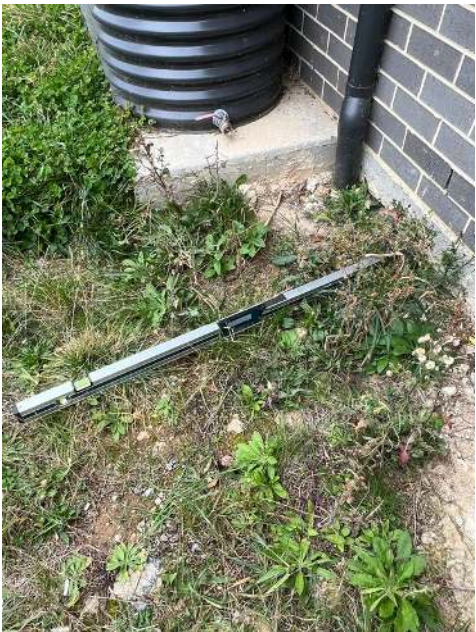
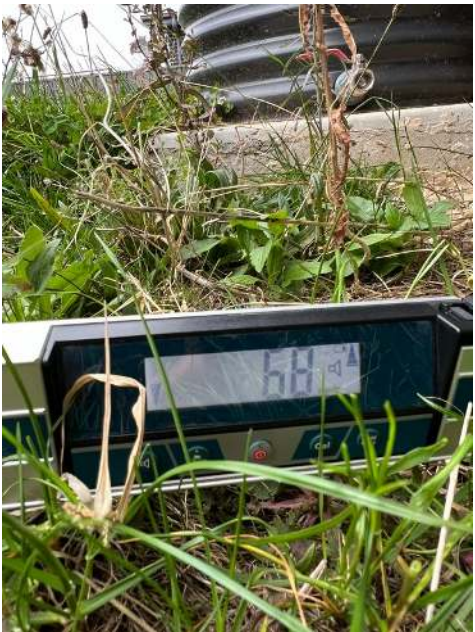
14: + SITE DRAINAGE

Grading must be completed in accordance with standards to ensure rainwater is directed away from the slab to prevent water pooling and potential damage.
