OWNER INSPECTIONS

## EXPERT WITNESS REPORT

8 Example Street  
Googong, NSW 2620

Client Name  
JULY 19, 2024

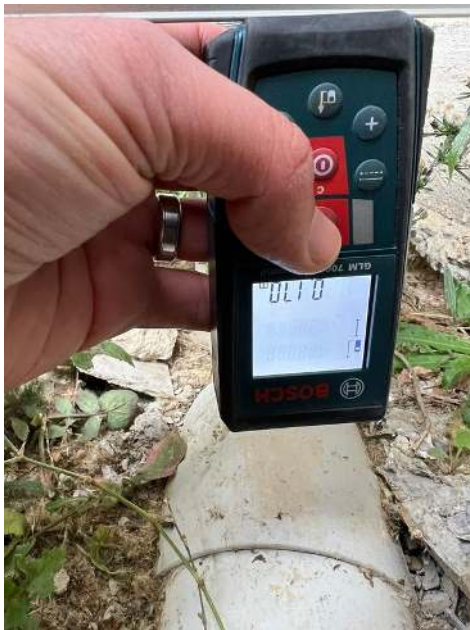
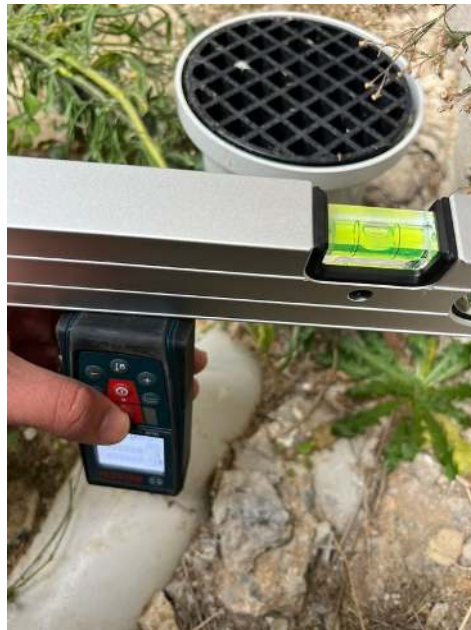
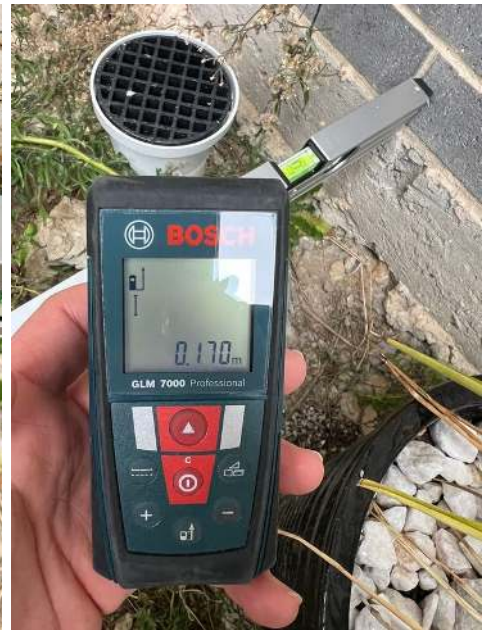
## 14.2.1 + Stormwater Drainage System (Underground)

**+ EXPOSED PIPE - INSUFFICIENT COVER**

**Defect:** Inadequate Clearance Between Brick Wall Cladding and Stormwater Pipe

The clearance between the bottom of the brick wall cladding and the adjoining soil top must be a minimum of 150mm, with an additional 100mm from the soil top to the top of the stormwater pipe, for a total of **250mm**. However, the current clearance is only **68mm**, exposing the stormwater pipe and increasing the risk of damage due to mechanical impact, soil movement, or weather conditions.

Insufficient clearance could result in the stormwater pipe being damaged, leading to potential blockages, water ingress, or flooding around the building foundation. Over time, this could compromise the structural integrity of the slab and cause moisture-related issues within the building.

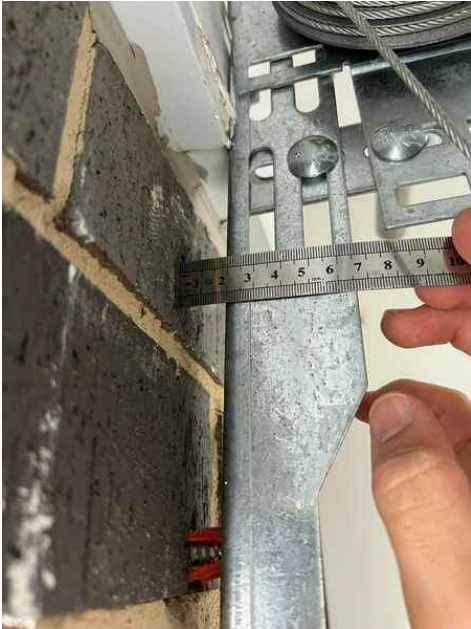
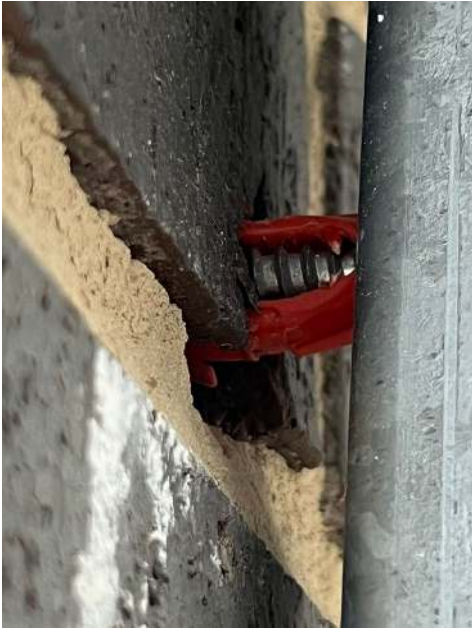
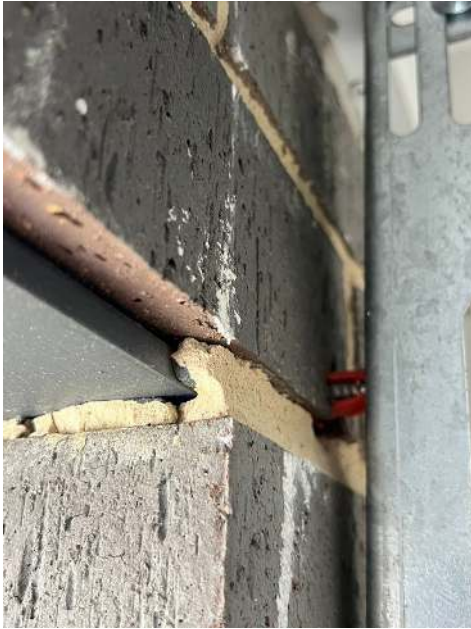
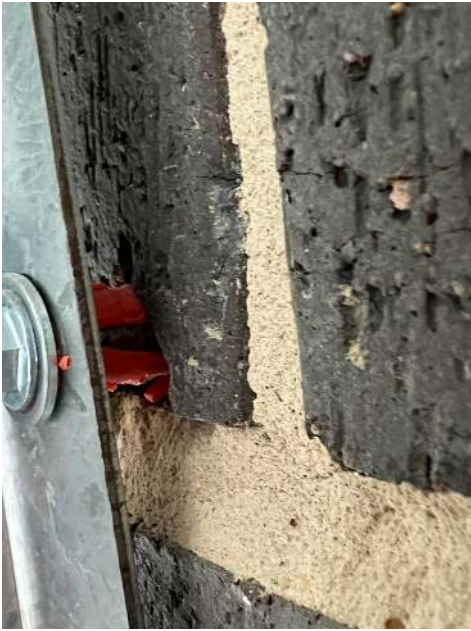
**IMPROPER INSTALLATION OF GARAGE DOOR BRACKET WITH UNEVEN GAPS**

**Defect:** The garage door bracket is not properly seated on the brickwork, leaving a gap of **20mm on the left side and 26mm on the right side** between the bracket and the wall. This indicates improper installation, as the top of the bracket is resting on plaster instead of securely on the brickwork. This issue likely arises due to the size of the beam extending outside the brickwork, which is not typical for similar types of buildings.

**Potential Future Issues:** The uneven gap and improper support can cause the bracket to loosen over time, especially due to the vibrations from the garage door's regular operation. This may lead to misalignment or malfunction of the garage door, and the bracket's inadequate support could cause damage to both the plaster and the door mechanism. Additionally, it increases the risk of structural failure, leading to costly repairs.

This installation does not follow good building practices and requires immediate rectification to ensure the stability and longevity of the garage door system.

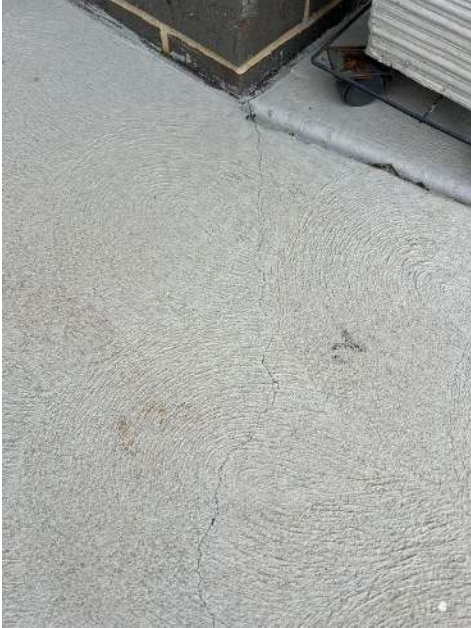
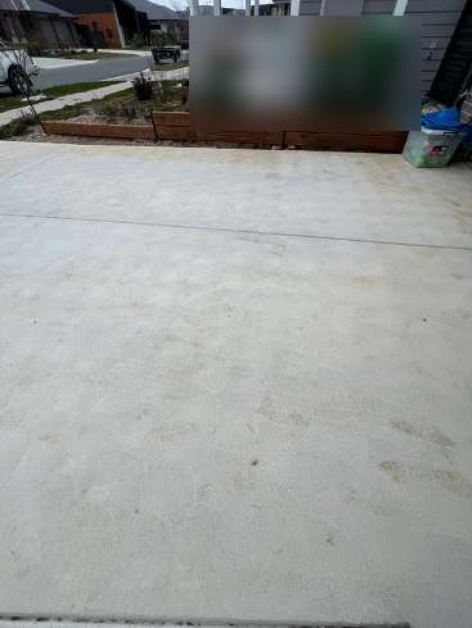
15.2.1 + Driveway/Pathways

IMPROPER SPACING OF CONCRETE CONTROL JOINTS

**Defect:** The defect identified is that the distance between the concrete control joints has been noted up to 6 metres (6000 mm), while it should ideally be between 2400 mm and 3000 mm. Control joints are critical in concrete construction as they help manage and direct the natural cracking that occurs due to shrinkage, temperature changes, and other forces.

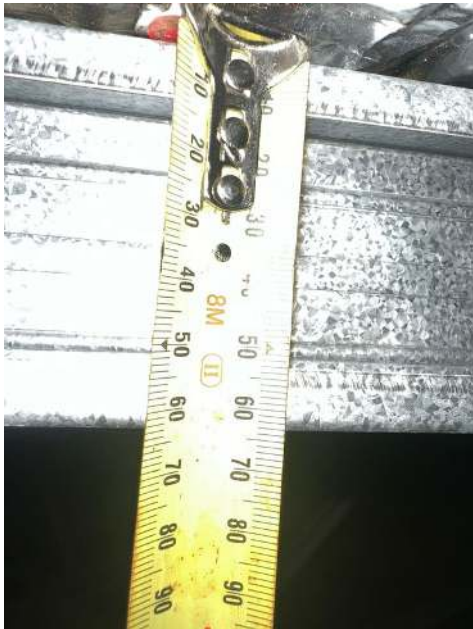
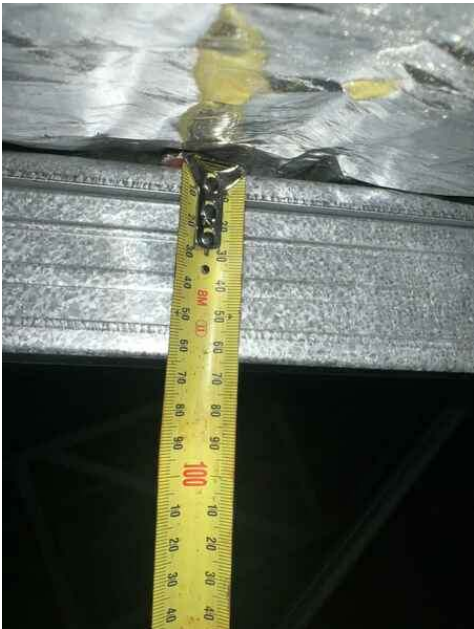
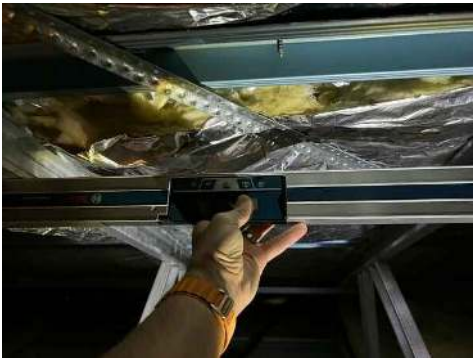
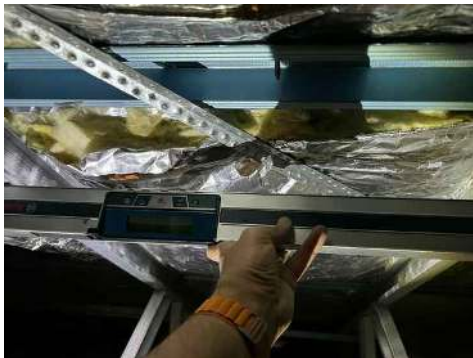
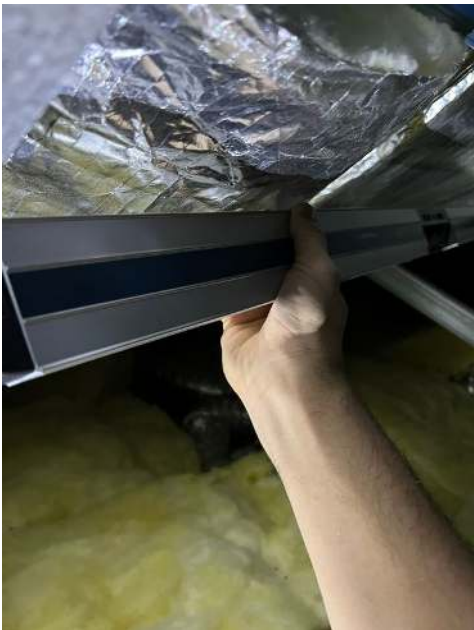
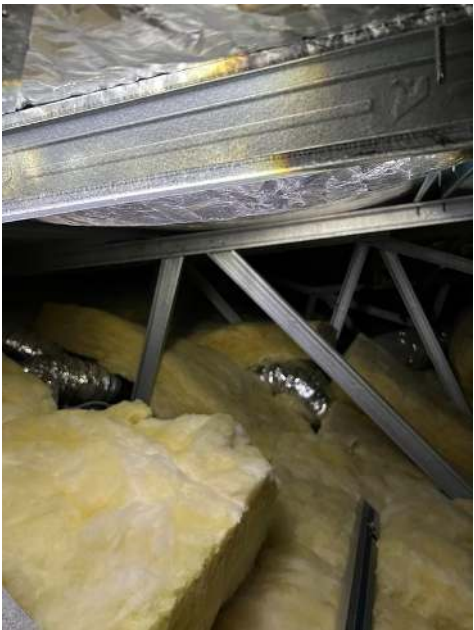
## 16.1.2 + Roof Structure

**DAMAGED OR CUT ROOF SARKING**

One or more sections of the roof sarking were noted to be damaged or cut.

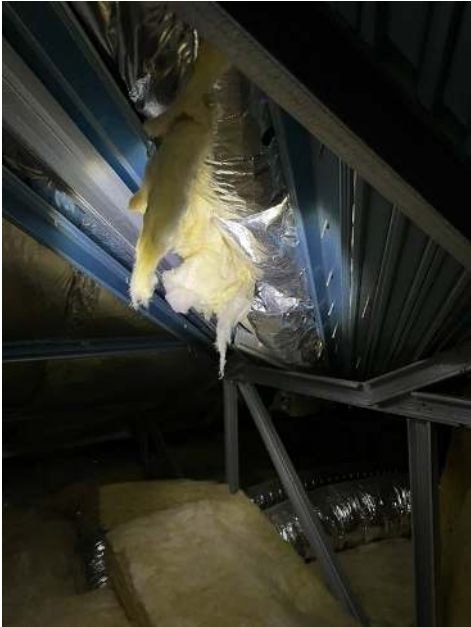
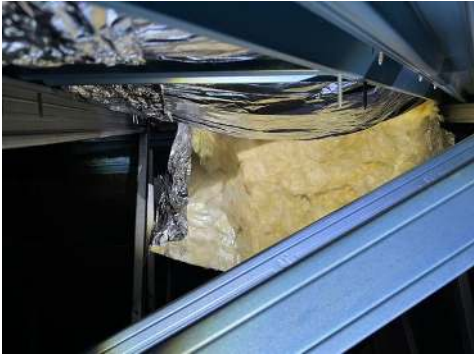
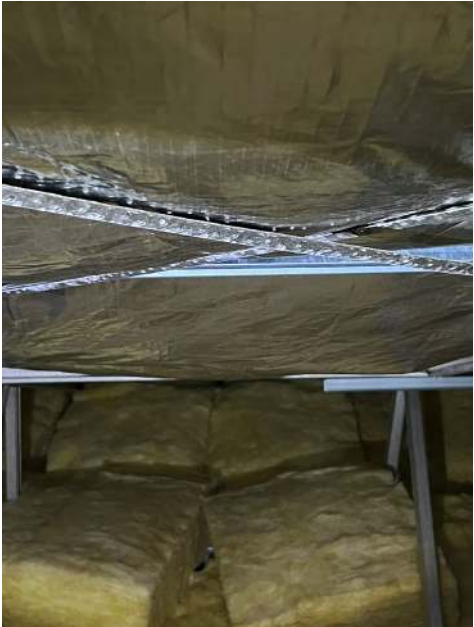
- (a) be provided in accordance with [Table 3.5.2.2](#); and
- (b) comply with AS/NZS 4200.1 and be installed with—
  - (i) each adjoining sheet or roll being—
    - (A) overlapped not less than 150 mm; or
    - (B) taped together; and
  - (ii) sarking fixed to supporting members at not more than 300 mm centres; and
  - (iii) no sags greater than 40 mm in the sarking.

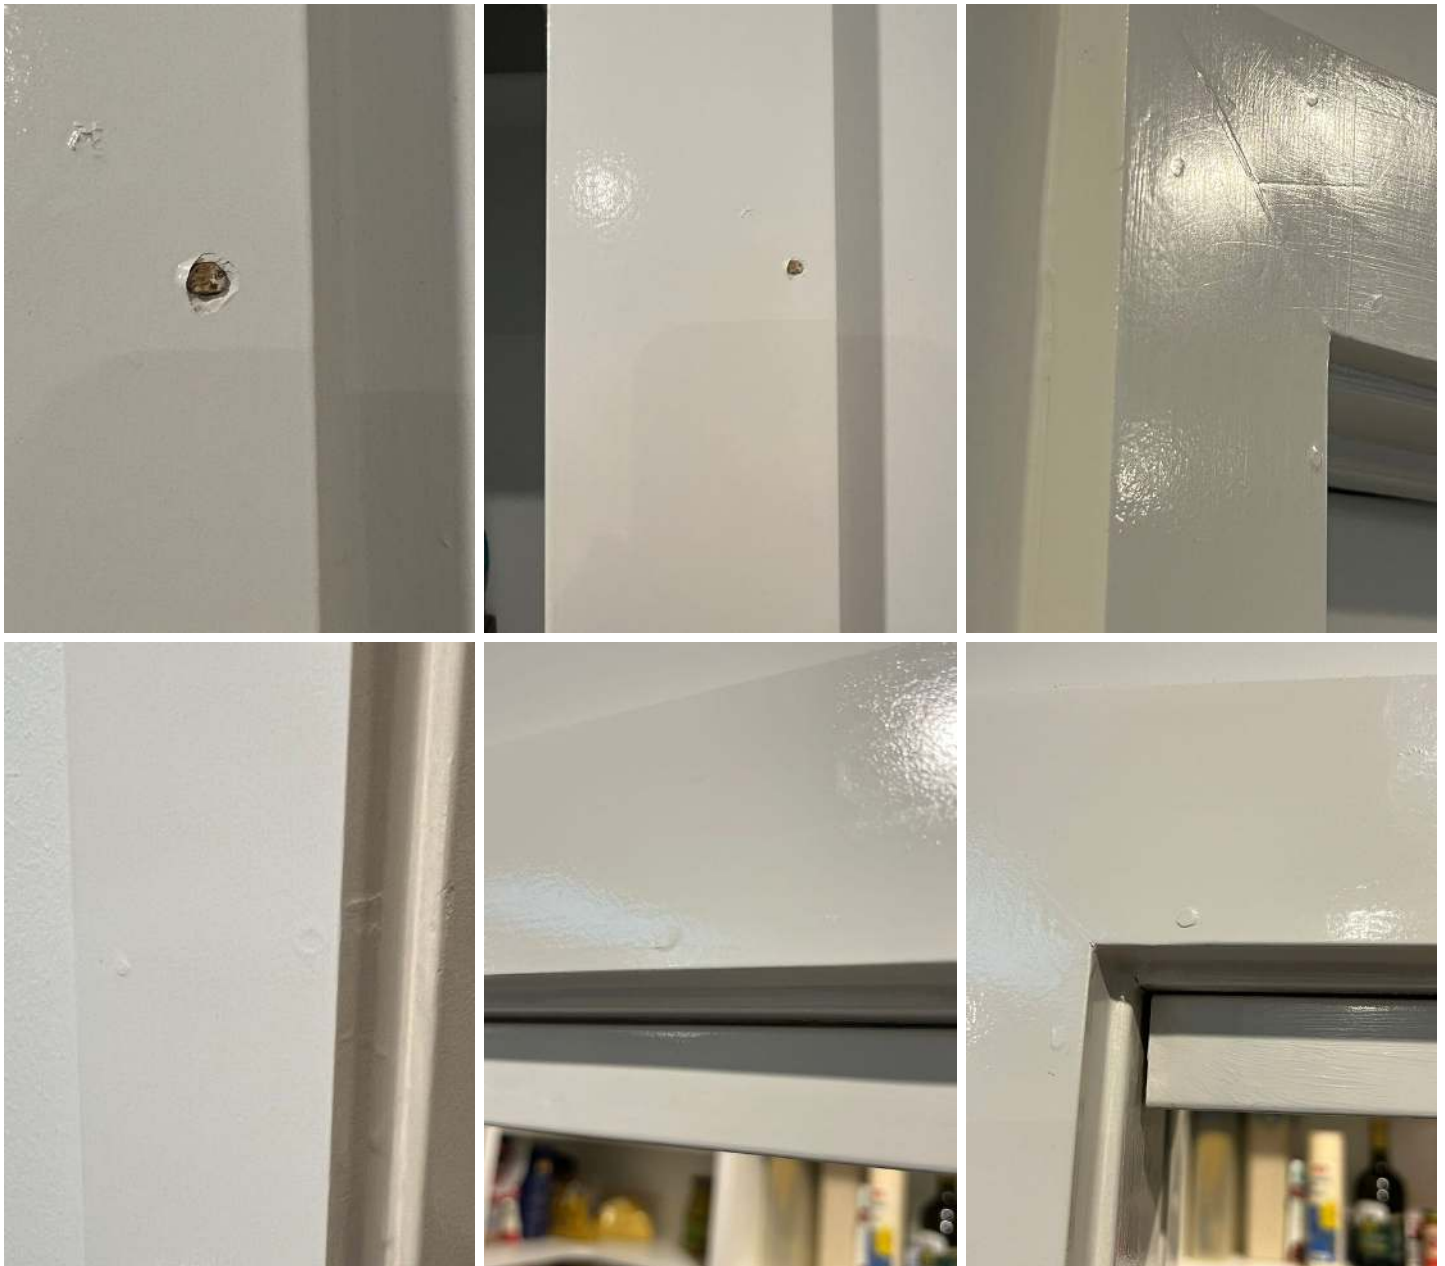
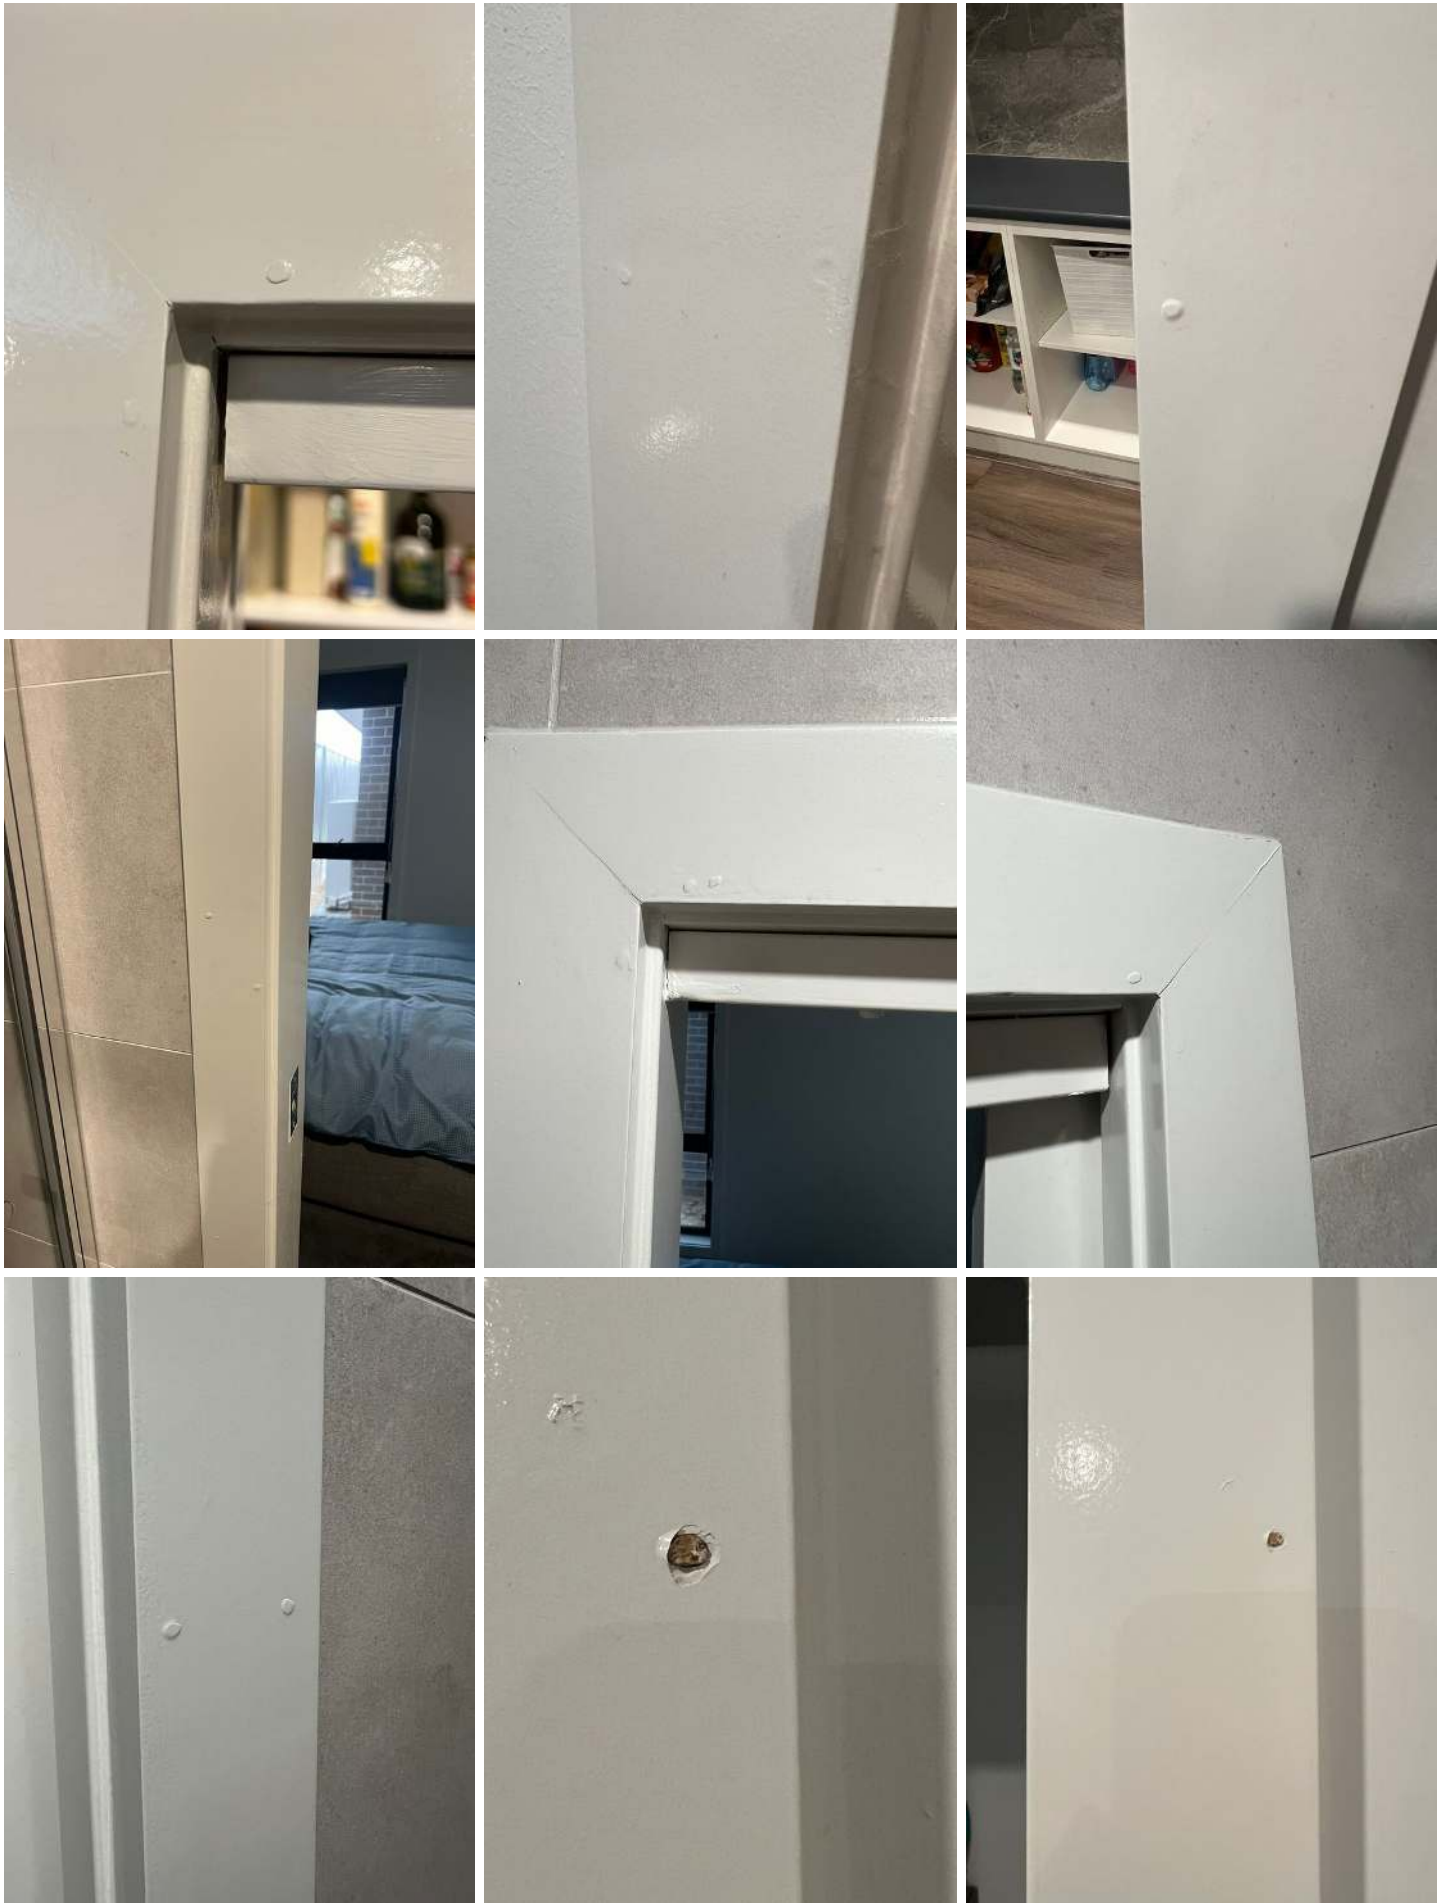
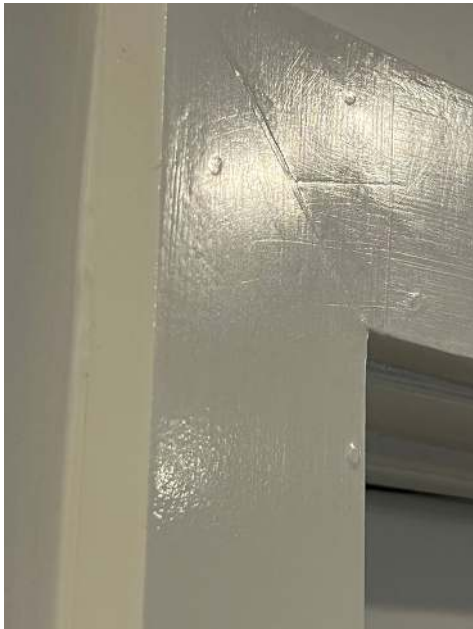
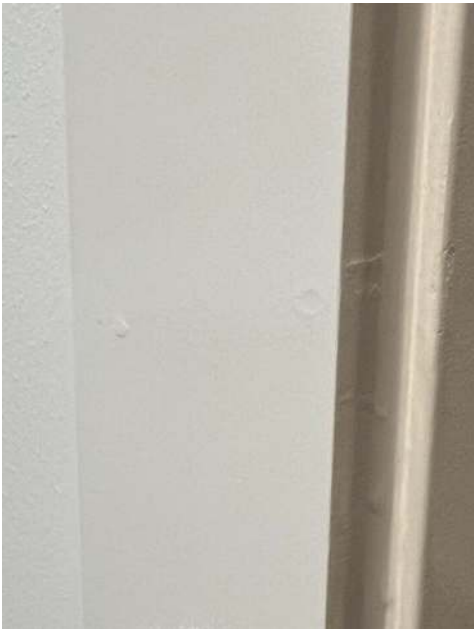
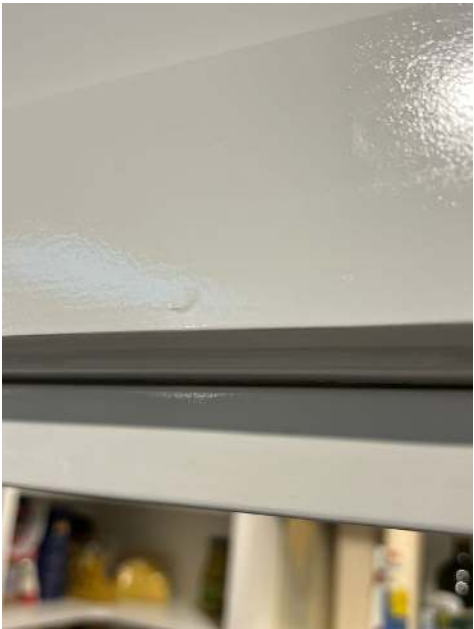
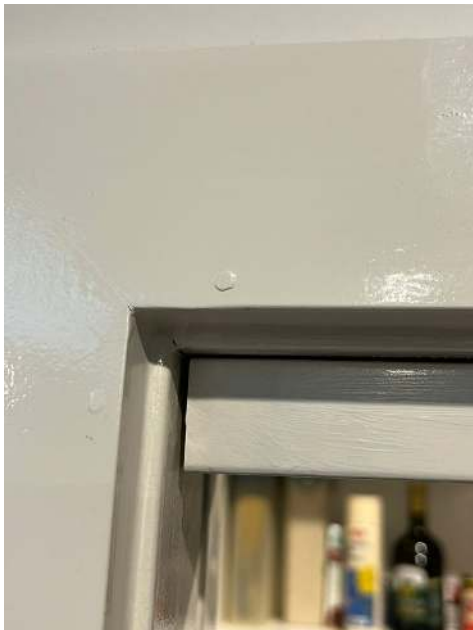
**Nail popping****10.19 Nail popping in surfaces**

Several instances of nail popping have been observed throughout the dwelling, marked with flagging tape. Nail pops, caused by natural expansion, contraction, or improper installation, result in protruding nails or screws, leading to cosmetic damage and potentially weakening the surface structure.

Nail popping in sheeting is defective if it exists at handover or occurs within the first 24 months of completion and can be seen from a normal viewing position.

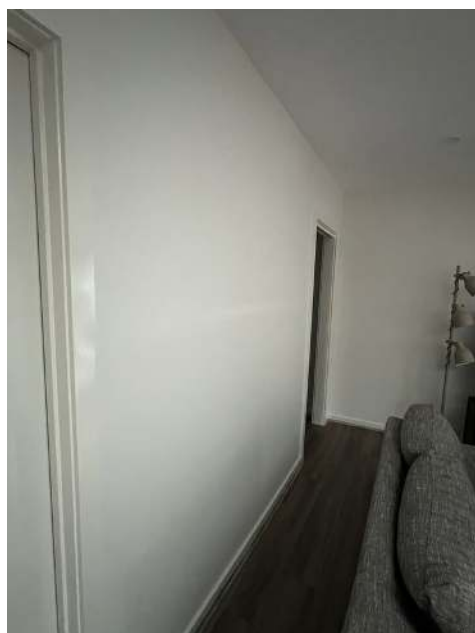
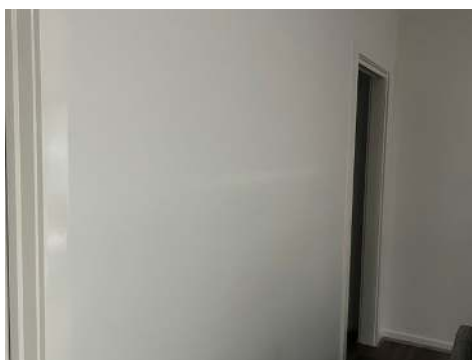
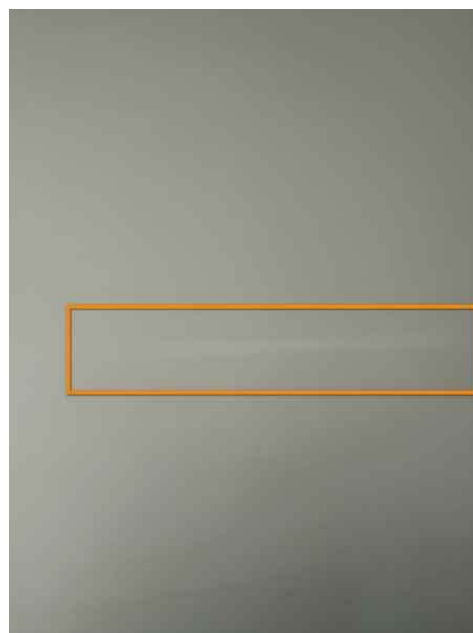
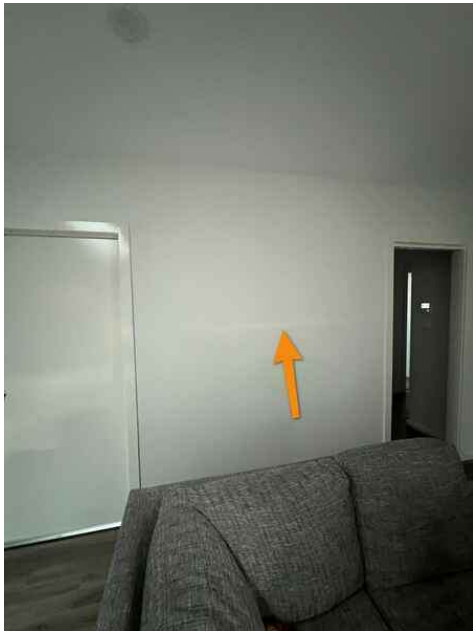
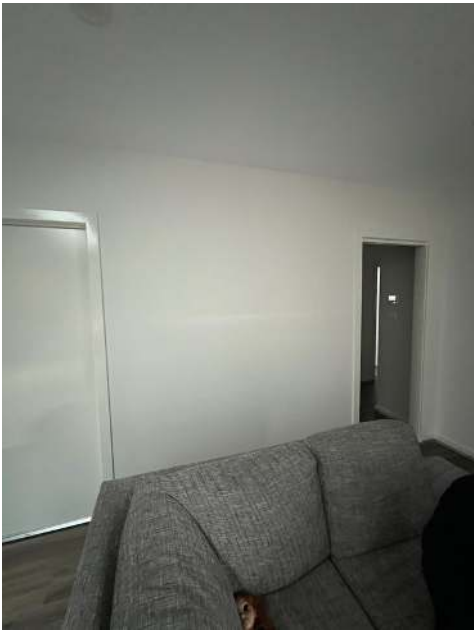
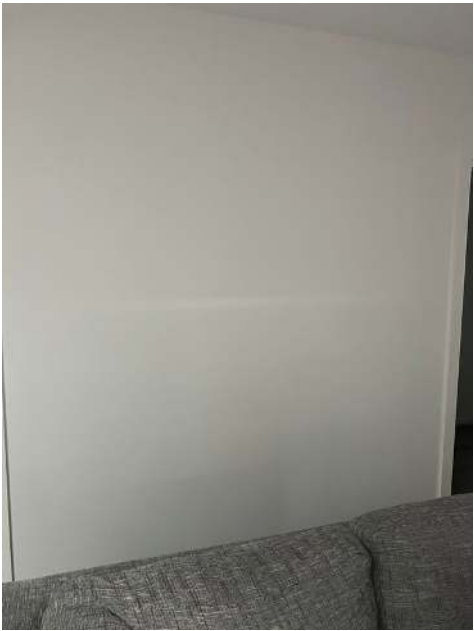
Plaster joint lines are visibly noticeable from a distance of 1.5 metres, indicating improper surface preparation or finishing. Additionally, poor architrave joints and other defective areas of paintwork have been observed, further diminishing the overall finish quality. Rectification is required to ensure that all surfaces, joints, and finishes meet acceptable standards for a professional appearance.

Paintwork is defective if the application has blemishes such as paint runs, paint sags, wrinkling, dust, bare or starved painted areas, colour variations, surface cracks, irregular and coarse brush marks, sanding marks, blistering, non-uniformity of gloss level and other irregularities in the surface that are visible from a normal viewing position.

Paintwork is defective if the application results in excessive over-painting of fittings, trims, skirtings, architraves, glazing and other finished edges.

Fixings or unfilled depressions caused by fixings are defective in painted or stained surfaces if they can be seen from a normal viewing position.

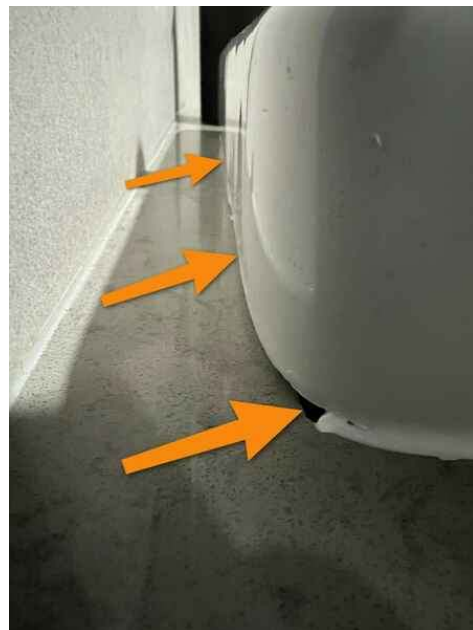
The basin premier must be sealed properly to prevent water leakage.
