## EXPERT WITNESS REPORT

Sample Property

09/06/2026

**Craig Palmer**

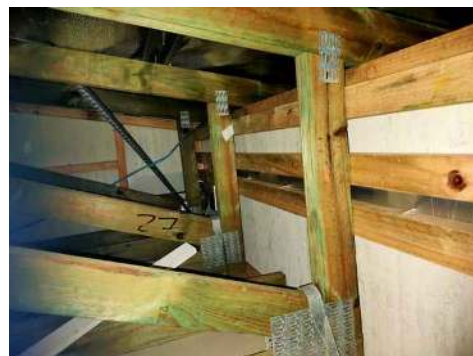
Roof-space framing — treated-pine studs/battens with a metal bracket connector and membrane behind; relevant to batten size/orientation and fixing into framing.

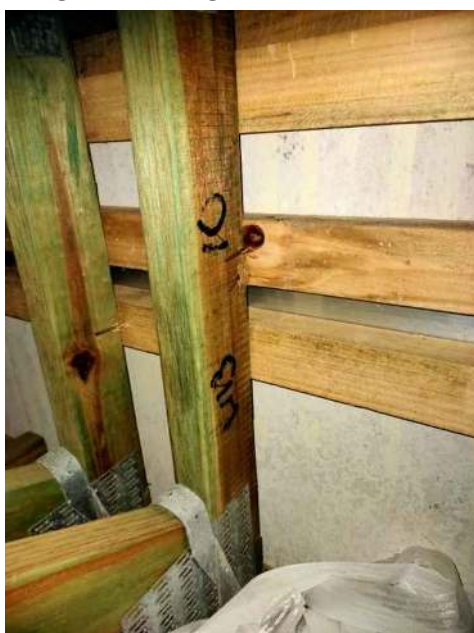
Roof-space framing — timber members fixed with metal strap / bracket connectors; load path and fixing into framing relevant to Items 9–11.

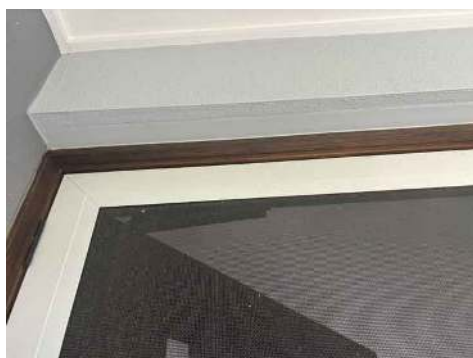
Upper-level window head corner with insect screen — head trim / reveal detail relevant to the window head-flashing assessment (Items 13–18).

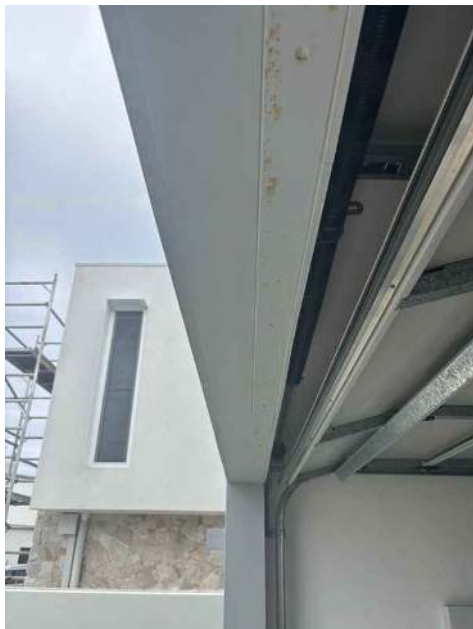
Eave / balcony soffit underside with rust-coloured staining and cladding above, scaffold and neighbouring dwelling beyond — coastal exposure and roof-edge detailing.

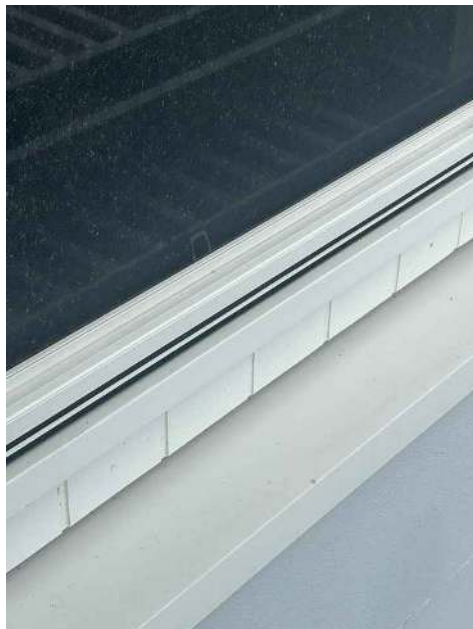
Upper-level window jamb / sill corner with insect screen meeting the Axon cladding — window perimeter and sill detailing relevant to the flashing assessment (Items 13–18).

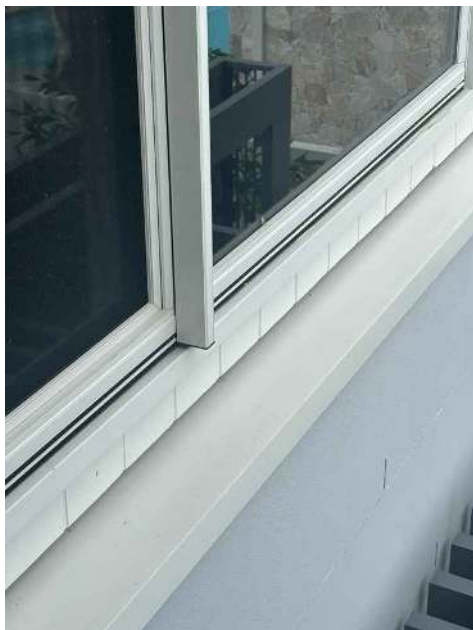
Upper-level window sill with insect screen — sill trim meeting the Axon cladding above the render; sill drainage detail relevant to the flashing assessment (Items 13–18).

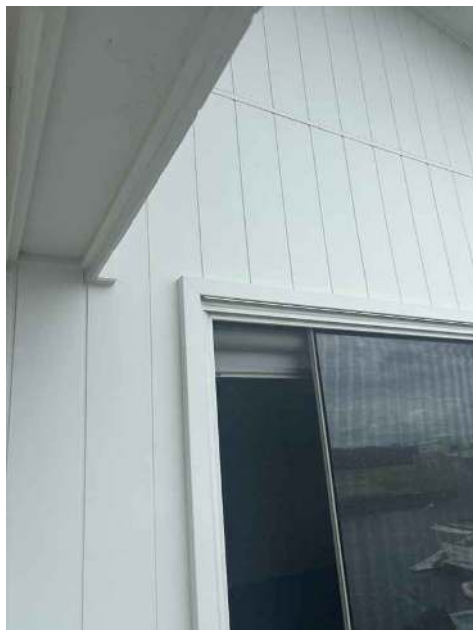
Upper-level window corner with insect screen — outdoor / canal area reflected; window perimeter detailing relevant to the flashing assessment (Items 13–18).

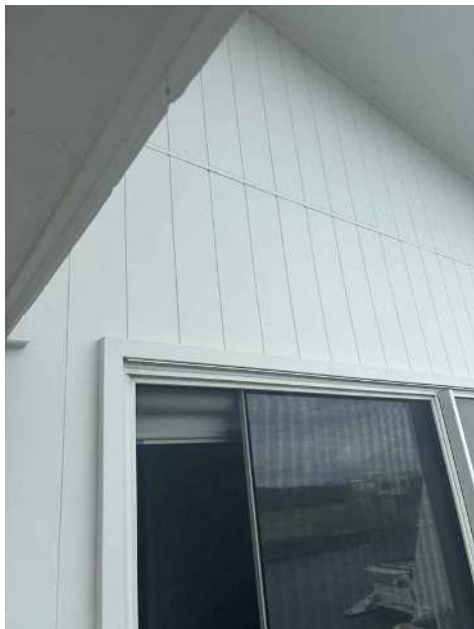
Raking gable cladding junction — Axon vertical boards meeting at the gable apex beneath the eave; membrane and flashing continuity significant at this junction.

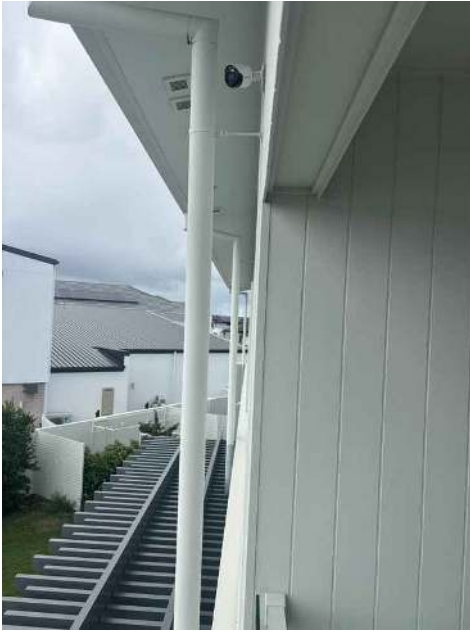
Downpipe and upper bracket at the eave / fascia running down past the cladding — upper bracket location relevant to the corrosion complaint (Items 19–20).

**Downpipe brackets — early corrosion at upper-level fixings (House External Items 19–20).**

**Site observations.** Staining and corrosion indicators were observed at downpipe fixings and at box-gutter / rainhead outlet junctions at the upper-level locations identified — consistent with the complaint, which records significant corrosion at the upper brackets of seven downpipes (four to the right side, three to the left). The pattern appearing on both sides strengthens the concern that the issue is systemic rather than isolated.
