## EXPERT WITNESS REPORT

Unit 5 / 21 Sample Street  
Dandenong, VIC 3175

Client Name  
DECEMBER 1, 2023

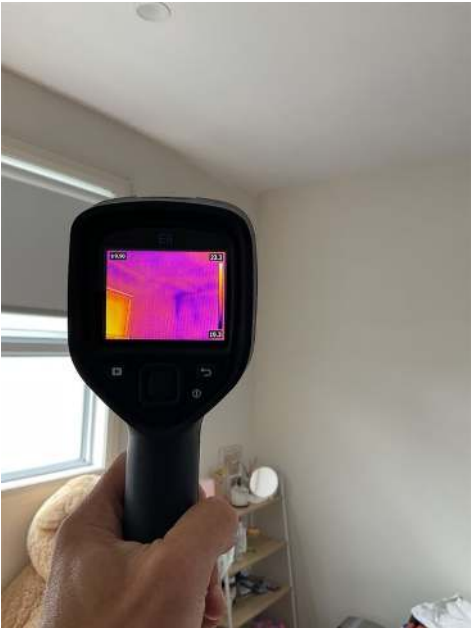
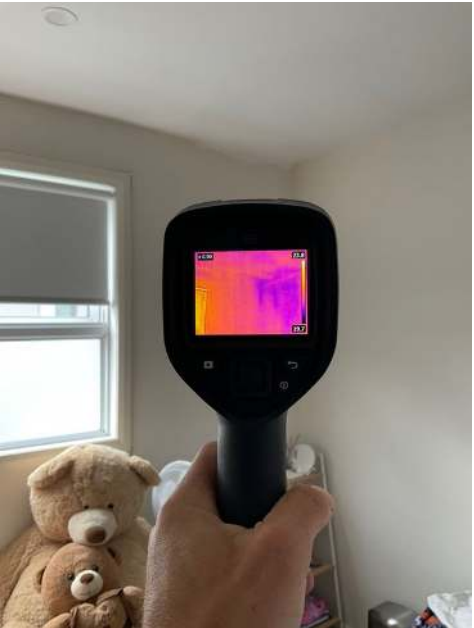
1st Floor bedroom

8.1.1 + House Internal - + General Information - Ceiling/Wall plaster: + Bedroom First Floor - Plaster Repaired by owner - No Defect

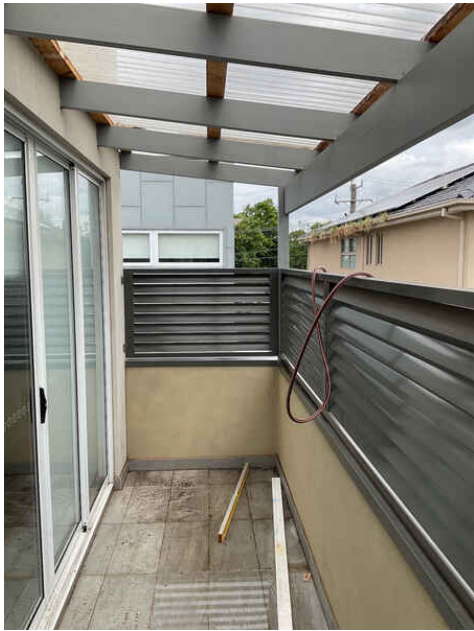
Roof over balcony.

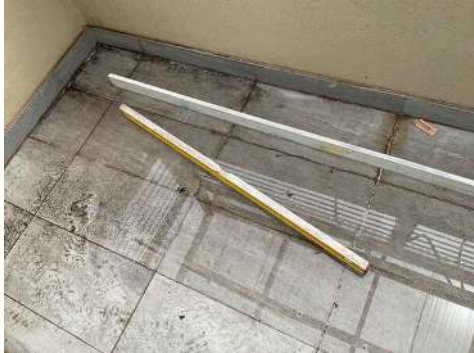
Negative fall where ponding begins

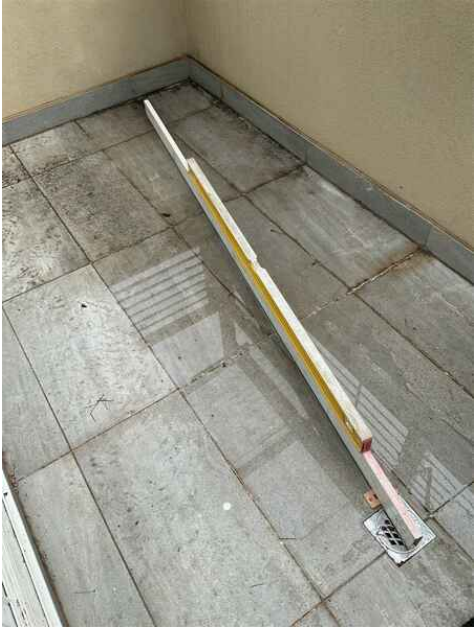
5mm fall over 2m - Insufficient

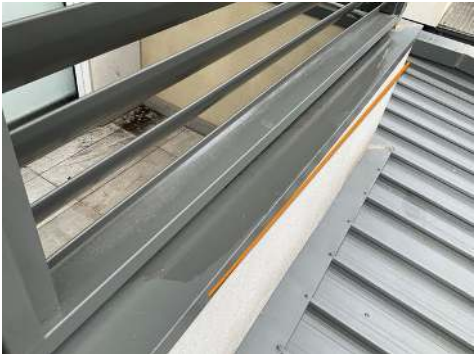
Water ponding to cappings adjacent to post

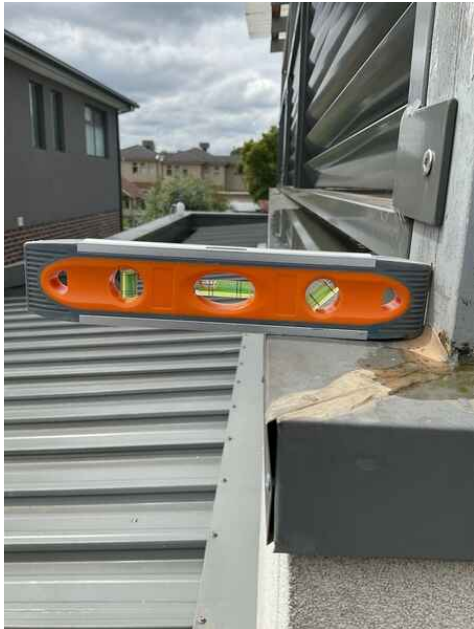
Negative fall towards timber posts which is causing water to pond around the timber post

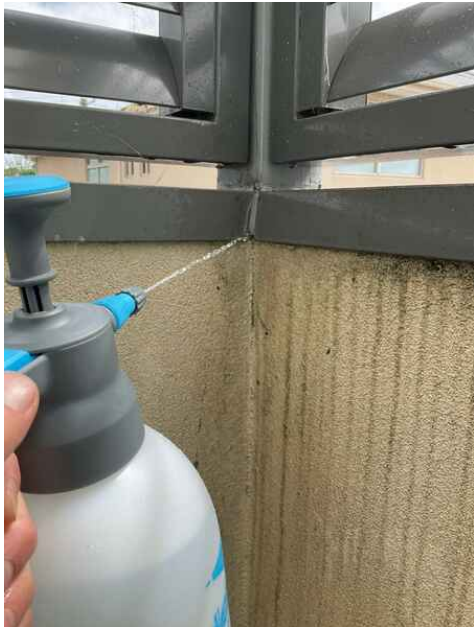
Hot water spray test to hole below metal capping to left corner of balcony

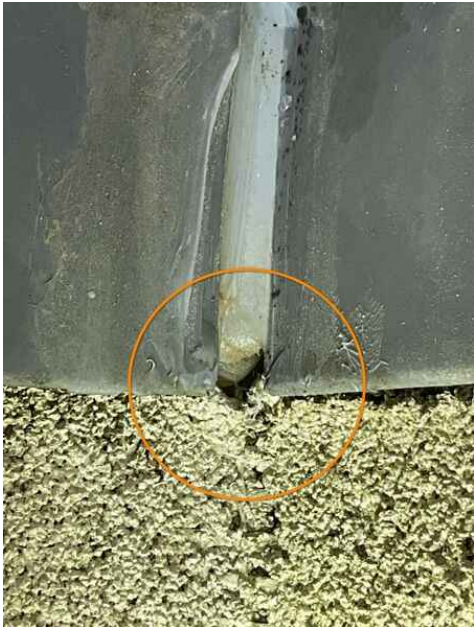
Hole in flashing at corner of balcony

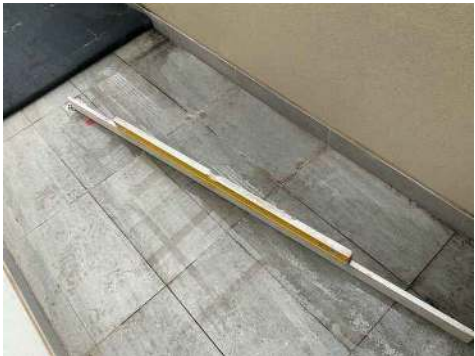
Hot water spray test over kitchen

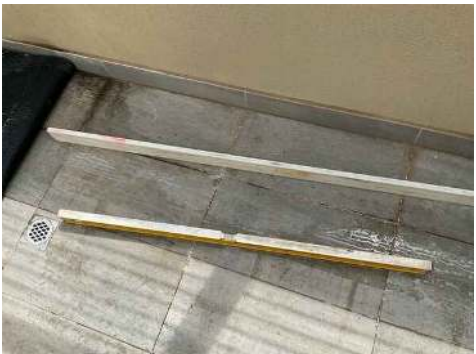
3mm packer

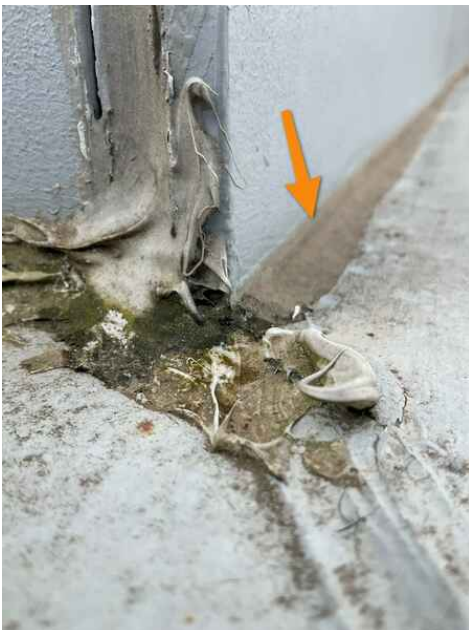
Homeowners Maintenance

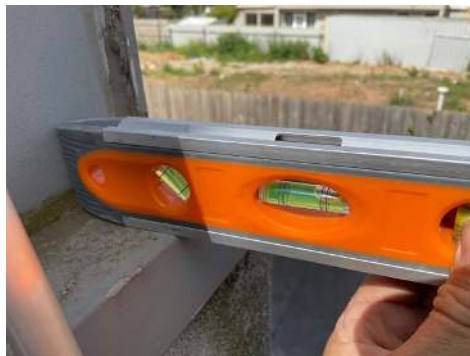
No 6mm gap and silicone installed between sill flashing and matrix cladding.

The sill flashing needs to be rectified to ensure adequate fall is achieved, the matrix cladding is to have the required 6mm gap installed between the bottom of the cladding and the sill flashing, and the existing sealant is to be removed. These building defects must be repaired to ensure no future water ingress occurs to this area.

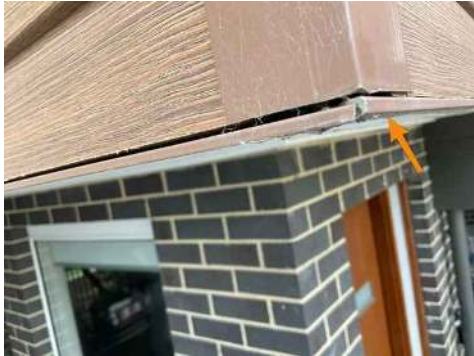
Euroclad Vertical Started Profile is not falling away from the ceiling. It is falling towards the ceiling

The Euroclad vertical starter profile does not have the required fall to drain water away from the cladding and adjacent eaves lining. There is no gap to the bottom of the cladding that is also required to drain water away from the cladding. The vertical starter profile is to be adjusted with the required fall and gap to prevent water ingress/damage.

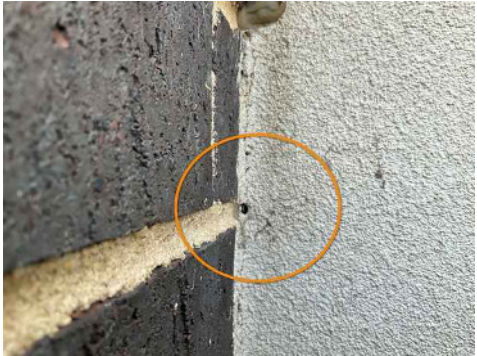
Holes to matrix cladding

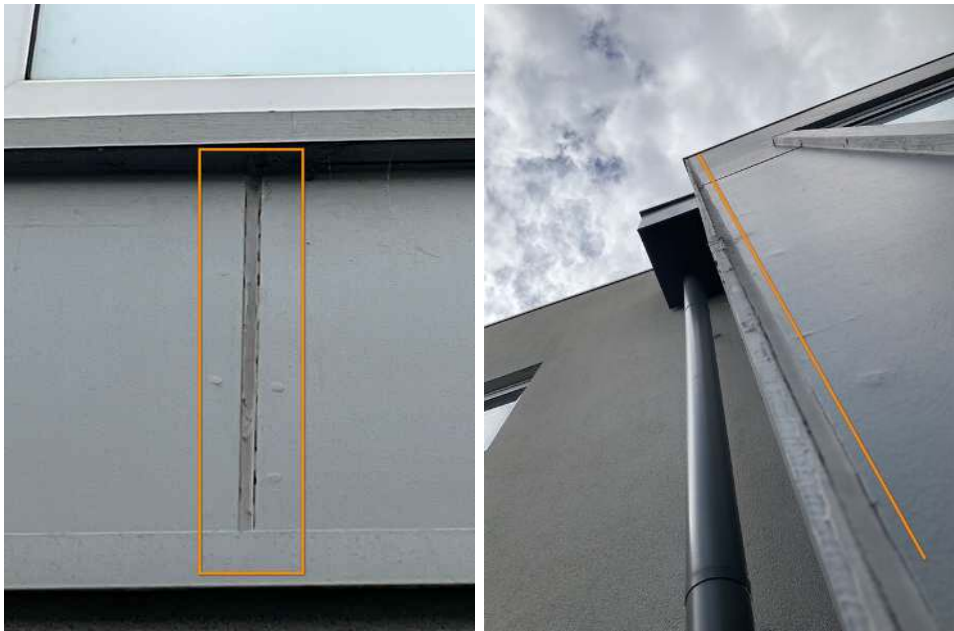
Sealing to matrix/flashing connection to be removed as per installation manual

Matrix to be fully resealed to front facade
