FRAME INSPECTION

Sample Property

14/09/2026

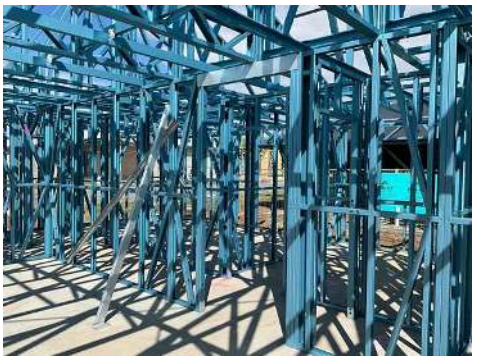
2.1.1 Inspection Summary

Frame is visually fine and built to engineers plans

OVERALL CONDITIONS - MID LEVEL/ACCEPTABLE

The frame was generally observed to have been constructed to an acceptable standard with some minor defects noted that require repair.

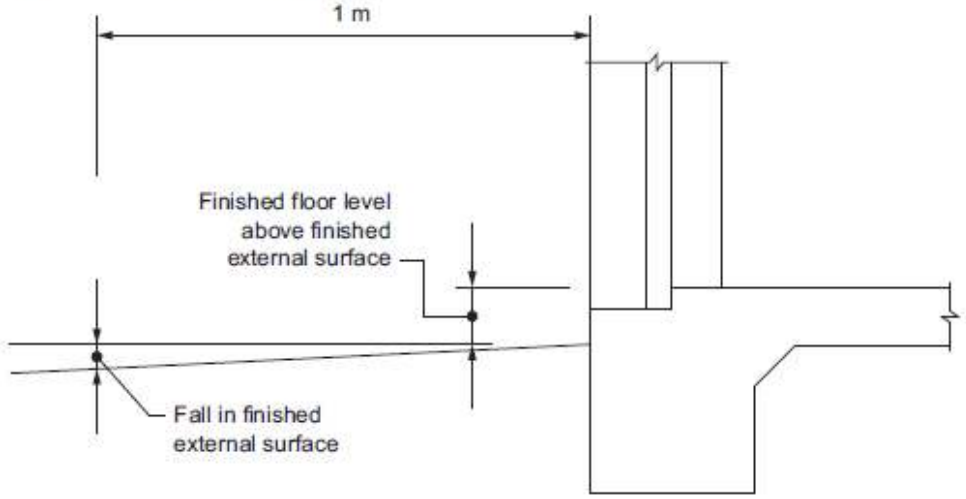
The site has not been graded. If the site remains ungraded during construction, rainwater can flow towards the building, accumulating and seeping under the slab. This can lead to moisture issues, compromising the foundation and causing potential long-term damage. The site is required to be graded in accordance with *ABCB Housing Provisions (2022) - Section 3.3.3* at 'handover'.

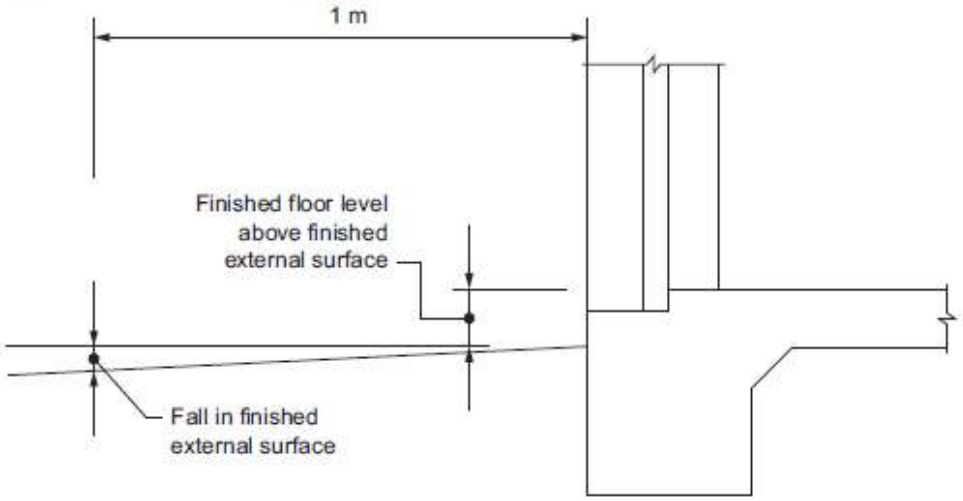
6.1.2 Site Grading

Although sections of the site are graded, certain areas remain ungraded. It is required that the entire perimeter of the building be graded in accordance with ABCB Housing Provisions (2022) – Section 3.3.3 at the time of handover. If the site remains ungraded during construction, rainwater can flow towards the building, accumulating and seeping under the slab. This can lead to moisture issues, compromising the foundation and causing potential long-term damage.

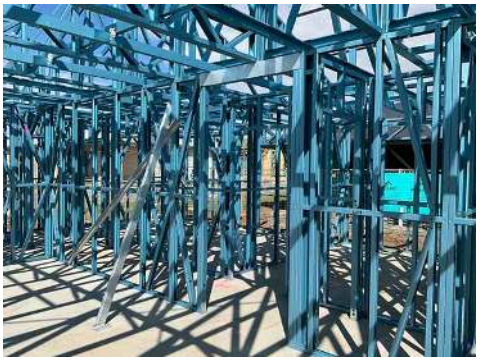
THE INSTALLATION OF STEEL FRAMES IS VISULLY FINE
