# PRE-PURCHASE INSPECTION (BUILDING & PEST)

Sample Property

10/08/2026

Inspector
Kosie (Kosmas) Touretsoglou
Registered Building Practitioner & Pest Inspector
1300 471 805
booking@ownerinspections.com.au

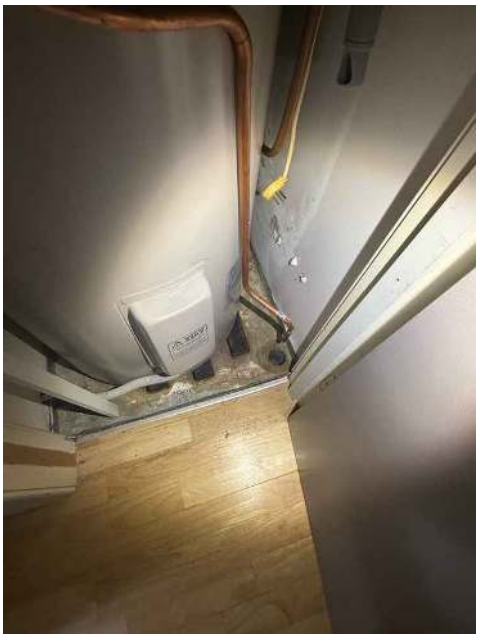
## HOT WATER UNIT – SERVICEABLE CONDITION

The hot water unit appeared to be in generally good and serviceable condition at the time of inspection, with no obvious defects or items of concern identified. Please note that the assessment is visual in nature and does not include extensive testing, efficiency testing or assessment of the internal components of the unit.

Contact a qualified professional.

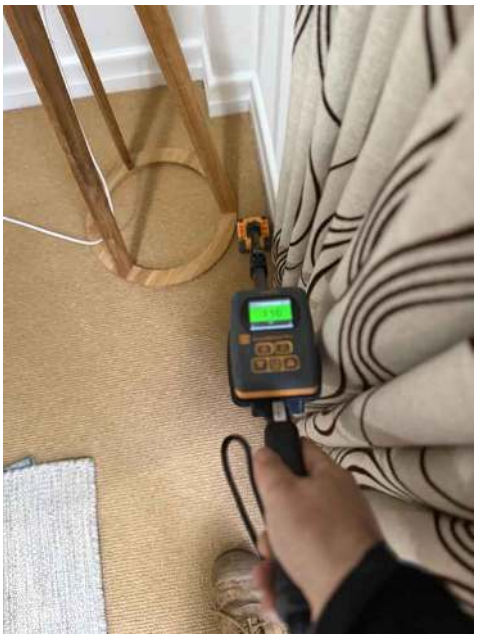
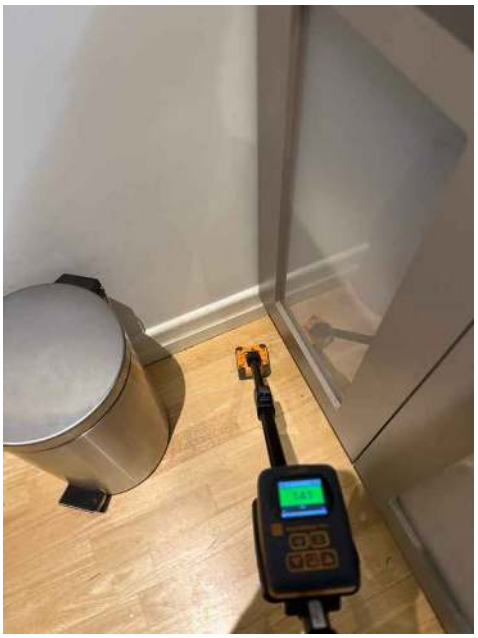
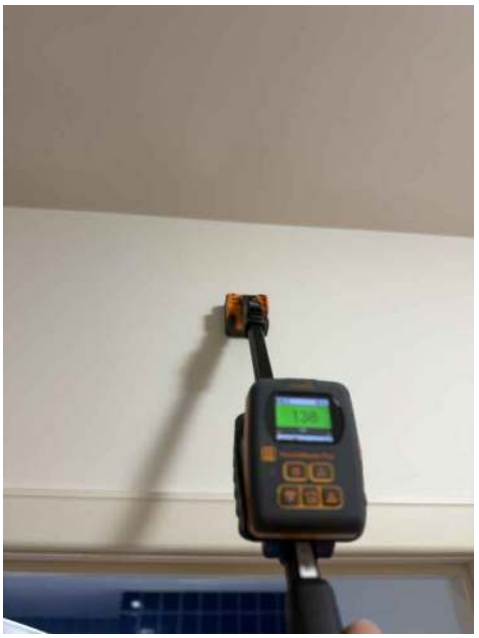
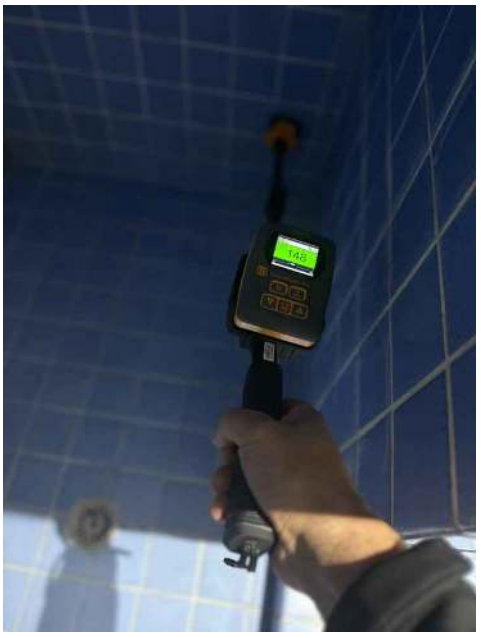
4.2.1 Moisture meter scanning

## MOISTURE METER SCANNING – NO ELEVATED READINGS TO SAMPLED AREAS

Moisture meter scanning was carried out to selected accessible areas throughout the property. No elevated moisture readings were detected within the areas sampled below at the time of inspection. Any elevated moisture readings identified during the inspection have been documented separately within the relevant sections of this report.

Contact a qualified professional.

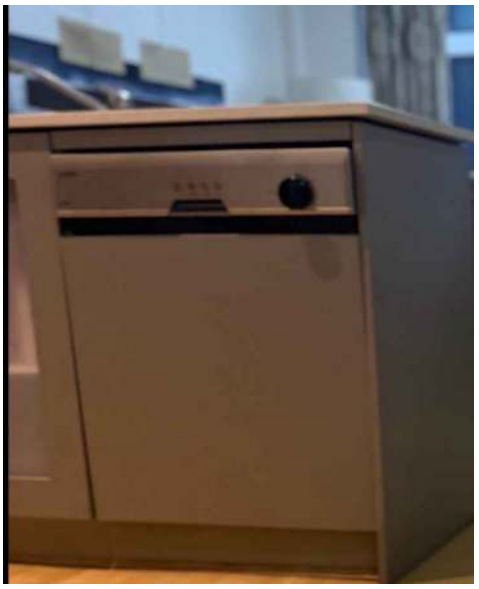
7.9.1 Appliances

Maintenance Item/Information Only

Contact a qualified professional.
