## LOCK-UP (PRE-PLASTER) INSPECTION

Sample Property

21/09/2026

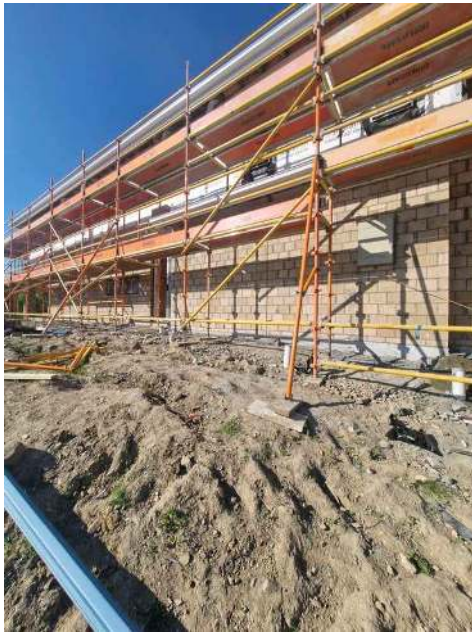
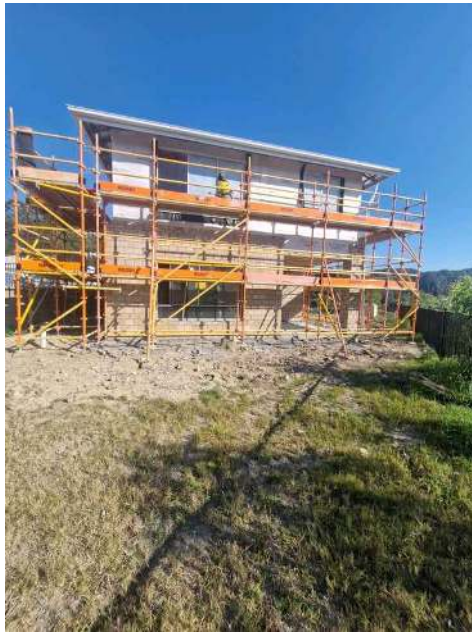
The building of external wall/cladding has not completed yet. All cladding must be installed ASAP to prevent water damage to plasters. (The cladding supposed to be in the previous stage (Lock-up)).

"lock-up stage" means the stage when a home's external wall cladding and roof covering is fixed, the flooring is laid and external doors and external windows are fixed (even if those doors or windows are only temporary).

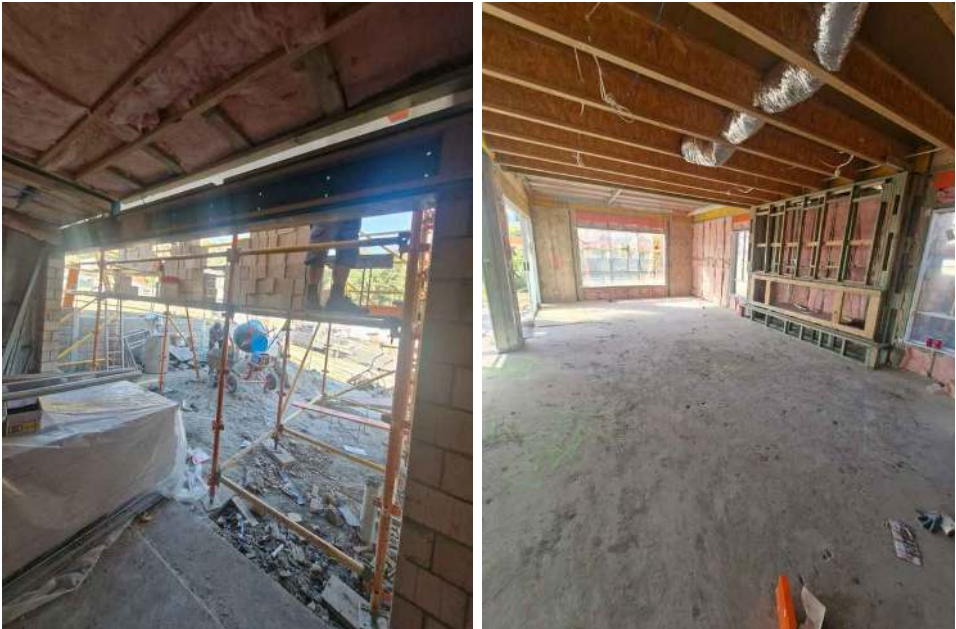
Unable to inspect the slab due to stored material on the slab. Where is visible looks fine.

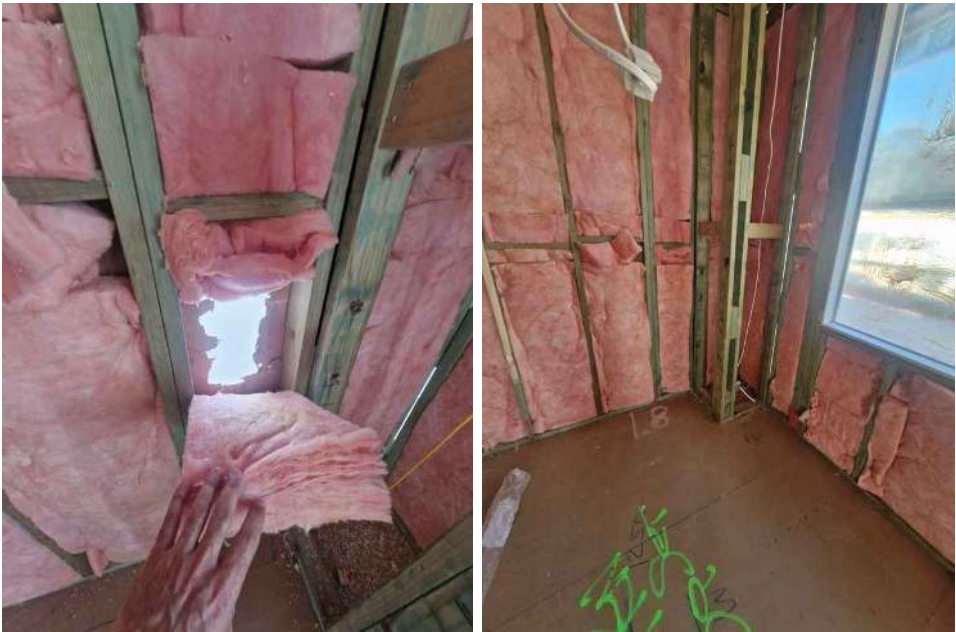
One bracing has been cut. Bracing provides stability and resists lateral loads in building and should not be removed/cut. Builder told that he had replaced the bracing and get the engineer certification.

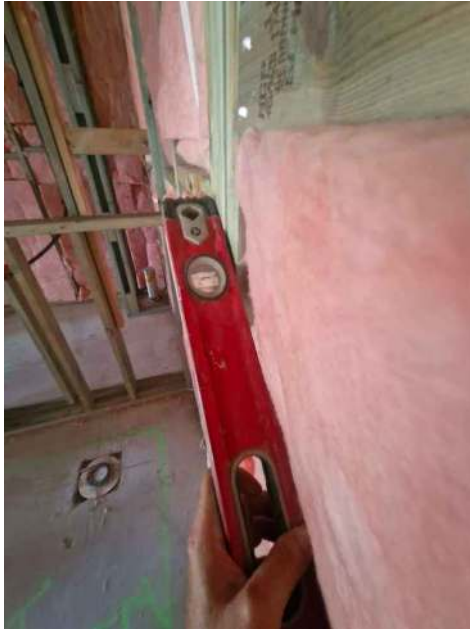
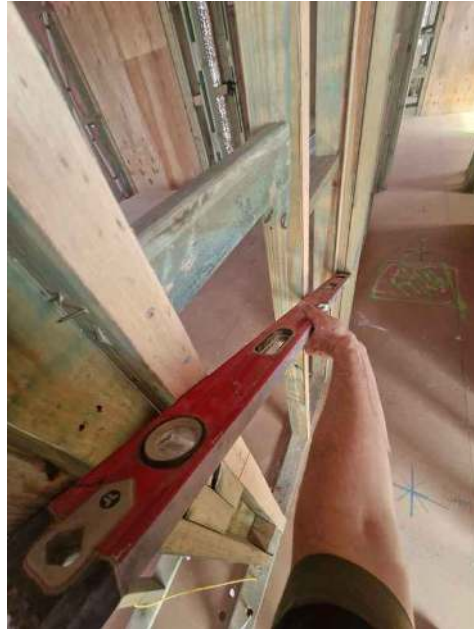
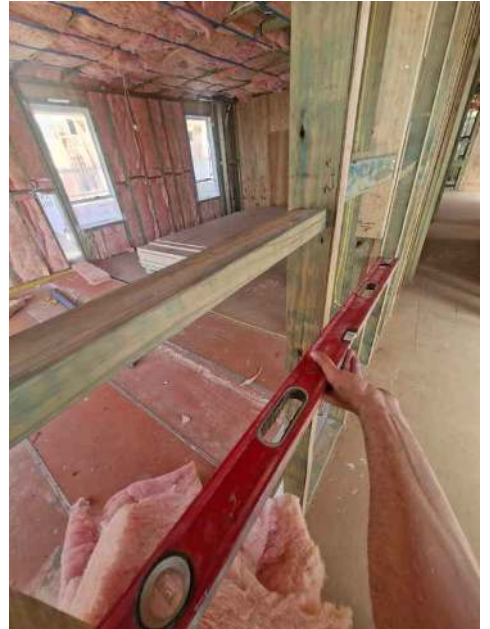
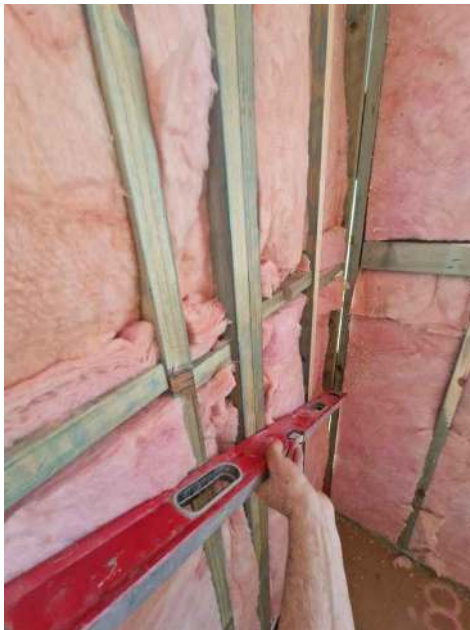
## 11.2.1 Studs

**+ STUD NOT SECURE/PLUMB**

Studs needs to be fixed.

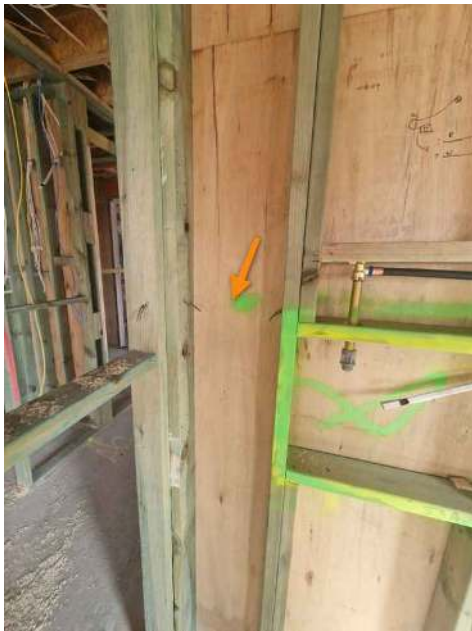
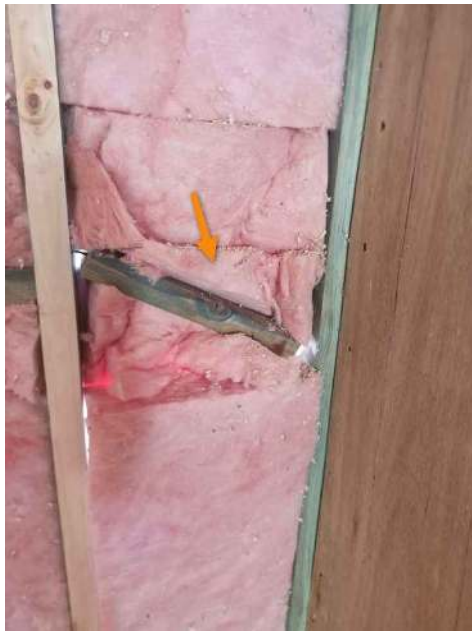
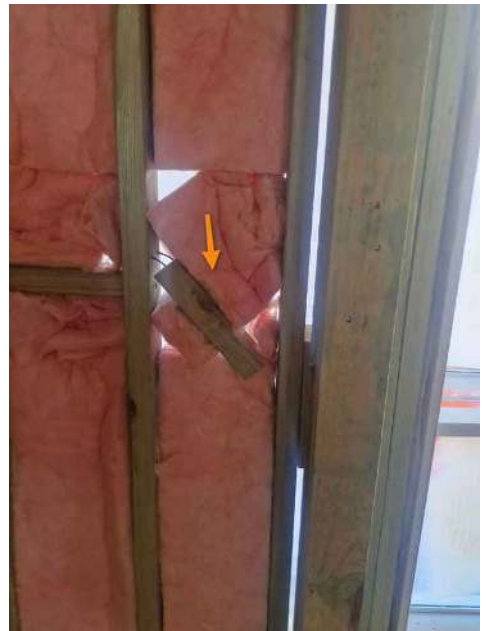
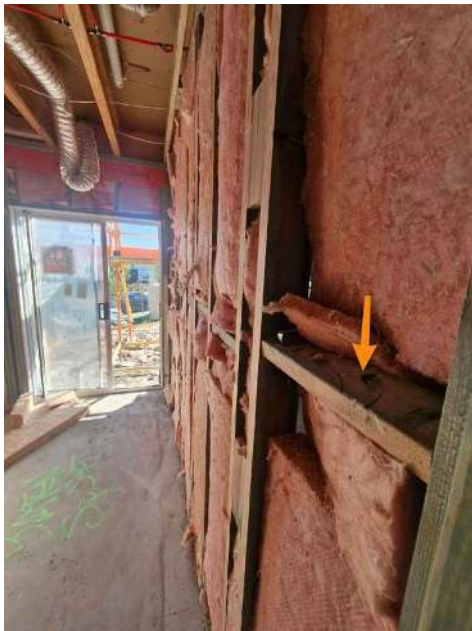
## 11.3.1 Noggings

**MISSING**

One or more noggings missing.

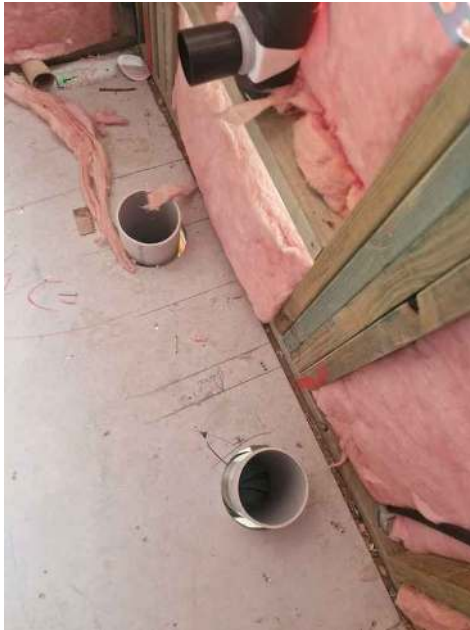
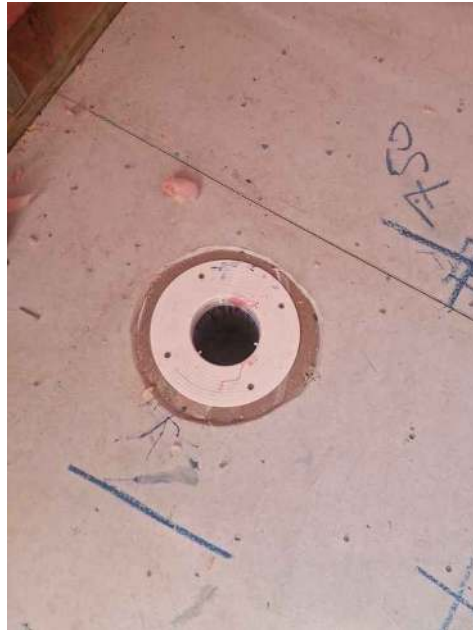
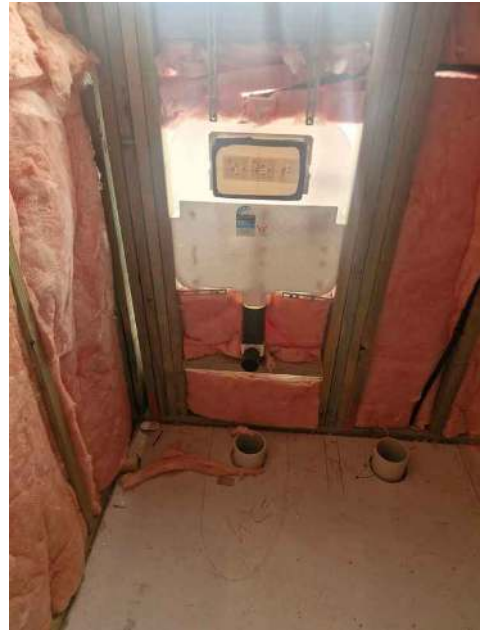
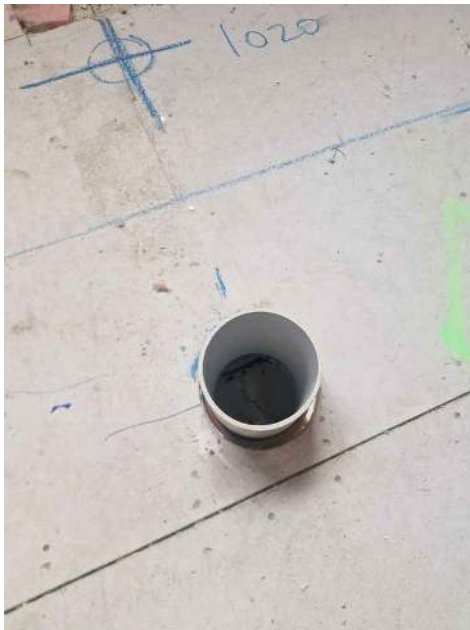
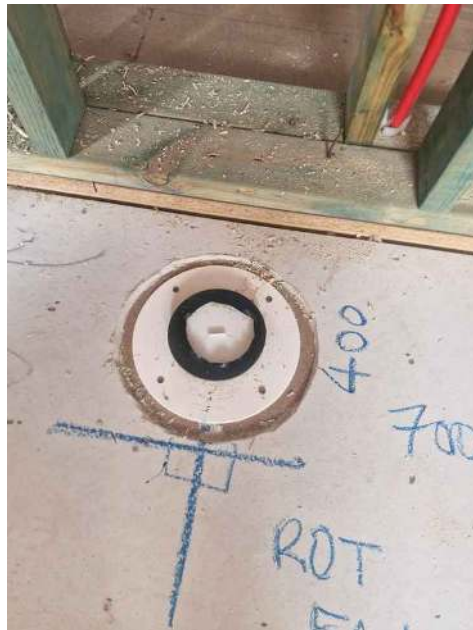
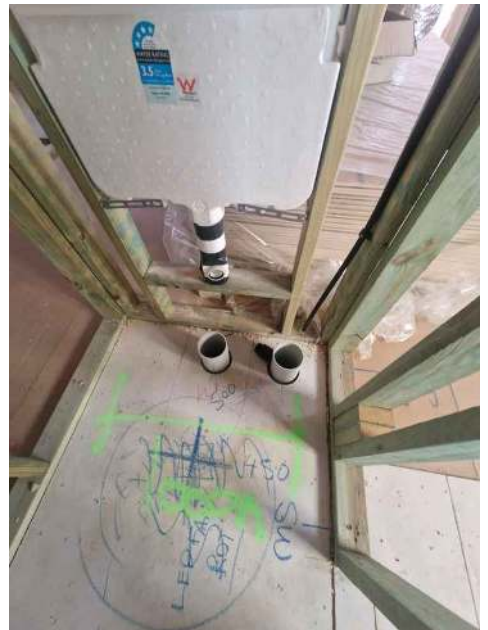
## 12.3.1 Sewer Pipes

**+ SEWER PIPES NOT CAPPED**

One or more sewer pipes are not capped. The material and debris can fall into the pipes and block the sewerage system. Cappings to be installed ASAP.

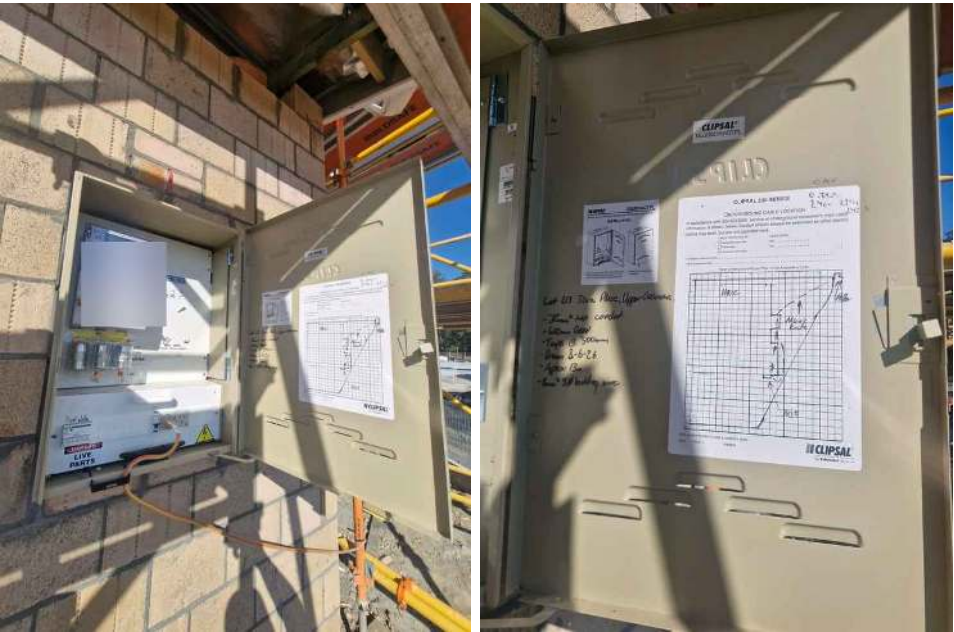
+ TERMITE MANAGEMENT NOTICE NOT FOUND

The termite management notice was not found in the metre box at the time of inspection.

A durable notice must be permanently fixed to the building in a prominent location, such as in a meter box or the like, Indicating:
