## FIXING (INC. WATERPROOFING) INSPECTION

Sample Property

27/08/2026

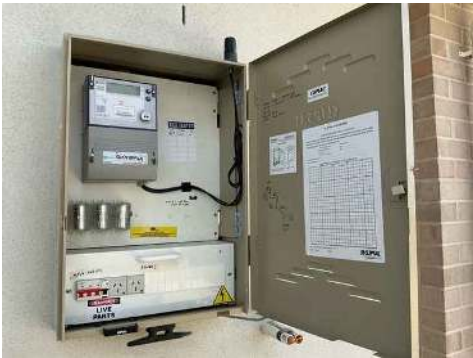
The termite management notice was not found in the metre box at the time of inspection.

A durable notice must be permanently fixed to the building in a prominent location, such as in a meter box or the like, Indicating:

- (a)the termite management system used; and
- (b)the date of installation of the system; and
- (c)where a chemical is used, its life expectancy as listed on the appropriate authority’s register label; and
- (d)the installer’s or manufacturer’s recommendations for the scope and frequency of future inspections of termite activity.
