## PRACTICAL COMPLETION INSPECTION (PCI)

Sample Property

Suburb  
withheld, VIC

23/09/2026

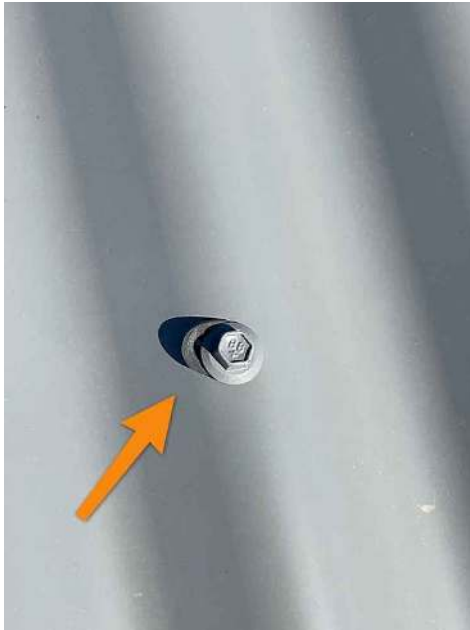
Right Rear

One or more screws are not installed properly or the rubber is damaged. they need to be rectified to avoid any water leak/damage.

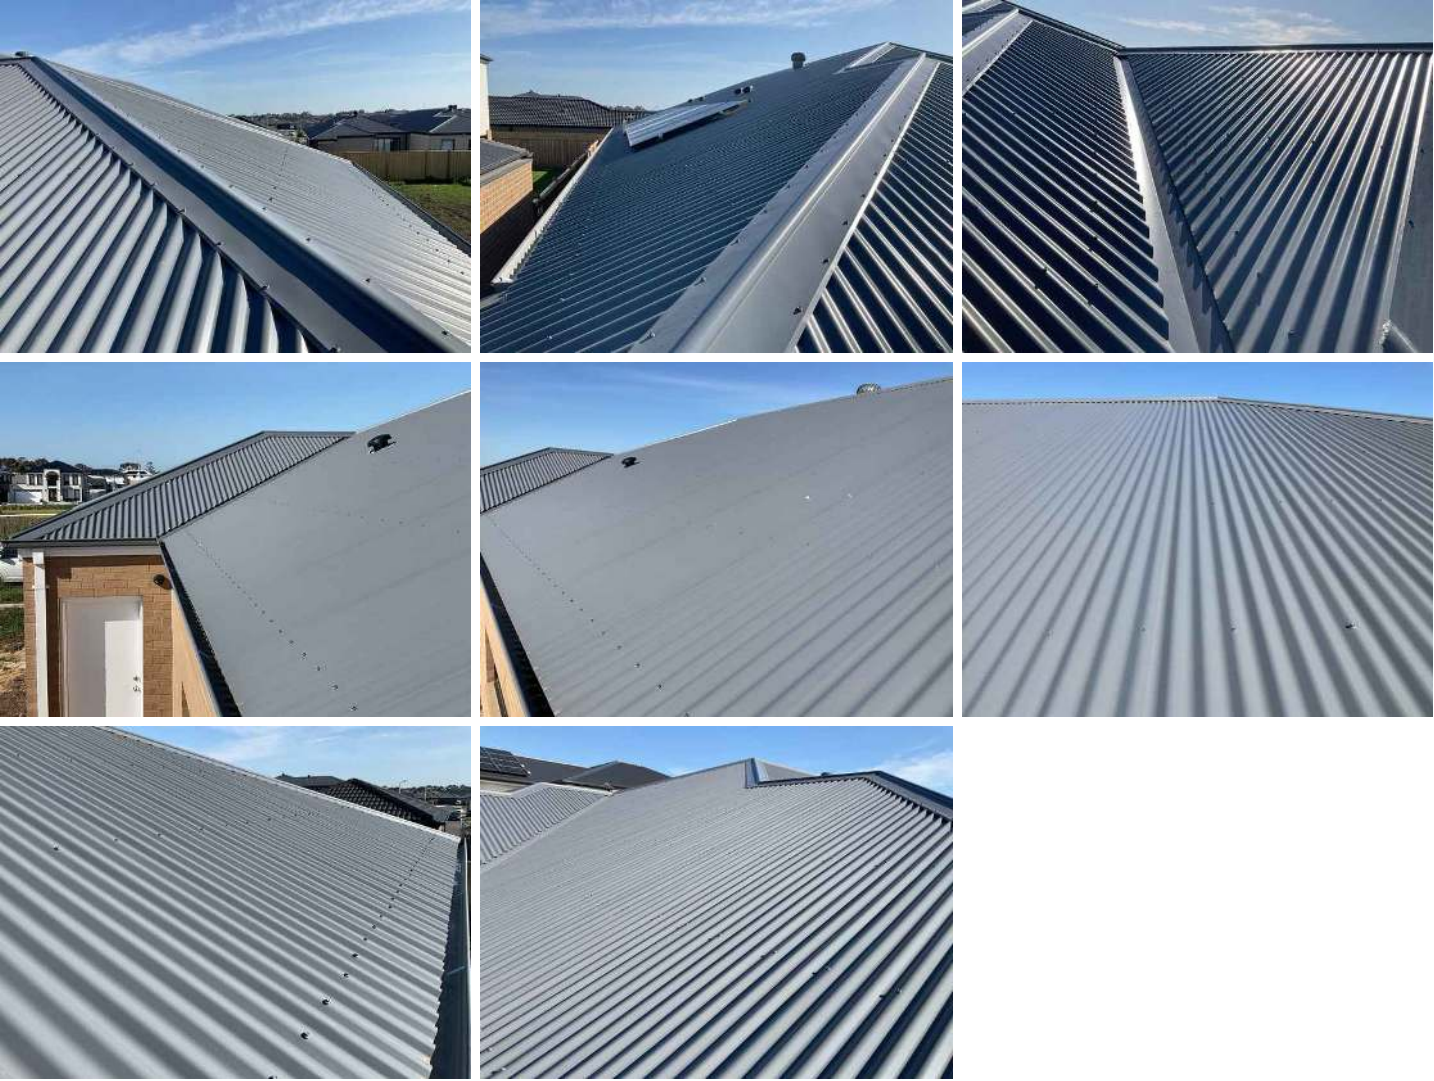
4.1.2 + Roof Cladding (Metal sheet Roofing)

General views of the roof cladding.

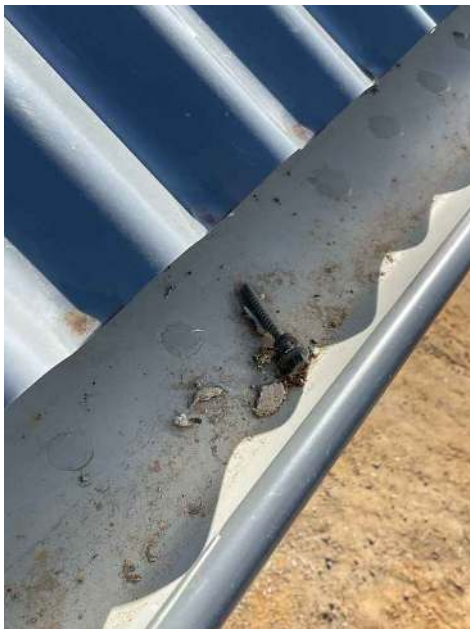
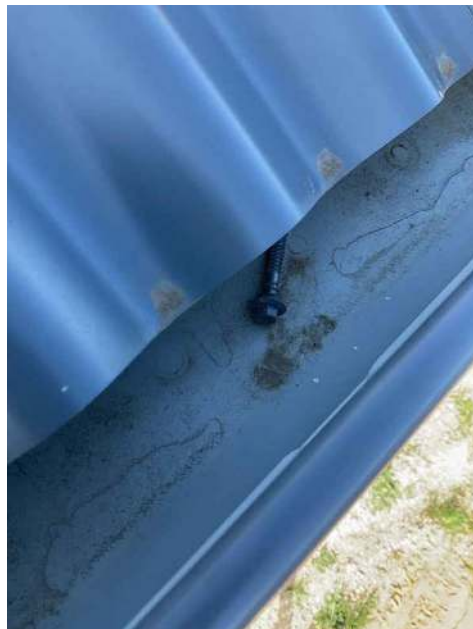
Many debris found in gutters around the dwelling. All debris to be removed from gutters as soon as possible to prevent them from entering the downpipes and causing water damage.

Installation of each new or altered section of the roof drainage system shall comply with the following:

- (a) There shall be no restrictions to the free flow of stormwater due to-
  - (i) protrusions or other obstructions; or
  - (ii) debris (e.g. cement, mortar, clippings and similar debris).**
- (b) All accessories shall be effectively fixed and securely anchored.

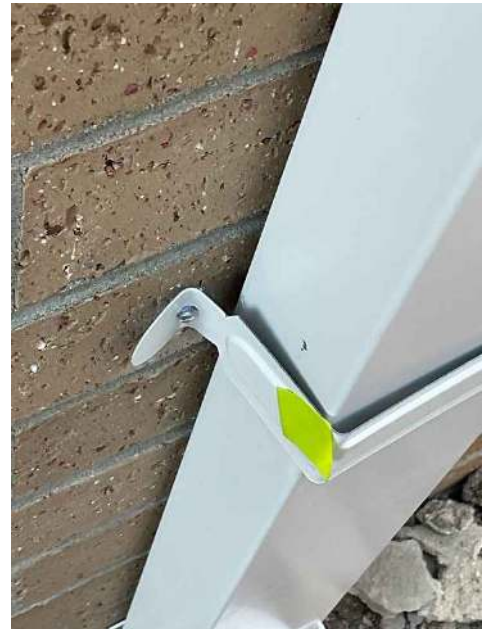
Left

**+ NOT SECURED**

Gutters and downpipes are defective if they are not securely fixed.

For the installation of downpipes, see AS/NZS 3500.3. In addition, for best practice, the following are to be observed:

NOTE: Support systems for metal downpipes should comply with AS/NZS 2179.1.

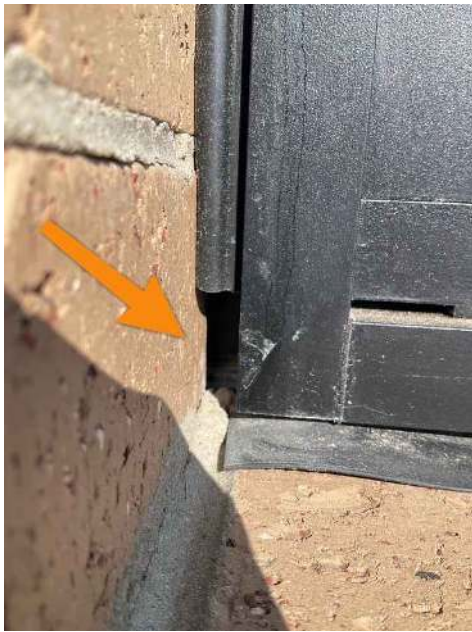
Unless documented otherwise, external windows and doors are defective if they are not installed and flashed in accordance with the manufacturer's installation instructions.

where the compressible rubber strip is not watertight they require sealing

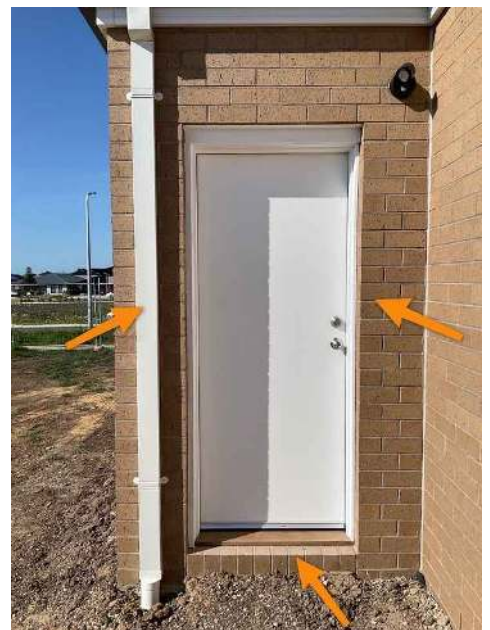
## 6.1.2 + Windows (External)

**+ CAULKING REQUIRED TO TOP/SIDES**

Where the gap between the window (or door) and the external cladding is excessive and can not be covered by the bottom/side flashings, such gaps must be caulked using the same colour proper caulking material.

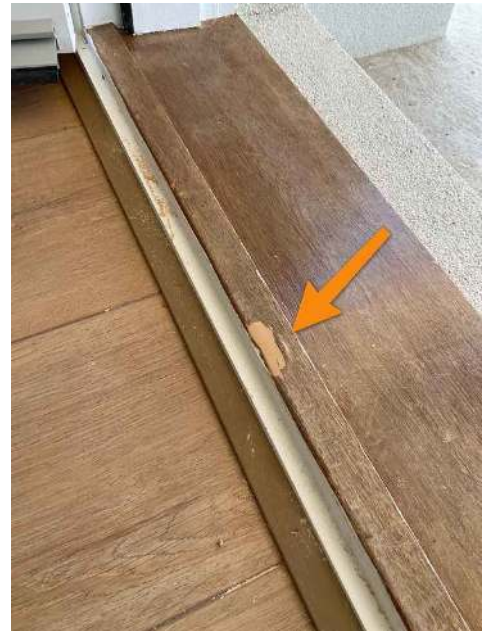
Entrance

**+ DAMAGED**

There is notable damage to the door and/or door frame.

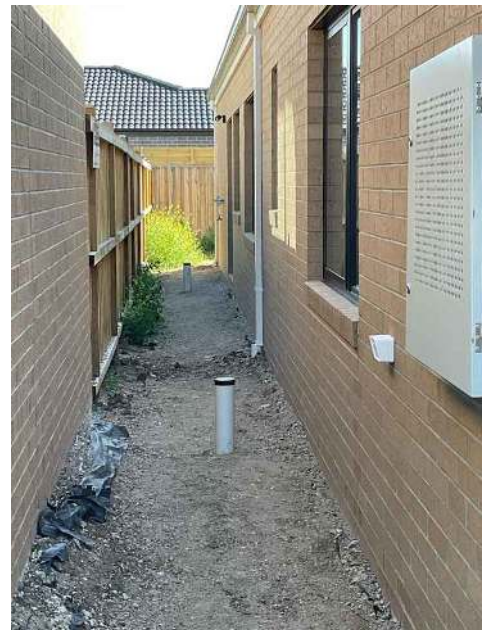
## 6.3.1 + External Appliances

**+ NOT INSTALLED**

The external appliances have not been installed at the time of inspection. It is usual to install the at the time of handover to prevent them from theft.

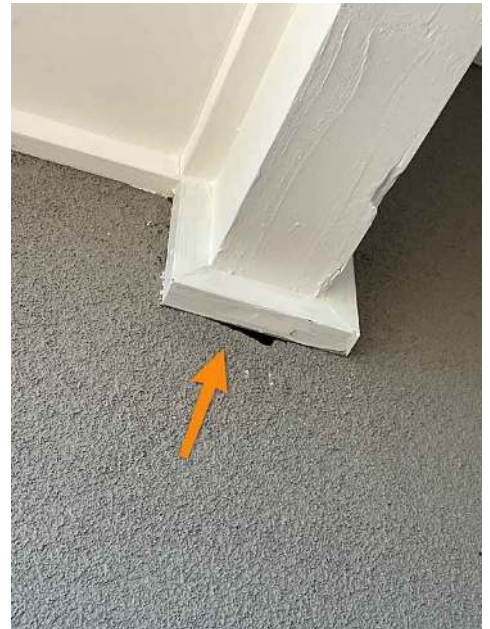
Porch

**GAPS TO EXTERNAL WALLS**

Gaps to parts of external walls need caulking to reduce the risk of water penetration.

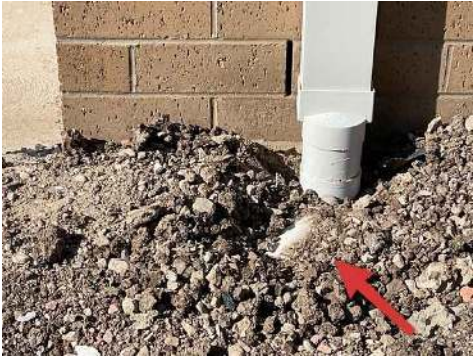
The stormwater pipe cover is insufficient. A minimum cover is required to prevent the pipe from potential damages.

stormwater pipes must be the required depth below the future concrete paving. weep hole clearance allowed for. Rear

Cover to stormwater drains:  
the cover to 90 mm Class 6 UPVC stormwater drains installed underground must be not less than:  
(i)under soil — 100 mm; or  
(ii)under paved or concrete areas — 50 mm; or  
(iii)under areas subject to light vehicle traffic—  
(A)reinforced concrete — 75 mm; or  
(B)paved — 100 mm.

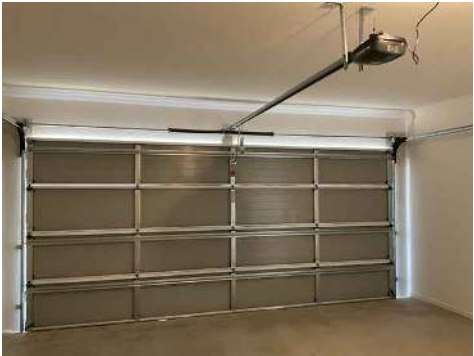
+ **NOT WORKING**

The garage front door electric opener was inoperable or not connected at the time of inspection. Recommend re-attached or repaired by qualified professional.

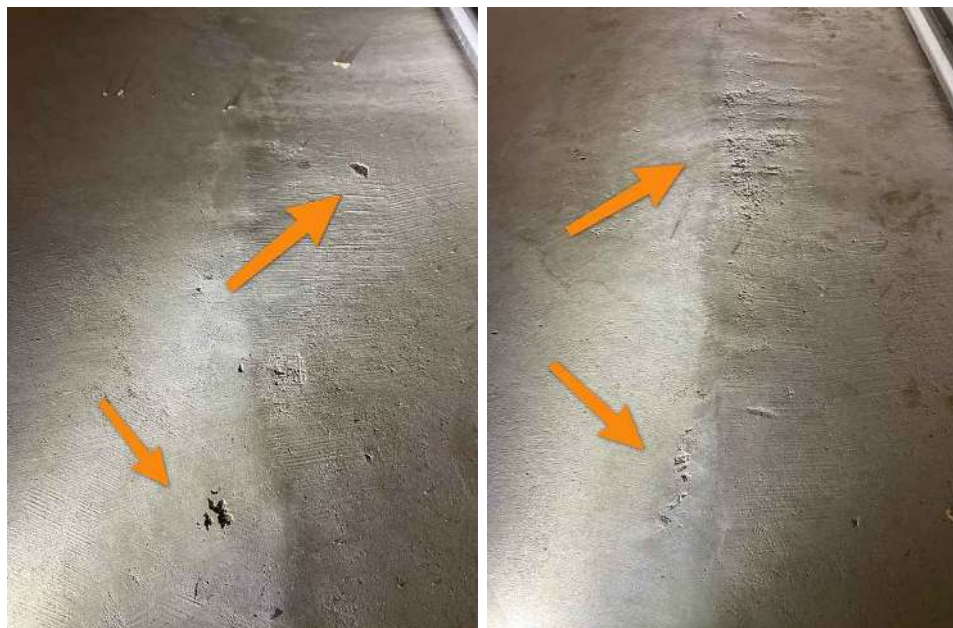
## 9.2.1 + Floor (Slab Surface Finish)

**+ CONCRETE DAMAGED/CHIPPED**

The concrete floor noted chipped/damaged at the time of inspection. Repair erosive areas and also holes to prevent further deterioration.

Repairs, where failure has been due to cracking and/or movement, may involve the removal of the affected area. The repair is defective if it does not, as closely as practicable match the existing work in appearance, colour and texture. Minor variations in finish may not be considered to be defective.

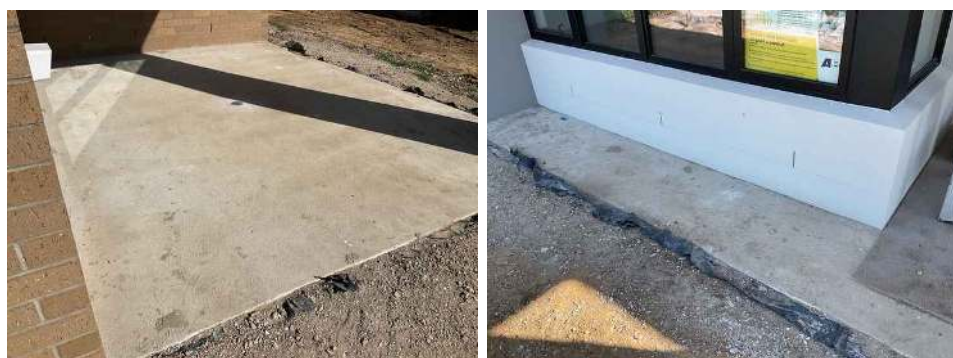
## 9.3.1 + Driveway/Pathways

**+ CLEANING REQUIRED**

The driveway/pathways must be cleaned prior to handover.

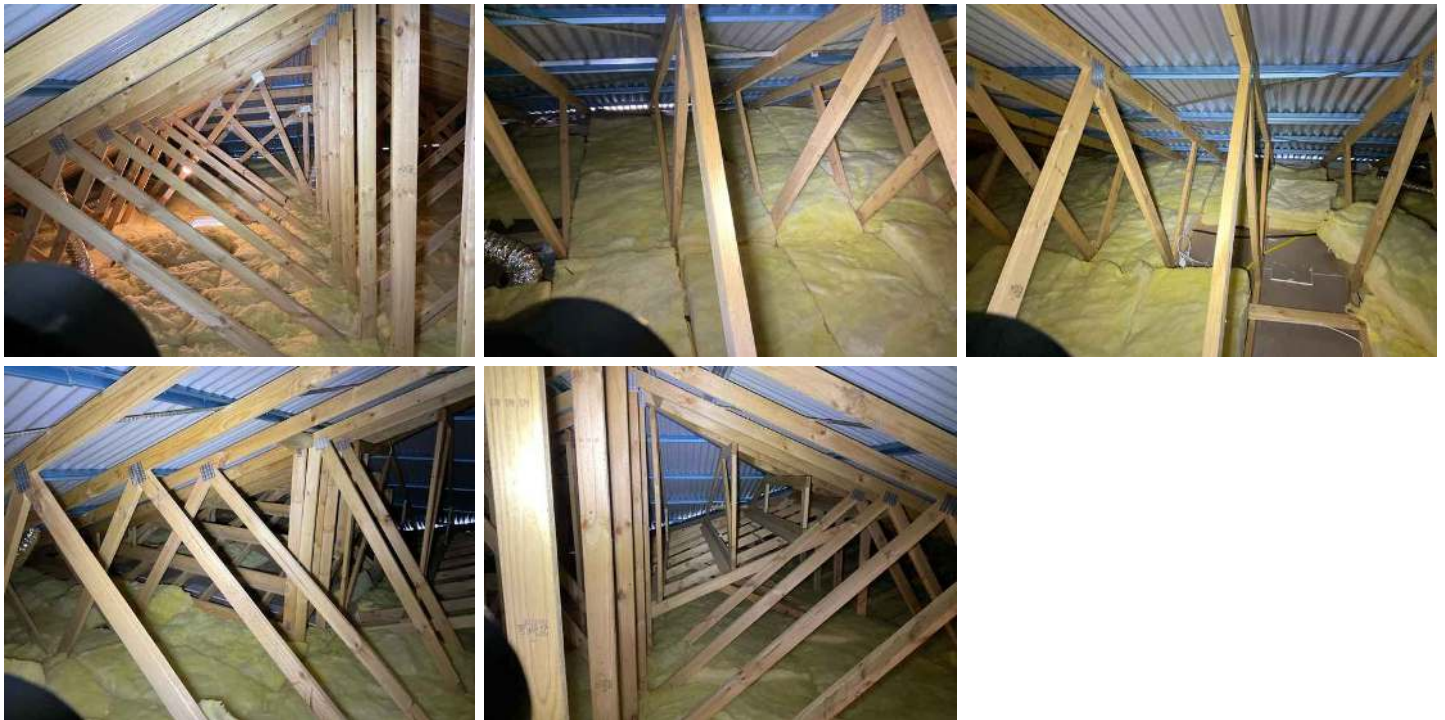
The general views of the roof space at the time of inspection

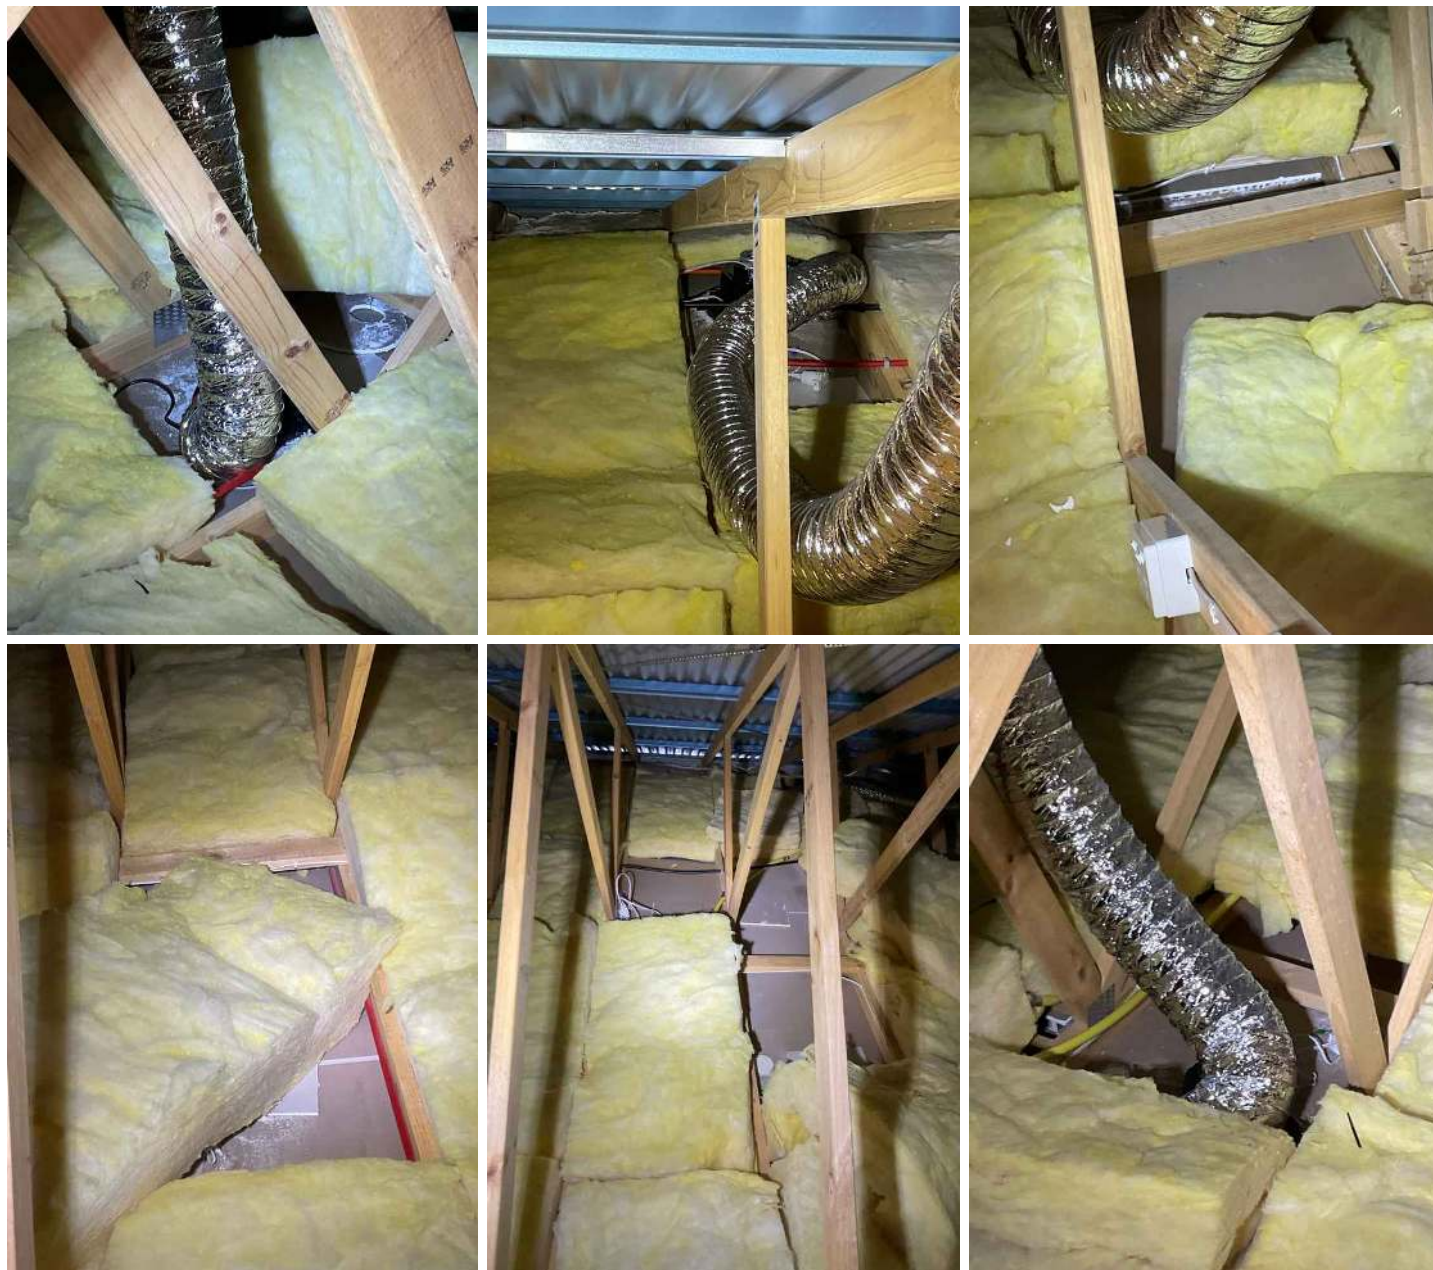
## 10.2.1 + Insulation

**+ LOOSE/OUT OF PLACE INSULATION**

One or more parts of insulation are loose and/or not installed properly. This needs fixing to prevent energy wasting.

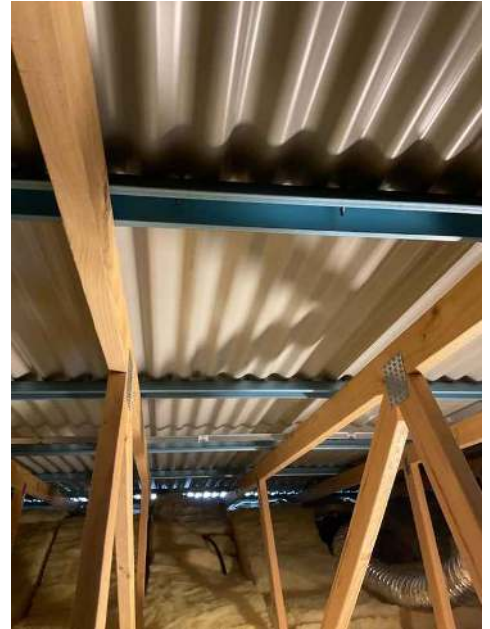
## 10.3.1 + Sarking/Sisolation

**+ SARKING UNDER METAL ROOF - NOT INSTALLED**

Sarking is the sheet material which can be put over the roof trusses before the final roof covering is installed. It's normally standard on a metal roof as it prevents condensation on the underside of a roof from dropping onto the ceiling below.

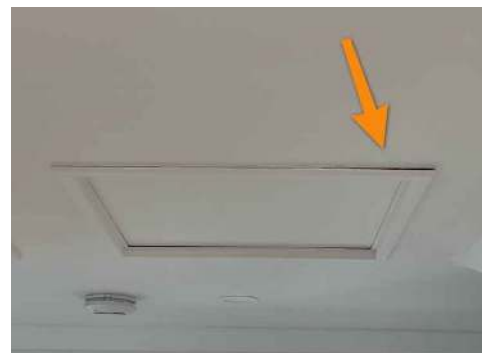
## 10.5.1 + Manhole Opening

**CLEANING/REPAINTING REQUIRED**

The manhole opening requires cleaning or repainting.

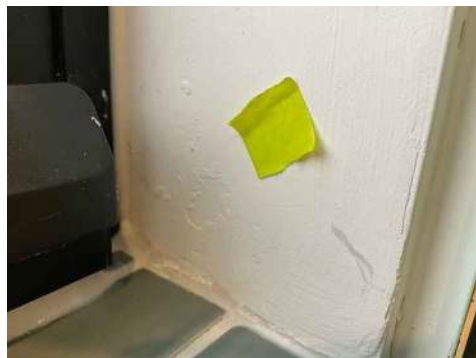
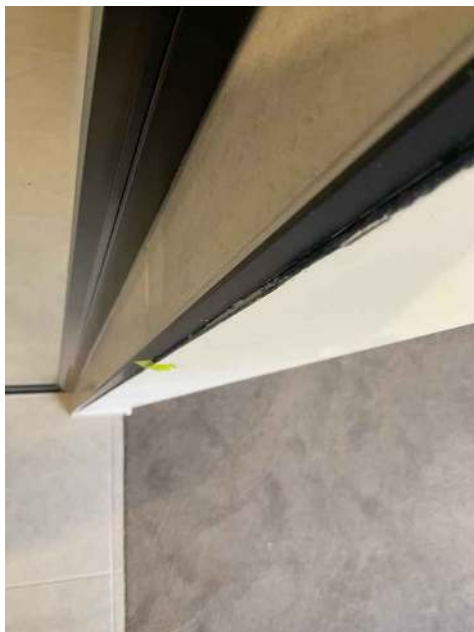
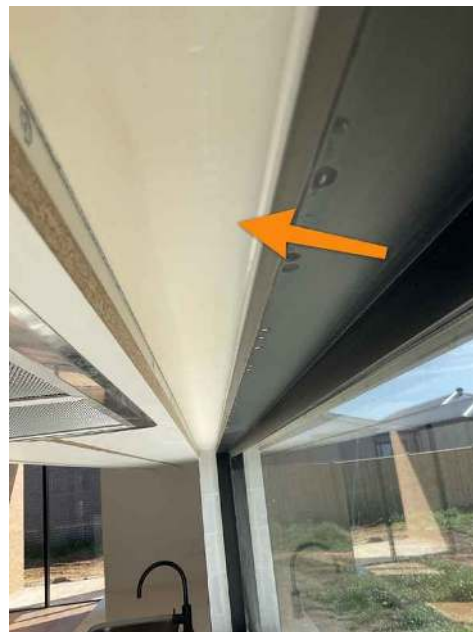
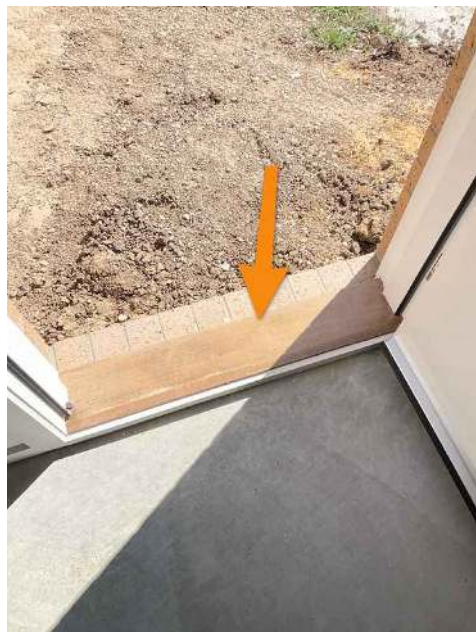
## 11.1.1 + General Painting Defects

**MINOR PAINT DEFECTS**

Minor paint defects, paint runs, smears, and marks require touch-ups prior to handover. Example photo shown. Builder to assess all areas and have rectified.

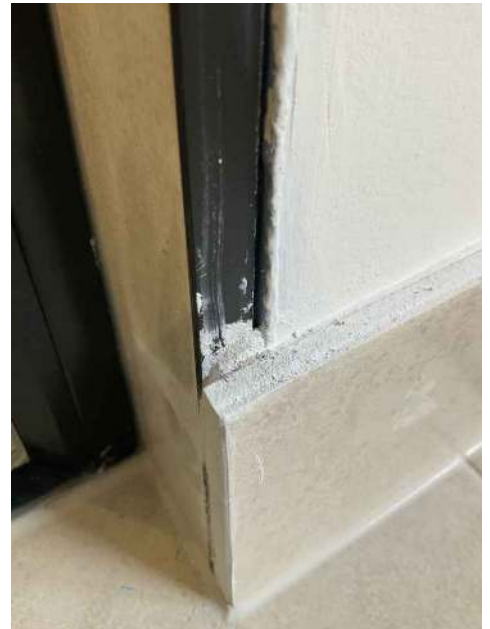
## 11.3.1 + General Cleaning

**+ GENERAL CLEANING REQUIRED**

Building sites are defective if they are not clear of building debris.

Building works are defective where windows are not clean, floors are not swept, mopped or vacuumed as appropriate, tiles, sinks, basins, troughs, baths, etc. are not cleaned, and shelving, drawers and cupboards ready for use.

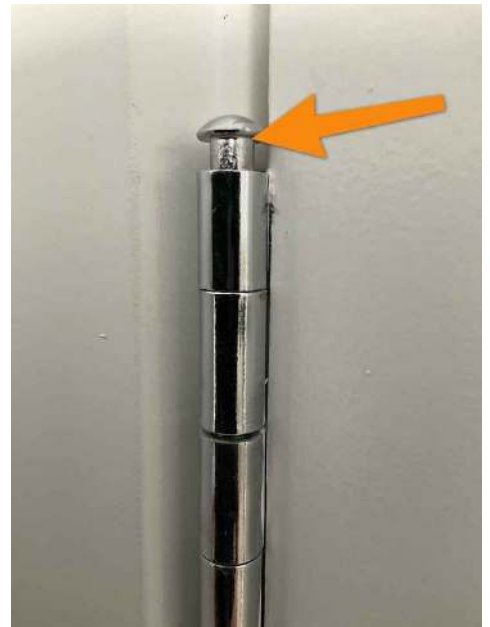
## 11.4.1 + Doors (Internal)

**HINGE PINS**

Fully hit down hinge pins throughout the property

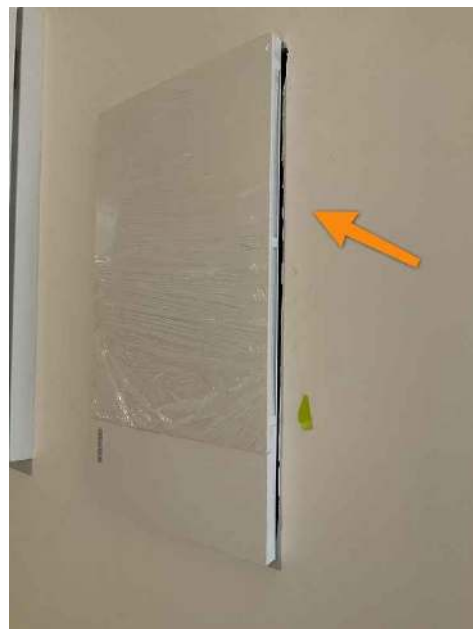
Garage

**+ PLASTER DAMAGED**

One or more areas of the wall/ceiling are damaged and need repair, patching, proper sanding and repainting.

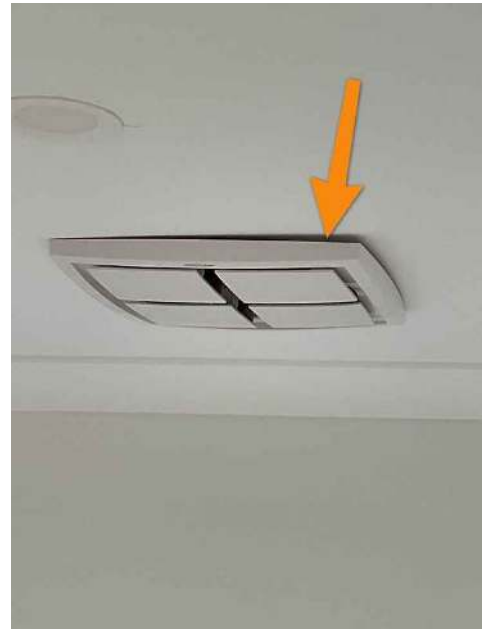
Laundry

**+ NOT FLUSH WITH CEILING/WALL**

One or more vents/outlets do not flush with the ceiling/wall plaster.  
Fixing required.

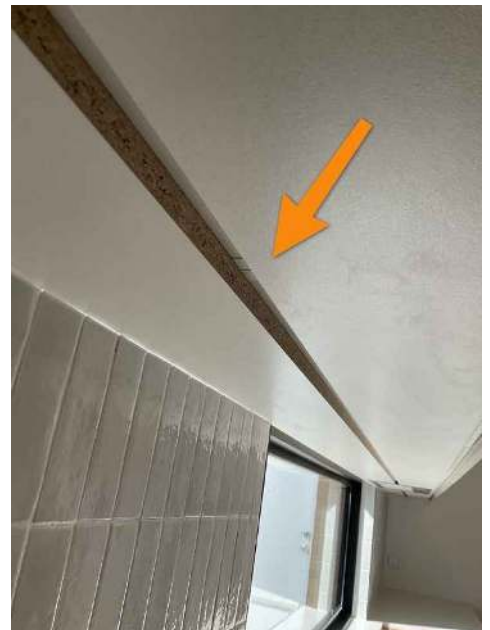
11.11.1 + Lights/switches/downlights

**+ NOT INSTALLED - LED LIGHT STRIP**

A light LED strip missing.

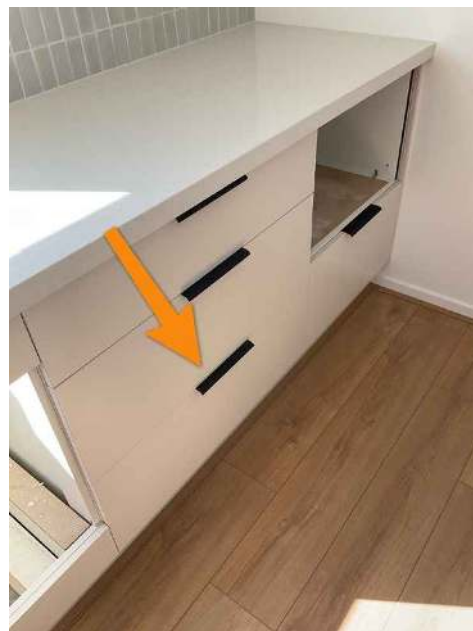
One or more drawers of the cabinetry noted hard to close. Adjustment required.

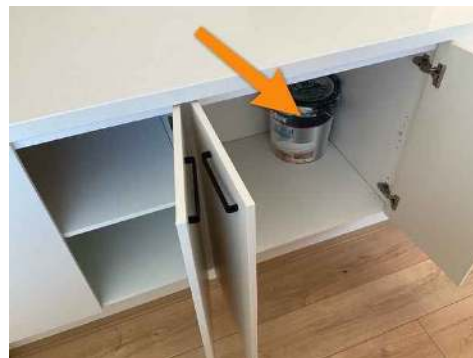
#### 12.5.2 + Cabinetry

##### + **SHELVES NOT INSTALLED**

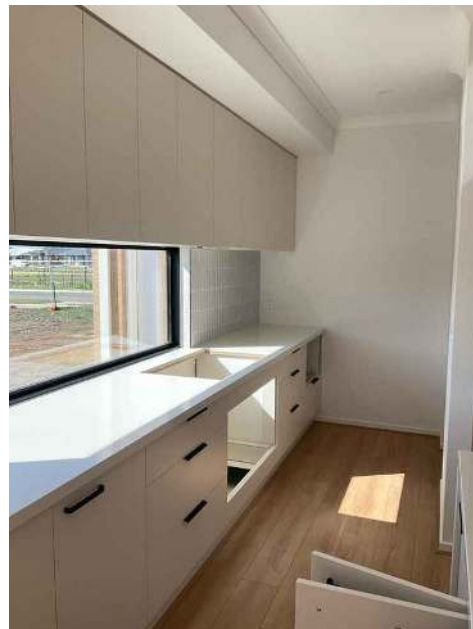
## 12.6.1 + Oven/Stove/Rangehood

**+ NOT INSTALLED**

The appliances have not been installed at the time of inspection. It is usual for the appliances to be installed on the day of handover to prevent theft.

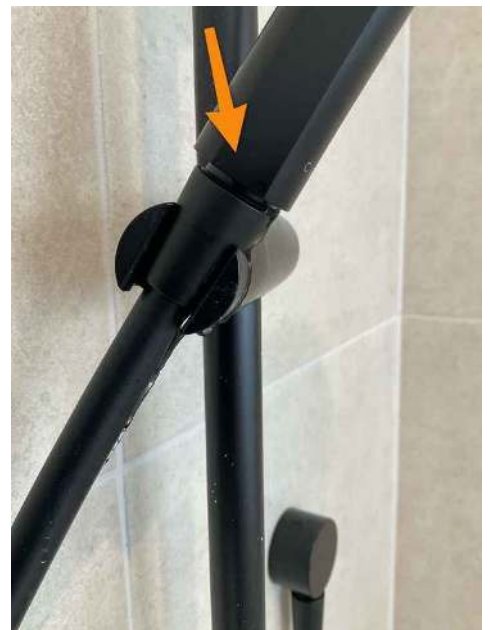
Bathroom

### + MIXER/PIPE LEAKING

The mixer/pipe noted leaking at the time of inspection. Plumber to fix the leakage ASAP to prevent any water damage to the property.

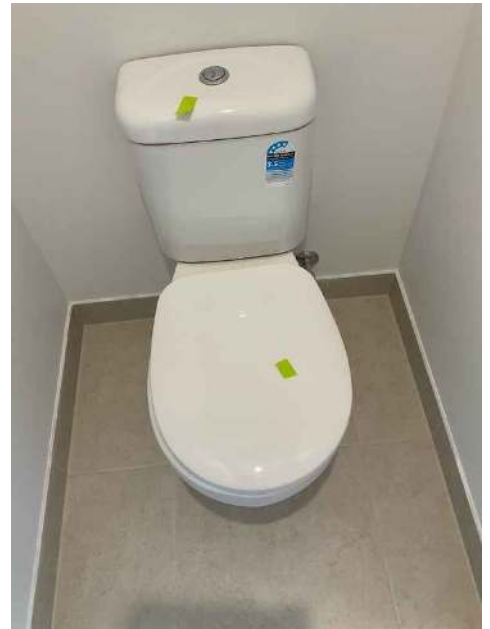
Wc

**+ TOILET SEAT/ - LOOSE/UNSECURED**

The toilet seat is loose/unsecured.
