OWNER INSPECTIONS

## FRAME INSPECTION

Sample Property

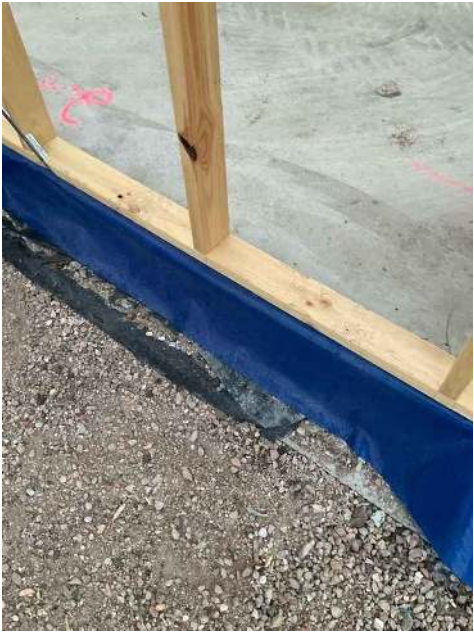
### UNABLE TO INSPECT

Unable to inspect all sections of the slab edge due to the presence of a termite physical barrier, damp-proof membrane, or sarking/flashing.

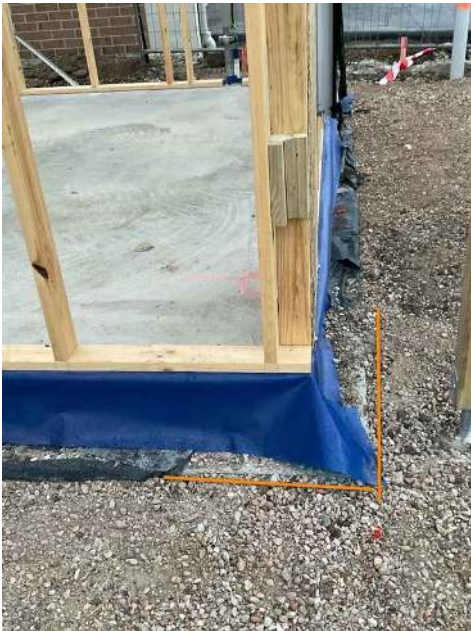
Porch

## 3.2.1 Vapour Barriers

**VAPOUR BARRIERS - SECTIONS MISSING**

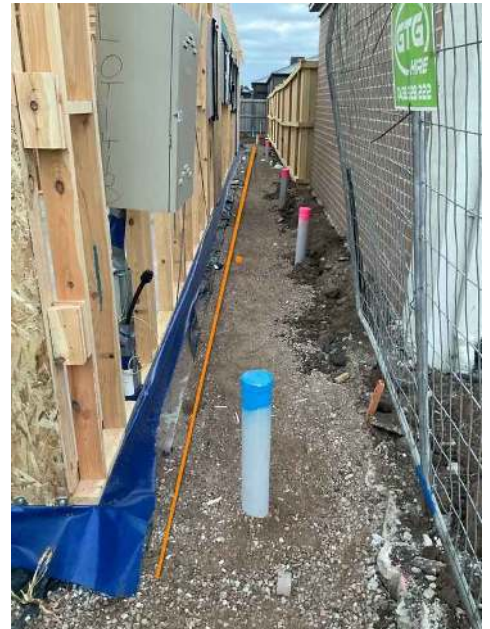
Right side

Although sections of the site are graded, certain areas remain ungraded. It is required that the entire perimeter of the building be graded in accordance with ABCB Housing Provisions (2022) – Section 3.3.3 at the time of handover. If the site remains ungraded during construction, rainwater can flow towards the building, accumulating and seeping under the slab. This can lead to moisture issues, compromising the foundation and causing potential long-term damage.

The external finished surface surrounding the slab must be drained to move surface water away from the building and graded to give a slope of not less than

- (i) 25 mm over the first 1 m from the building in low rainfall intensity areas for surfaces that are reasonably impermeable (such as concrete or clay paving); or
- (ii) 50 mm over the first 1 m from the building in any other case.

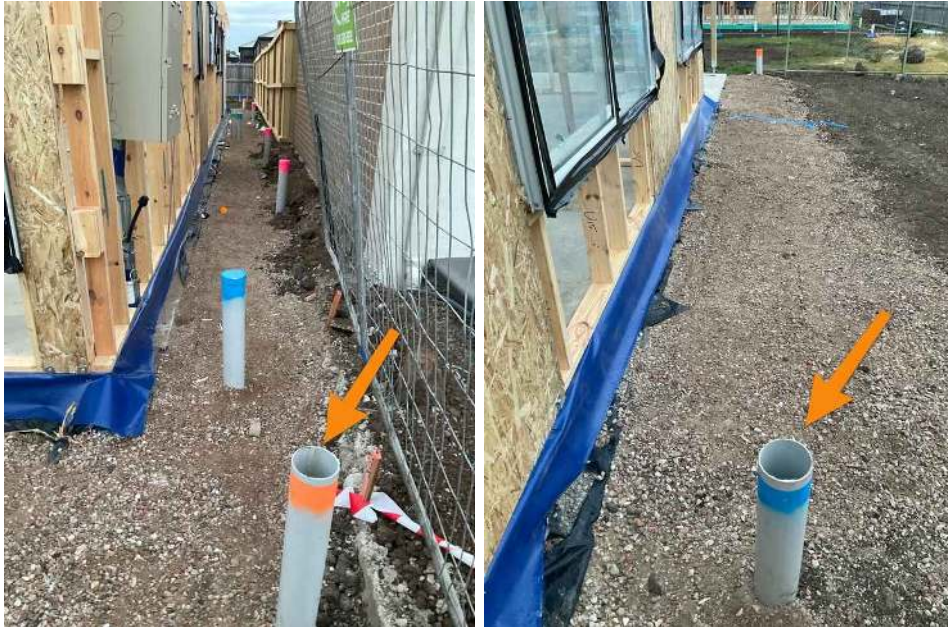
## 5.2.1 Underground Stormwater pipes

**Observation:** The stormwater pipe(s) have been left uncapped, which may allow construction materials and debris to enter, potentially causing blockages in the stormwater system. This can obstruct water flow and lead to drainage issues, possibly resulting in property damage.

**Recommendation:** The stormwater pipe(s) should be capped to prevent debris entry. A CCTV inspection is recommended to confirm the pipes are clear of any obstructions before further work or handover.

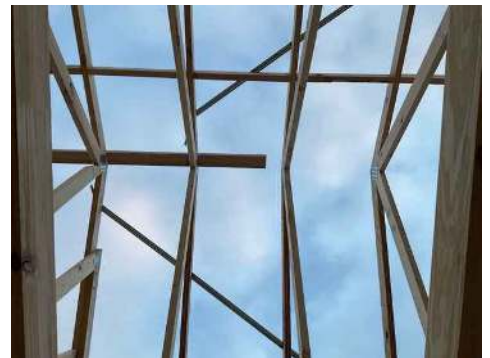
#### 6.2.1 Roof Bracings

The roof bracings appear visually in good condition with no obvious signs of damage or misalignment observed during the inspection.

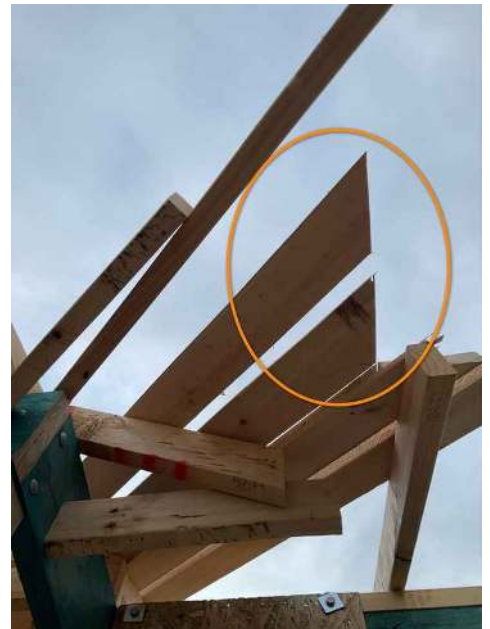
## 6.5.1 + Valley boards

**+ END SUPPORT REQUIRED**

Valley board ends to be supported to prevent valley board sagging and hammering once it's installed and during strong winds and storms.

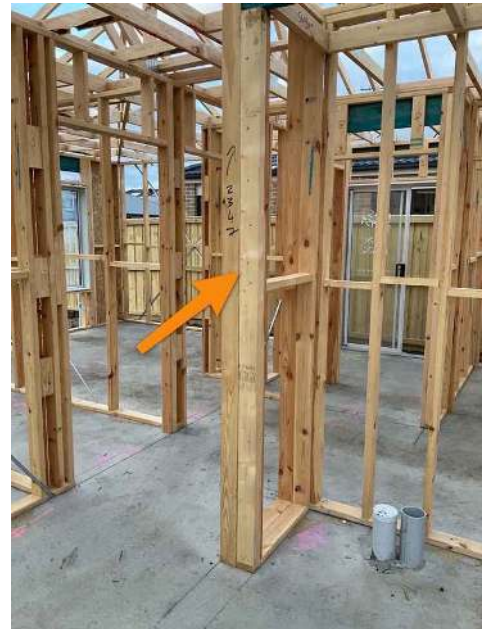
## 7.3.1 + Wall Fixings

**+ DOUBLE WALL CONNECTIONS**

Double walls to be fixed together using nail plates (or blocking at the rear) to prevent them from the future plaster cracking to the joints.

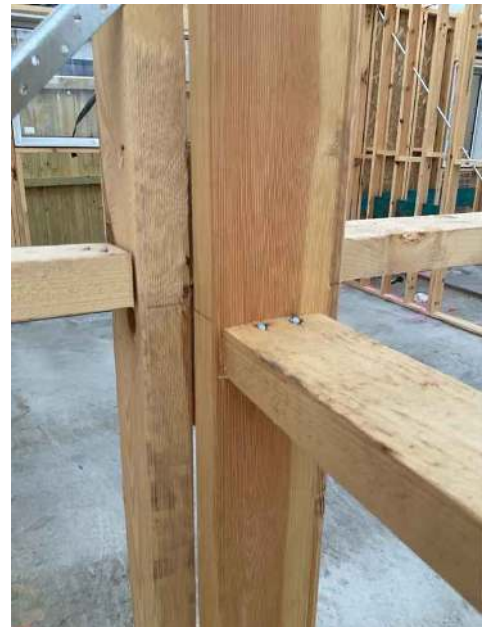
## 7.4.1 + Junction Fixings

**JUNCTIONS NOT NAILED OFF.**

Walls checked for plumb once all nailed off

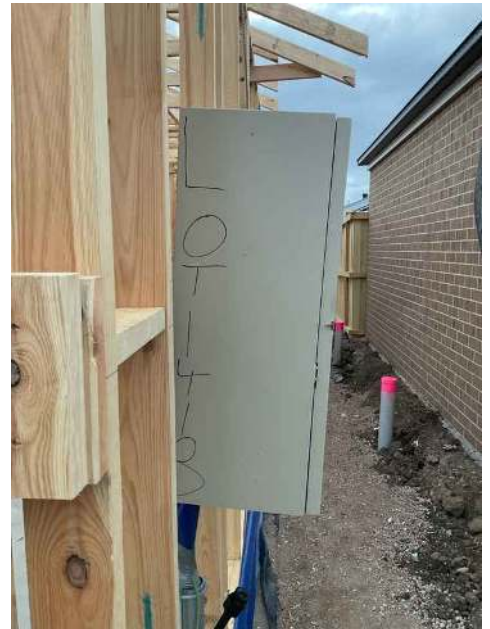
## 7.5.1 + Plumbness

**+ METER BOX NOT PLUMB**

Meter box is not plumb, needs to be fixed

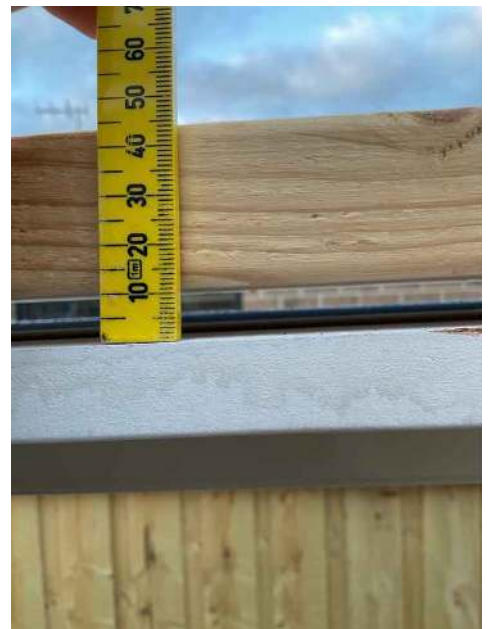
## 7.6.1 + Frame/Opening Clearance

**+ ABOVE WINDOW MINIMUM CLEARANCE - 15MM**

A minimum clearance of 15 mm shall be provided between the underside of the lintel or lintel trimmer and the top of the window frame.

**Australian Standards - AS1684.4 - 6.2.3**

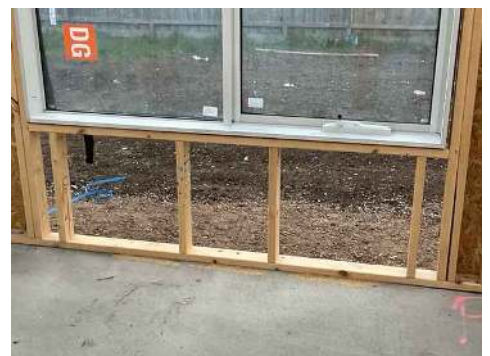
Laundry

## 7.7.1 + Window Sill Trimmers

**+ INSTALLED ACCORDING TO STANDARDS**

The window opening sills are installed according to standards.

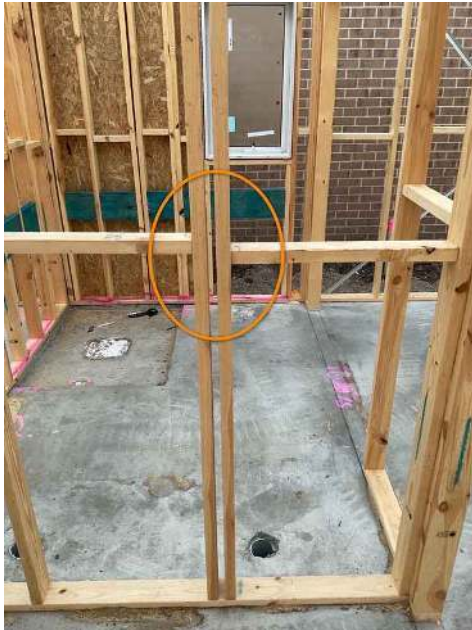
## 7.8.1 + Noggings

**+ MISSING NOGGINGS**

**AS1684.6.2.1.5**

Wall studs shall have continuous rows of noggings.

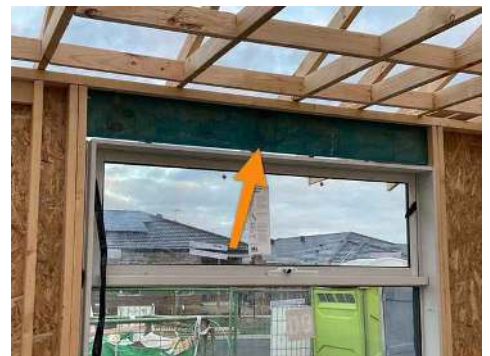
Kitchen

## 7.9.1 + Window/Door Lintels

**TRIMMERS MISSING**

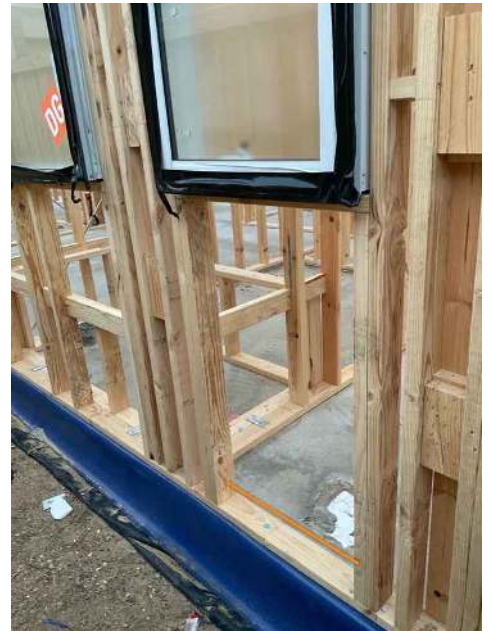
Front

## 7.12.1 + Bottom Plates

**BLOCKING REQUIRED**

splice plate required. Join under window opening.

Install splice plate when bottom plate is joined under openings

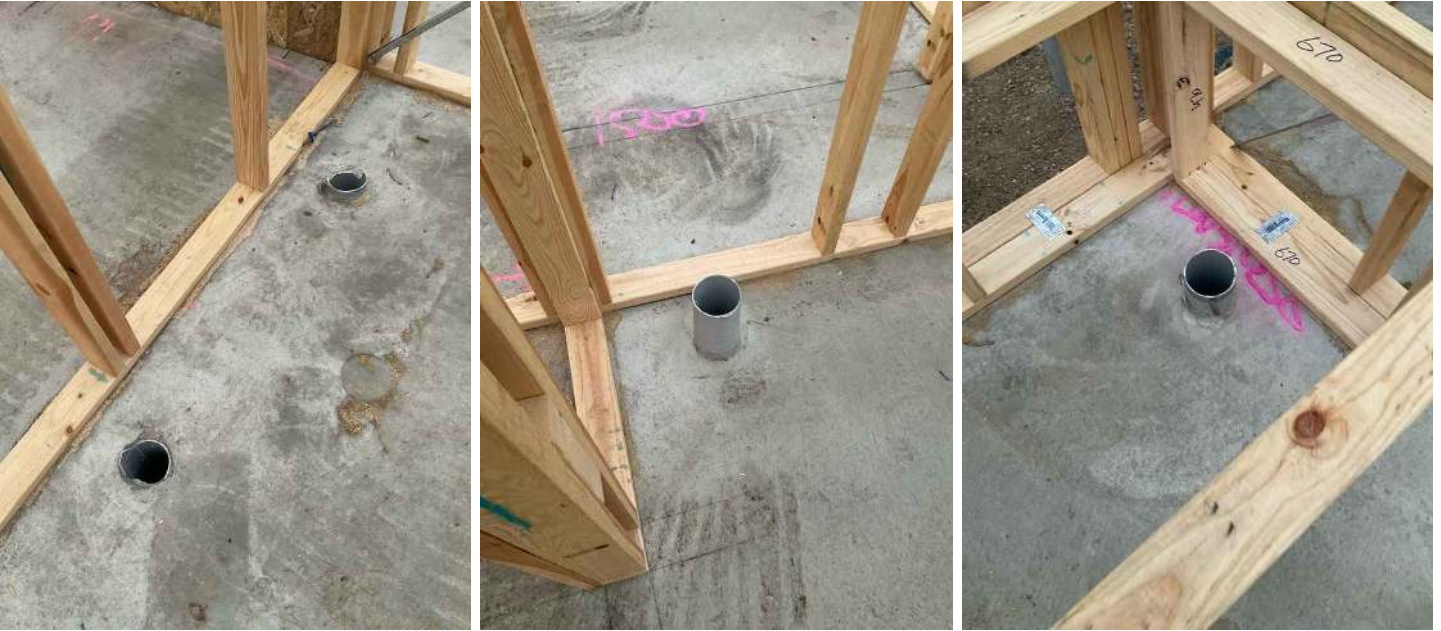
9.1.1 + Capping and Damages

+ UNCAPPED SEWER PIPE

One or more waste pipes were uncapped at the time of inspection. All pipes must be capped to prevent debris from falling in and causing blockage.

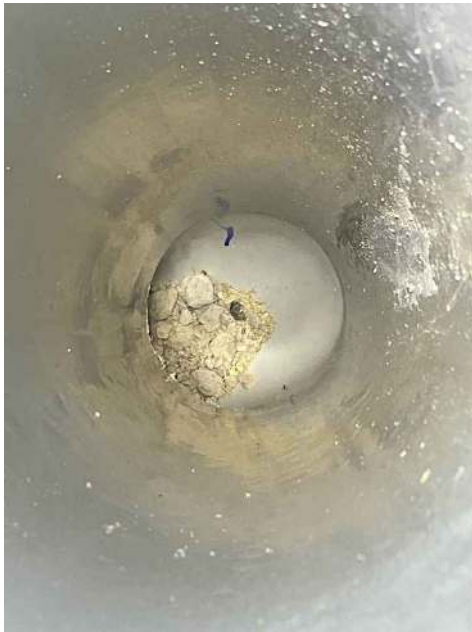
## 9.1.2 + Capping and Damages

**+ DEBRIS INSIDE**

One or more drainage pipes had debris noted inside at the time of inspection. These drains to be cleaned of any debris and camera inspection to ensure no debris left in the pipes to prevent any future blockage.

Laundry. Gravel inside drain

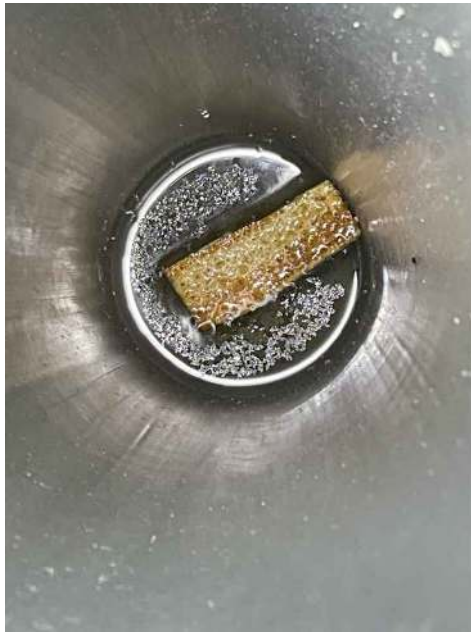
Bath. Timber inside drain

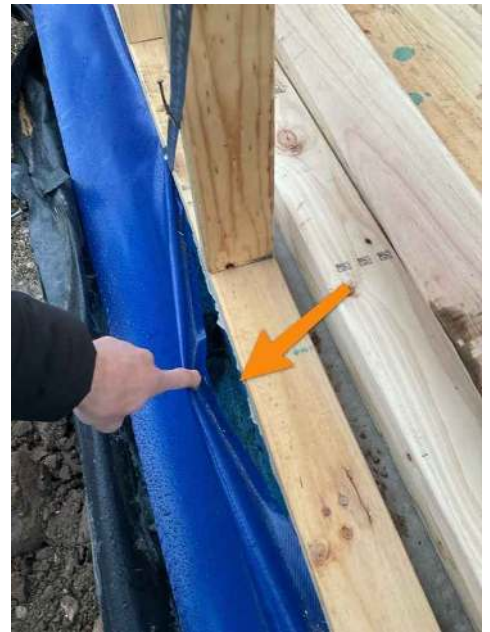
#### + LOOSE OR DAMAGES

Some parts of physical termite barrier aged or installed improperly. Fixing required.

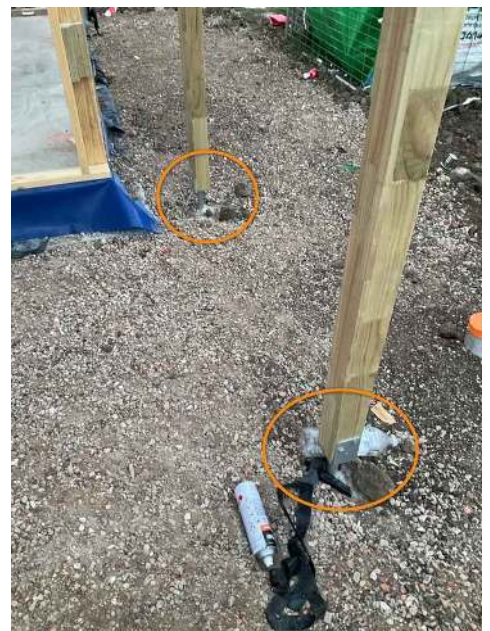
Garage

### 10.1.2 + Physical Barriers

Porch posts no barrier installed

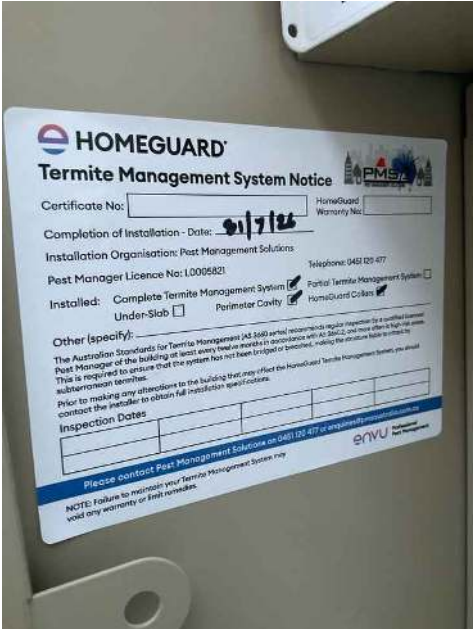
10.2.1 + Termite Management  
Notice  
**FOUND**
