## INVESTIGATION REPORT

# BUILDING DEFECT, WATER INGRESS AND MOULD ASSESSMENT REPORT

**\*\*Report purpose:\*\*** Assessment of reported roof water ingress, consequential internal damage, elevated moisture and mould contamination, together with a recommended rectification scope of works.

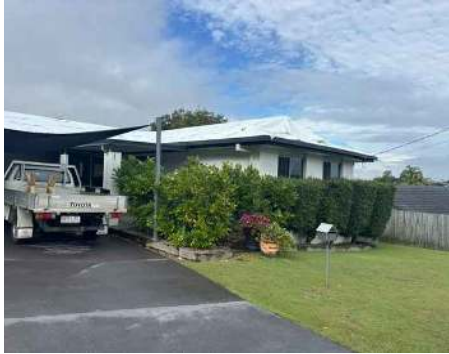
front of the property from the roadside

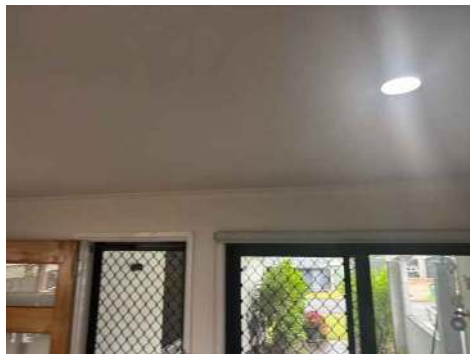
evidence of staining into the Cornice ceiling junction

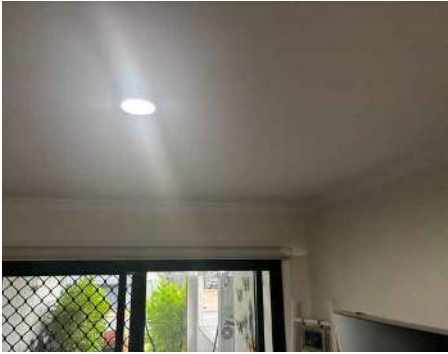
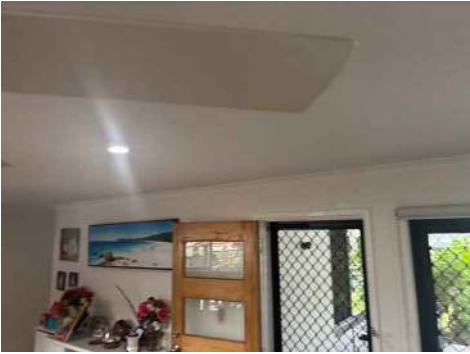
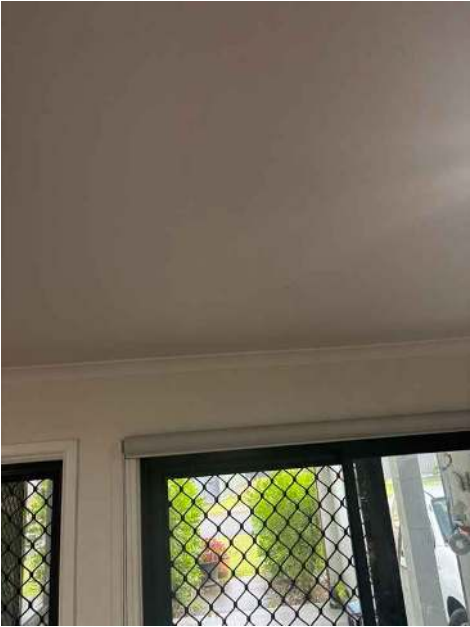
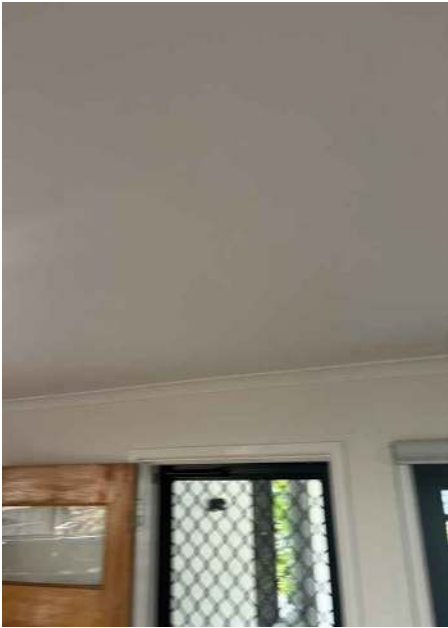
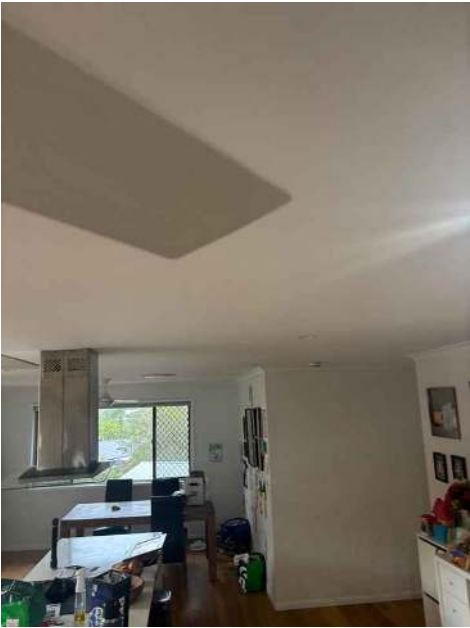
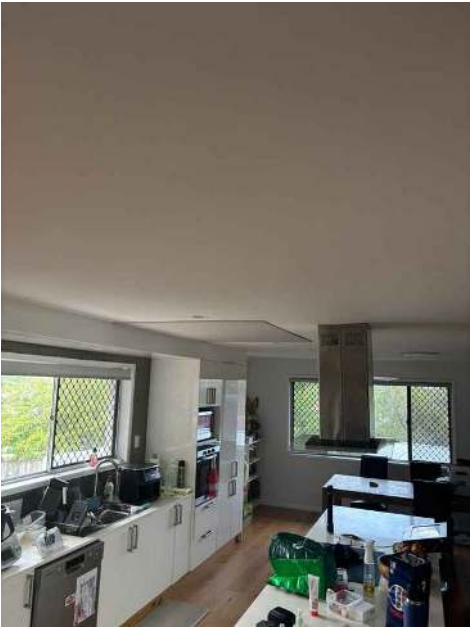
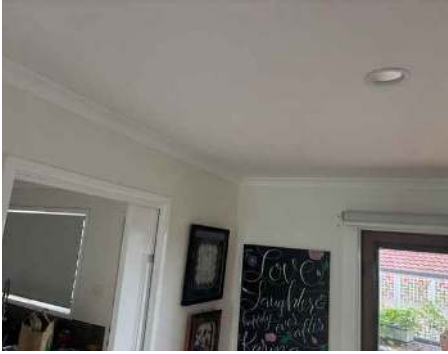
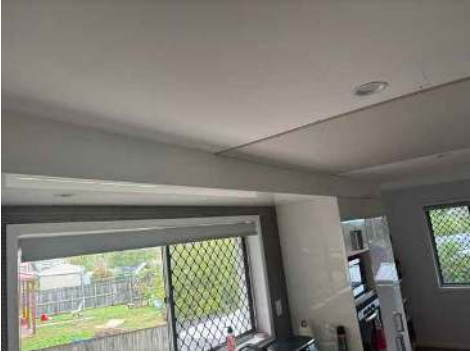
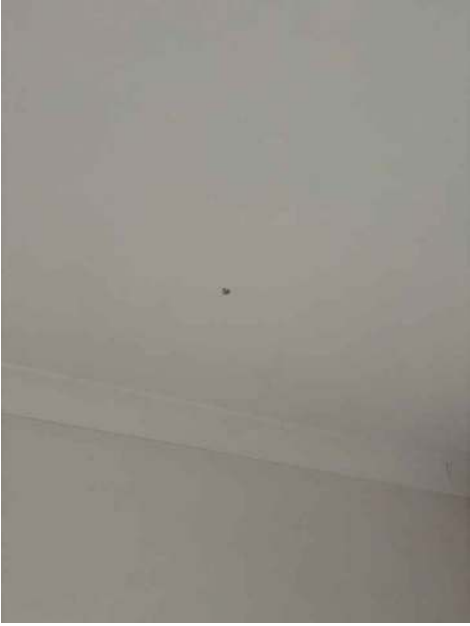
minor water staining and small mould marks to the children's playroom / bedroom at the front of the house
