## EXPERT WITNESS REPORT

Unit 5 / 21 Sample Street  
Dandenong, VIC 3175

Client Name  
DECEMBER 1, 2023

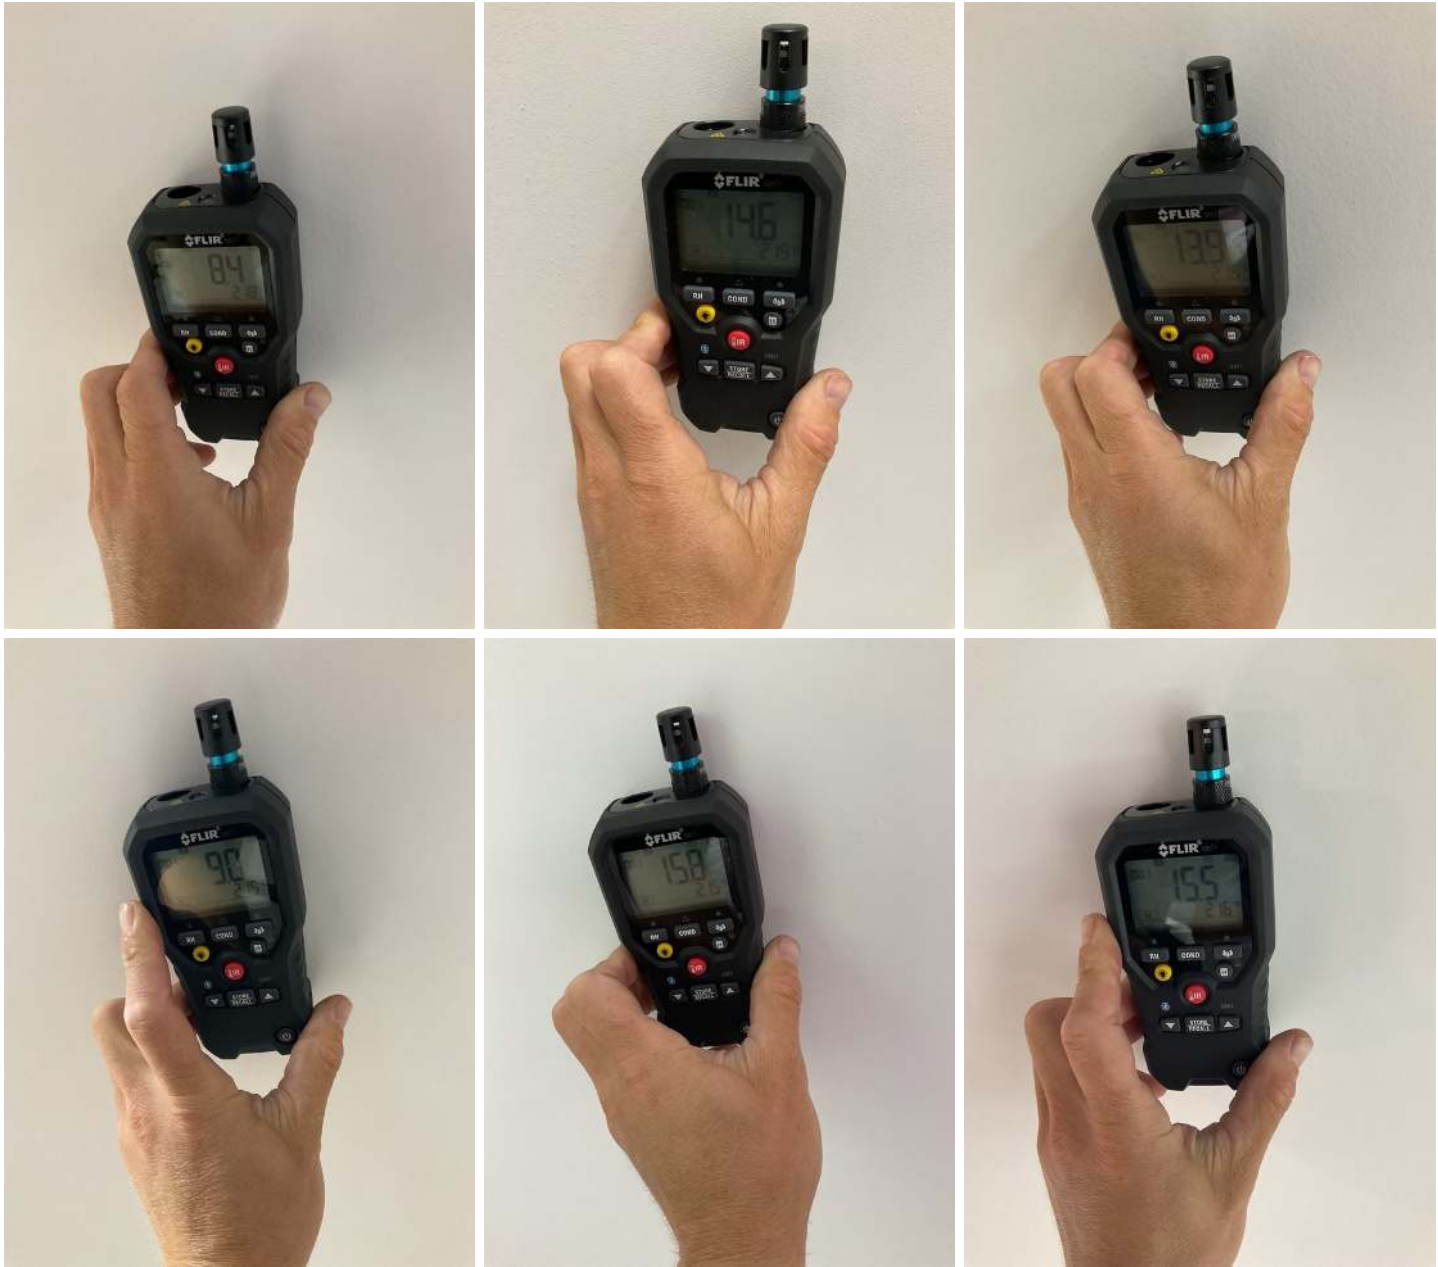
General Relative Moisture Readings to the Living and Dining Room Area. Information provided only for the purpose of this report.

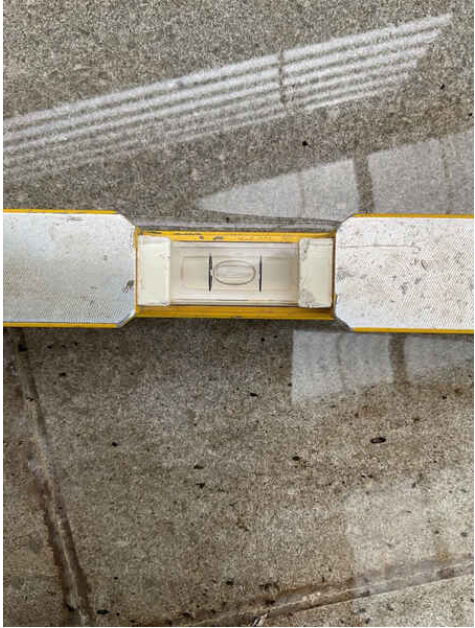
5mm fall over 2m - Insufficient

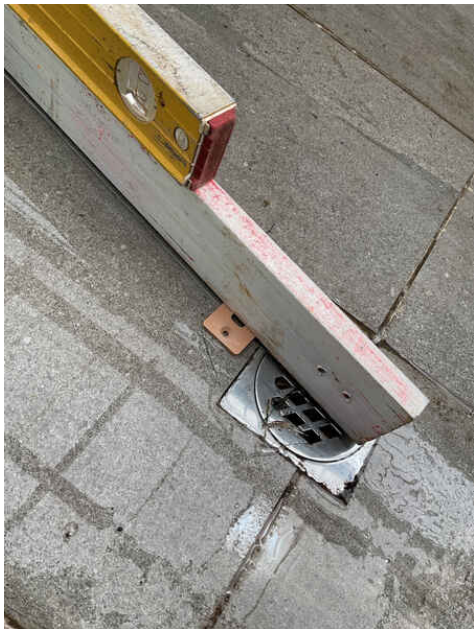
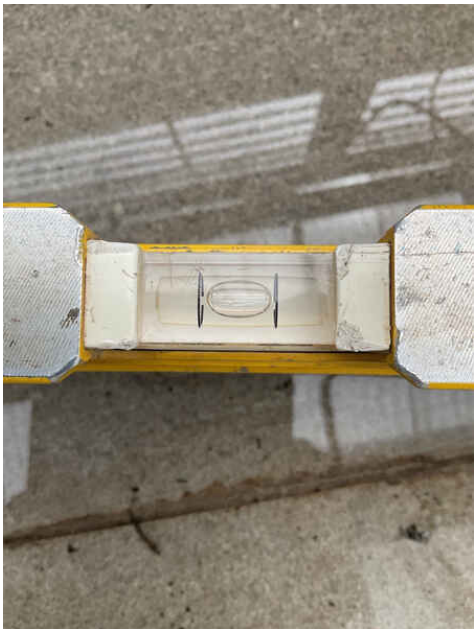
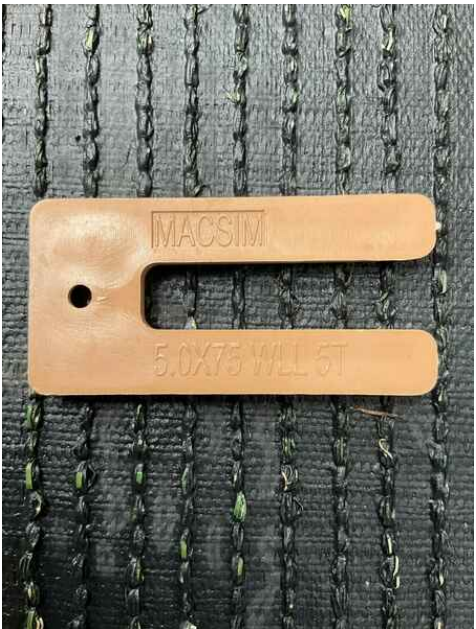
5mm packer used

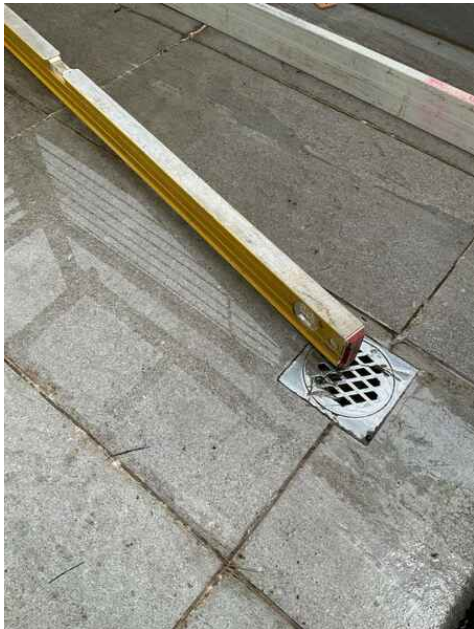
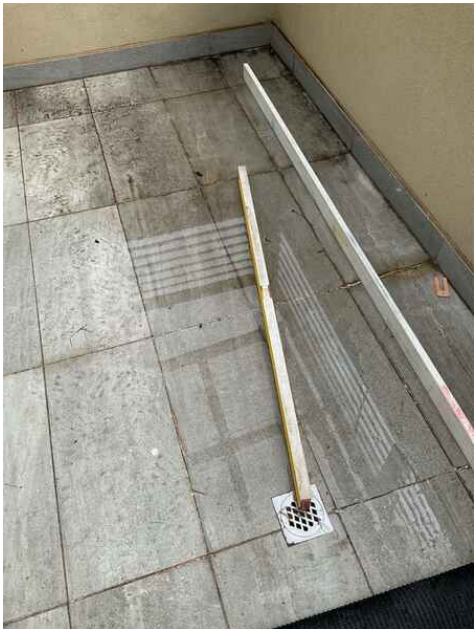
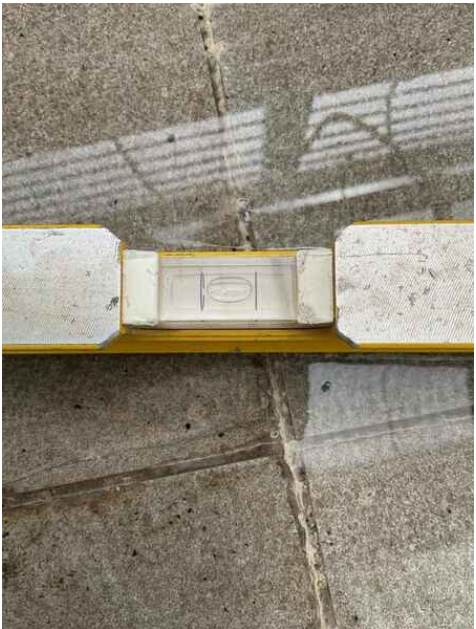
Using a 1200mm level, shows no fall at the drain

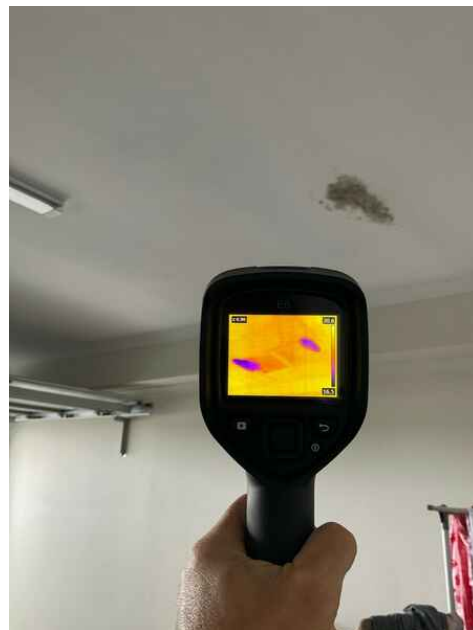
2 x locations to garage showing water ingress

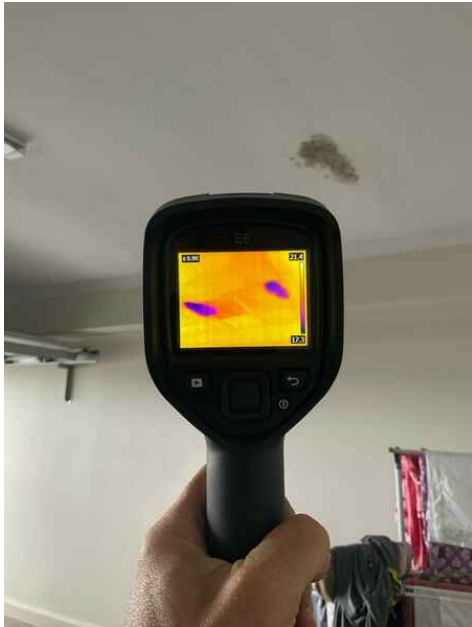
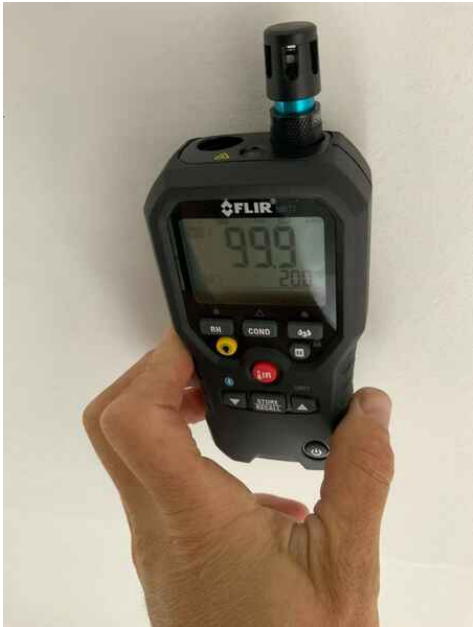
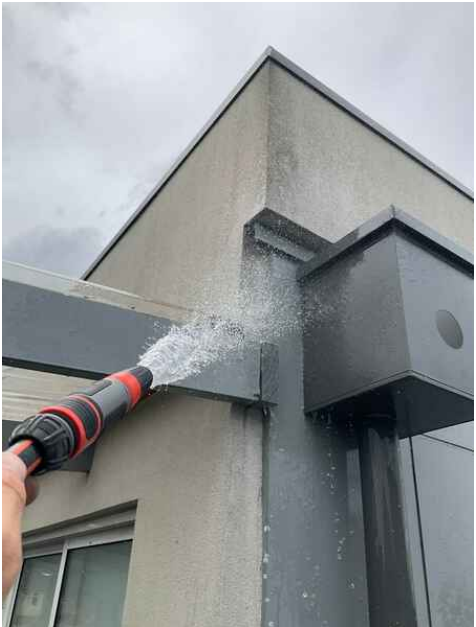
High Moisture Reading to Garage Ceiling at Leak No.2

Hose test to render cracks and timber post to metal flashing connection

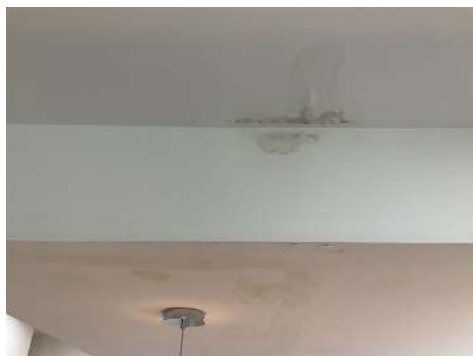
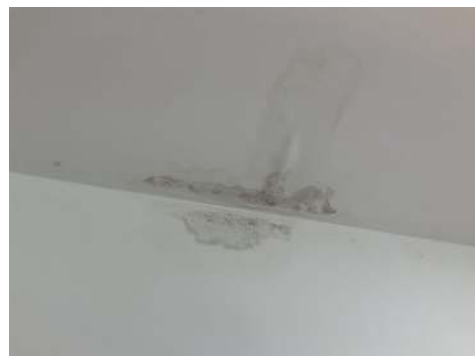
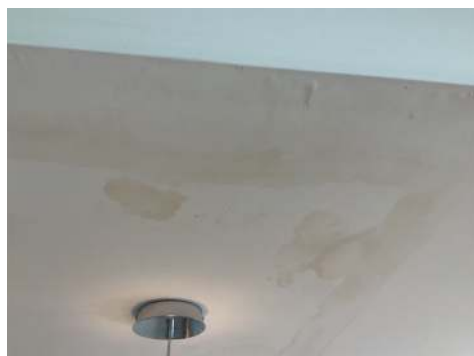
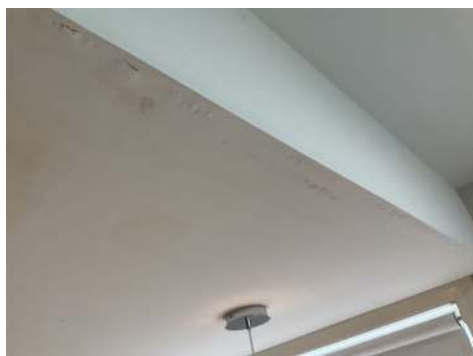
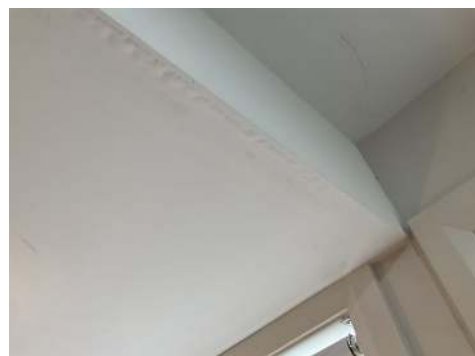
Water Stain and Mould to Kitchen Area

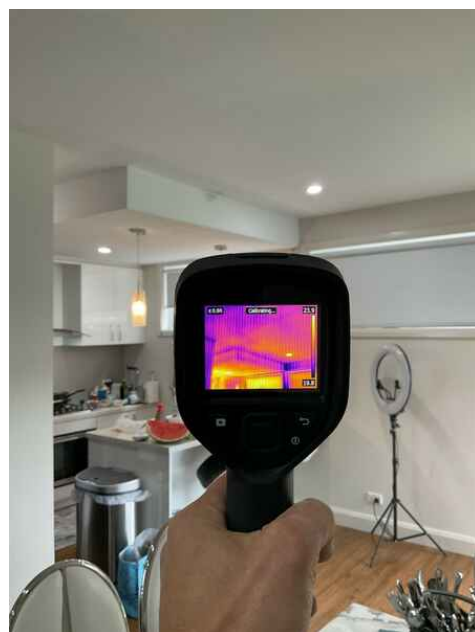
No moisture prior to hose test

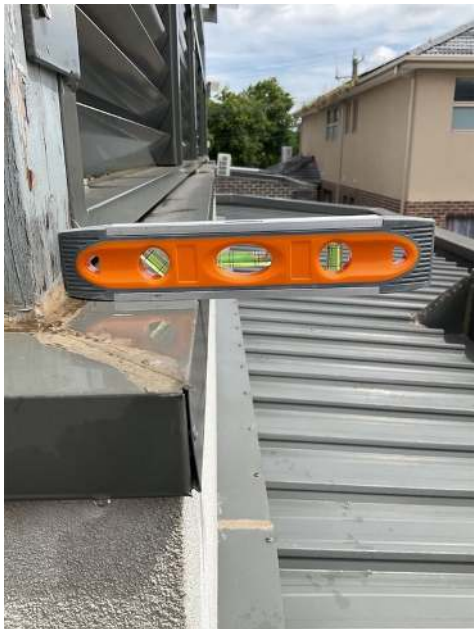
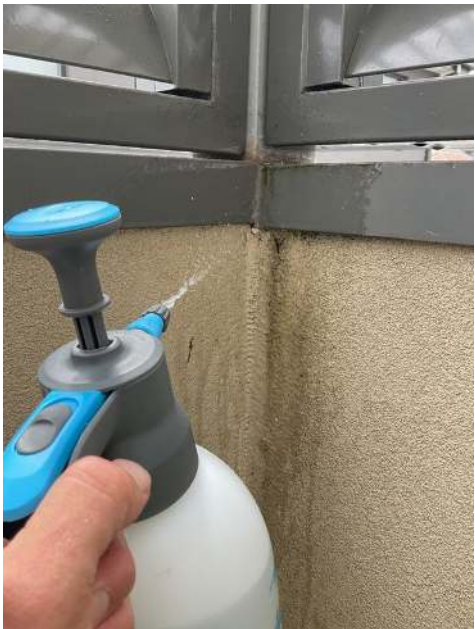
Negative fall towards post to flashing connection

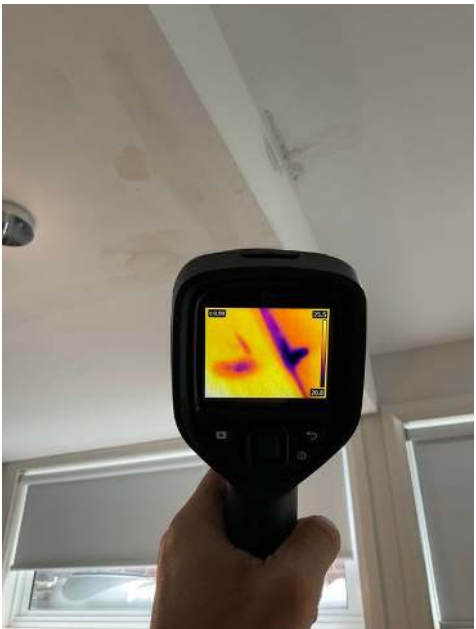
Hot water spray test

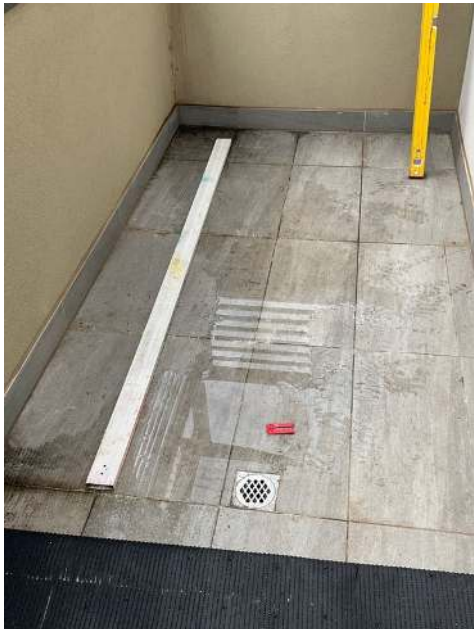
Hot water spray test over kitchen

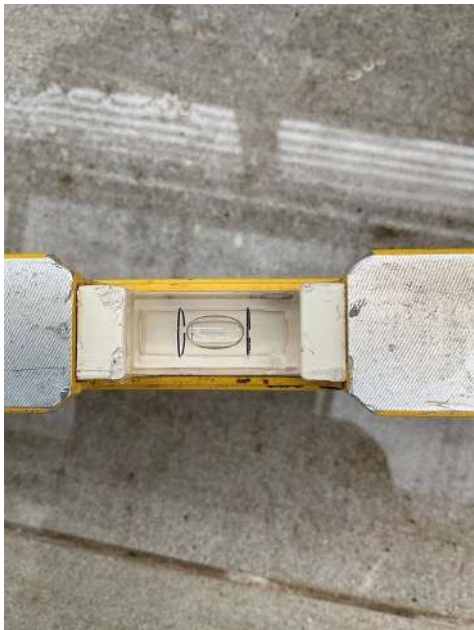
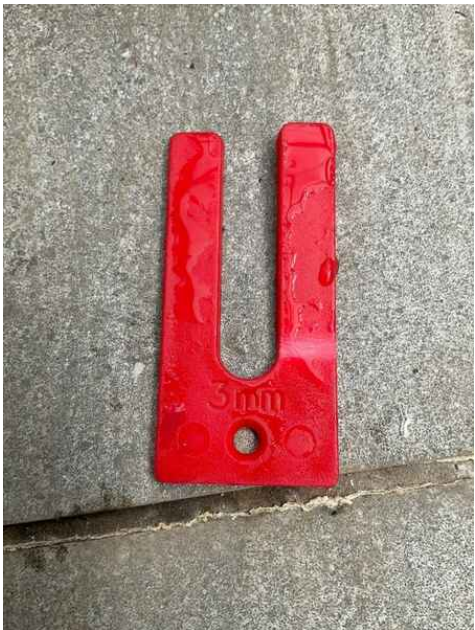
Water ponding to balcony above the water stain area

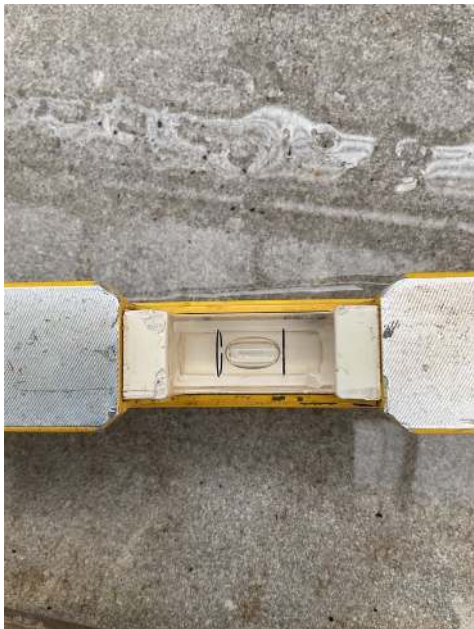
Floor is level for the first 1200mm away from the drain.

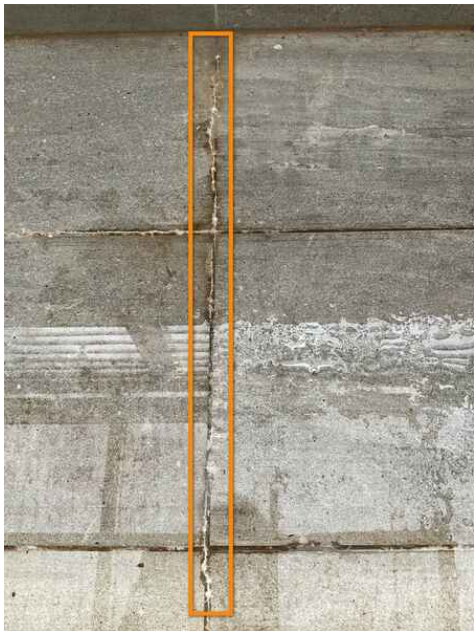
Efflorescence to the balcony in this area

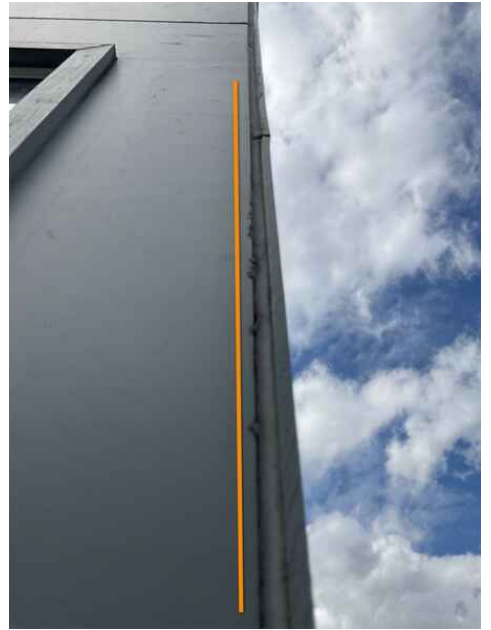
Matrix cladding joints require re sealing. - Homeowners Maintenance

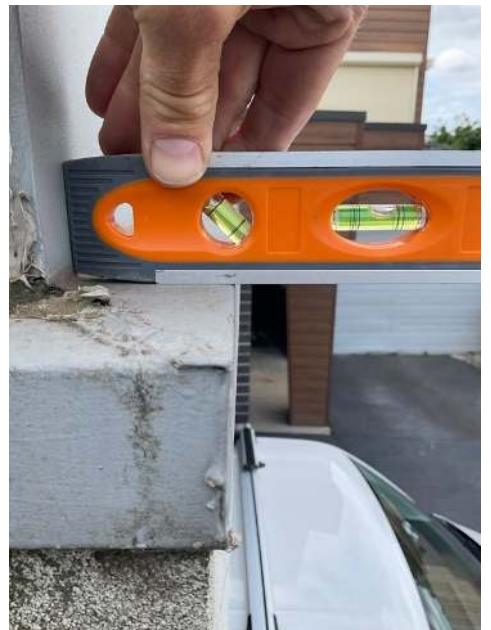
Negative fall to sill flashing.

The sill flashing needs to be rectified to ensure adequate fall is achieved, the matrix cladding is to have the required 6mm gap installed between the bottom of the cladding and the sill flashing, and the existing sealant is to be removed. These building defects must be repaired to ensure no future water ingress occurs to this area.

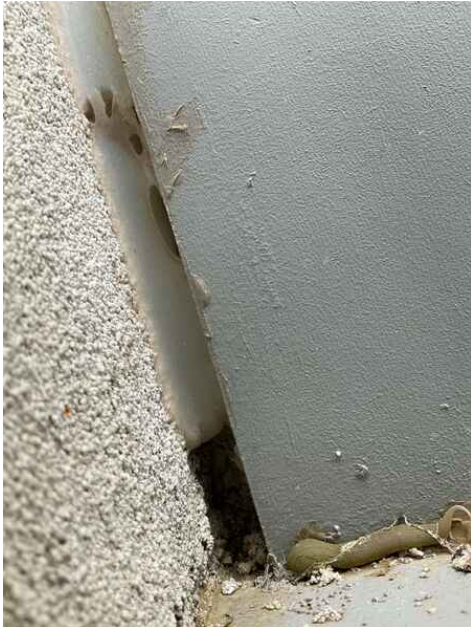
Holes not selaed

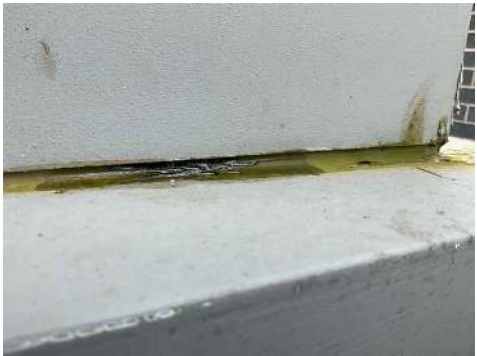
Ponding water. No flashing installed
